**Site:** Morris Street, Radcliffe  
**Plots:** 10-25  
**Date:** February 2023

## 1 INTRODUCTION

LK Consult (LKC) has been appointed by Watson Construction Ltd to provide verification of the gas protection measures installed at the development at Morris Street, Radcliffe.

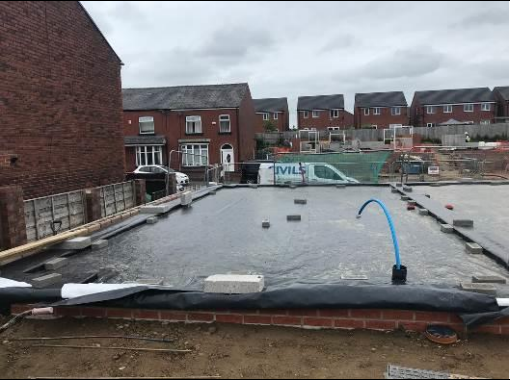
| | <p><b>Photograph 1:</b><br/>Evidence of gas membrane installed across the plot.</p> |

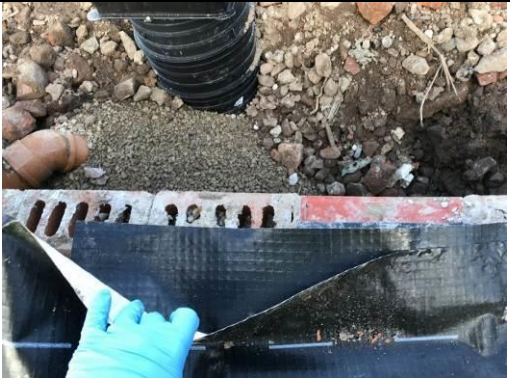
| | <p><b>Photograph 2:</b><br/>Example of overlapping and sealing of gas membrane appropriately sealed at joints.</p> |

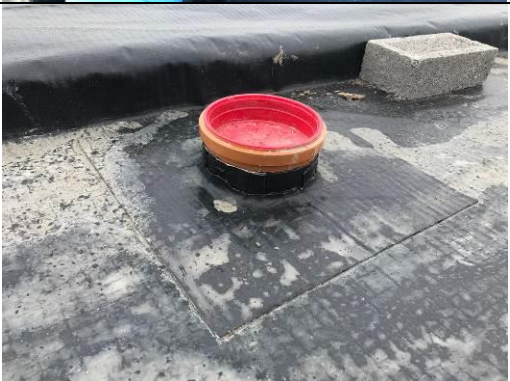
| | <p><b>Photograph 3:</b><br/>Evidence of top hats and sealing at service entry points.</p> |

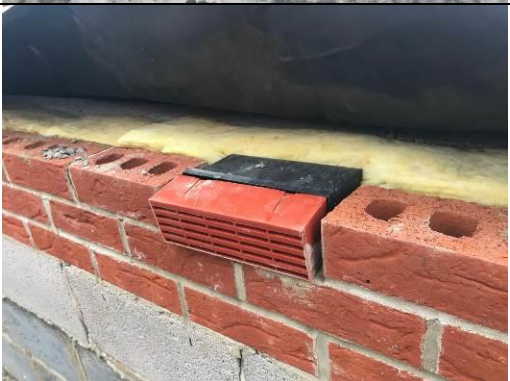
| | <p><b>Photograph 4:</b><br/>Evidence of installation of air bricks.</p> |

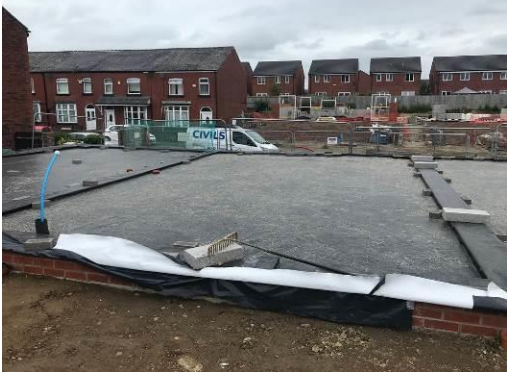
| | <p><b>Photograph 1:</b><br/>Evidence of gas membrane installed across the plot.</p> |

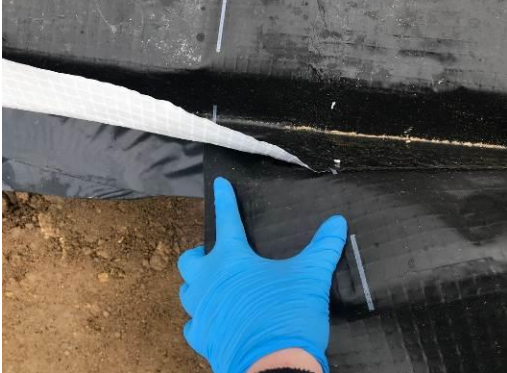
| | <p><b>Photograph 2:</b><br/>Example of overlapping and sealing of gas membrane appropriately sealed at joints.</p> |

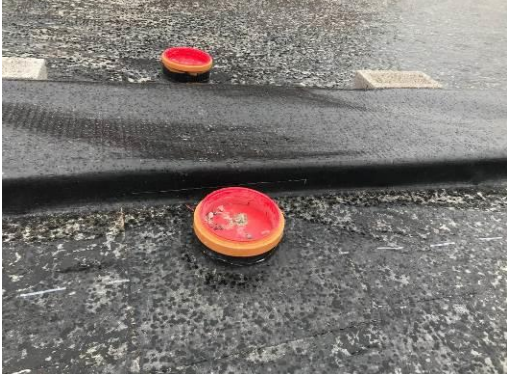
| | <p><b>Photograph 3:</b><br/>Evidence of top hats and sealing at service entry points.</p> |

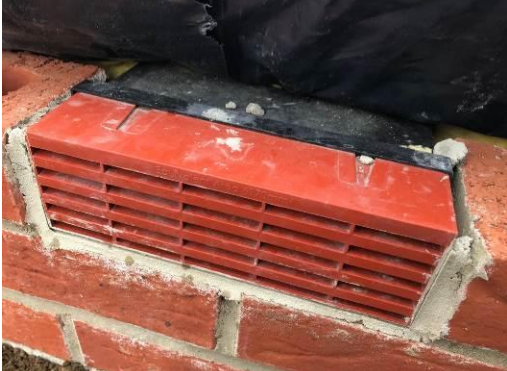
| | <p><b>Photograph 4:</b><br/>Evidence of installation of air bricks.</p> |

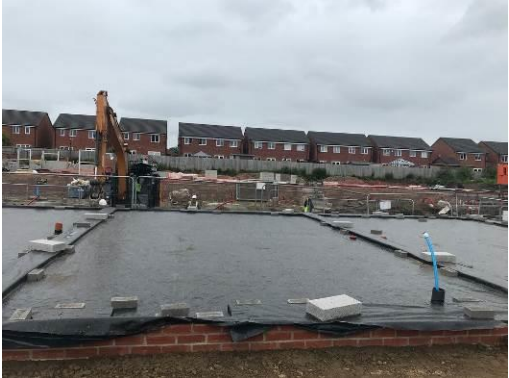
| | | <p><b>Photograph 1:</b><br/>Evidence of gas membrane installed across the plot.</p> |

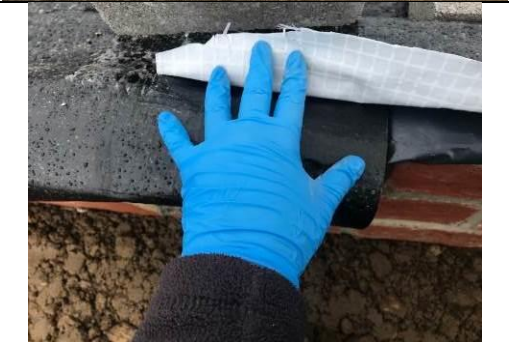
| | | <p><b>Photograph 2:</b><br/>Example of overlapping and sealing of gas membrane appropriately sealed at joints.</p> |

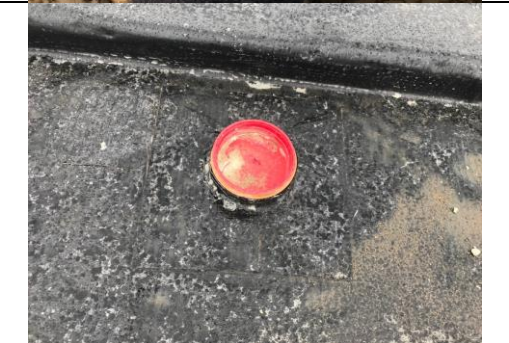
| | | <p><b>Photograph 3:</b><br/>Evidence of top hats and sealing at service entry points.</p> |

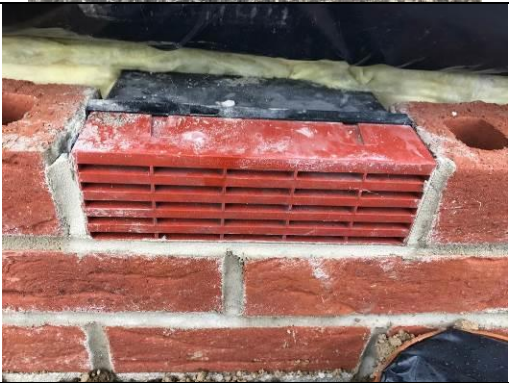
| | | <p><b>Photograph 4:</b><br/>Evidence of installation of air bricks.</p> |

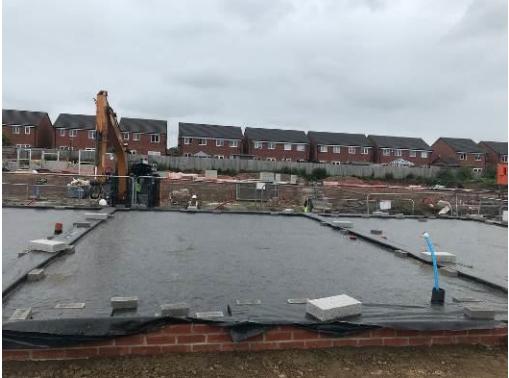
| | | <p><b>Photograph 1:</b><br/>Evidence of gas membrane installed across the plot.</p> |

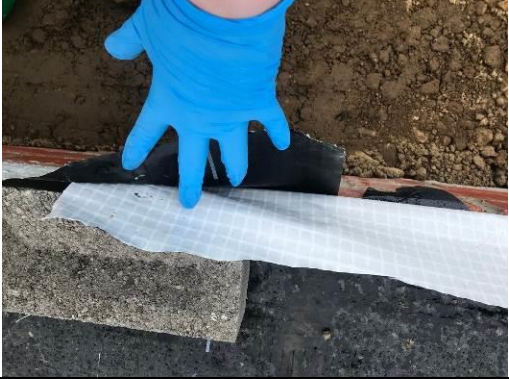
| | | <p><b>Photograph 2:</b><br/>Example of overlapping and sealing of gas membrane appropriately sealed at joints.</p> |

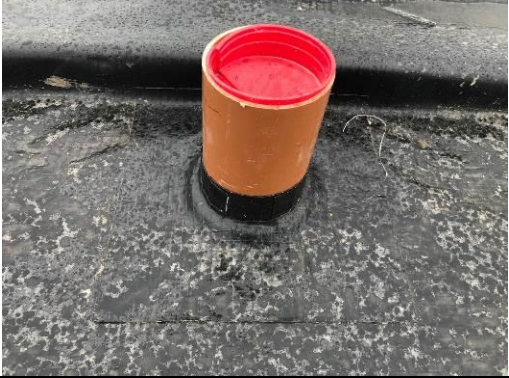
| | | <p><b>Photograph 3:</b><br/>Evidence of top hats and sealing at service entry points.</p> |

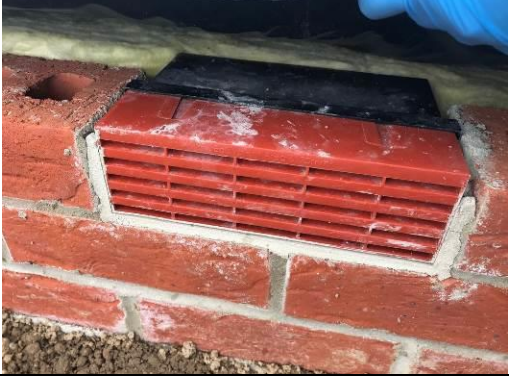
| | | <p><b>Photograph 4:</b><br/>Evidence of installation of air bricks.</p> |

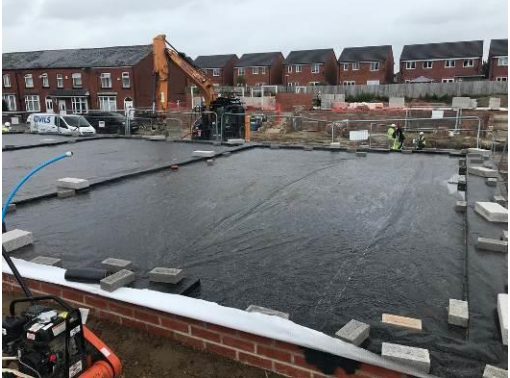
| | <p><b>Photograph 1:</b><br/>Evidence of gas membrane installed across the plot.</p> |

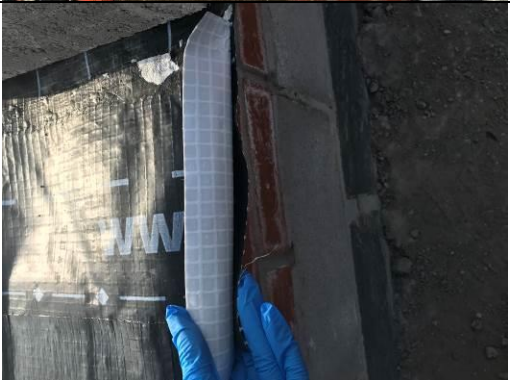
| | <p><b>Photograph 2:</b><br/>Example of overlapping and sealing of gas membrane appropriately sealed at joints.</p> |

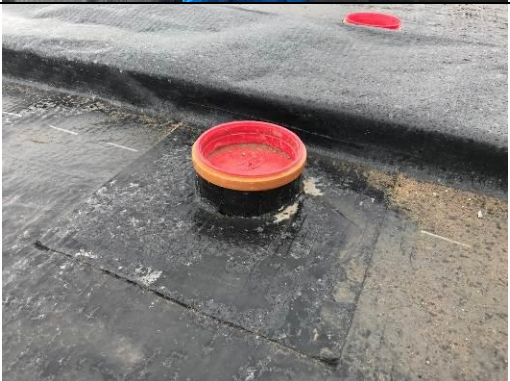
| | <p><b>Photograph 3:</b><br/>Evidence of top hats and sealing at service entry points.</p> |

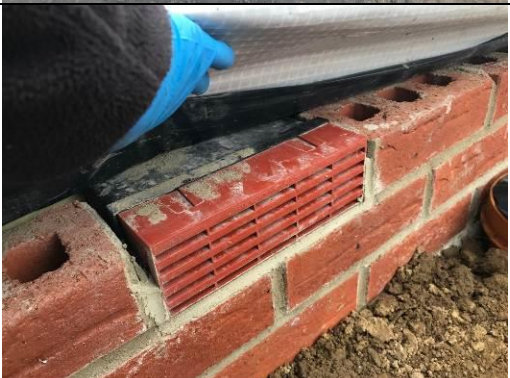
| | <p><b>Photograph 4:</b><br/>Evidence of installation of air bricks.</p> |

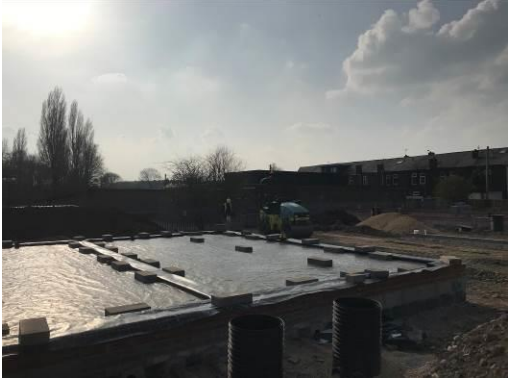
| | <p><b>Photograph 1:</b><br/>Evidence of gas membrane installed across the plot.</p> |

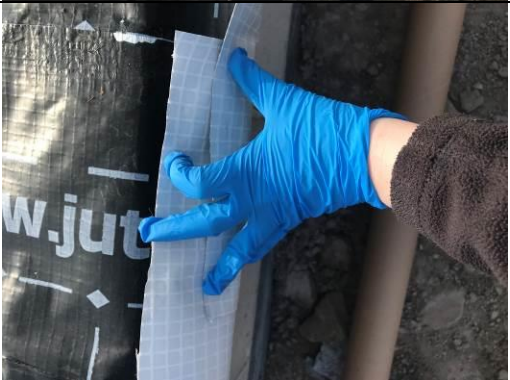
| | <p><b>Photograph 2:</b><br/>Example of overlapping and sealing of gas membrane appropriately sealed at joints.</p> |

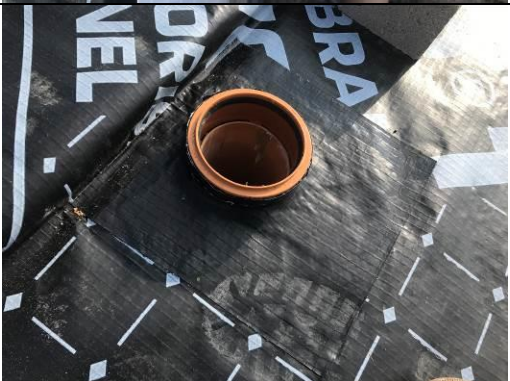
| | <p><b>Photograph 3:</b><br/>Evidence of top hats and sealing at service entry points.</p> |

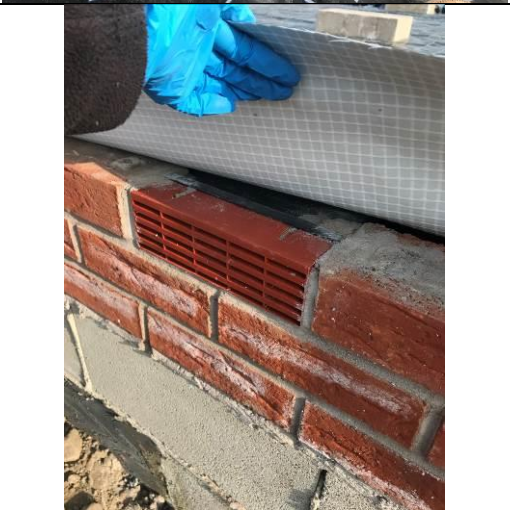
| | <p><b>Photograph 4:</b><br/>Evidence of installation of air bricks.</p> |

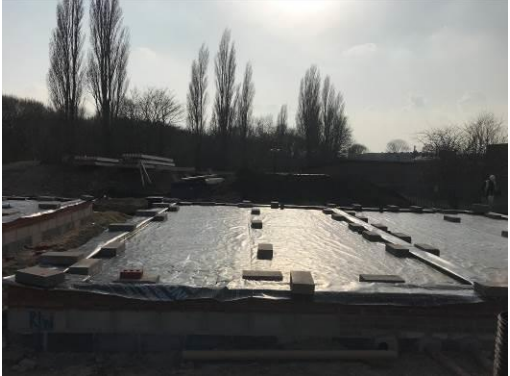
| | <p><b>Photograph 1:</b><br/>Evidence of gas membrane installed across the plot.</p> |

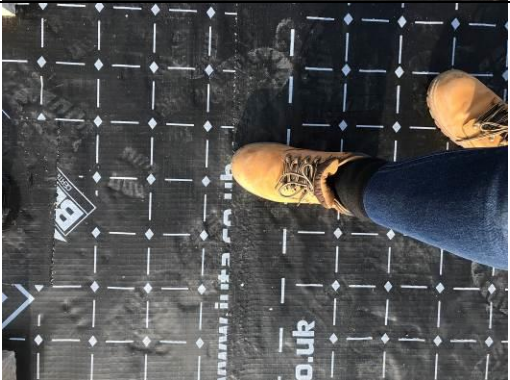
| | <p><b>Photograph 2:</b><br/>Example of overlapping and sealing of gas membrane appropriately sealed at joints.</p> |

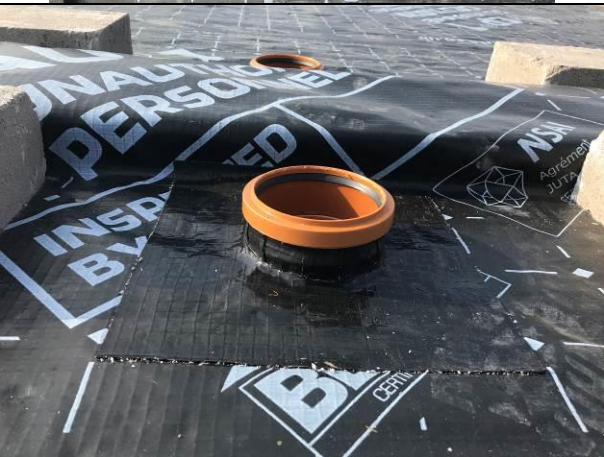
| | <p><b>Photograph 3:</b><br/>Evidence of top hats and sealing at service entry points.</p> |

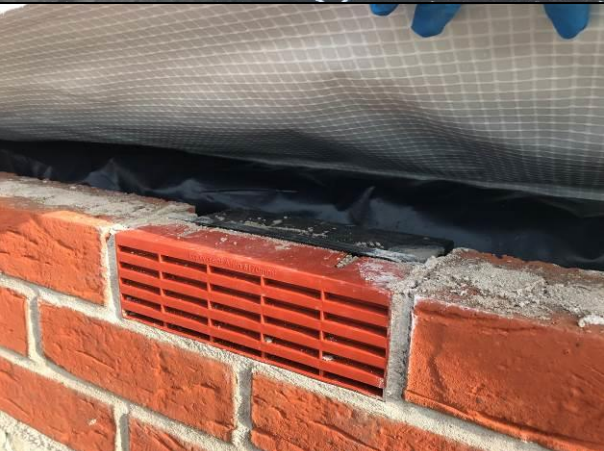
| | <p><b>Photograph 4:</b><br/>Evidence of installation of air bricks.</p> |

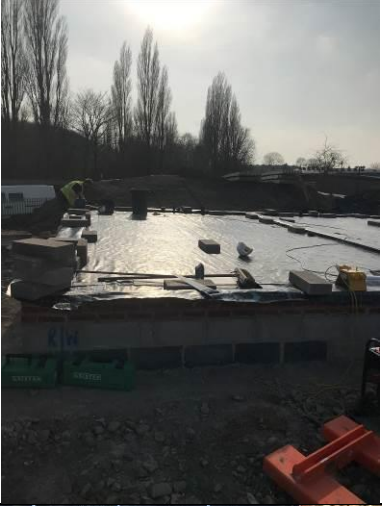
| | | <p><b>Photograph 1:</b><br/>Evidence of gas membrane installed across the plot.</p> |

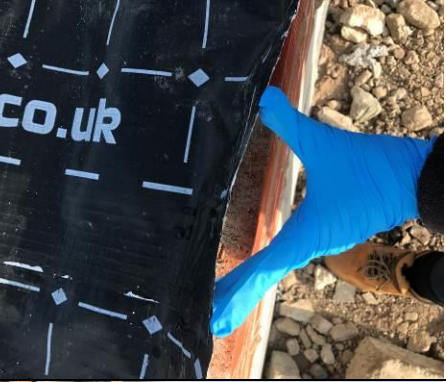
| | | <p><b>Photograph 2:</b><br/>Example of overlapping and sealing of gas membrane appropriately sealed at joints.</p> |

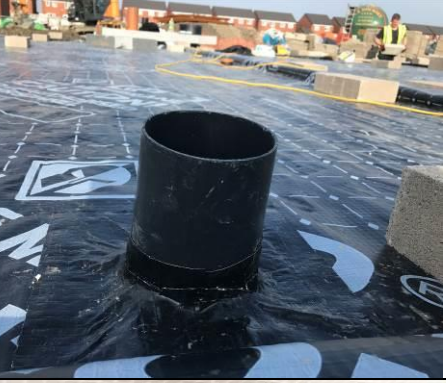
| | | <p><b>Photograph 3:</b><br/>Evidence of top hats and sealing at service entry points.</p> |

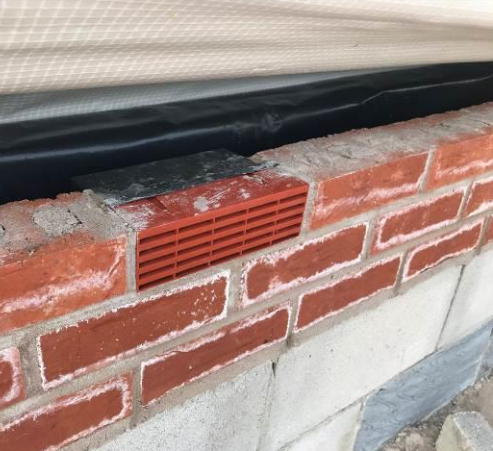
| | | <p><b>Photograph 4:</b><br/>Evidence of installation of air bricks.</p> |

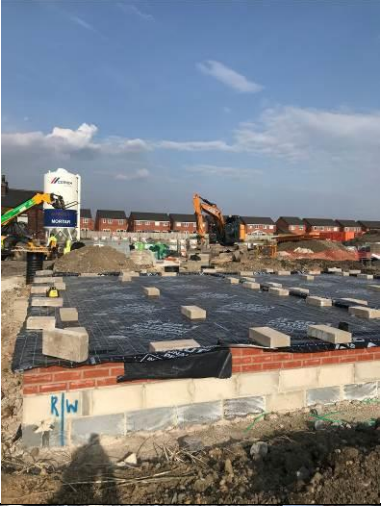
| | | <p><b>Photograph 1:</b><br/>Evidence of gas membrane installed across the plot.</p> |

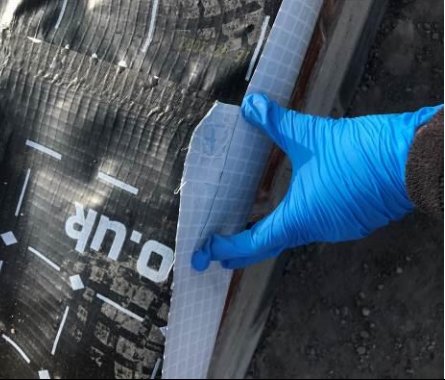
| | | <p><b>Photograph 2:</b><br/>Example of overlapping and sealing of gas membrane appropriately sealed at joints.</p> |

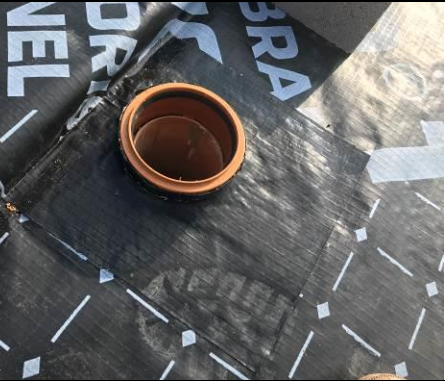
| | | <p><b>Photograph 3:</b><br/>Evidence of top hats and sealing at service entry points.</p> |

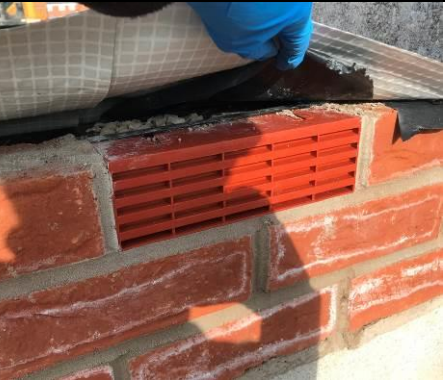
| | | <p><b>Photograph 4:</b><br/>Evidence of installation of air bricks.</p> |

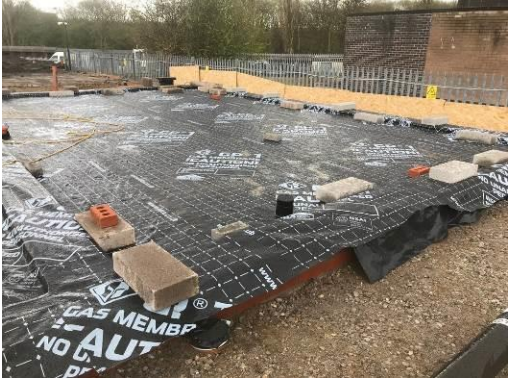
| | <p><b>Photograph 1:</b><br/>Evidence of gas membrane installed across the plot.</p> |

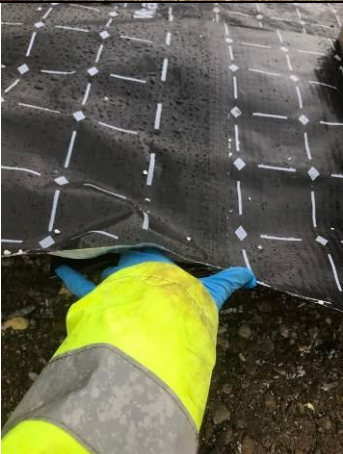
| | <p><b>Photograph 2:</b><br/>Example of overlapping and sealing of gas membrane appropriately sealed at joints.</p> |

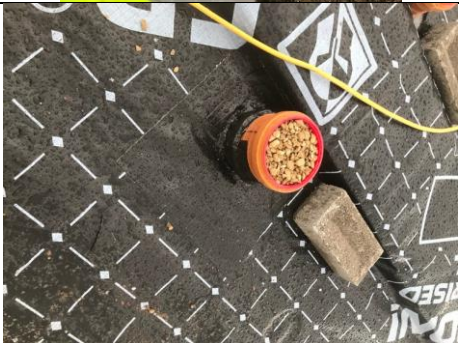
| | <p><b>Photograph 3:</b><br/>Evidence of top hats and sealing at service entry points.</p> |

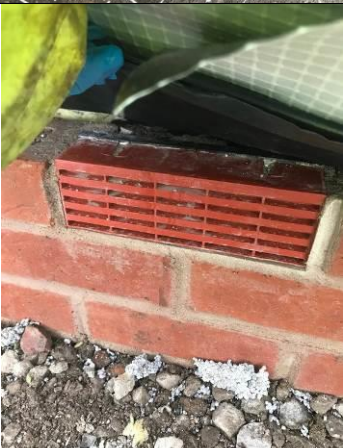
| | <p><b>Photograph 4:</b><br/>Evidence of installation of air bricks.</p> |

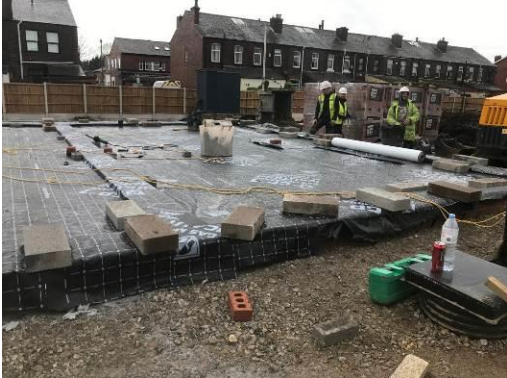
| | <p><b>Photograph 1:</b><br/>Evidence of gas membrane installed across the plot.</p> |

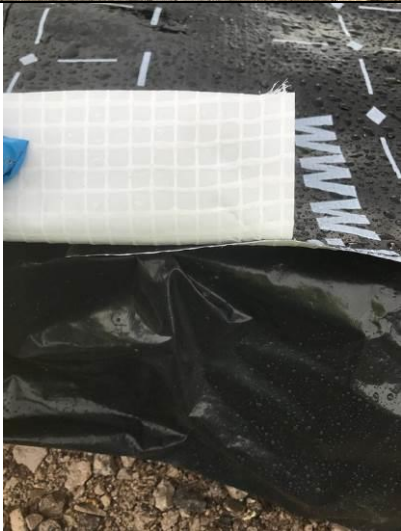
| | <p><b>Photograph 2:</b><br/>Example of overlapping and sealing of gas membrane appropriately sealed at joints.</p> |

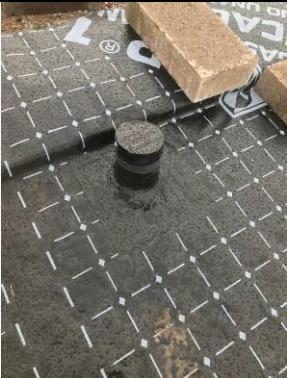
| | <p><b>Photograph 3:</b><br/>Evidence of top hats and sealing at service entry points.</p> |

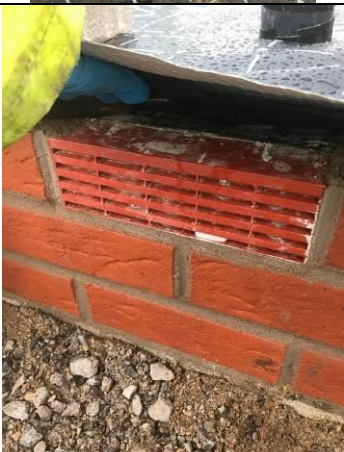
| | <p><b>Photograph 4:</b><br/>Evidence of installation of air bricks.</p> |

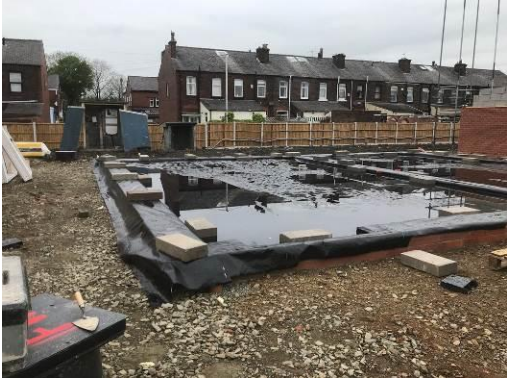
| | <p><b>Photograph 1:</b><br/>Evidence of gas membrane installed across the plot.</p> |

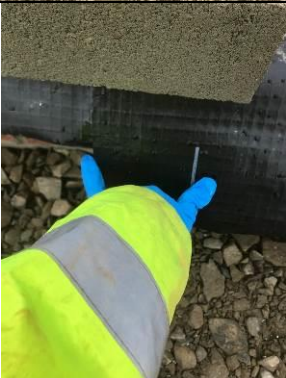
| | <p><b>Photograph 2:</b><br/>Example of overlapping and sealing of gas membrane appropriately sealed at joints.</p> |

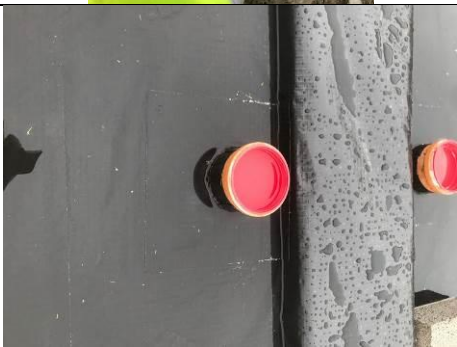
| | <p><b>Photograph 3:</b><br/>Evidence of top hats and sealing at service entry points.</p> |

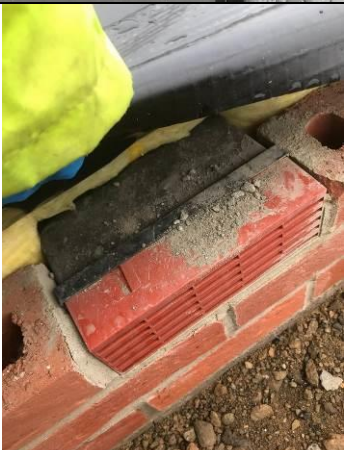
| | <p><b>Photograph 4:</b><br/>Evidence of installation of air bricks.</p> |

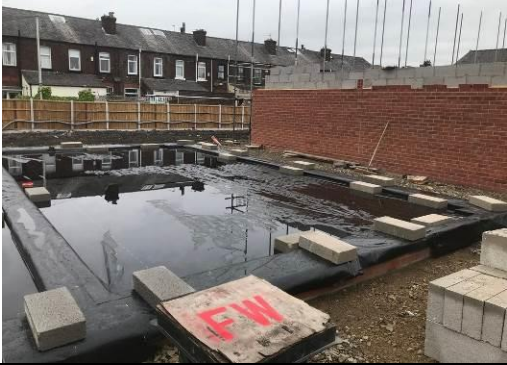
| | <p><b>Photograph 1:</b><br/>Evidence of gas membrane installed across the plot.</p> |

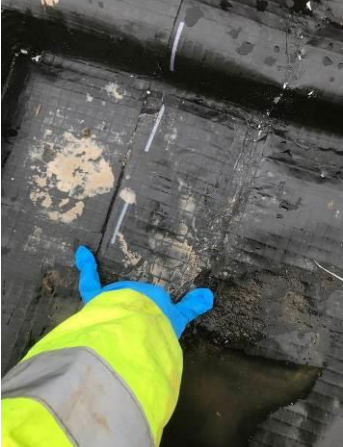
| | <p><b>Photograph 2:</b><br/>Example of overlapping and sealing of gas membrane appropriately sealed at joints.</p> |

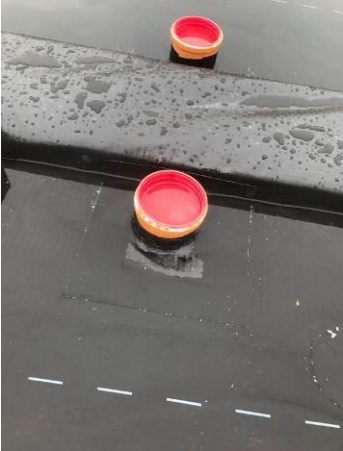
| | <p><b>Photograph 3:</b><br/>Evidence of top hats and sealing at service entry points.</p> |

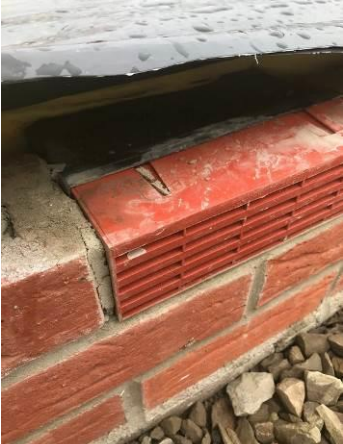
| | <p><b>Photograph 4:</b><br/>Evidence of installation of air bricks.</p> |

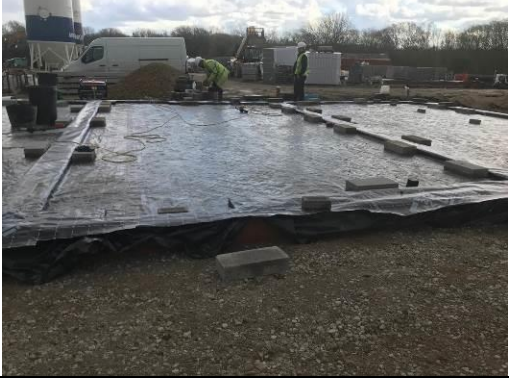
| | <p><b>Photograph 1:</b><br/>Evidence of gas membrane installed across the plot.</p> |

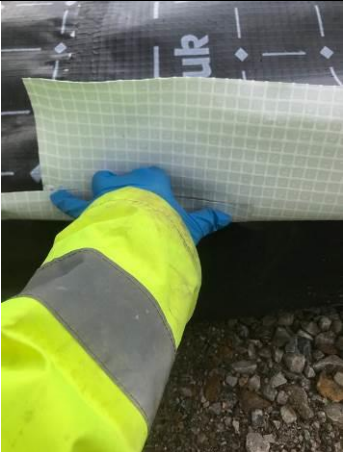
| | <p><b>Photograph 2:</b><br/>Example of overlapping and sealing of gas membrane appropriately sealed at joints.</p> |

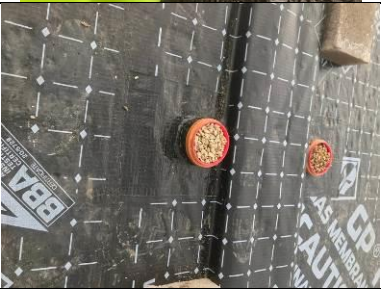
| | <p><b>Photograph 3:</b><br/>Evidence of top hats and sealing at service entry points.</p> |

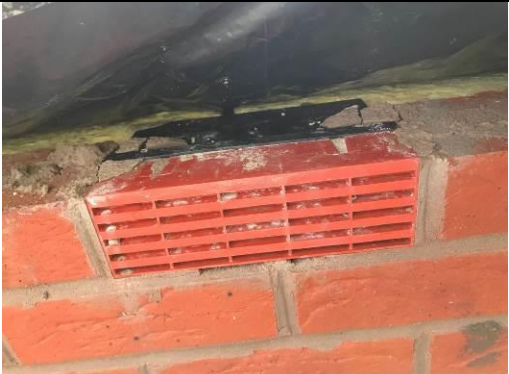
| | <p><b>Photograph 4:</b><br/>Evidence of installation of air bricks.</p> |

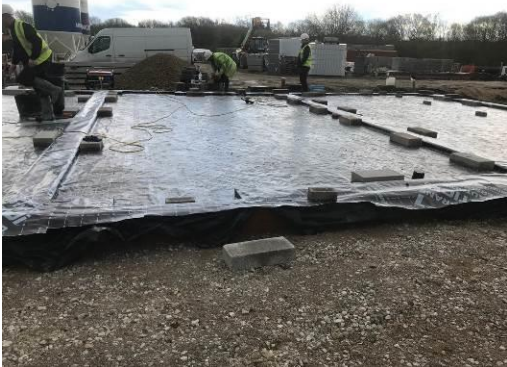
| | <p><b>Photograph 1:</b><br/>Evidence of gas membrane installed across the plot.</p> |

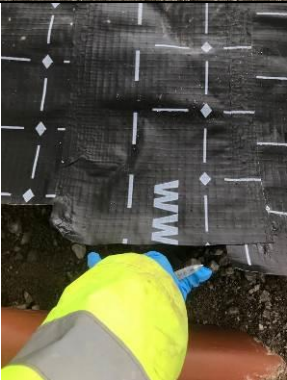
| | <p><b>Photograph 2:</b><br/>Example of overlapping and sealing of gas membrane appropriately sealed at joints.</p> |

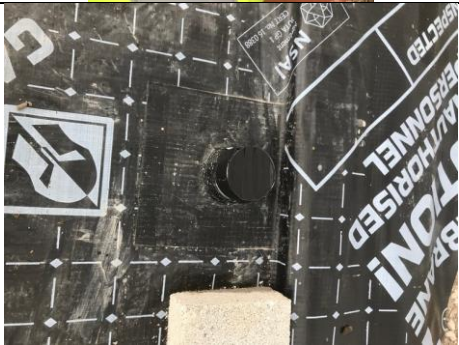
| | <p><b>Photograph 3:</b><br/>Evidence of top hats and sealing at service entry points.</p> |

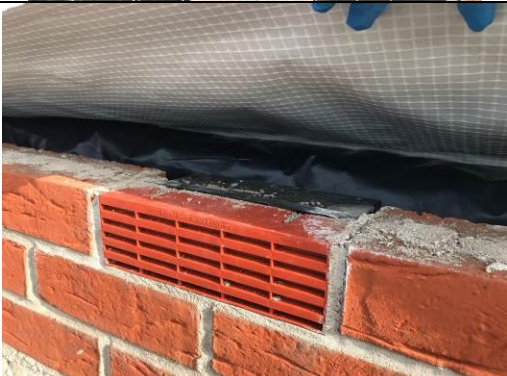
| | <p><b>Photograph 4:</b><br/>Evidence of installation of air bricks.</p> |

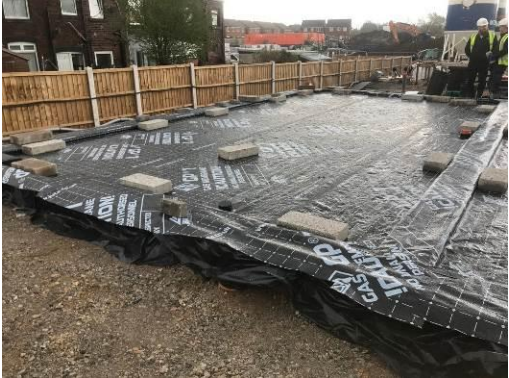
| | <p><b>Photograph 1:</b><br/>Evidence of gas membrane installed across the plot.</p> |

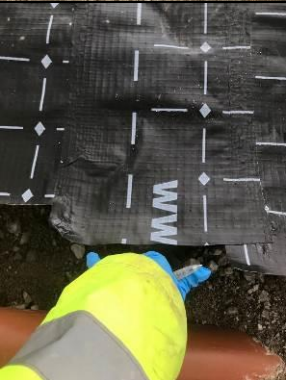
| | <p><b>Photograph 2:</b><br/>Example of overlapping and sealing of gas membrane appropriately sealed at joints.</p> |

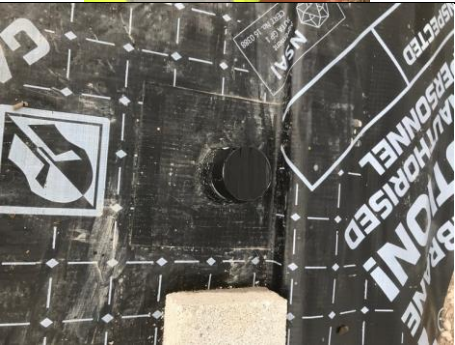
| | <p><b>Photograph 3:</b><br/>Evidence of top hats and sealing at service entry points.</p> |

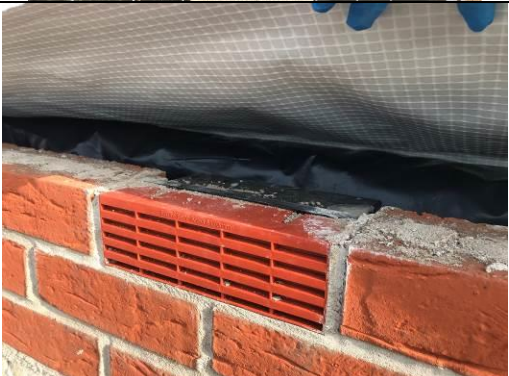
| | <p><b>Photograph 4:</b><br/>Evidence of installation of air bricks.</p> |
