# PRELIMINARY ROOST ASSESSMENT

**FEBRUARY 2023**

**The Rock, Bury**

137 The Rock,  
Bury  
BL9 0ND

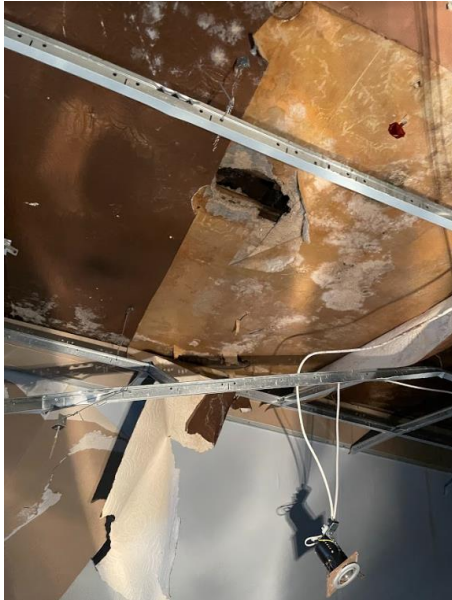
The ground floor was in a state of disrepair, with extensive damage present in the majority of the internal walls and ceilings. A false ceiling was present, with the tiles mostly having been removed or had fallen to expose insulation material and electrical wiring, with crevices present leading into the cavity below the first floor.

**Photograph 1 – Damaged false ceiling**

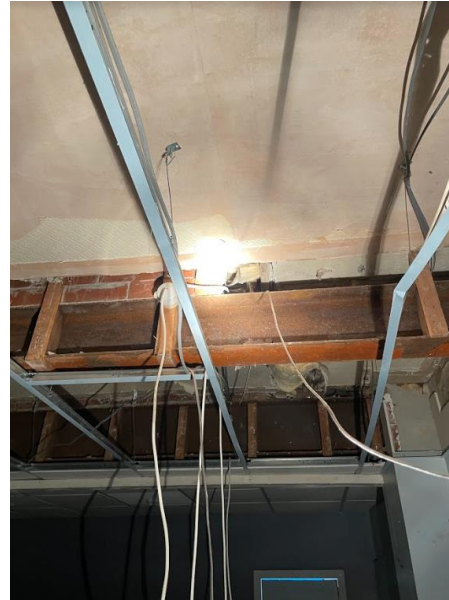
**Photograph 2 – Damaged false ceiling**

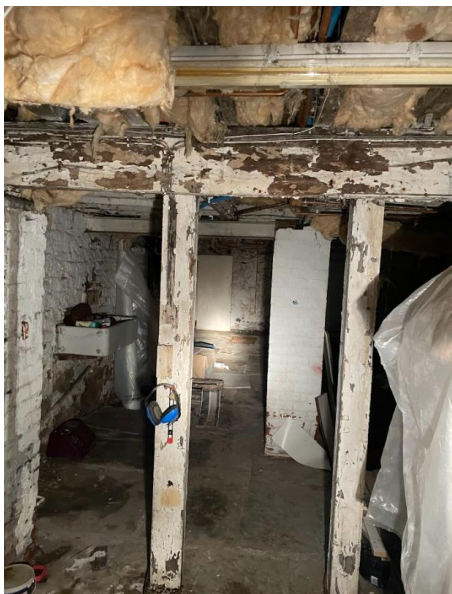
A cellar space was present beneath the building, accessible from the main ground floor where an open hatch was exposed, leading to a staircase. This floor featured extensive damage to the ceiling, with the cavity below the ground floor fully exposed and open gaps visible into the floor above.

**Photograph 3 – Cellar with removed ceiling**

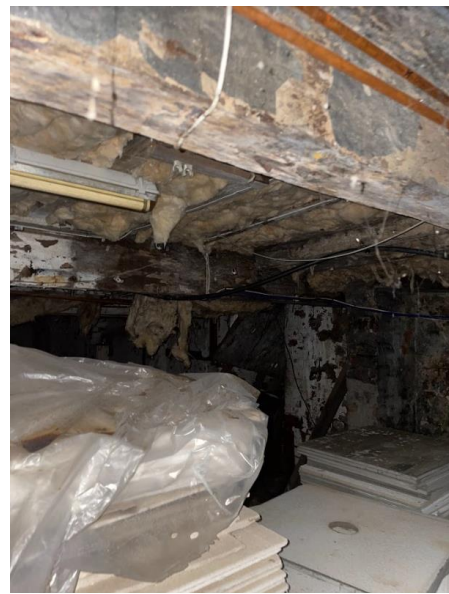
**Photograph 4 – Damage within cellar**

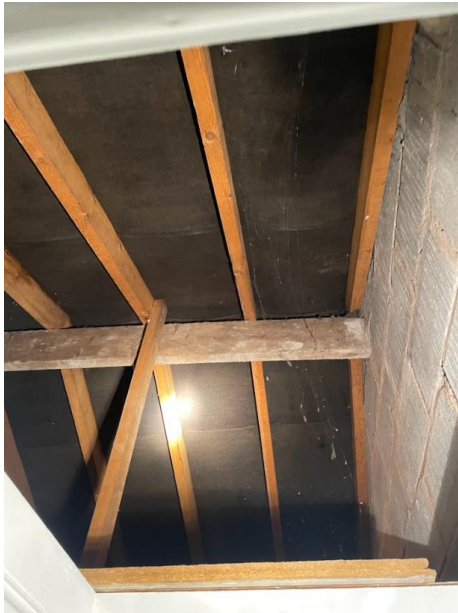
The first floor was comprised of a hallway which extended out into multiple rooms. Multiple rooms featured windows, though no access from the outside was present. One room to the south of the first floor featured a loft hatch, extending into the first floor ceiling cavity. This cavity was generally well sealed,

with no access visible from the outside, although several small tears in the insulation were present. Multiple cobwebs were visible, with no evidence of bats present within the void.

**Photograph 5 – First floor loft void**

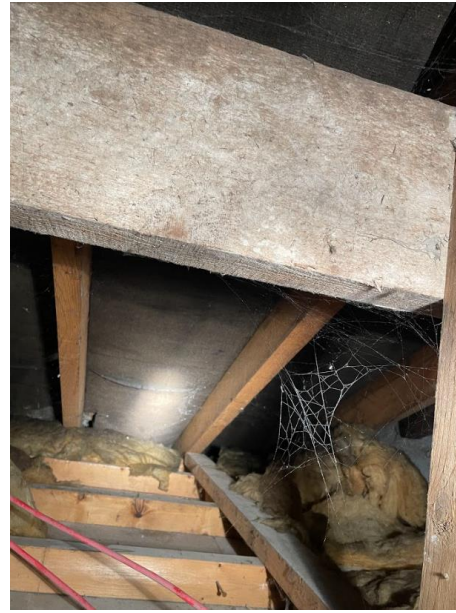
**Photograph 6 – First floor loft void with tear in insulation fabric present**

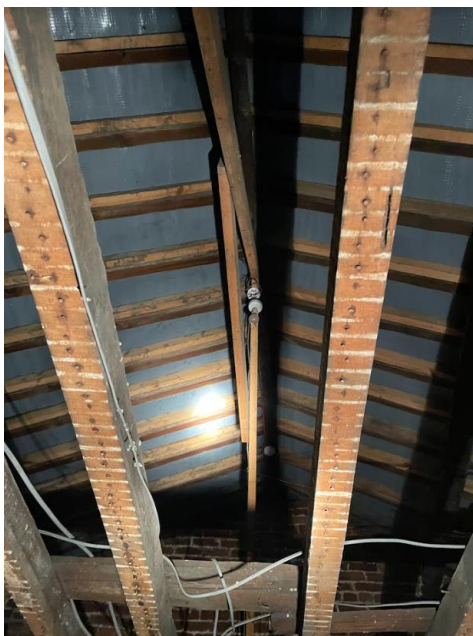
The second floor comprised a set of empty rooms featuring bare brick walling and windows, some of which were boarded. The ceiling extended up to the roof, with no loft void present. The ceiling was found to be in a well-sealed condition, with no tears in the insulation material or gaps in the roofing allowing light within the building. A fireplace was present, extending into a chimney from which fallen debris was present. Long wooden beams spanned the length of the pitching.

**Photograph 7 – Second floor rooftop**

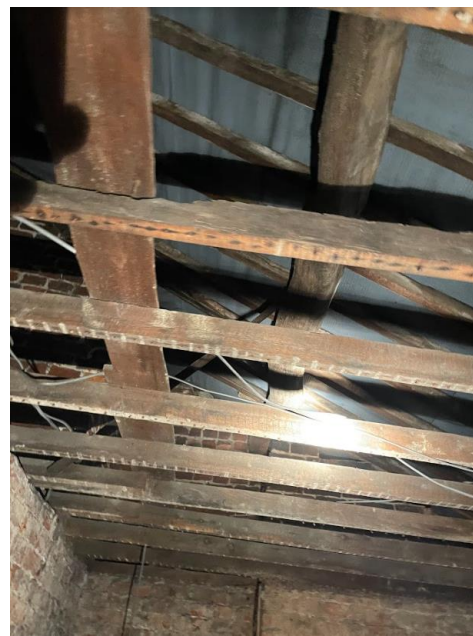
**Photograph 8 – Beams present within second floor rooftop**

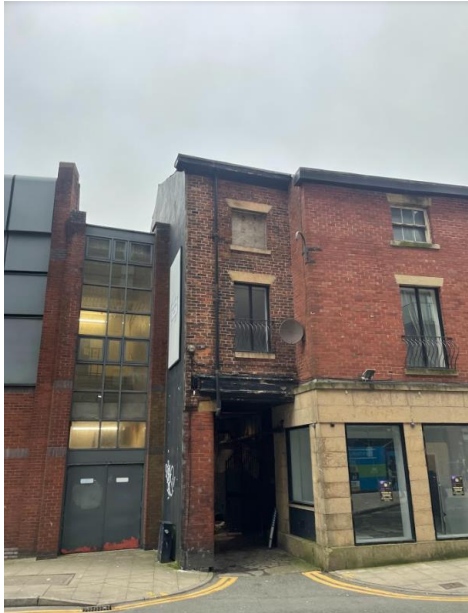
Externally the building comprised a mixture of exposed brick, slate tiled, and mortared walling. The southern facing wall covered all three floors and was well sealed across all aspects, with no obvious PRFs visible. The roof was unable to be surveyed due to a lack of a suitable vantage point from which to be viewed.

**Photograph 9 – Southern aspect of B1**

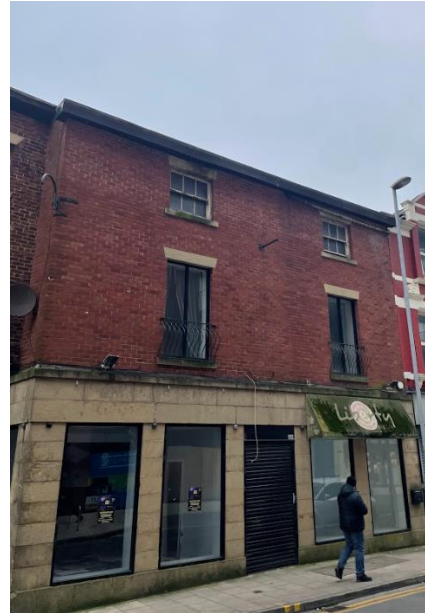
**Photograph 10 – Southern aspect of B1**

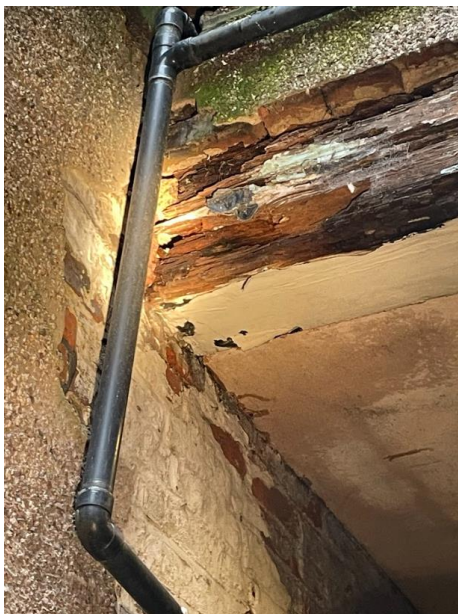
An underpass was present under the first floor of B1 (see Photograph 9), leading to the rear courtyard. The roof of the underpass featured numerous PRFs, with extensive damage exposing potential gaps and cavities.

**Photograph 11 – Rotting wood exposing crevices within the underpass**

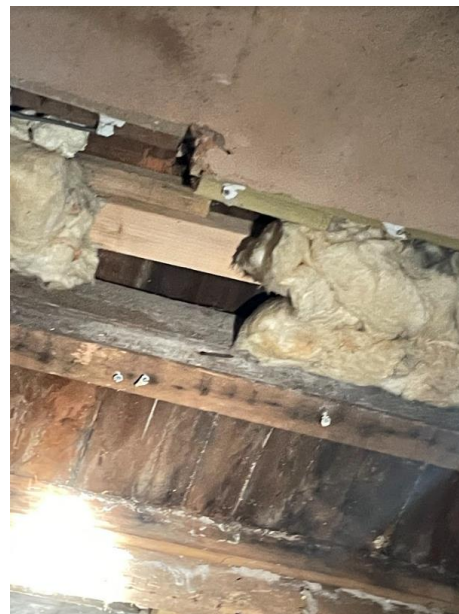
**Photograph 12 – Damage to the underpass roof exposing gaps in the insulation material**

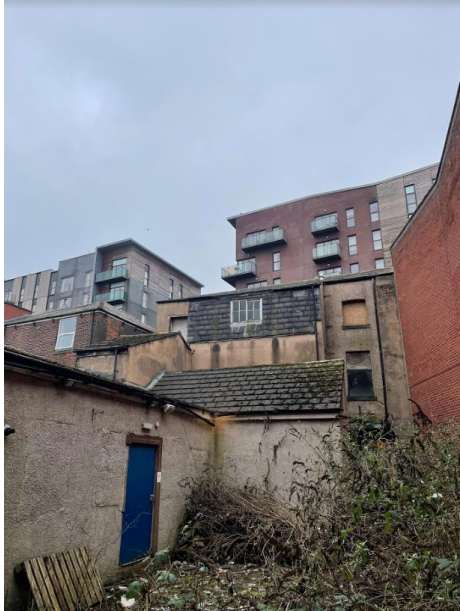
The rear courtyard was in a state of disrepair, having not been managed for some time. Three pitched rooves were present across three individual floors, all in various states of disrepair. No large external

**Photograph 13 – Rear courtyard featuring multiple pitched roofs**

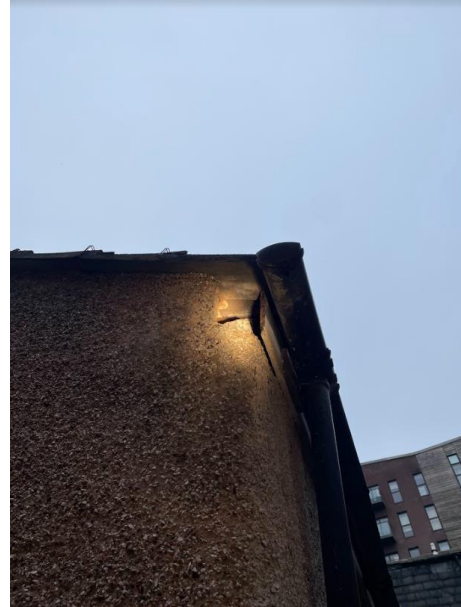
The ground floor roof had an extensive gap beneath the eaves on the northern aspect, possibly leading into the roof cavity (see Photograph 14). The roof tiling above this section was well sealed, providing suitable tight cover for bats to roost within.

**Photograph 14 – Gap below the eaves on the northern aspect of the ground floor roof**

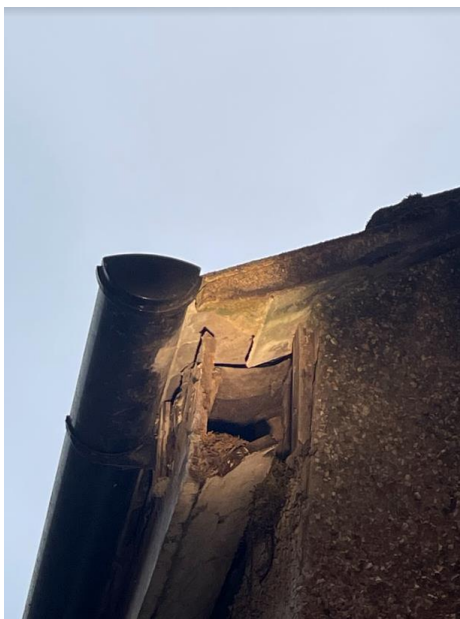
A second gap in the eaves was present along the southwestern aspect of the ground floor roof (see Photograph 15). This was similar to the previous PRF, with well-sealed roofing above, providing tight cover for bats to roost within. This also served as a suitable PRF.

**Photograph 15 – Gap below the eaves on the southwestern aspect of the ground floor roof**

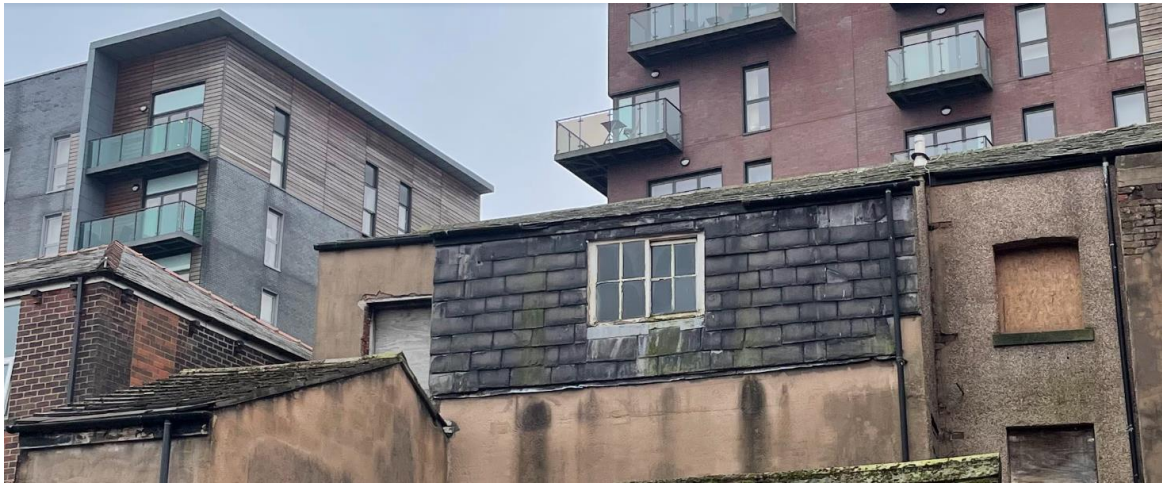
The second floor roof did not visibly display any PRFs, with the roof tiling appearing to be in a well-sealed state. The northern aspect of this rooftop was not able to be surveyed due to a lack of a suitable vantage points, though this served as a relatively small part of the roof.

**Photograph 16 – Third floor wall and second floor rooftop**

Lead flashing was present below the tiled portion of the third-floor wall, being shown to have lifted extensively providing further possible PRFs, though this was unable to be ascertained by visual assessment. Some gaps were also present above the flashing along the lowest layer of tiles. The third floor rooftop was visible from the farthest section of the rooftop, with the tiles appearing to be in a well-sealed state.
