# MILLWOOD SEN SCHOOL RADCLIFFE

## SHALLOW COAL MINING SITE INVESTIGATION WORKS

**Job Number:** LKC 23 1383  
**Date:** September 2023  
**Client:** ISG Construction Ltd

| <b>LK Consult</b><br><b>Document Verification</b> | | | |
|---|---|---|---|
| <b>Report Title</b> | Shallow Coal Mining Investigation Works | | |

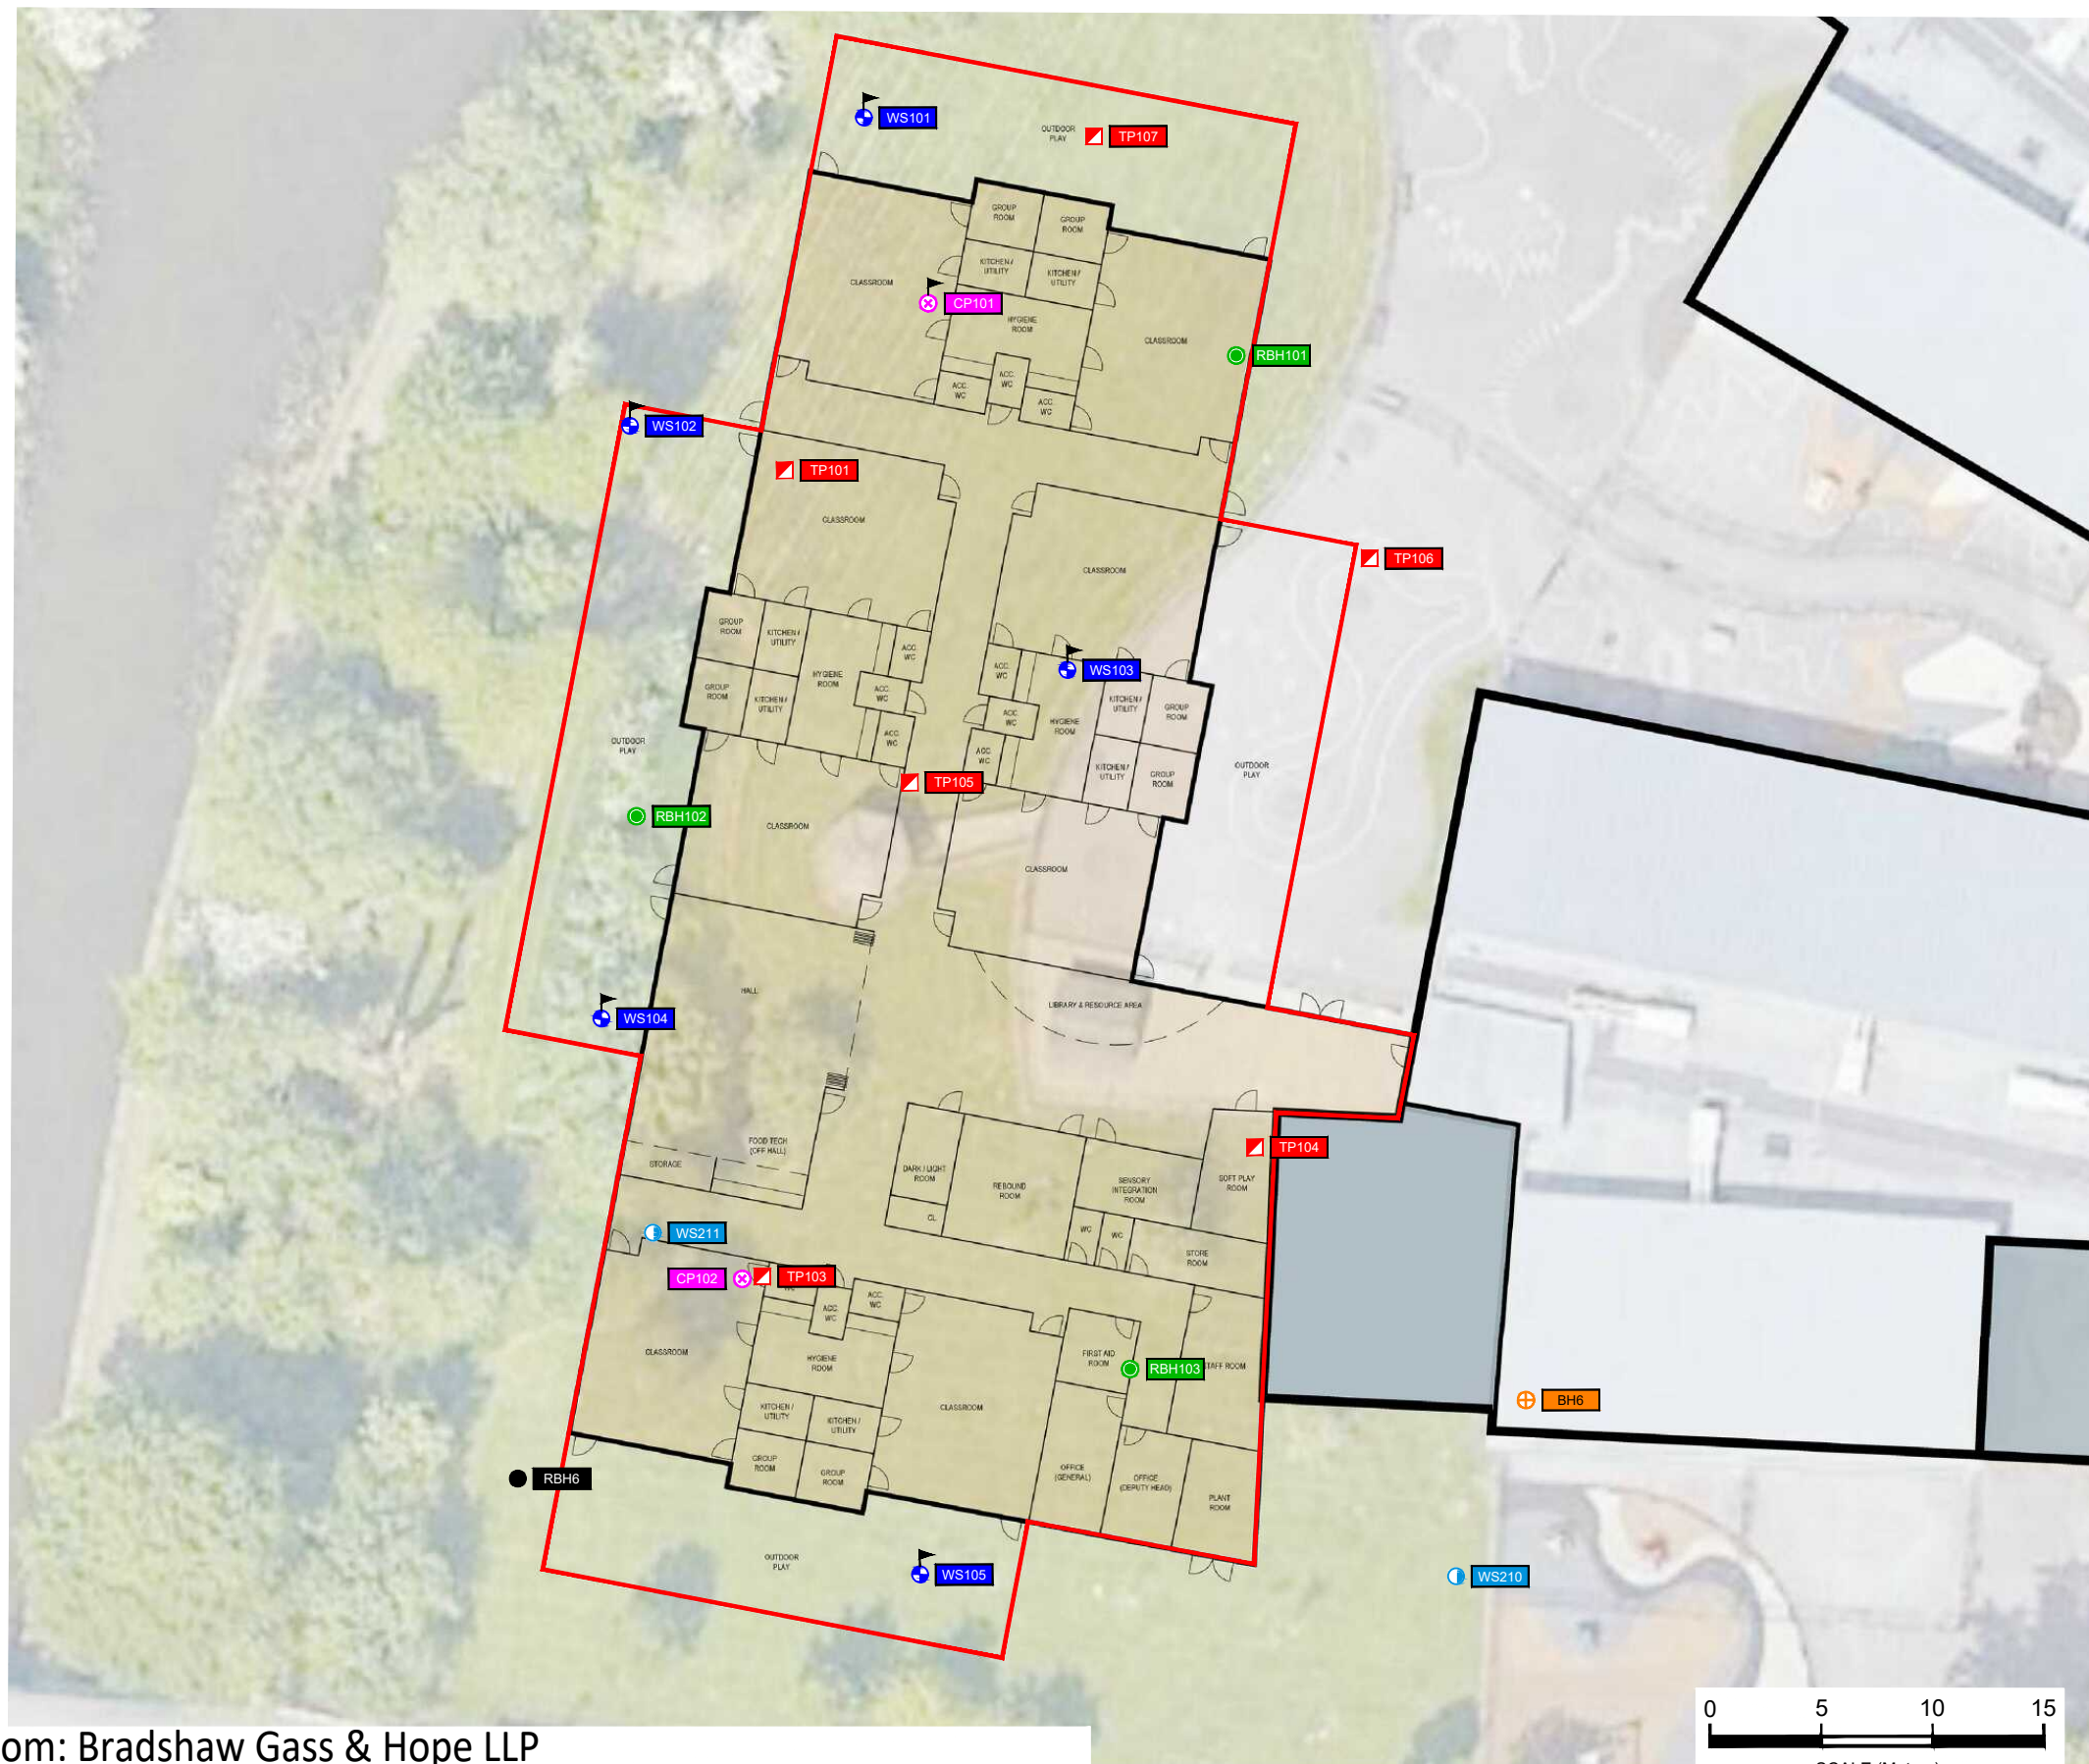
- Light grey sandstone with mudstone bands recorded between 21.20mbgl and 30.80mbgl.
- Light grey mudstone recorded between 30.10mbgl and 42.00mbgl. Sandstone bands were recorded within the light grey mudstone in RBH103 between 30.10mbgl and 41.50mbgl.

- Shaley mudstone was recorded in RBH103 between 43.00mbgl and 43.30mbgl.
- **Coal** recorded in RBH101 at 42.00-43.50mbgl (shaley coal, intact) and at 43.8-44.7mbgl (coal, intact). Thin band of dark grey mudstone (0.30m thick) between the coal seams.

- **Coal** recorded in RBH102 at 40.80-41.90mbgl (shaley coal, intact) and at 43.00-43.80mbgl (coal, intact). Thin band of dark grey mudstone (1.10m thick) between the coal seams.

- **Coal** recorded in RBH103 at 41.50-43.00mbgl (coal, intact) and 43.30-44.20mbgl (coal, intact). Thin band of dark grey shaley mudstone (0.3m thick) between the coal seams.

No evidence of loss of flush, loss of flush, broken drilling, fast drilling or the sudden dropping of the drill string were recorded. However, as described above, intact coal seams were encountered, in which potential for workings cannot be ruled out. This is discussed further in Sections 5.

Based on the above assessment, stabilisation work (i.e. grouting) is recommended and should be designed by an appropriately experienced and qualified contractor using the information provided. The scope should be agreed with the Coal Authority prior to undertaking the work.
