**Report No. DJ181109B**  
**Asbestos Refurb/Demo Survey**

**Textile Mill, Topping Street, Bury BL8 6DR**

**Date of survey:** 09/11/18

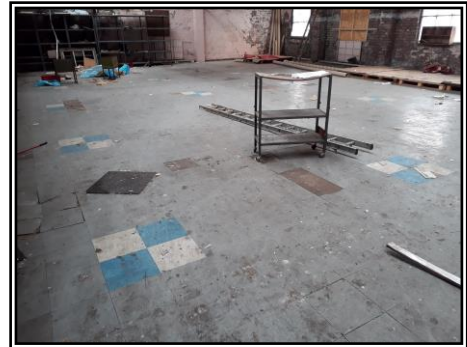
**Sample no:** 01  
**Room no:** 1/02  
**Location:** first floor workshop  
**Item:** grey vinyl floor tiles  
**Accessibility:** easy  
**Sample Taken:** Yes  
**Lab Result:** non-asbestos  
**Quantity:** N/A  
**Surface Treatment:** N/A  
**Areas of Damage:** N/A

**Comments:** Non-asbestos material.

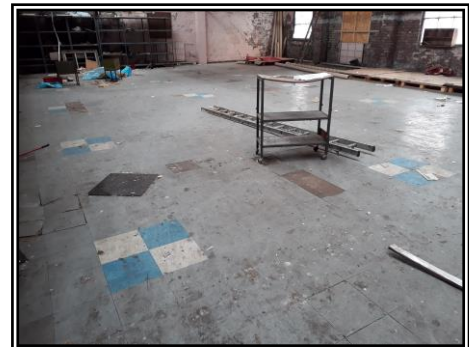
**Sample no:** 02  
**Room no:** 1/02  
**Location:** first floor workshop  
**Item:** blue vinyl floor tiles  
**Accessibility:** easy  
**Sample Taken:** Yes  
**Lab Result:** non-asbestos  
**Quantity:** N/A  
**Surface Treatment:** N/A  
**Areas of Damage:** N/A

**Comments:** Non-asbestos material.

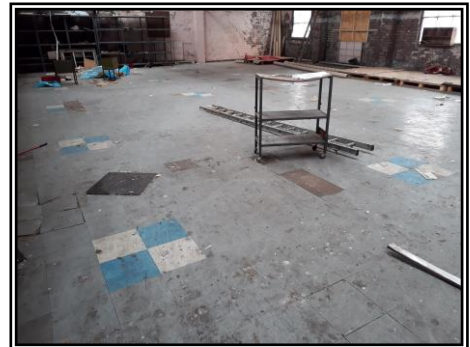
**Sample no:** 03  
**Room no:** 1/02  
**Location:** first floor workshop  
**Item:** white vinyl floor tiles  
**Accessibility:** easy  
**Sample Taken:** Yes  
**Lab Result:** non-asbestos  
**Quantity:** N/A  
**Surface Treatment:** N/A  
**Areas of Damage:** N/A

**Comments:** Non-asbestos material.

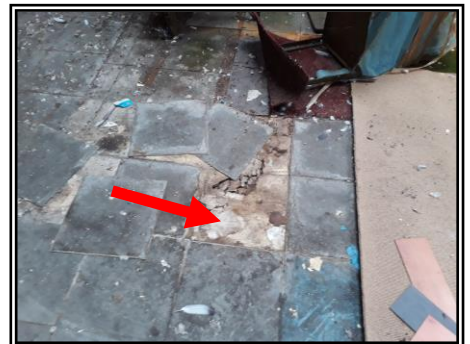
**Sample no:** 04  
**Room no:** 1/02  
**Location:** first floor workshop  
**Item:** white floor lining  
**Accessibility:** easy  
**Sample Taken:** Yes  
**Lab Result:** non-asbestos  
**Quantity:** N/A  
**Surface Treatment:** N/A  
**Areas of Damage:** N/A

**Comments:** Non-asbestos material.

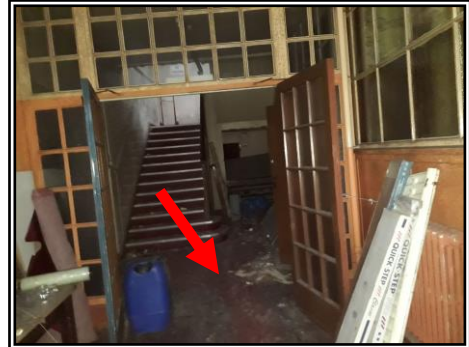
**Sample no:** 05  
**Room no:** 0/02  
**Location:** entrance hall  
**Item:** red vinyl sheet flooring  
**Accessibility:** easy  
**Sample Taken:** Yes  
**Lab Result:** non-asbestos  
**Quantity:** N/A  
**Surface Treatment:** N/A  
**Areas of Damage:** N/A

**Comments:** Non-asbestos material.

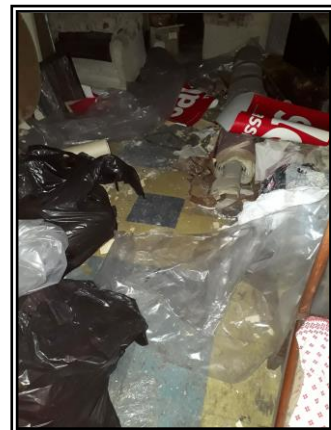
**Sample no:** 06  
**Room no:** 0/09 & 0/16  
**Location:** GF storage area  
**Item:** blue vinyl floor tiles  
**Accessibility:** easy  
**Sample Taken:** Yes  
**Lab Result:** chrysotile asbestos  
**Quantity:** 70sq.m  
**Surface Treatment:** composite  
**Areas of Damage:** minor

**Comments:** Asbestos material. The vinyl floor tiles to the ground floor storage area contain asbestos fibres. Asbestos vinyl floor tiles are a non-licensed material that may be removed by a suitably trained general contractor wearing appropriate RPE/PPE and following HSE guidance work methods. If removed, the floor tiles must be disposed as hazardous waste. Alternatively, the floor tiles may be overlaid and managed in-situ.

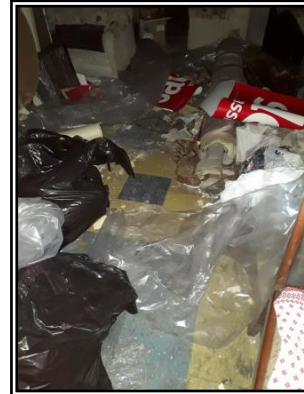
**Sample no:** 07  
**Room no:** 0/09  
**Location:** GF storage area  
**Item:** yellow vinyl floor tiles  
**Accessibility:** easy  
**Sample Taken:** Yes  
**Lab Result:** chrysotile asbestos  
**Quantity:** 50sq.m  
**Surface Treatment:** composite  
**Areas of Damage:** minor

**Comments:** Asbestos material. The vinyl floor tiles to the ground floor storage area contain asbestos fibres. Asbestos vinyl floor tiles are a non-licensed material that may be removed by a suitably trained general contractor wearing appropriate RPE/PPE and following HSE guidance work methods. If removed, the floor tiles must be disposed as hazardous waste. Alternatively, the floor tiles may be overlaid and managed in-situ.

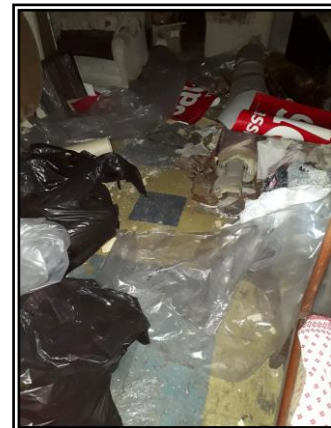
**Sample no:** 08  
**Room no:** 0/09 & 0/16  
**Location:** GF storage area  
**Item:** floor tile adhesive  
**Accessibility:** moderate  
**Sample Taken:** Yes  
**Lab Result:** chrysotile asbestos  
**Quantity:** 120sq.m  
**Surface Treatment:** overlaid  
**Areas of Damage:** none

**Comments:** Asbestos material. The bitumen adhesive that the vinyl floor tiles to the storage area are laid on contains asbestos fibres. Asbestos bitumen adhesive is a non-licensed material that may be removed by a suitably trained general contractor wearing appropriate RPE/PPE and following HSE guidance work methods. If removed, this material must be disposed as hazardous waste. Alternatively, the bitumen adhesive may be overlaid and managed in-situ.

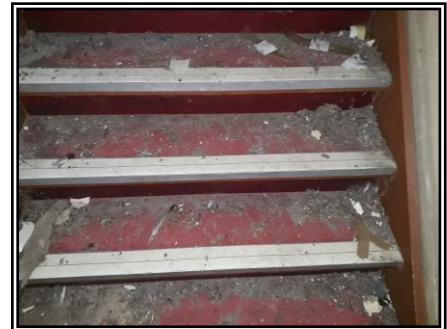
**Sample no:** 09  
**Room no:** 0/10  
**Location:** stairway  
**Item:** white stair nosings  
**Accessibility:** easy  
**Sample Taken:** Yes  
**Lab Result:** non-asbestos  
**Quantity:** N/A  
**Surface Treatment:** N/A  
**Areas of Damage:** N/A

**Comments:** Non-asbestos material.

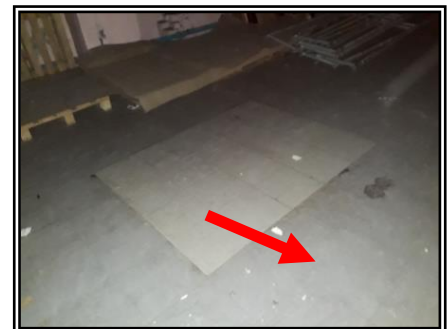
**Sample no:** 10  
**Room no:** 0/17  
**Location:** GF workshop  
**Item:** dark grey vinyl floor tiles  
**Accessibility:** easy  
**Sample Taken:** Yes  
**Lab Result:** non-asbestos  
**Quantity:** N/A  
**Surface Treatment:** N/A  
**Areas of Damage:** N/A

**Comments:** Non-asbestos material.

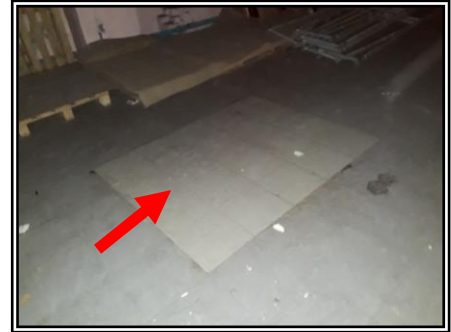
**Sample no:** 11  
**Room no:** 0/17  
**Location:** GF workshop  
**Item:** light grey vinyl floor tiles  
**Accessibility:** easy  
**Sample Taken:** Yes  
**Lab Result:** non-asbestos  
**Quantity:** N/A  
**Surface Treatment:** N/A  
**Areas of Damage:** N/A

**Comments:** Non-asbestos material.

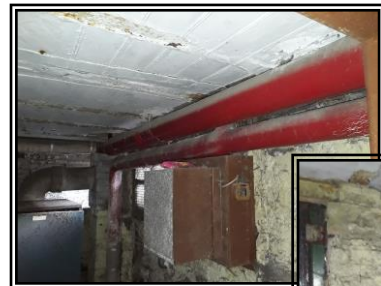
Asbestos **pipe insulation** is present to the basement stairway and boiler room. Asbestos insulation is a high risk material that may only be removed by a HSE-licensed contractor. At the time of inspection the pipe insulation was in poor condition with debris and visible fibres (as dust) to the floor and other surfaces. Removal is advised followed by a full environmental clean of the boiler room and stairway. Access to the basement must be highly restricted until this work is completed.

**Sample no:** 12  
**Room no:** -1/02  
**Location:** basement boiler room  
**Item:** pipe insulation  
**Accessibility:** easy  
**Sample Taken:** Yes  
**Lab Result:** chrysotile & crocidolite  
**Quantity:** 13m  
**Surface Treatment:** unsealed in parts  
**Areas of Damage:** high

**Comments:** Asbestos material. Asbestos pipe insulation is present to the basement stairway and boiler room. Asbestos insulation is a high risk material that may only be removed by a HSE-licensed contractor. At the time of inspection the pipe insulation was in poor condition with debris and visible fibres (as dust) to the floor and other surfaces. Removal is advised followed by a full environmental clean of the boiler room and stairway. Access to the basement must be highly restricted until this work is completed.

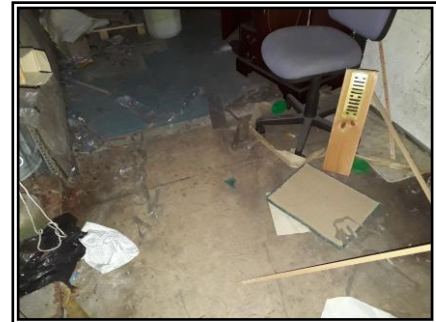
**Sample no:** 13  
**Room no:** 0/13  
**Location:** GF stock room  
**Item:** white vinyl sheet flooring  
**Accessibility:** easy  
**Sample Taken:** Yes  
**Lab Result:** non-asbestos  
**Quantity:** N/A  
**Surface Treatment:** N/A  
**Areas of Damage:** N/A

**Comments:** Non-asbestos material.

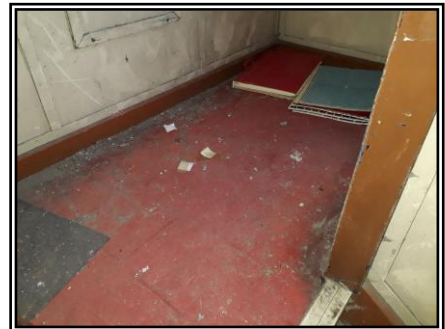
**Sample no:** 14  
**Room no:** 1/01  
**Location:** stairway  
**Item:** red vinyl floor tiles  
**Accessibility:** easy  
**Sample Taken:** Yes  
**Lab Result:** chrysotile asbestos  
**Quantity:** 8sq.m  
**Surface Treatment:** vinyl  
**Areas of Damage:** none

**Comments:** Asbestos material. The vinyl floor tiles to the stairway contain asbestos fibres. Asbestos vinyl floor tiles are a non-licensed material that may be removed by a suitably trained general contractor wearing appropriate RPE/PPE and following HSE guidance work methods. If removed, the floor tiles must be disposed as hazardous waste. Alternatively, the floor tiles may be managed in-situ.

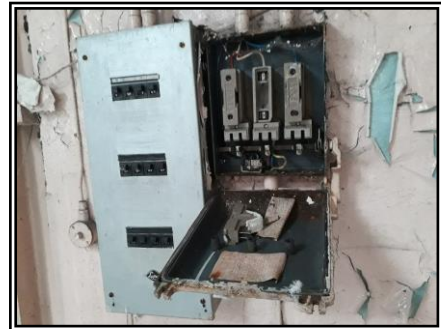
The **flash pads** within multiple fuse boxes throughout the building are an asbestos rope material. Asbestos rope seals and arc shields may also be present. The **electrics** were not fully inspected due to the absence of an isolation certificate. We advise that all fuse boxes be removed as whole units and disposed as hazardous waste. This is non-licensed work.

**Sample no:** 15  
**Room no:** 1/02  
**Location:** FF workshop  
**Item:** flash pad  
**Accessibility:** easy  
**Sample Taken:** Yes  
**Lab Result:** chrysotile asbestos  
**Quantity:** 3No. minimum  
**Surface Treatment:** enclosed  
**Areas of Damage:** none

**Comments:** Asbestos material. The flash pads are an asbestos rope material. We advise that the fuse box be removed as a whole unit and disposed as hazardous waste. This is non-licensed work.

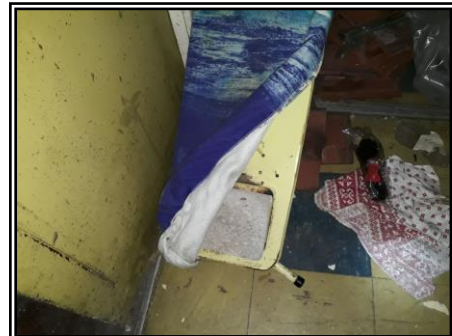
An **ironing board** with an asbestos insulation board panel is present to the ground floor storage area. We advise that the ironing board is disposed as hazardous waste. This is non-licensed work providing the ironing board is disposed as a whole unit.

**Sample no:** 16  
**Room no:** 0/09  
**Location:** GF storage area  
**Item:** panel to ironing board  
**Accessibility:** easy  
**Sample Taken:** Yes  
**Lab Result:** chrysotile asbestos  
**Quantity:** 1 No.  
**Surface Treatment:** none  
**Areas of Damage:** none

**Comments:** Asbestos material. The ironing board panel is asbestos insulation board (AIB). We advise that the ironing board is disposed as hazardous waste. This is non-licensed work providing the ironing board is disposed as a whole unit.

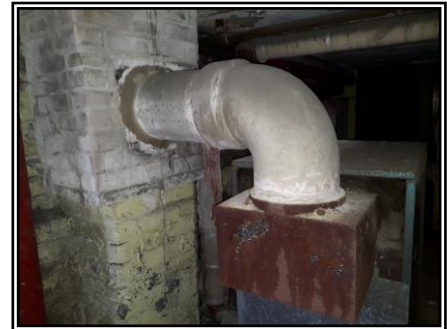
The **boiler flue** within the basement boiler room is asbestos cement. Asbestos cement is a non-licensed material that may be removed by a suitably trained general contractor wearing appropriate RPE/PPE and following HSE guidance work methods. If removed, the flue must be disposed as hazardous waste. The full extent of the flue could not be determined as it is partially concealed within a chimney.

**Sample no:** 17  
**Room no:** -1/02  
**Location:** basement boiler room  
**Item:** cement flue  
**Accessibility:** partially behind brickwork  
**Sample Taken:** Yes  
**Lab Result:** chrysotile asbestos  
**Quantity:** 1m minimum  
**Surface Treatment:** cement  
**Areas of Damage:** none

**Comments:** Asbestos material. The boiler flue is asbestos cement. Asbestos cement is a non-licensed material that may be removed by a suitably trained general contractor wearing appropriate RPE/PPE and following HSE guidance work methods. If removed, the flue must be disposed as hazardous waste. The full extent of the flue could not be determined as it is partially concealed within a chimney.

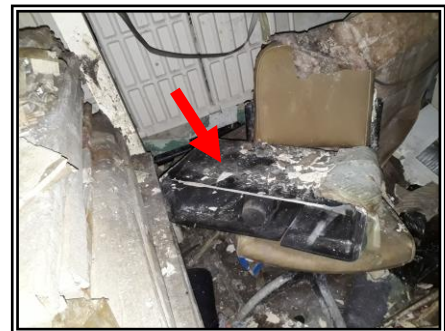
**Sample no:** 18  
**Room no:** 0/07  
**Location:** GF office  
**Item:** redundant cistern  
**Accessibility:** easy  
**Sample Taken:** Yes  
**Lab Result:** non-asbestos  
**Quantity:** N/A  
**Surface Treatment:** N/A  
**Areas of Damage:** N/A

**Comments:** Non-asbestos material.

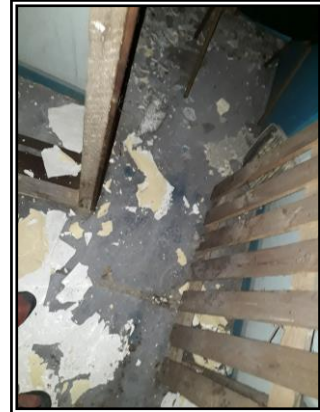
**Sample no:** 19  
**Room no:** 0/12  
**Location:** GF male WC  
**Item:** blue vinyl sheet flooring  
**Accessibility:** easy  
**Sample Taken:** Yes  
**Lab Result:** non-asbestos  
**Quantity:** N/A  
**Surface Treatment:** N/A  
**Areas of Damage:** N/A

**Comments:** Non-asbestos material.

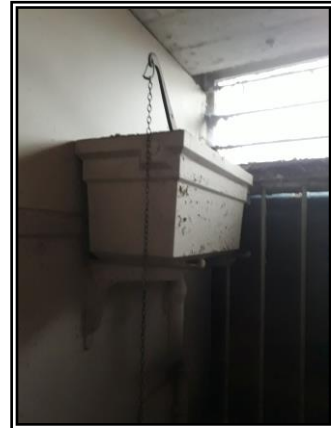
The **toilet cistern** to the female WC contains asbestos fibres. Asbestos cisterns are a low risk non-licensed material that may be removed by a suitably trained general contractor wearing appropriate RPE/PPE and following HSE guidance work methods.

**Sample no:** 20  
**Room no:** 0/13  
**Location:** GF female WC  
**Item:** toilet cistern  
**Accessibility:** easy  
**Sample Taken:** Yes  
**Lab Result:** crocidolite asbestos  
**Quantity:** 1 No.  
**Surface Treatment:** composite  
**Areas of Damage:** none

**Comments:** Asbestos material. The toilet cistern to the female WC contains asbestos fibres. Asbestos cisterns are a low risk non-licensed material that may be removed by a suitably trained general contractor wearing appropriate RPE/PPE and following HSE guidance work methods. If removed, the cistern must be disposed as hazardous waste.

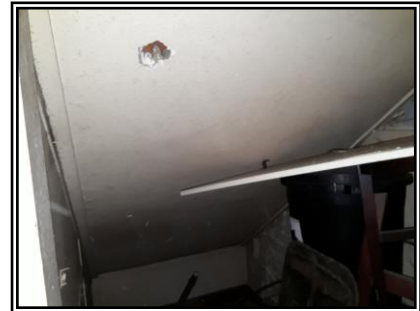
**Sample no:** 21  
**Room no:** 0/10  
**Location:** GF toilet lobby  
**Item:** panels below stairs  
**Accessibility:** easy  
**Sample Taken:** Yes  
**Lab Result:** non-asbestos  
**Quantity:** N/A  
**Surface Treatment:** N/A  
**Areas of Damage:** N/A

**Comments:** Non-asbestos material.

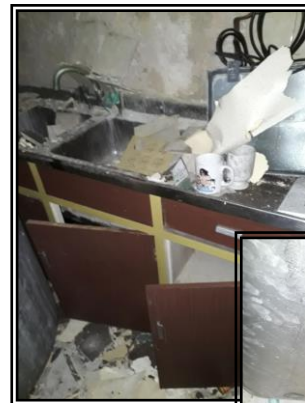
The **bitumen pad** to the underside of the sink unit within the ground floor kitchen area of the store room contains asbestos fibres. If removed, we suggest disposing of the sink as a whole unit as hazardous waste.

**Sample no:** 22  
**Room no:** 0/09  
**Location:** kitchen area  
**Item:** sink pad  
**Accessibility:** easy  
**Sample Taken:** Yes  
**Lab Result:** chrysotile asbestos  
**Quantity:** 1 No.  
**Surface Treatment:** composite  
**Areas of Damage:** minor

**Comments:** Asbestos material. The bitumen pad to the underside of the sink unit within the ground floor kitchen area of the store room contains asbestos fibres. Asbestos sink pads are a non-licensed material that may be removed by a suitably trained general contractor wearing appropriate RPE/PPE and following HSE guidance work methods. If removed, we suggest disposing of the sink as a whole unit as hazardous waste.

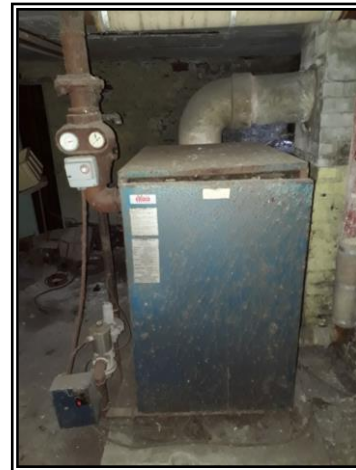
The **boiler** within the basement was not fully inspected due to heavy contamination from the nearby pipe insulation. The boiler is presumed to contain asbestos components such as rope seals and gaskets due to its age. As the boiler is redundant, we advise removal and disposal by a HSE-licensed contractor under controlled conditions as the boiler may require dismantling to facilitate removal. The boiler must be disposed as hazardous waste.

**Presumption:** B  
**Room no:** -1/02  
**Location:** basement boiler room  
**Item:** boiler components  
**Accessibility:** difficult  
**Sample Taken:** No  
**Presumption:** asbestos materials  
**Quantity:** 1 No. boiler  
**Surface Treatment:** enclosed  
**Areas of Damage:** unknown

**Comments:** Presumed asbestos material. The boiler was not fully inspected due to heavy contamination from the nearby pipe insulation. The boiler is also presumed to contain asbestos components such as rope seals and gaskets due to its age. As the boiler is redundant, we advise removal and disposal by a HSE-licensed contractor under controlled conditions as the boiler may require dismantling to facilitate removal. The boiler must be disposed as hazardous waste.
