# Soil vapour and ground gas risk assessment: Topping Mill, Topping Street, Bury

**Report reference** 4332R1

**Date of reporting** 24<sup>th</sup> January 2024

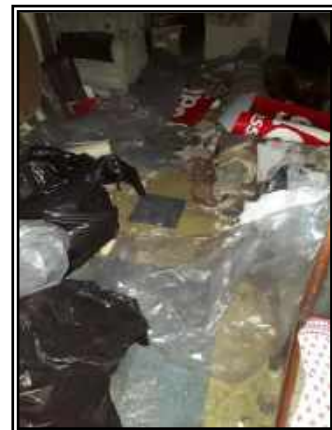
**Sample no:** 06  
**Room no:** 0/09 & 0/16  
**Location:** GF storage area  
**Item:** blue vinyl floor tiles  
**Accessibility:** easy  
**Sample Taken:** Yes  
**Lab Result:** chrysotile asbestos  
**Quantity:** 70sq.m  
**Surface Treatment:** composite  
**Areas of Damage:** minor

**Comments:** Asbestos material. The vinyl floor tiles to the ground floor storage area contain asbestos fibres. Asbestos vinyl floor tiles are a non-licensed material that may be removed by a suitably trained general contractor wearing appropriate RPE/PPE and following HSE guidance work methods. If removed, the floor tiles must be disposed as hazardous waste. Alternatively, the floor tiles may be overlaid and managed in-situ.

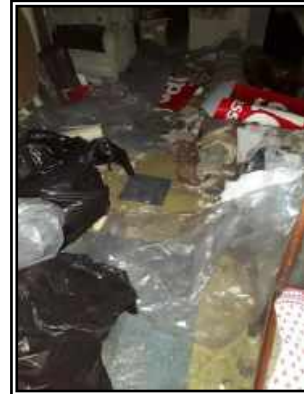
**Sample no:** 07  
**Room no:** 0/09  
**Location:** GF storage area  
**Item:** yellow vinyl floor tiles  
**Accessibility:** easy  
**Sample Taken:** Yes  
**Lab Result:** chrysotile asbestos  
**Quantity:** 50sq.m  
**Surface Treatment:** composite  
**Areas of Damage:** minor

**Comments:** Asbestos material. The vinyl floor tiles to the ground floor storage area contain asbestos fibres. Asbestos vinyl floor tiles are a non-licensed material that may be removed by a suitably trained general contractor wearing appropriate RPE/PPE and following HSE guidance work methods. If removed, the floor tiles must be disposed as hazardous waste. Alternatively, the floor tiles may be overlaid and managed in-situ.

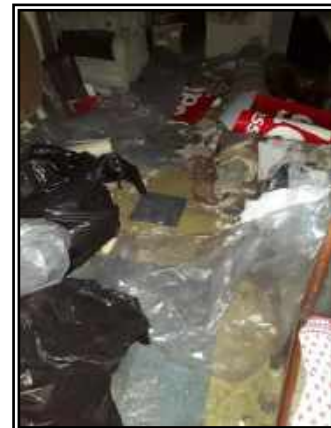
**Sample no:** 08  
**Room no:** 0/09 & 0/16  
**Location:** GF storage area  
**Item:** floor tile adhesive  
**Accessibility:** moderate  
**Sample Taken:** Yes  
**Lab Result:** chrysotile asbestos  
**Quantity:** 120sq.m  
**Surface Treatment:** overlaid  
**Areas of Damage:** none

**Comments:** Asbestos material. The bitumen adhesive that the vinyl floor tiles to the storage area are laid on contains asbestos fibres. Asbestos bitumen adhesive is a non-licensed material that may be removed by a suitably trained general contractor wearing appropriate RPE/PPE and following HSE guidance work methods. If removed, this material must be disposed as hazardous waste. Alternatively, the bitumen adhesive may be overlaid and managed in-situ.

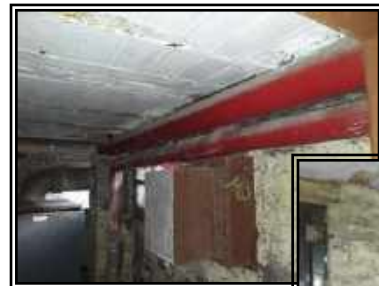
**Sample no:** 12  
**Room no:** -1/02  
**Location:** basement boiler room  
**Item:** pipe insulation  
**Accessibility:** easy  
**Sample Taken:** Yes  
**Lab Result:** chrysotile & crocidolite  
**Quantity:** 13m  
**Surface Treatment:** unsealed in parts  
**Areas of Damage:** high

**Comments:** Asbestos material. Asbestos pipe insulation is present to the basement stairway and boiler room. Asbestos insulation is a high risk material that may only be removed by a HSE-licensed contractor. At the time of inspection the pipe insulation was in poor condition with debris and visible fibres (as dust) to the floor and other surfaces. Removal is advised followed by a full environmental clean of the boiler room and stairway. Access to the basement must be highly restricted until this work is completed.

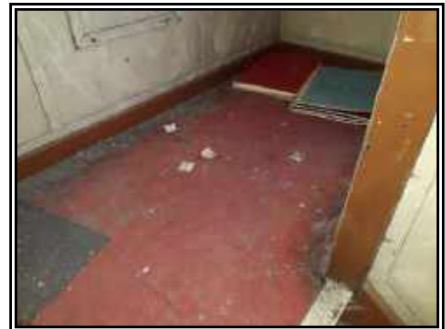
**Sample no:** 14  
**Room no:** 1/01  
**Location:** stairway  
**Item:** red vinyl floor tiles  
**Accessibility:** easy  
**Sample Taken:** Yes  
**Lab Result:** chrysotile asbestos  
**Quantity:** 8sq.m  
**Surface Treatment:** vinyl  
**Areas of Damage:** none

**Comments:** Asbestos material. The vinyl floor tiles to the stairway contain asbestos fibres. Asbestos vinyl floor tiles are a non-licensed material that may be removed by a suitably trained general contractor wearing appropriate RPE/PPE and following HSE guidance work methods. If removed, the floor tiles must be disposed as hazardous waste. Alternatively, the floor tiles may be managed in-situ.

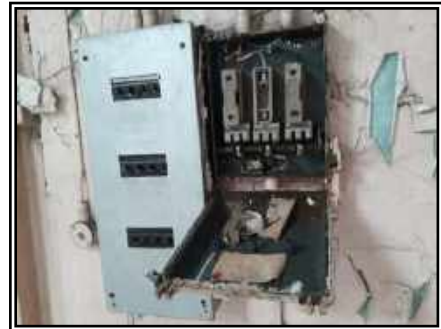
**Sample no:** 15  
**Room no:** 1/02  
**Location:** FF workshop  
**Item:** flash pad  
**Accessibility:** easy  
**Sample Taken:** Yes  
**Lab Result:** chrysotile asbestos  
**Quantity:** 3No. minimum  
**Surface Treatment:** enclosed  
**Areas of Damage:** none

**Comments:** Asbestos material. The flash pads are an asbestos rope material. We advise that the fuse box be removed as a whole unit and disposed as hazardous waste. This is non-licensed work.

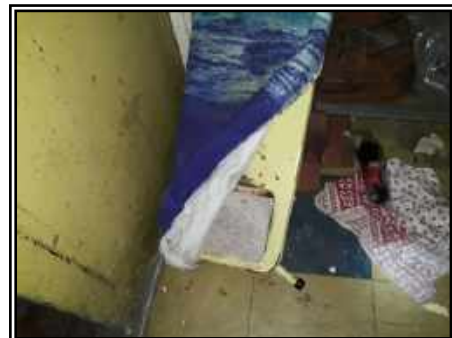
**Sample no:** 16  
**Room no:** 0/09  
**Location:** GF storage area  
**Item:** panel to ironing board  
**Accessibility:** easy  
**Sample Taken:** Yes  
**Lab Result:** chrysotile asbestos  
**Quantity:** 1 No.  
**Surface Treatment:** none  
**Areas of Damage:** none

**Comments:** Asbestos material. The ironing board panel is asbestos insulation board (AIB). We advise that the ironing board is disposed as hazardous waste. This is non-licensed work providing the ironing board is disposed as a whole unit.

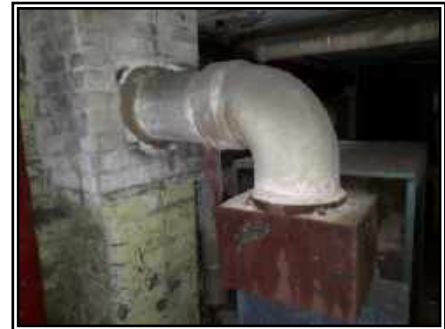
**Sample no:** 17  
**Room no:** -1/02  
**Location:** basement boiler room  
**Item:** cement flue  
**Accessibility:** partially behind brickwork  
**Sample Taken:** Yes  
**Lab Result:** chrysotile asbestos  
**Quantity:** 1m minimum  
**Surface Treatment:** cement  
**Areas of Damage:** none

**Comments:** Asbestos material. The boiler flue is asbestos cement. Asbestos cement is a non-licensed material that may be removed by a suitably trained general contractor wearing appropriate RPE/PPE and following HSE guidance work methods. If removed, the flue must be disposed as hazardous waste. The full extent of the flue could not be determined as it is partially concealed within a chimney.

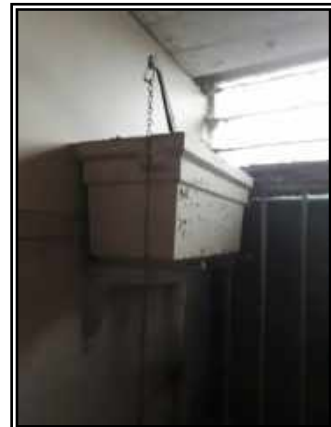
**Sample no:** 20  
**Room no:** 0/13  
**Location:** GF female WC  
**Item:** toilet cistern  
**Accessibility:** easy  
**Sample Taken:** Yes  
**Lab Result:** crocidolite asbestos  
**Quantity:** 1 No.  
**Surface Treatment:** composite  
**Areas of Damage:** none

**Comments:** Asbestos material. The toilet cistern to the female WC contains asbestos fibres. Asbestos cisterns are a low risk non-licensed material that may be removed by a suitably trained general contractor wearing appropriate RPE/PPE and following HSE guidance work methods. If removed, the cistern must be disposed as hazardous waste.

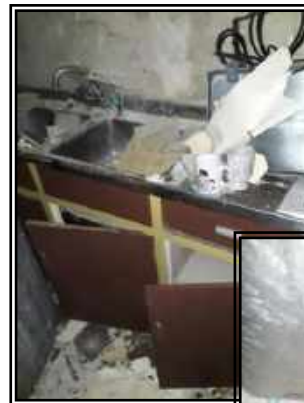
**Sample no:** 22  
**Room no:** 0/09  
**Location:** kitchen area  
**Item:** sink pad  
**Accessibility:** easy  
**Sample Taken:** Yes  
**Lab Result:** chrysotile asbestos  
**Quantity:** 1 No.  
**Surface Treatment:** composite  
**Areas of Damage:** minor

**Comments:** Asbestos material. The bitumen pad to the underside of the sink unit within the ground floor kitchen area of the store room contains asbestos fibres. Asbestos sink pads are a non-licensed material that may be removed by a suitably trained general contractor wearing appropriate RPE/PPE and following HSE guidance work methods. If removed, we suggest disposing of the sink as a whole unit as hazardous waste.

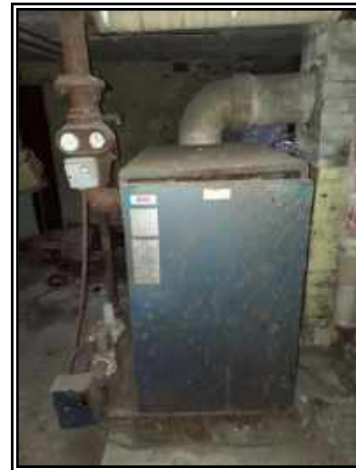
**Presumption:** B  
**Room no:** -1/02  
**Location:** basement boiler room  
**Item:** boiler components  
**Accessibility:** difficult  
**Sample Taken:** No  
**Presumption:** asbestos materials  
**Quantity:** 1 No. boiler  
**Surface Treatment:** enclosed  
**Areas of Damage:** unknown

**Comments:** Presumed asbestos material. The boiler was not fully inspected due to heavy contamination from the nearby pipe insulation. The boiler is also presumed to contain asbestos components such as rope seals and gaskets due to its age. As the boiler is redundant, we advise removal and disposal by a HSE-licensed contractor under controlled conditions as the boiler may require dismantling to facilitate removal. The boiler must be disposed as hazardous waste.

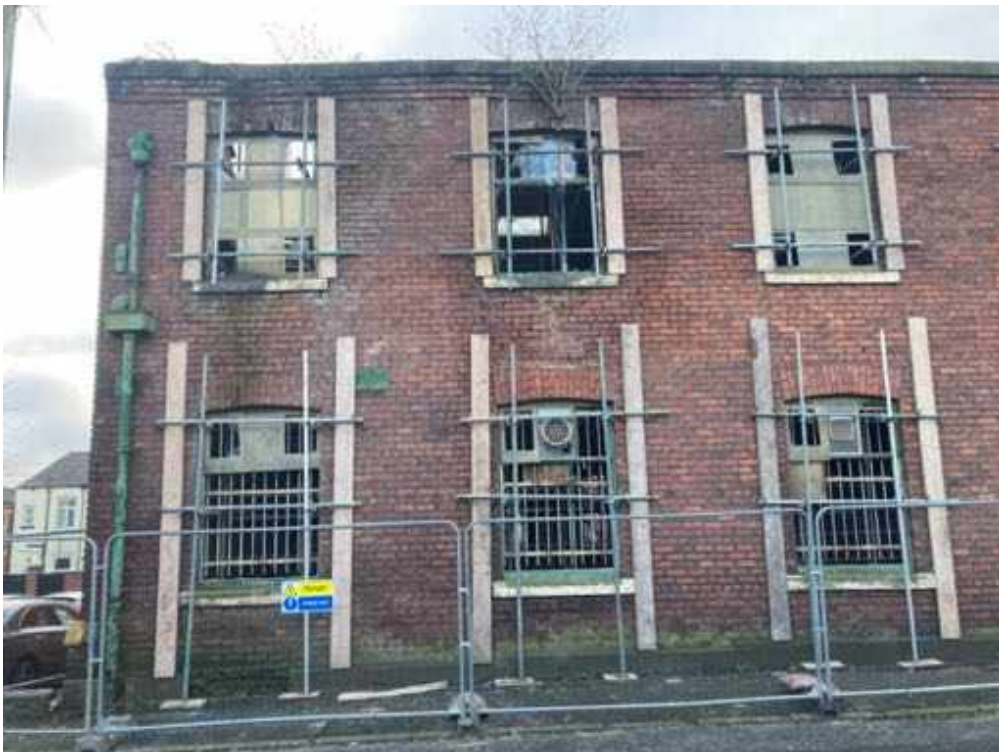
**Photograph 2**

- An adjoining car park (surfaced with tarmac) was present directly to the east of the Site (see Photograph 7 in Appendix B).
- The on-Site building was in a poor state of repair. Glass was absent from the majority of the window openings (see Photographs 2 and 5 in Appendix B) and sections of the roof were missing.

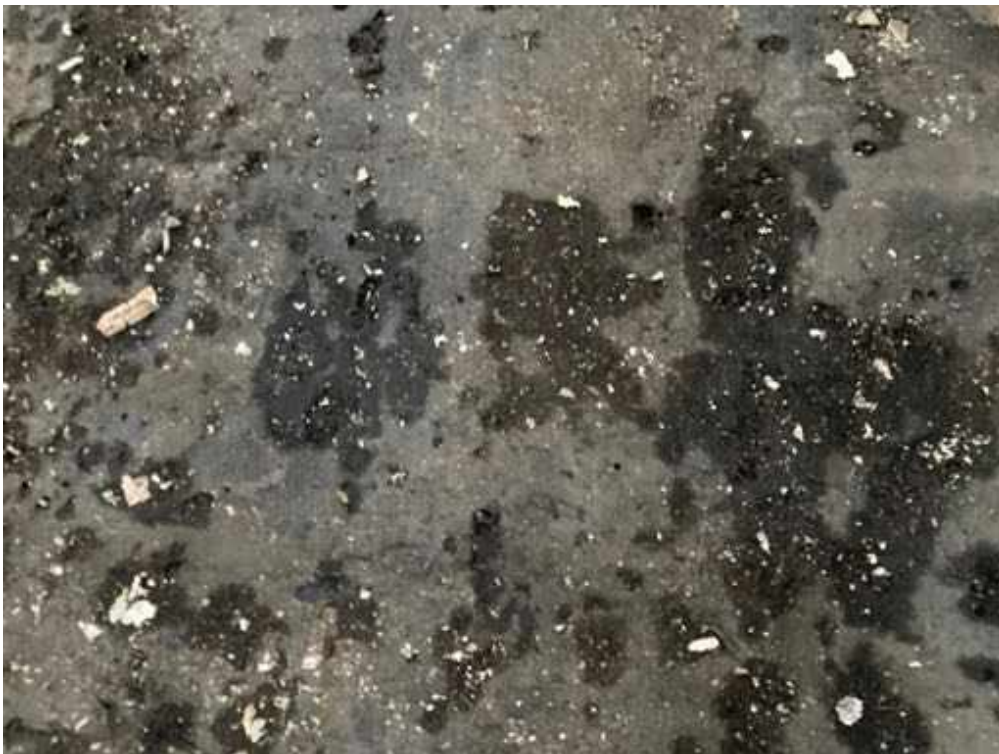
**Photograph 10**

- Concrete flooring was present across the ground floor level (see Photographs 8, 9, 12 and 14 in Appendix B). Some residual tile adhesive was present across the majority of the floor area (see Photograph 10 in Appendix B). The exposed concrete appeared to be in a reasonable state of repair.

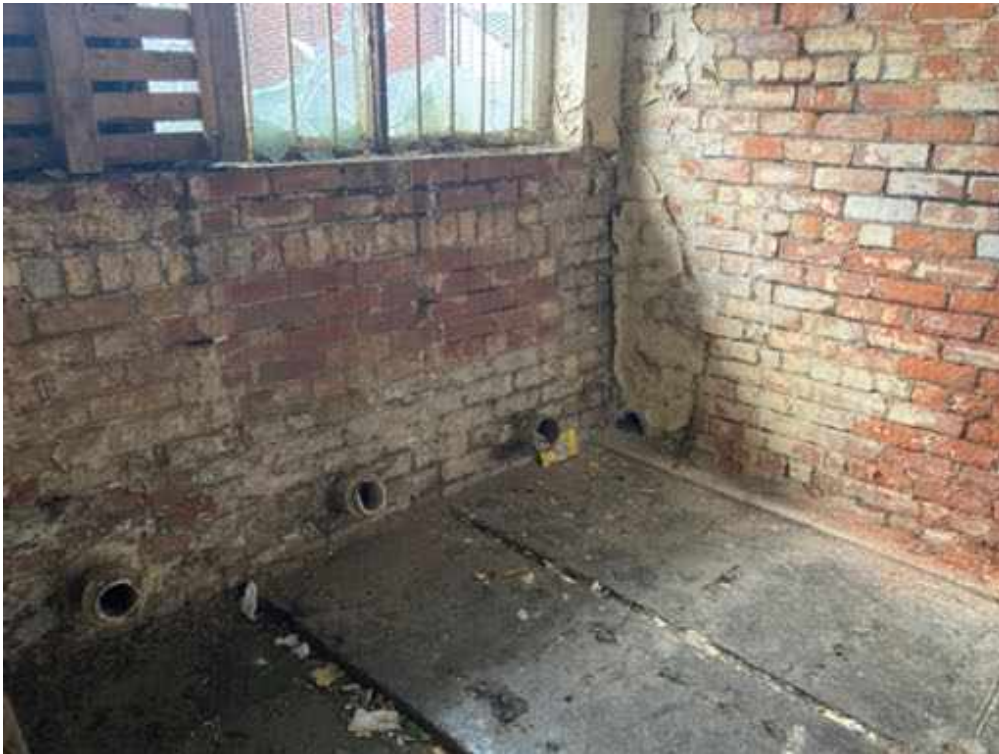
- No fuel or chemical storage was observed on-Site.
- No notable odours were recorded within the on-Site building.
- The ground floor layout included two open spaces either side of an entrance lobby and stairwell. A toilet block was observed at the southern edge of the building; all fittings had been removed and the waste pipes were directed through the external building wall (see Photograph 11 in Appendix B).

**Photograph 11**      **Description:** Former toilet block within on-Site building  
                         **Date:** 10/01/2024  
                         **Location:** Southern edge of the building

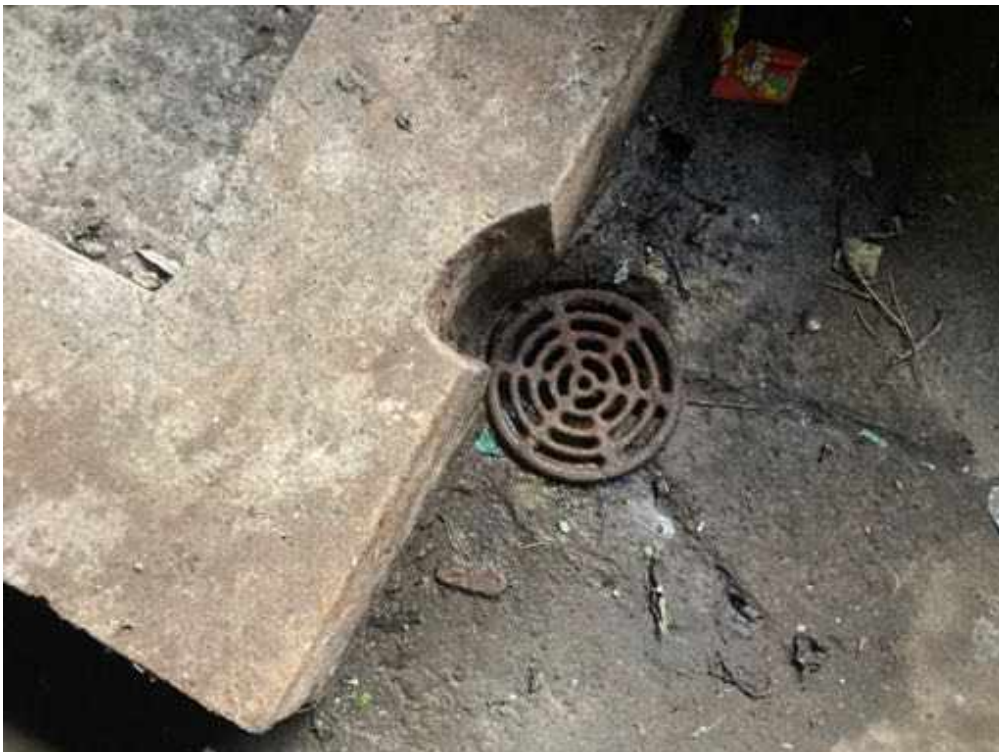
**Photograph 17**

- No manhole covers, service entry points or suchlike were evident across the ground floor level. A circular drainage cover was however observed within the floor of the 'cellar' room (see Photograph 17 in Appendix B); this feature was positioned directly adjacent to the former boiler.

It is recommended that the drainage cover present within the cellar room is appropriately sealed, in order to avoid the potential ingress of any localised soil vapours or ground gases.

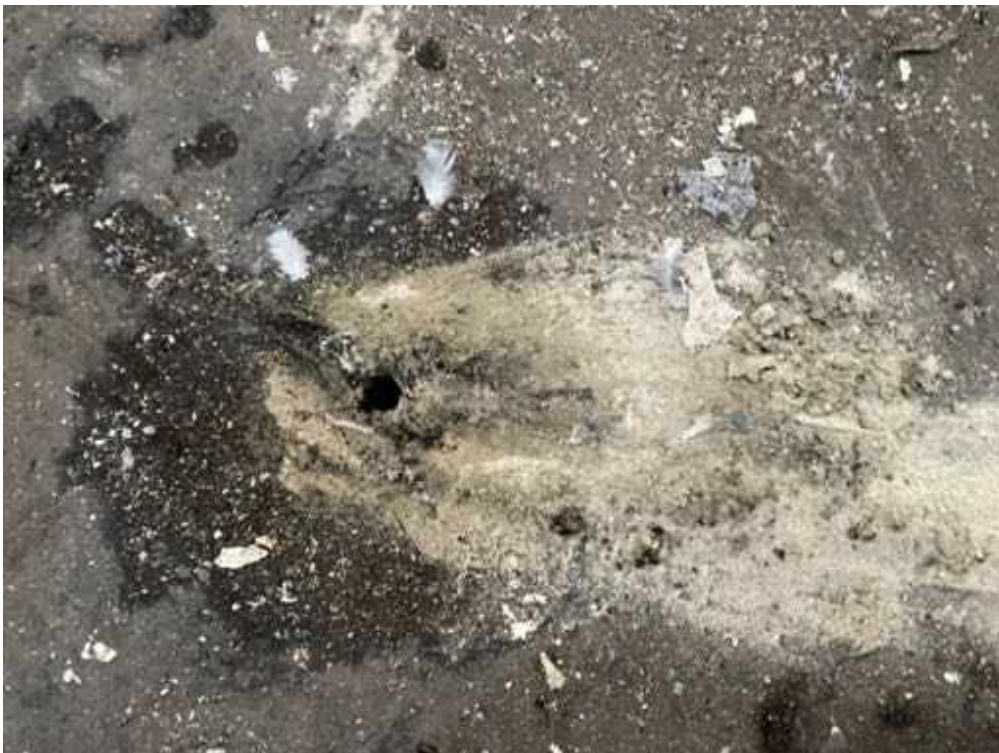
**Photograph 23**

Three 16 mm holes were drilled through the ground floor foundation slab (see Figure 3.1 and also Photograph 23 in Appendix B).

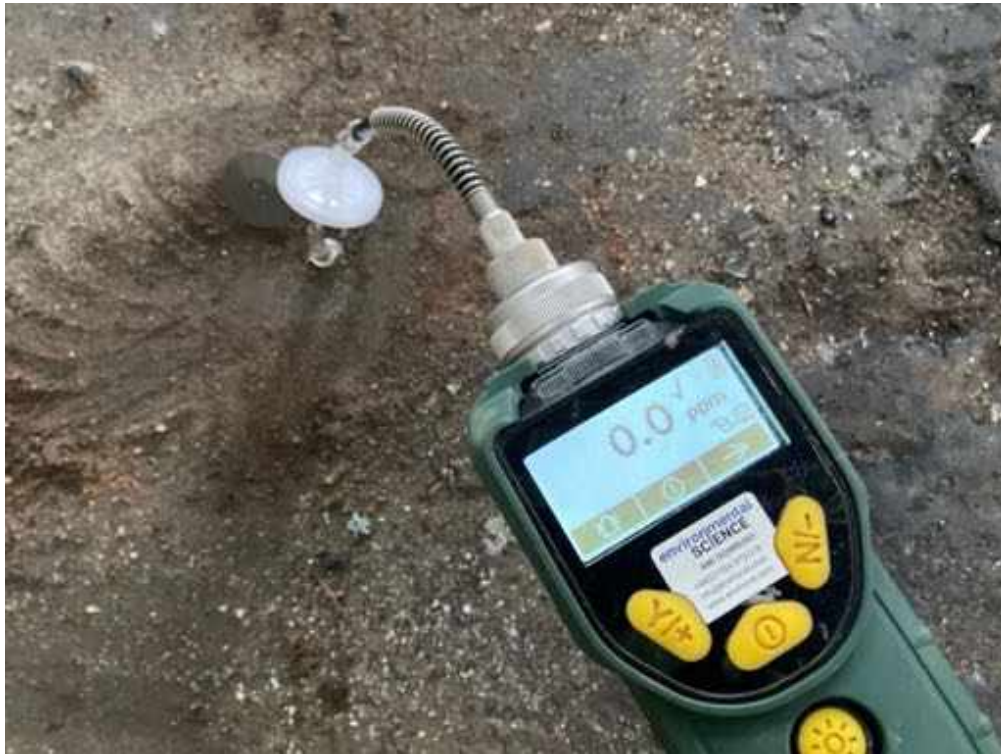
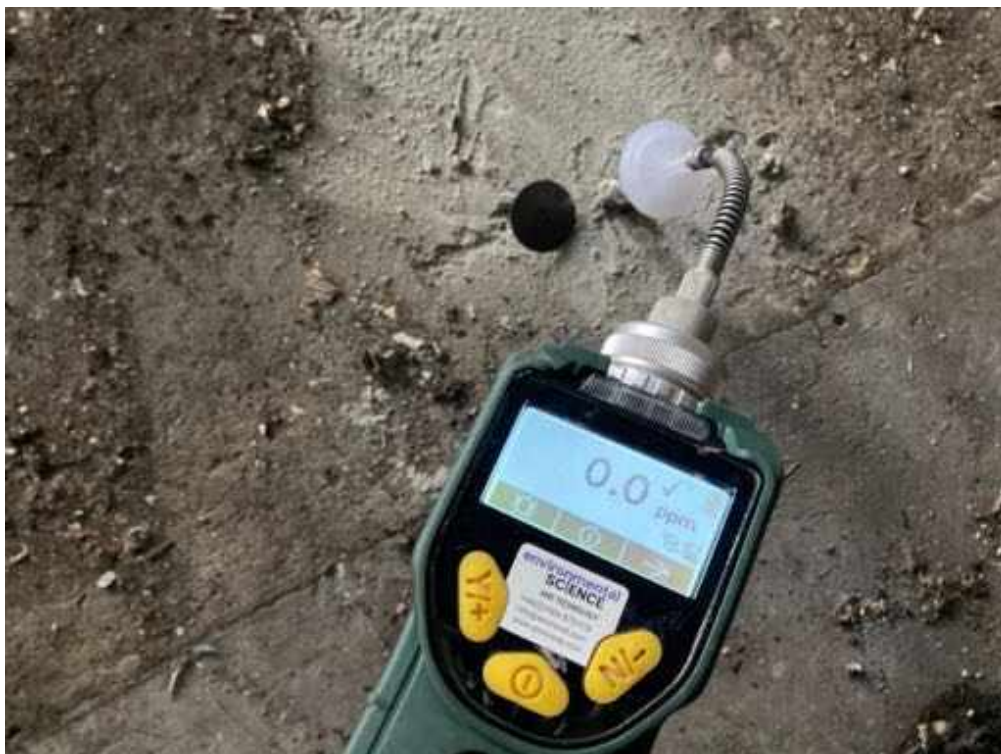
Further PID readings were taken from the two Vapor Pins (VP1 and VP2) installed within the foundation slab both directly after installation and also 2 hours following installation (see Photographs 26 and 27 in Appendix B). All PID readings were <0.01 ppm.
