### 6.3 *Interim Coal Mining Review Recommendations*

## 7 GEOTECHNICAL CONSIDERATIONS

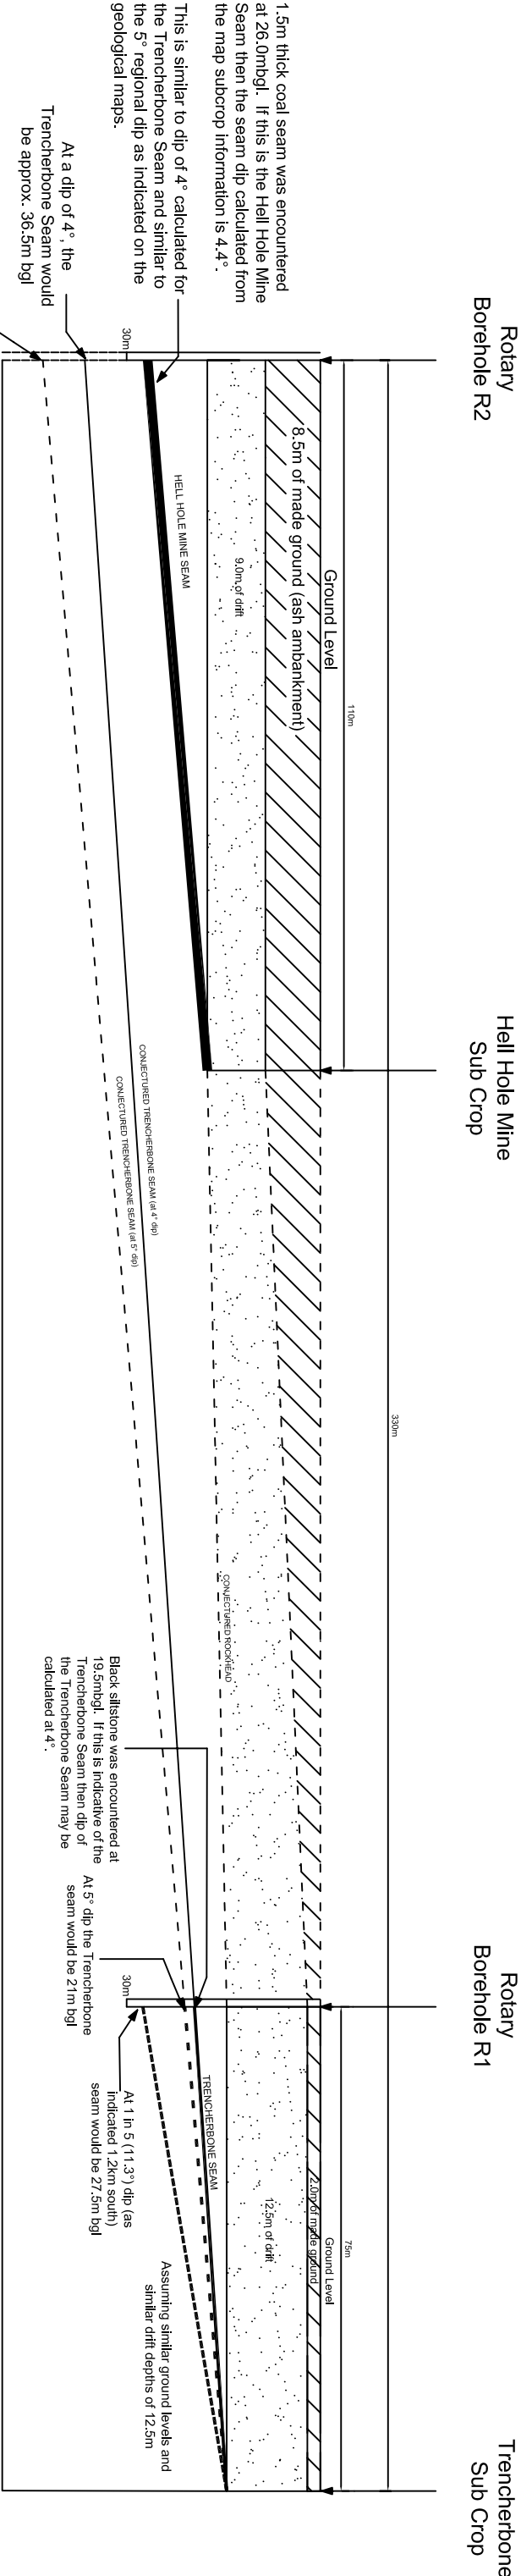
A schematic cross section of the site and the coal seams taken from the geological mapping and the site data is presented on Figure 6-1. Considering the assumptions highlighted on Figure 6-1, the dip of the possible Trencherbone and Hell Hole seams below the site has been calculated in the order of 4 to 4.4 degrees respectively.

The boreholes and cross sections indicate that the coal seams and the regional geology dip at around 4 to 4.4 degrees in the site vicinity.
