## DEMOLITION ASBESTOS SURVEY

**Rainsough Cottage  
Rainsough Brow  
Prestwich  
M25 9SU**

REF: BC/RA/590

**6<sup>th</sup> November 2020**

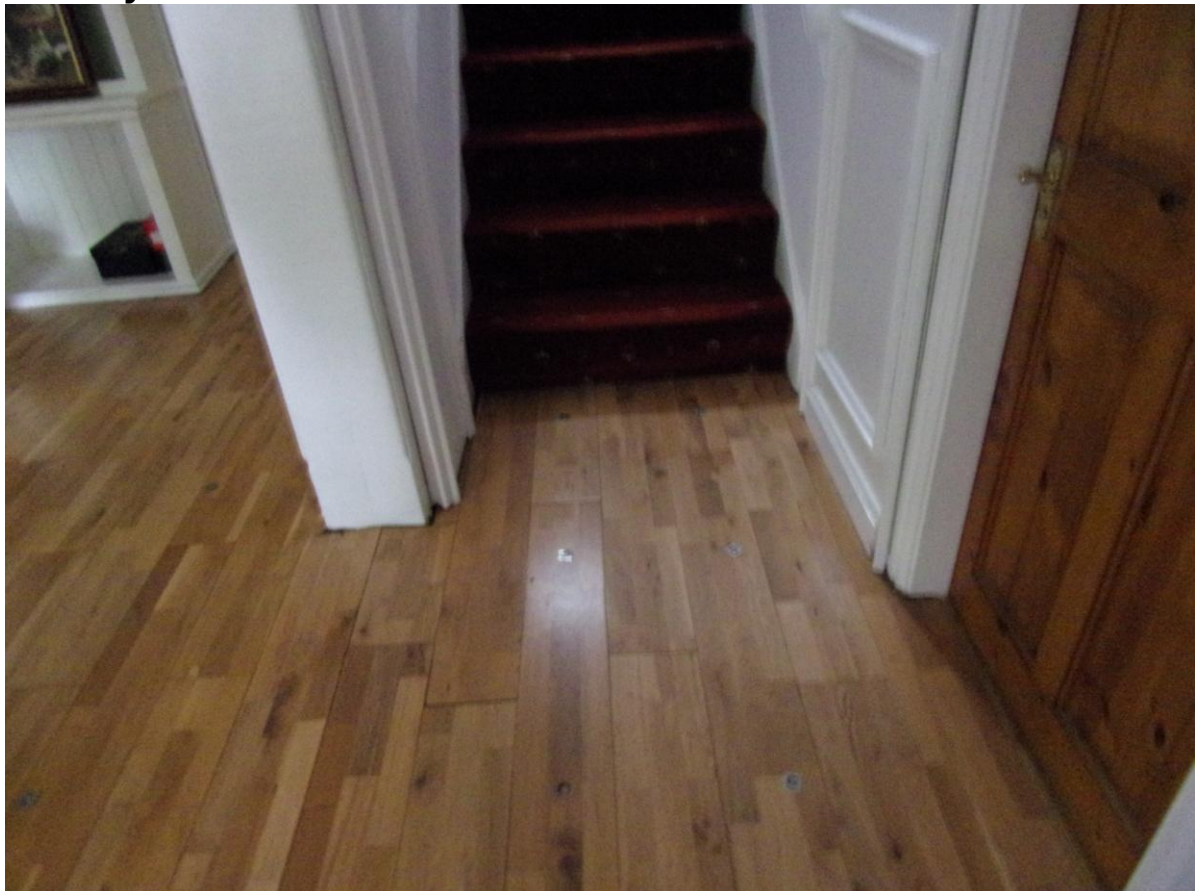
### Hallway

An inner double-glazed UPVC door leads into a hallway, with a laminate floor, painted timber-planked ceiling, and walls that are part timber-panelled and part painted decorative plaster.

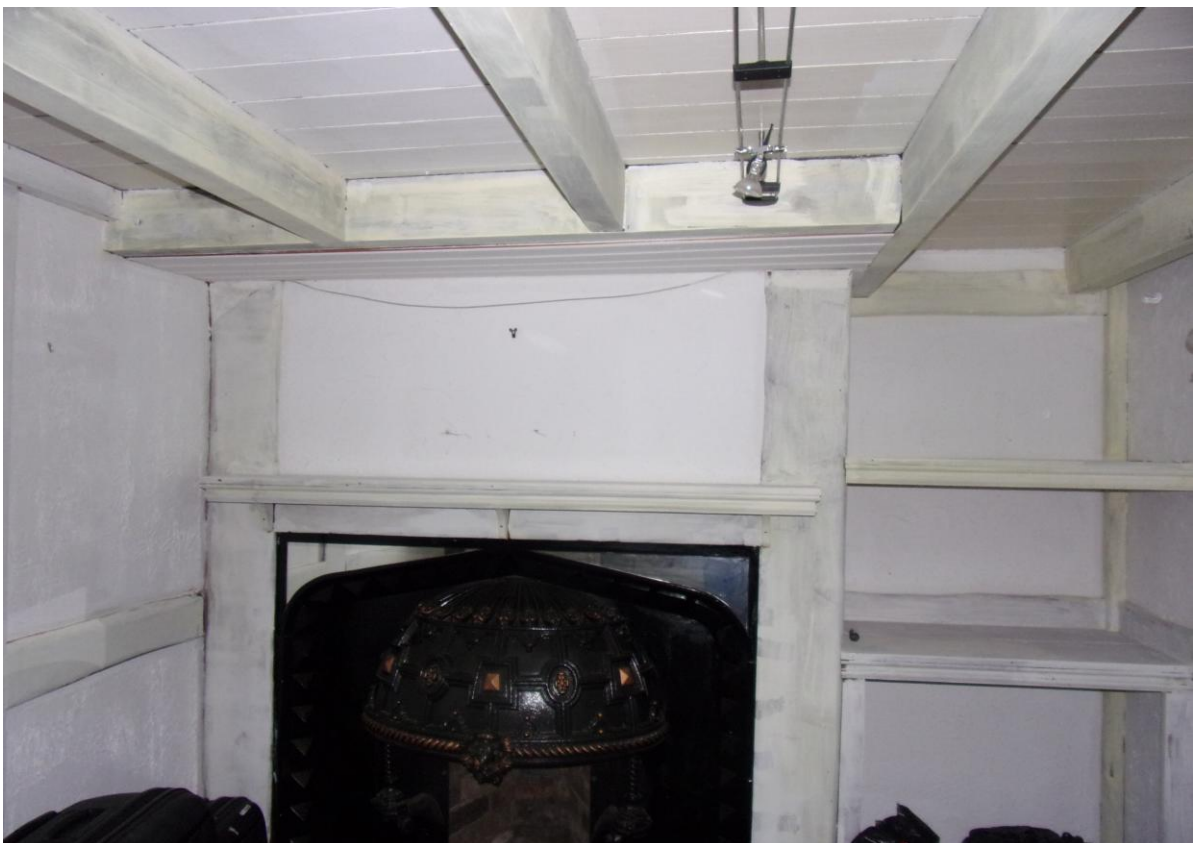
## Former Office

Off the hall to the left is a former office, with a feature cast-iron fireplace and a similar construction to the hall.

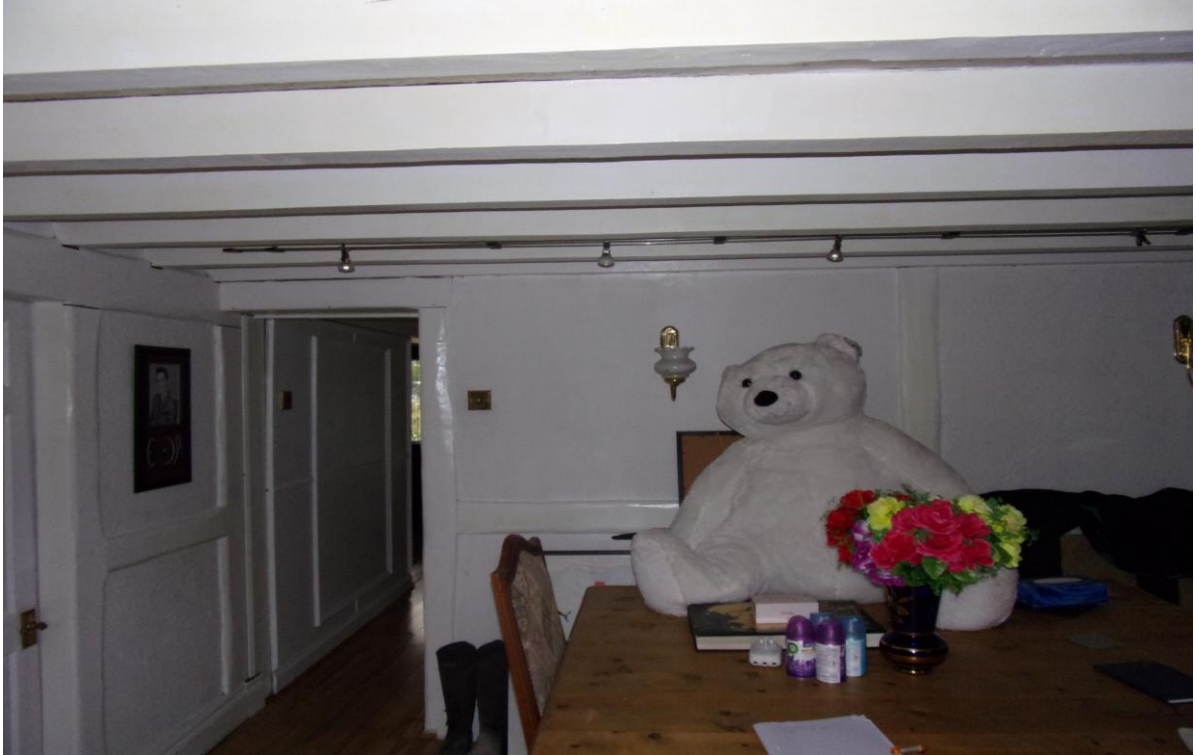
### **Dining Room**

Adjacent to the former office is the dining room, with a painted plaster ceiling, part timber-panelled and part painted textured plaster walls, and laminate flooring.

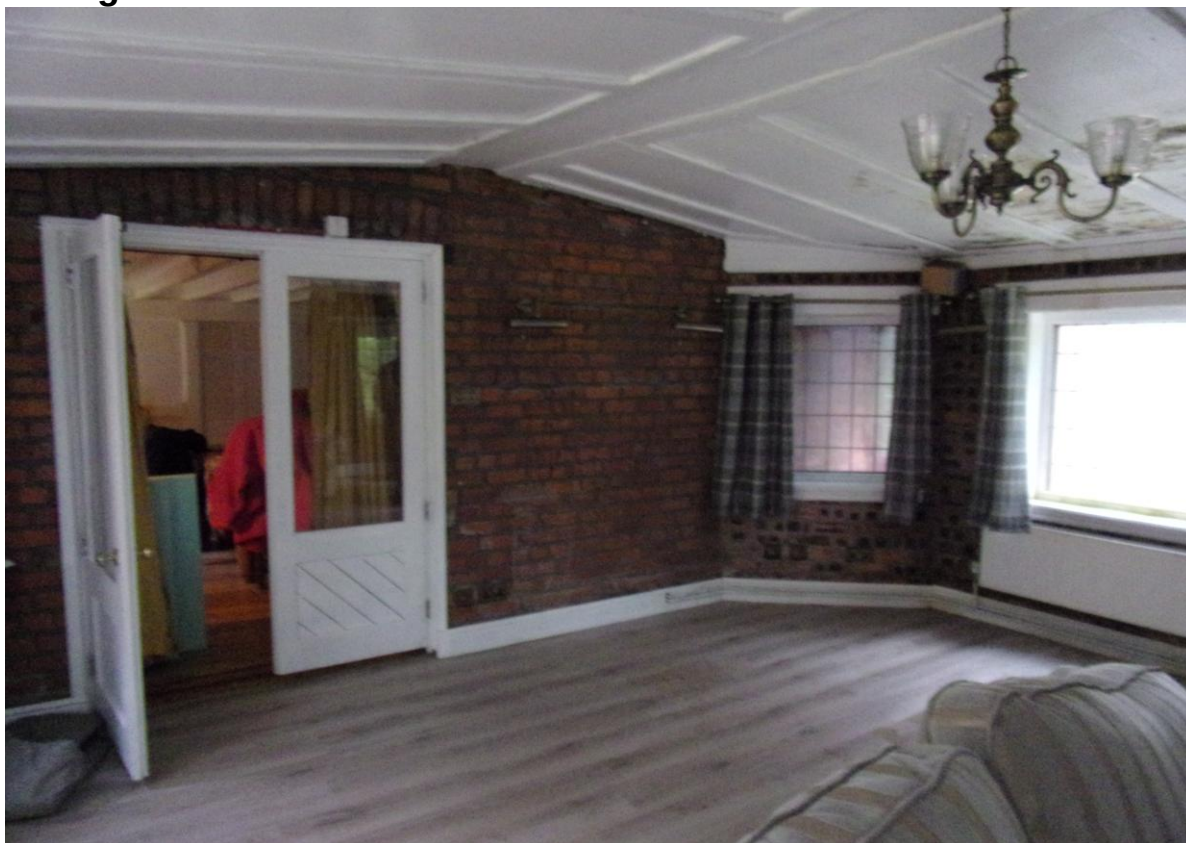
### Lounge

Off to the left of the dining room is a single-storey extension containing a lounge, with plain brick walls, a part painted timber panelling and part painted timber beam ceiling, and laminate flooring.

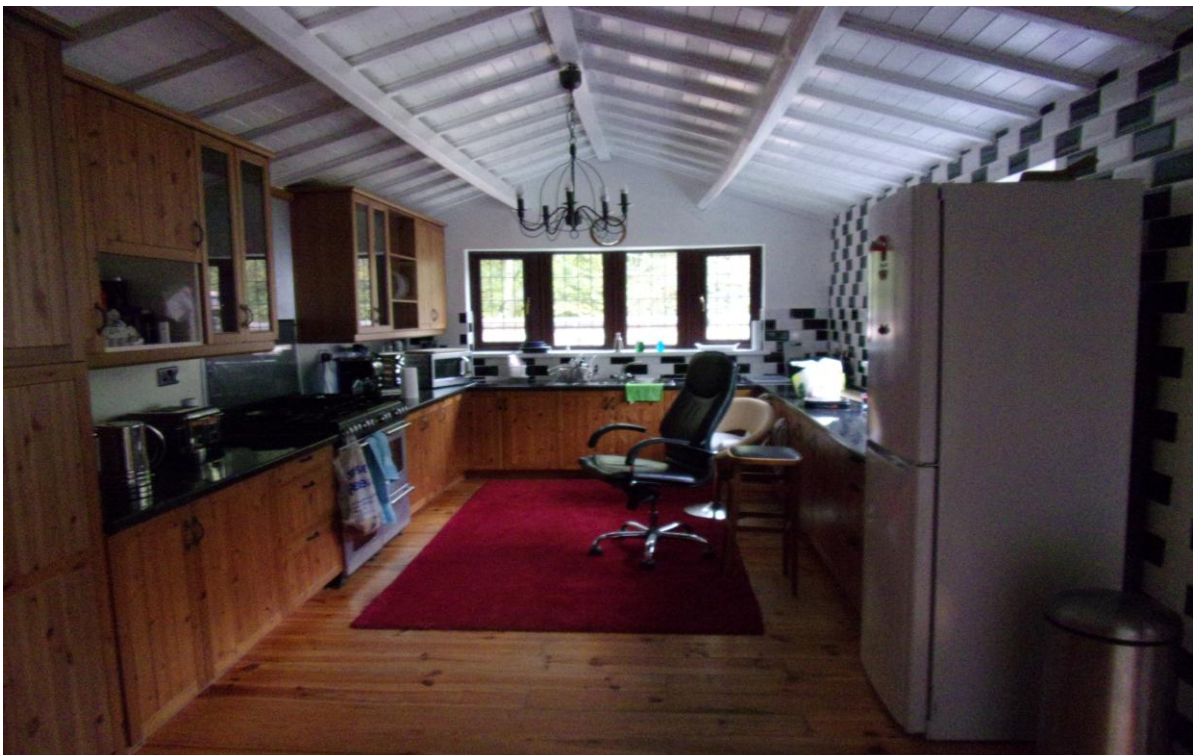
### **Kitchen**

Leading off from the utility room is the kitchen, which is housed in a single-storey extension, with a planked wooden ceiling, partial ceramic tiling around the sink and across one wall, and laminate flooring.

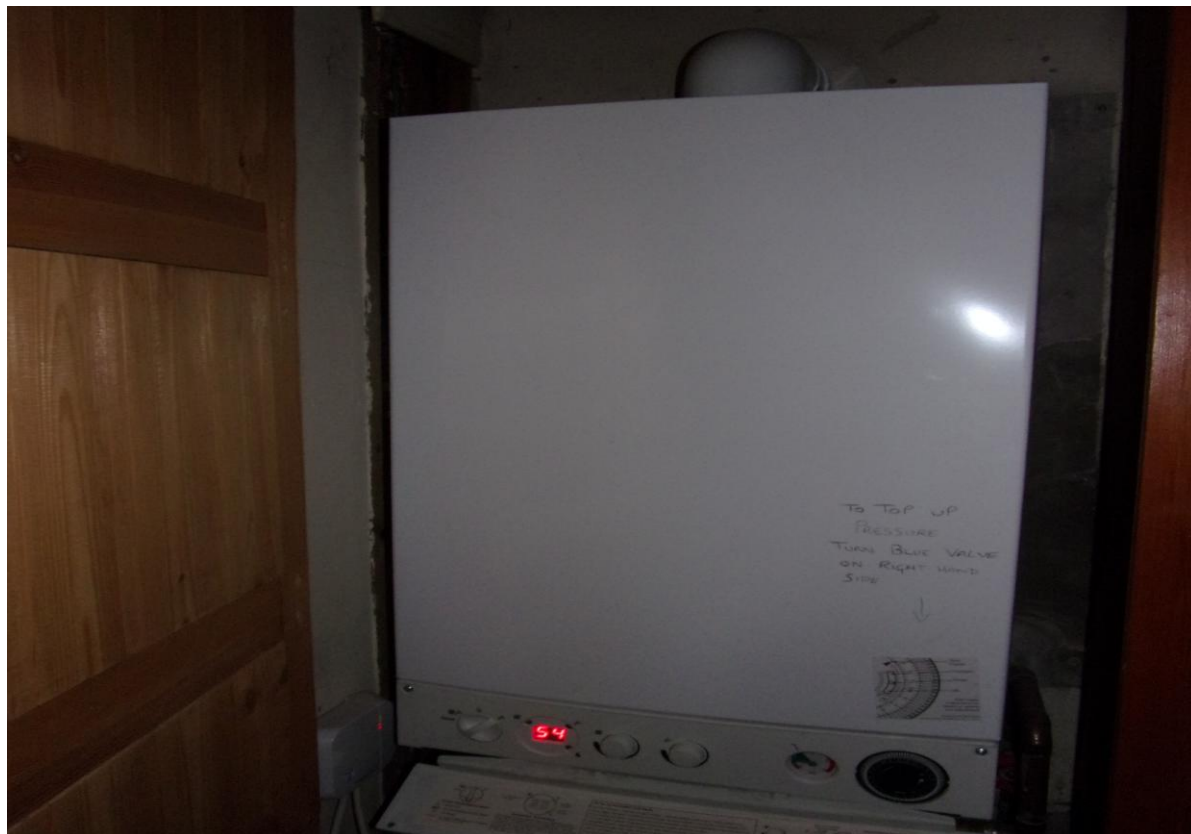
### Boiler

There is a modern gas-fired boiler in the kitchen, with a metal flue.

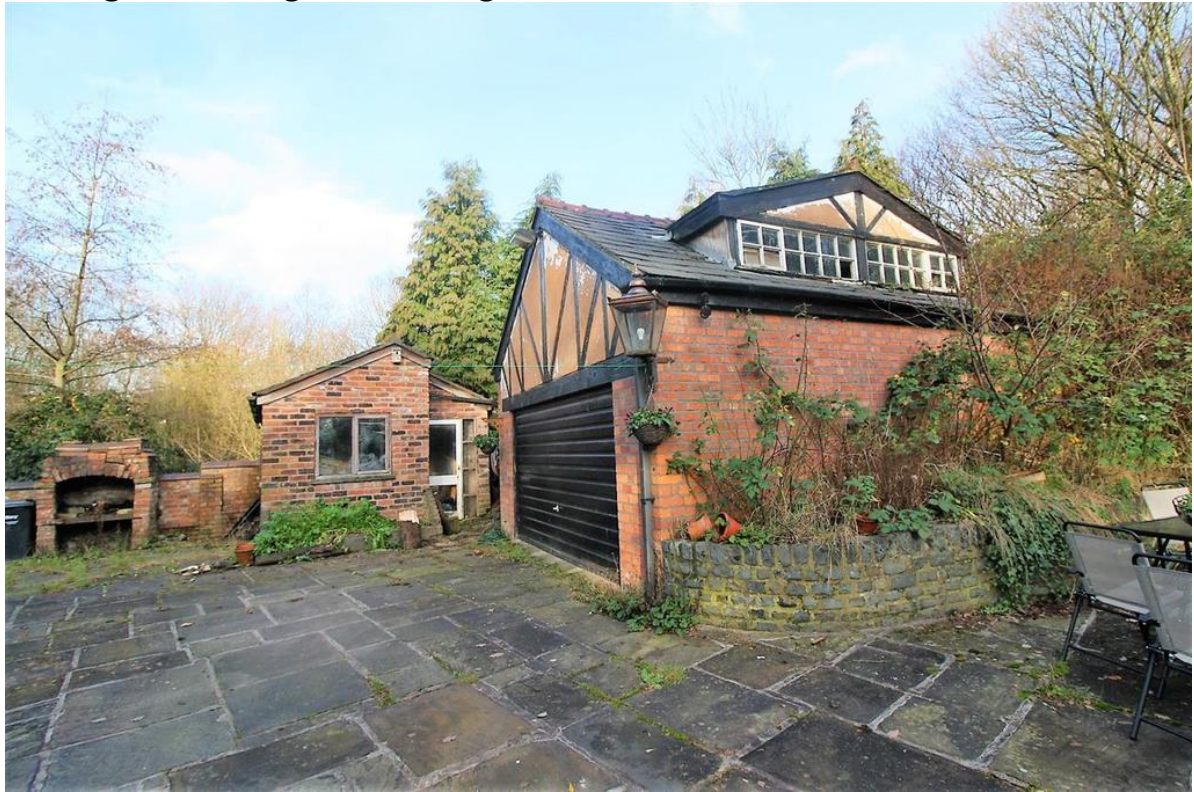
### **Storage Building and Garage**

To the right of the house, there is a garage and a storage building.

Both are built in brick, with concrete floors and slate roofs.

The storage building is single height, while the garage is double height and houses a former chicken coup in the loft area.

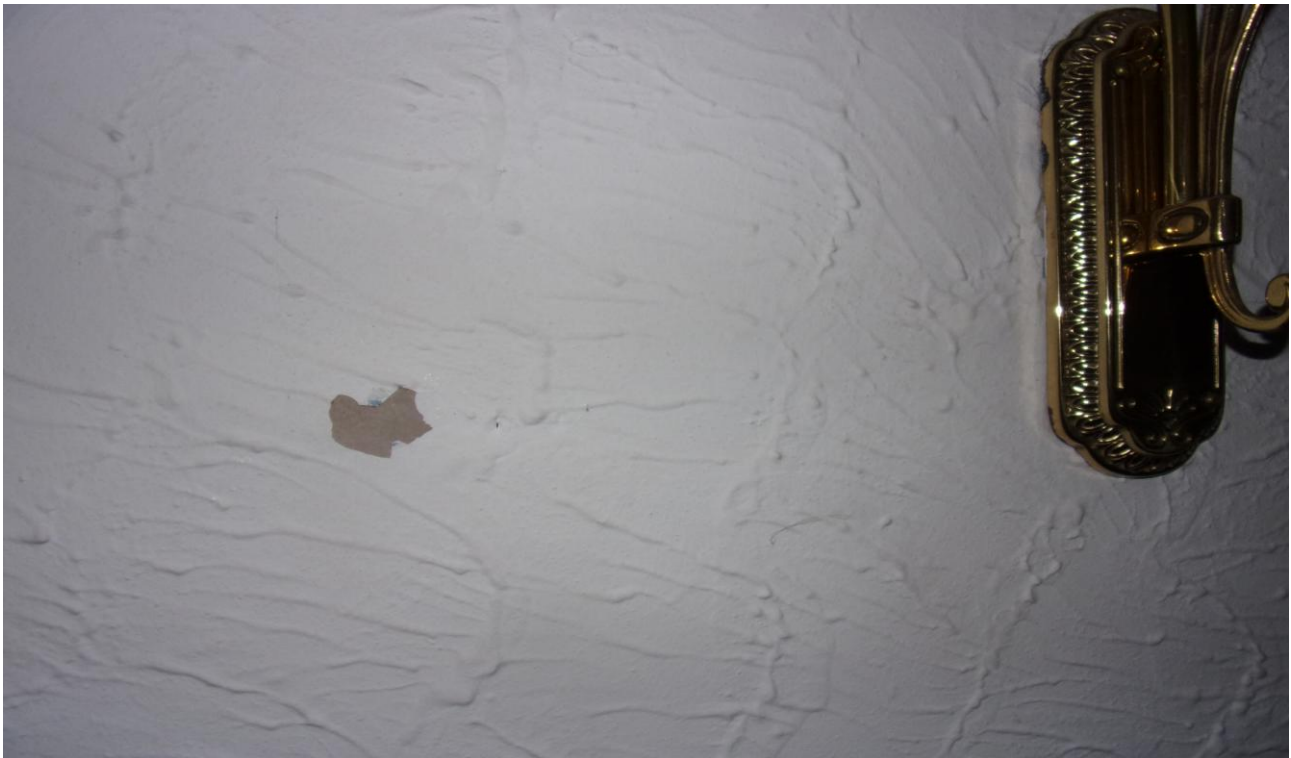
### Textured Decorative Paint on Ground Floor Walls

The only item to arouse any suspicion of the likely presence of asbestos-containing materials was the textured decorative paint present on a most of the walls on the cottage’s ground floor.

By means of the laboratory analysis of a sample taken of this in the former office (reference BS083596 on the Certificate of Bulk Fibre Analysis) this was **determined NOT to contain asbestos.**
