**Arboricultural Advice in accordance with  
BS 5837:2012 Trees in relation to construction – Recommendations  
Tree survey and Impact Assessment  
29<sup>th</sup> November 2024**

Subject Property: Land Adjacent to Titus Cottage  
Bradley Fold Road  
Ainsworth  
Bolton  
BL2 5QR

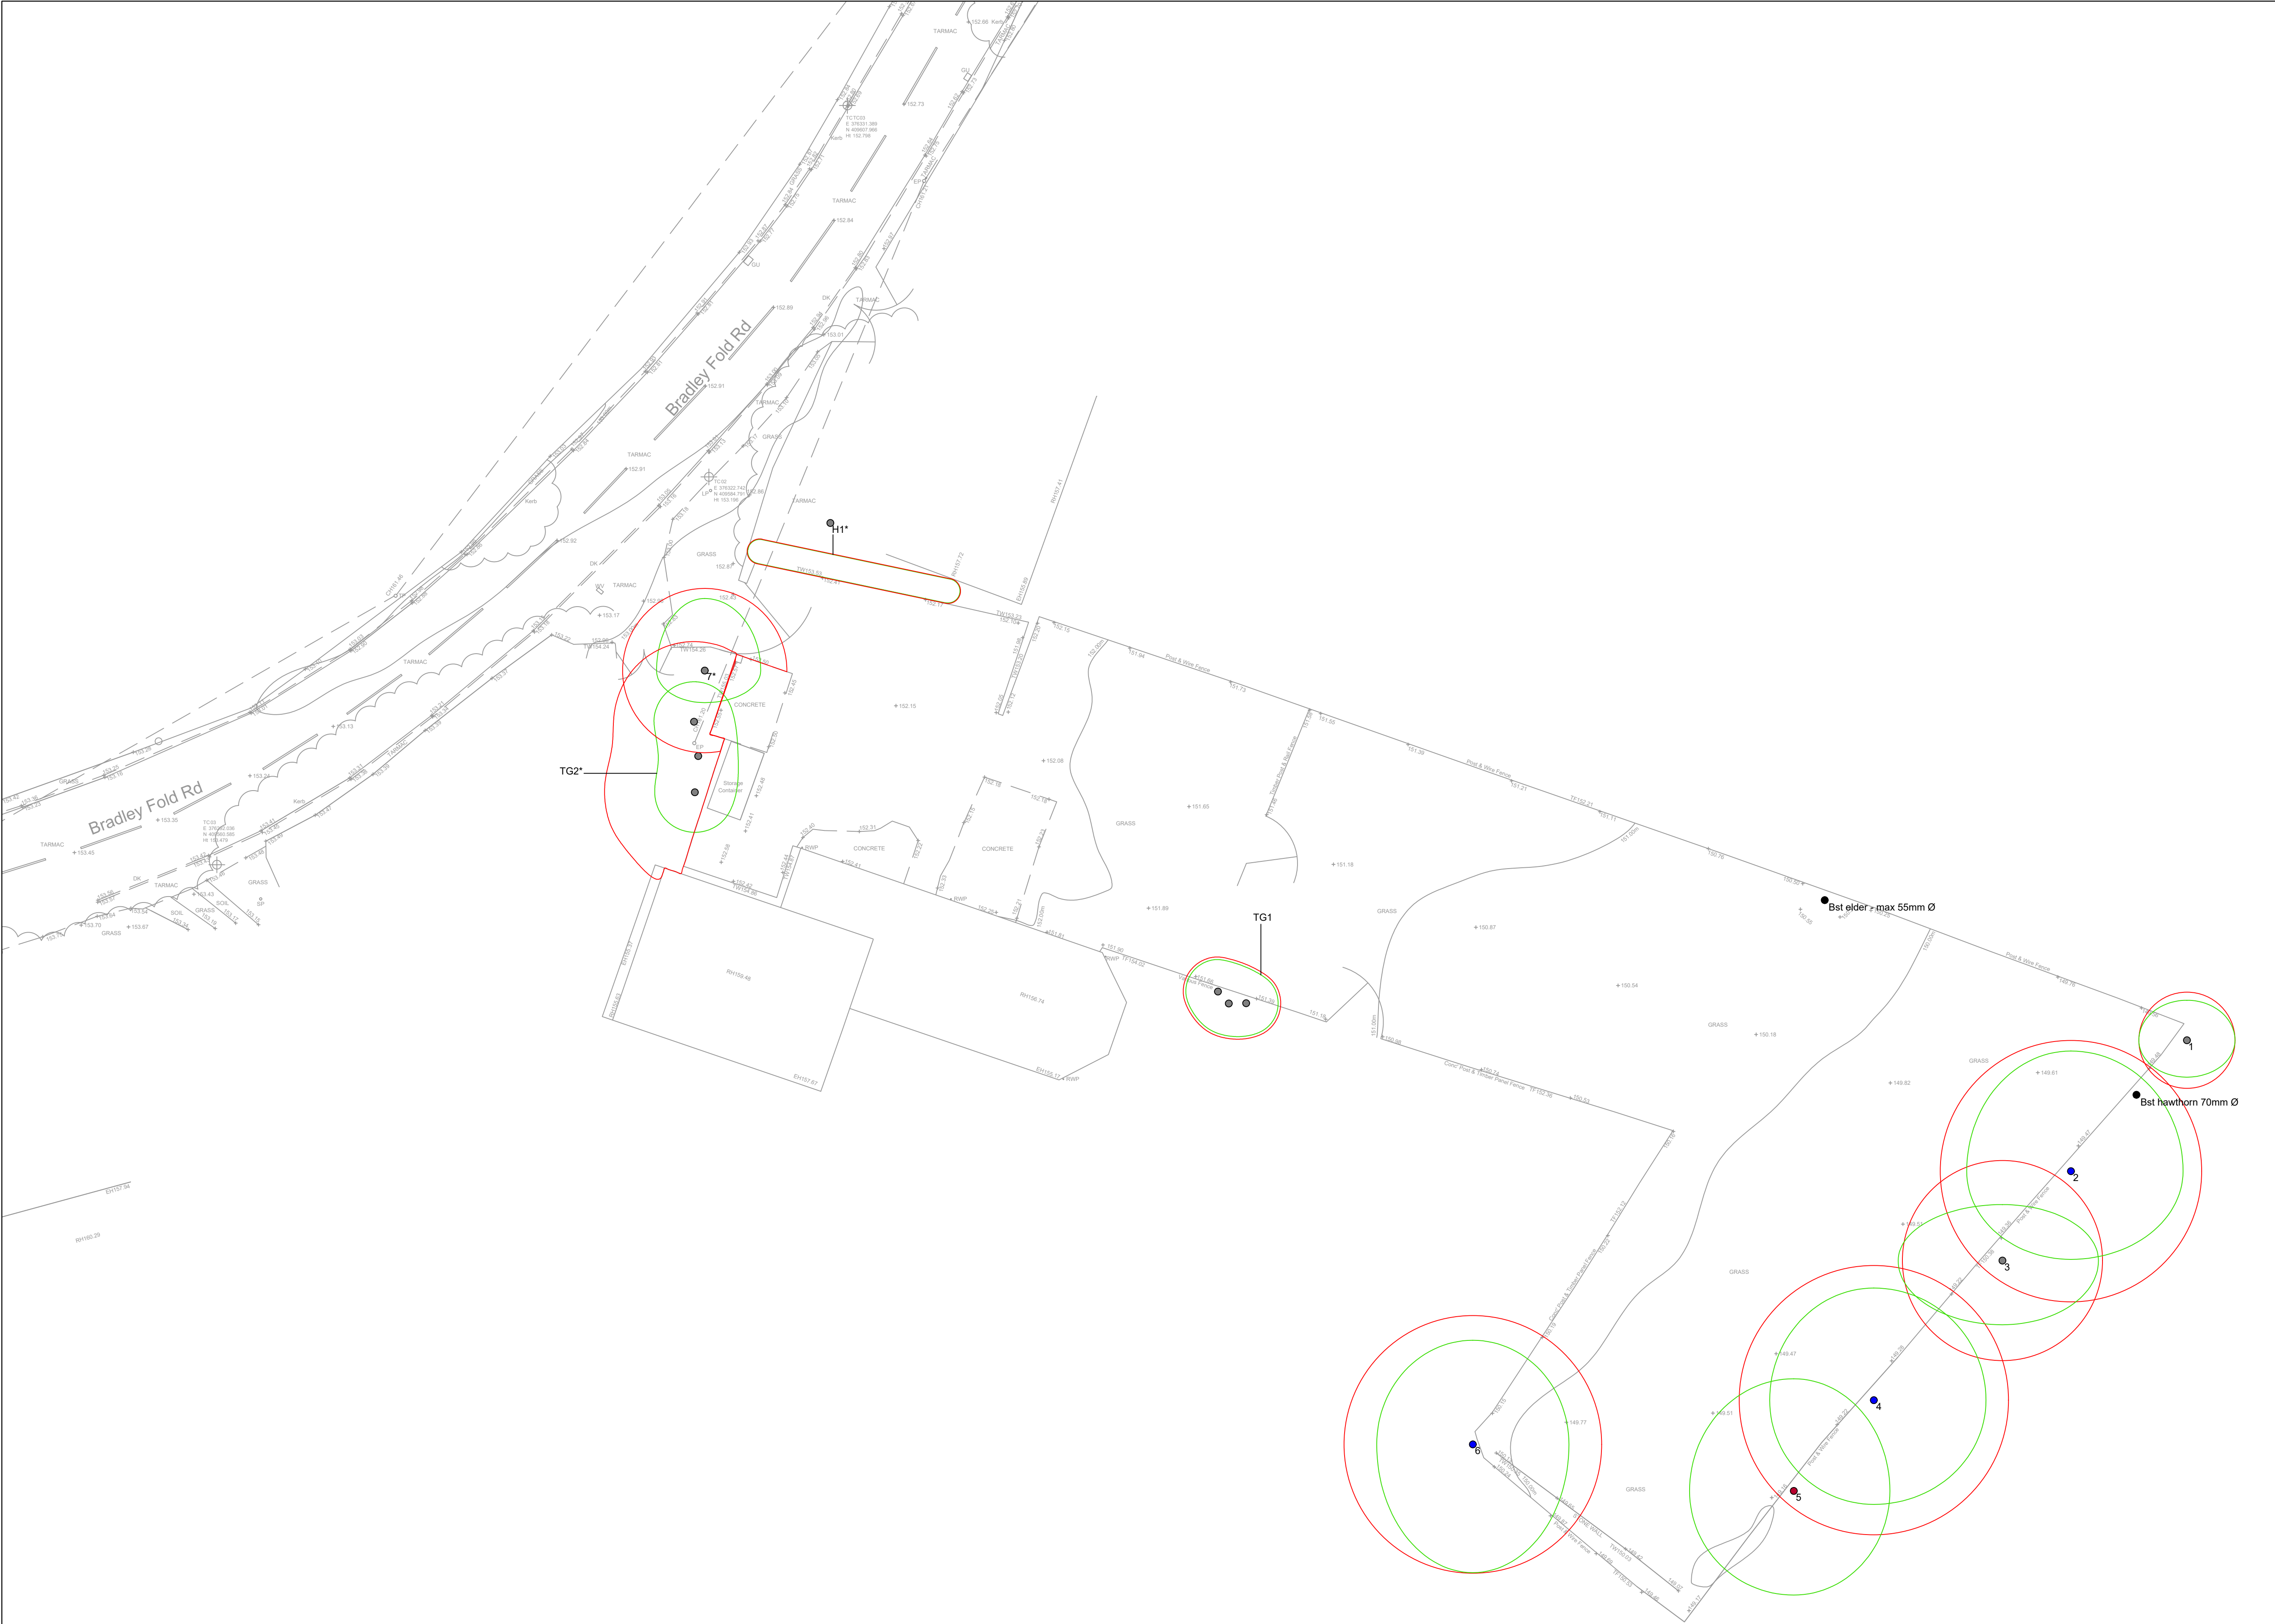
#### TREE RETENTION & REMOVAL PLAN

4.1.3 The proposed layout will entail the loss of no trees. All trees will be retained

4.1.4 It is advised that significant arboricultural work is undertaken to tree 5 due to its current condition. This is a mature ash tree that is suffering from ash dieback disease, and has significant dieback and fragile deadwood throughout its crown. This recommendation is advised whether or not the proposed development goes ahead.

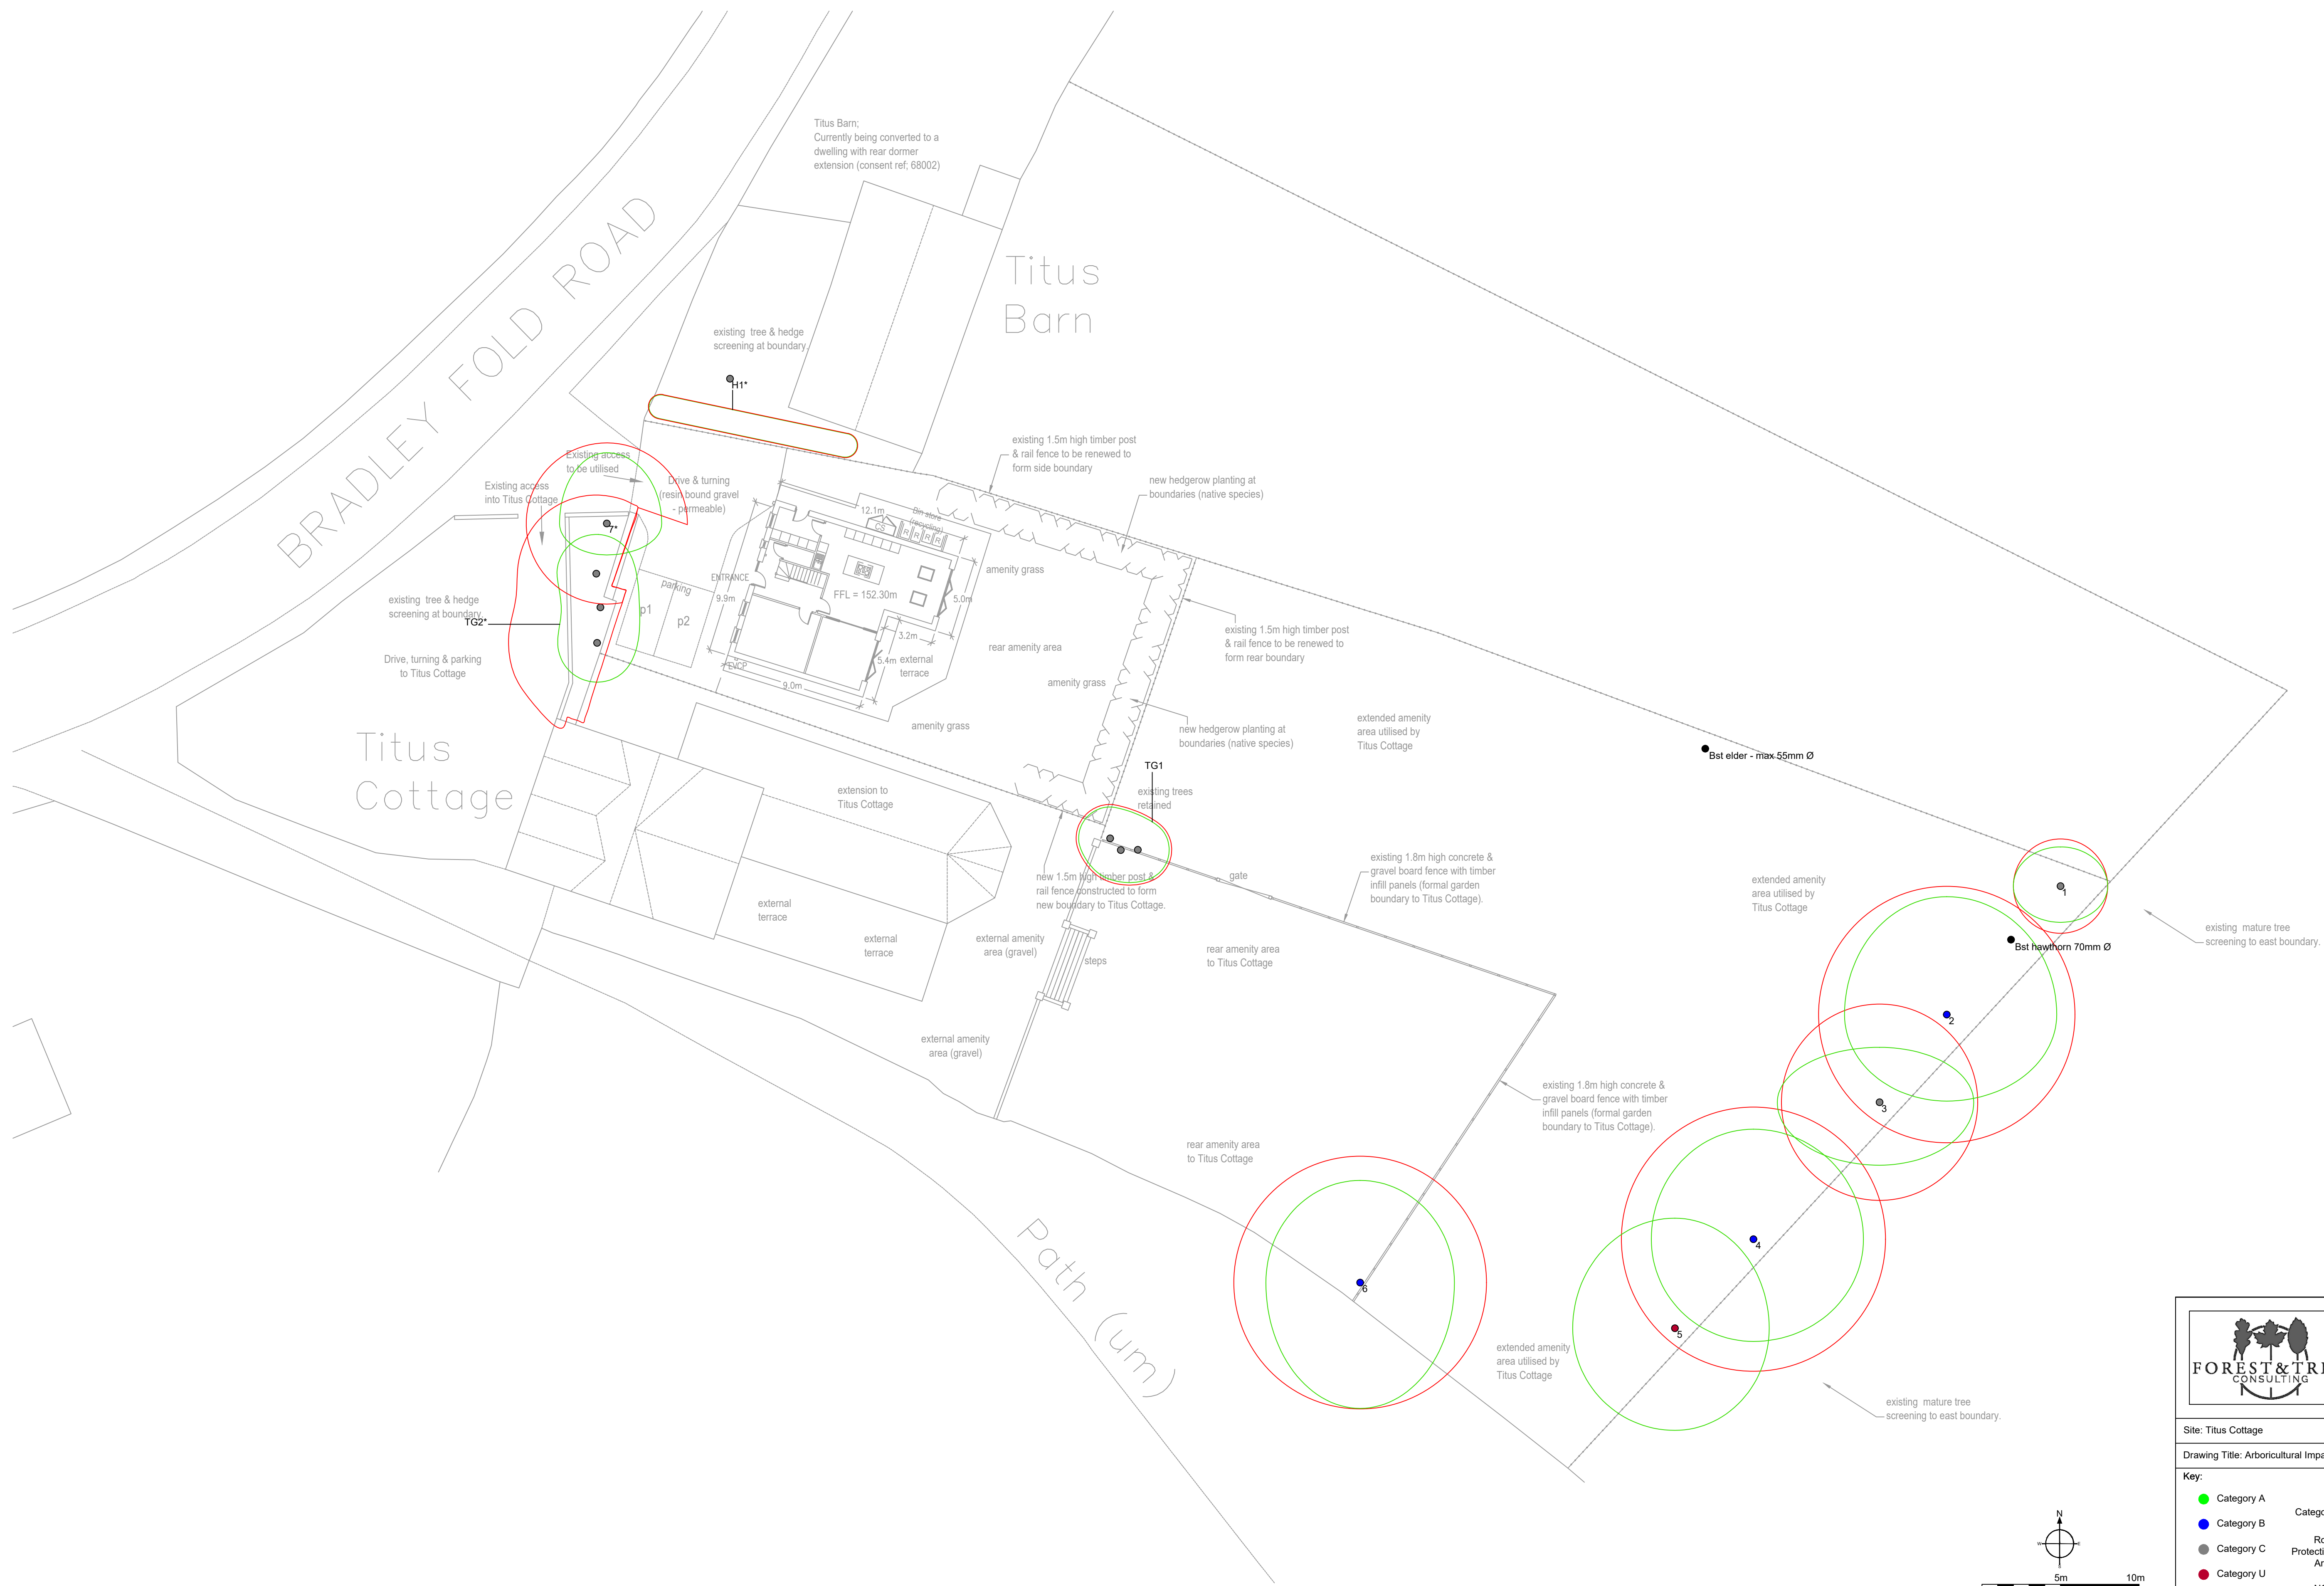
### ARBORICULTURAL IMPACT ASSESSMENT

4.2.1 A single instance of construction within an RPA is proposed. This is where the new driveway intersects with the RPA of tree 7.

4.2.2 This is a relatively minor incursion within the RPA. BS 5837 recommends, in section 7.4, that new hard surfacing within RPA's be constructed using methods that minimize the impact on the affected tree(s) and cover no more than 20% of the open ground within the RPA. The most appropriate means of construction is a no-dig method using a load-bearing cellular confinement system. The levels on site are well suited to the use of a no-dig system and I do not envisage any issues with installation. The new surface will cover 9.1sqm of the total of 65sqm of open ground within the RPA of tree 4. At 14% this is well below the maximum of 20% recommended in BS 5837.

4.4.1 The increased hard standing and fencing installation have the potential to cause harm to retention trees if constructed using conventional techniques. Therefore the methods for installing hard surfaces and for excavations in RPAs recommended in BS5837 should be followed. Suggested methodologies are provided as part of the tree protection plan.
