# **CONDITION REPORT**

## **PERIMETER FENCING**

### **St. Stephen's CE Primary School**

**OVERALL CONDITION/PRIORITY RATING: D1**

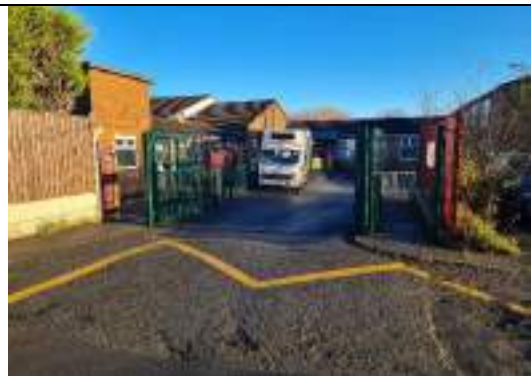
**Photo 1**

*Remarks:* Vehicle access gates are left open during deliveries. Allowing unrestricted access to site. Height and design do not meet DFE's output specification.  
*Condition/Priority Rating:* **D1**

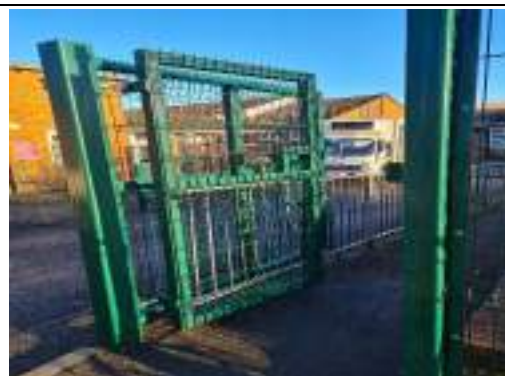
**Photo 2**

*Remarks:* Manually operated gates with no access controls allows access to site. Height and design do not meet DFE's output specification.  
*Condition/Priority Rating:* **D1**

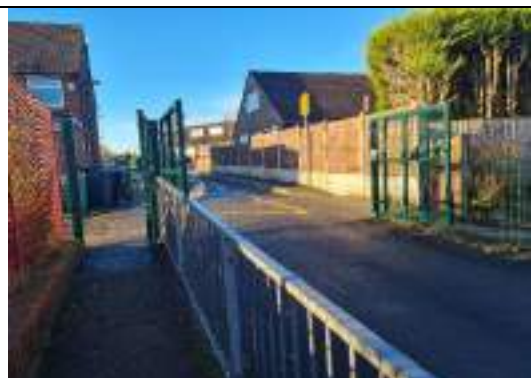
**Photo 3**

*Remarks:* Street view from entrance driveway. Height and design do not meet DFE's output specification  
*Condition/Priority Rating:* **D1**

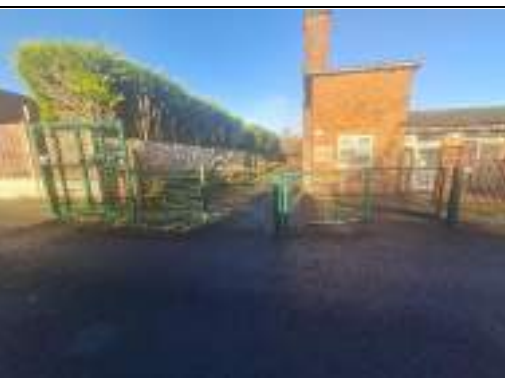
**Photo 4**

*Remarks:* Low level (c1200) open mesh fence provides in adequate safeguarding for pathway to EYFS area. Fence can easily be scaled.  
*Condition/Priority Rating:* **D1**

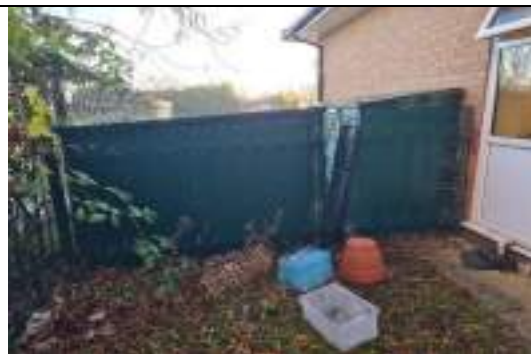
**Photo 5**

*Remarks:* Low level open mesh fence line separates EYFS and playing field. Open mesh fence line does not meet DFE's output specification guidance.  
*Condition/Priority Rating:* **D1**

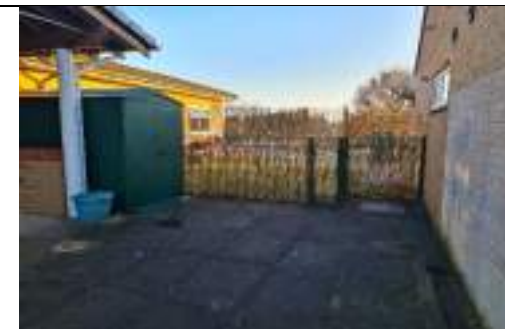
**Photo 6**

*Remarks:* Low level open mesh fence line separates EYFS and Play Area. Open mesh fence line does not meet DFE's output specification guidance for internal fencing. *Condition/Priority Rating:* **D1**

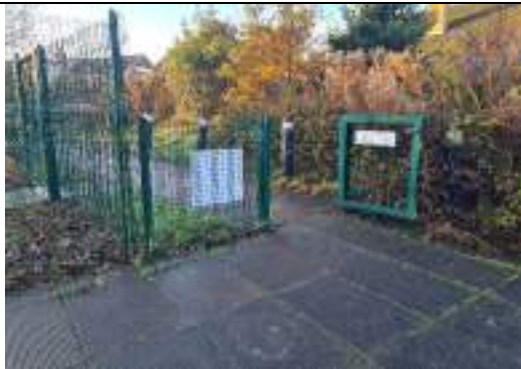
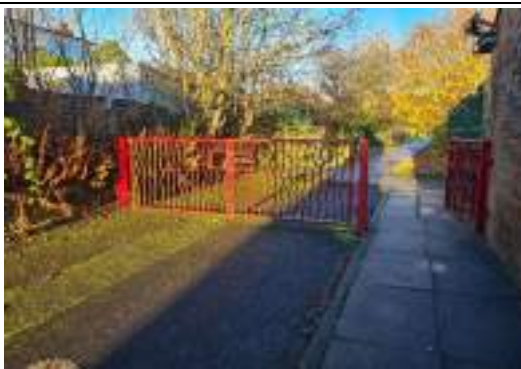
| <i>Remarks: Low level open mesh fence and gate to EYFS entrance path. Open mesh fencing can easily be scaled.</i><br><i>Condition/Priority Rating: <b>D1</b></i> | <i>Remarks: Low level metal double rail gate and single gate to EYFS entrance path. Railings are not anti-climb or vandal and can be easily scaled.</i><br><i>Condition/Priority Rating: <b>D1</b></i> |

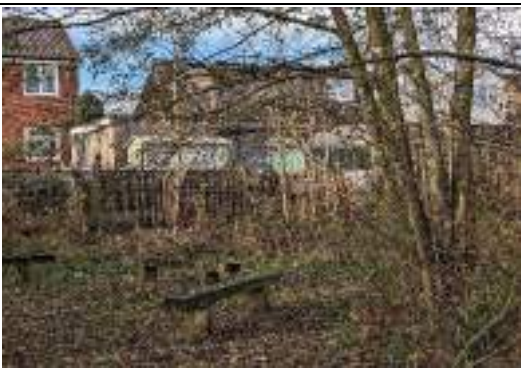
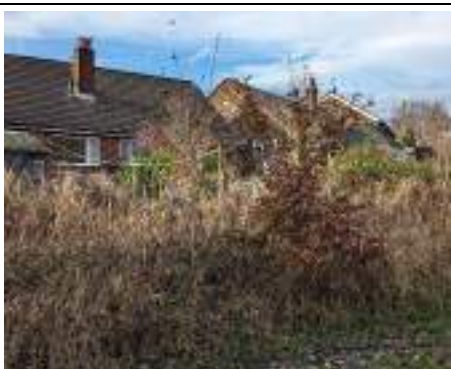
| <i>Remarks: Open chain link fence to residential properties. Open mesh can easily be scaled. Note proximity to gardens.</i><br><i>Condition/Priority Rating: <b>D1</b></i> | <i>Remarks: Open chain link fence to residential properties. Open mesh can easily be scaled. Note proximity to gardens.</i><br><i>Condition/Priority Rating: <b>D1</b></i> |

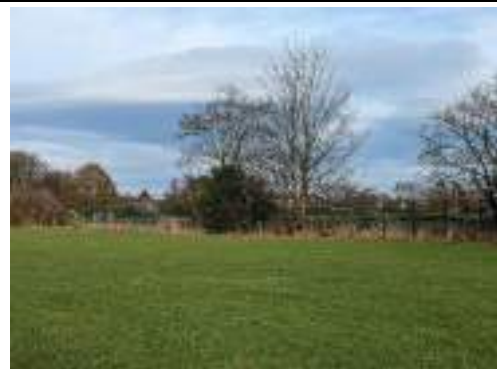
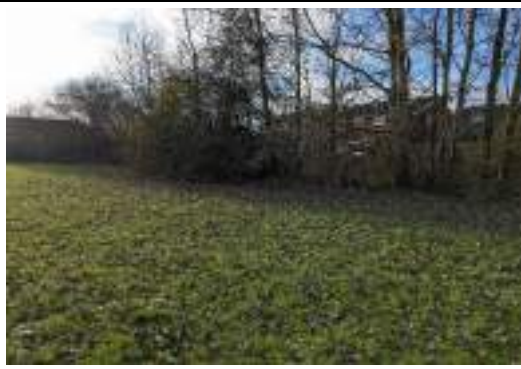
| <i>Remarks: Open mesh fence to perimeter fence line.</i><br><i>Condition/Priority Rating: <b>D1</b></i> | <i>Remarks: Extent of fence line to be replaced.</i><br><i>Condition/Priority Rating: <b>D1</b></i> |

It is strongly recommended that a new 2.4m high security fence is installed at the perimeter. The estimated cost associated with a security fence is circa £145,000.00 (including professional fees but excluding VAT). The costs are based on recently completed works within a locality of a similar scope and nature.

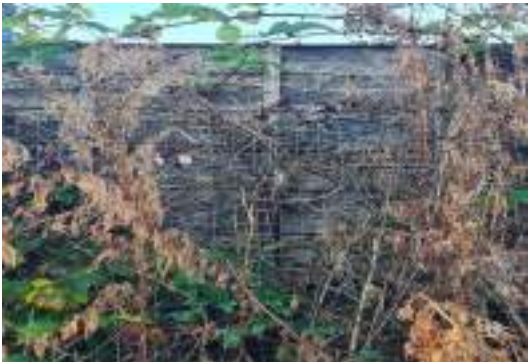
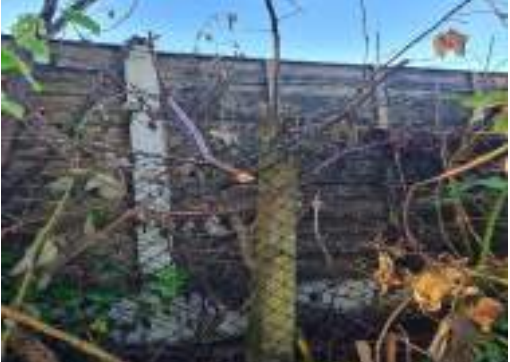
| <i>Remarks: Open chain link fence offset from aged residential standard timber fence. Note excessive vegetation growth.</i><br><i>Condition/Priority Rating: <b>D1</b></i> | <i>Remarks: Open chain link fence offset from aged residential standard timber fence. Note excessive vegetation growth. Concrete post leaning.</i><br><i>Condition/Priority Rating: <b>D1</b></i> |

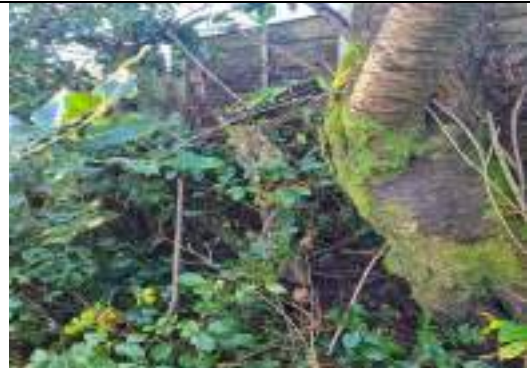
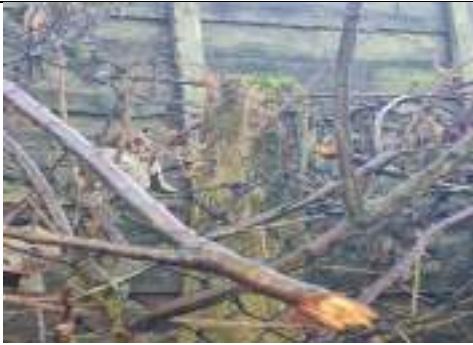
| <i>Remarks: Open chain link fence offset from aged residential standard timber fence. Note excessive vegetation growth.</i><br><i>Condition/Priority Rating: <b>D1</b></i> | <i>Remarks: Concrete post supporting chain link fence line. Post is leaning and is spalling. Vegetation growth present.</i><br><i>Condition/Priority Rating: <b>D1</b></i> |

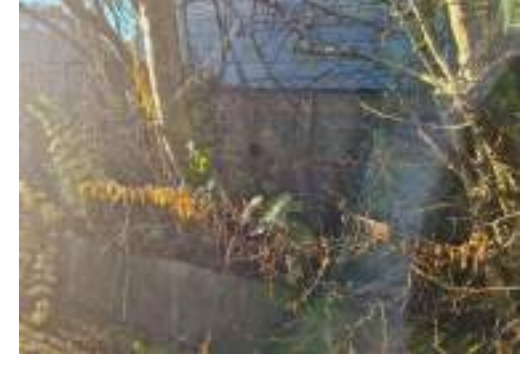
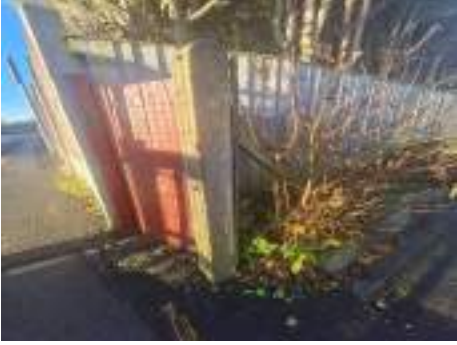
| <i>Remarks: Open chain link fence offset from aged residential standard timber fence. Note excessive vegetation growth.</i><br><i>Condition/Priority Rating: <b>D1</b></i> | <i>Remarks: Aged timber panel to vicinity of main entrance. Panel is aged and worn. Concrete post is leaning.</i><br><i>Condition/Priority Rating: <b>D1</b></i> |
