Phase I Geoenvironmental Site Assessment  
Fairways Lodge, Prestwich

Reference: 17-206-R1-1  
Date: September 2023

# PHASE I GEOENVIRONMENTAL SITE ASSESSMENT

Fairways Lodge  
George Street  
Prestwich  
Greater Manchester  
M25 9WS

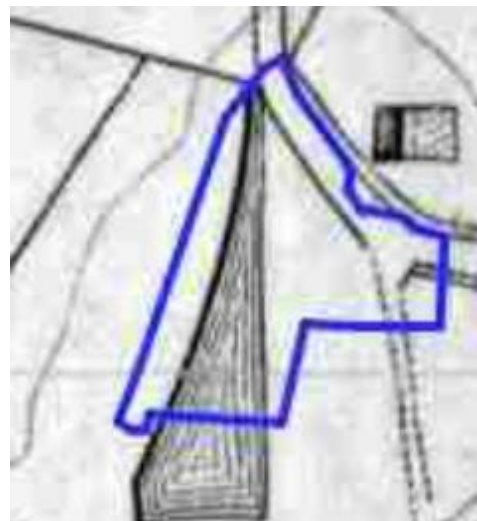
| MAP EDITION | HISTORICAL LAND USE | HISTORICAL MAP EXCERPT |
|---|---|---|
| <b>1848</b><br><b>1:10,560</b> | A pond/reservoir appears to be located across the majority of the site, likely associated with the Myrtle Grove Dye Works to the south of the site. | |

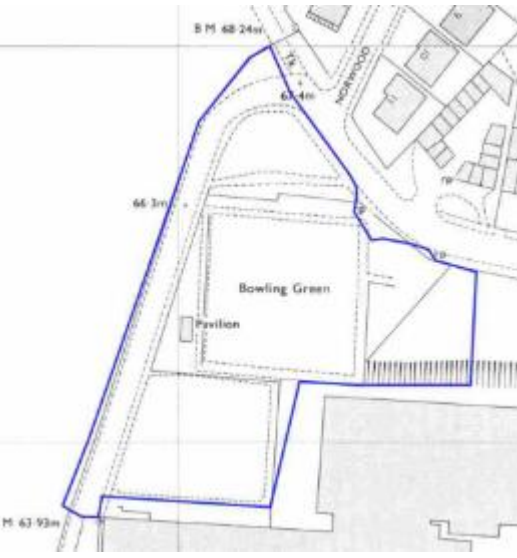
| MAP EDITION | HISTORICAL LAND USE | HISTORICAL MAP EXCERPT |
|---|---|---|
| <p>1973<br/>1:1,250</p> | <p>The reservoir in the south appears to have been infilled. A Pavilion is now present to the west of the Bowling Green, rather than to the north.</p> <p>An area of ground workings/land raising is present in the southeast.</p> | |

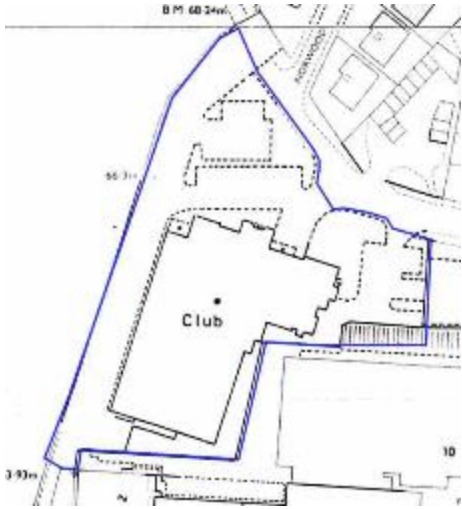
| MAP EDITION | HISTORICAL LAND USE | HISTORICAL MAP EXCERPT |
|---|---|---|
| <p><b>1988</b><br/><b>1:1,250</b></p> | <p>The reservoir in the south has been infilled.</p> <p>The Bowling Green is no longer present and a Club building has been constructed across the majority of the site.</p> | |

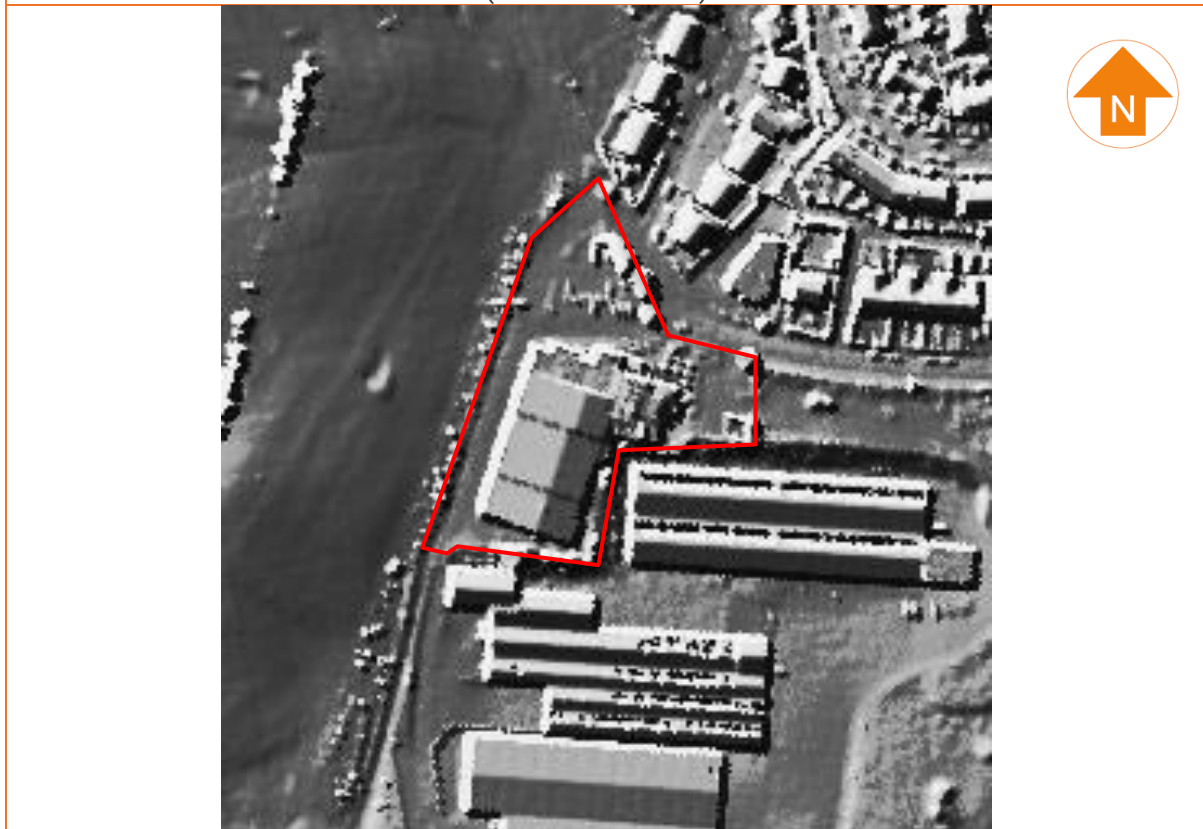
FIGURE 4.1 SURFACE LIDAR DATA (HOUSEPRICES.IO)

It would appear that the placement and upfilling of material will have formed the current site level plateau before the construction of the existing building.

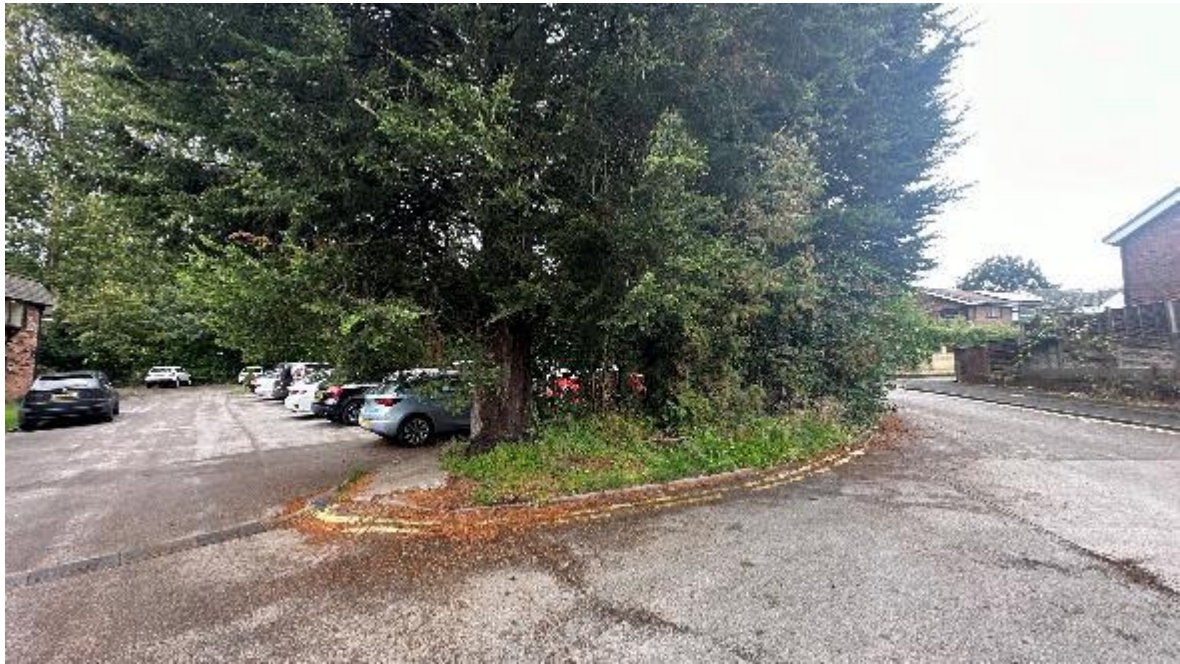
PLATE 3 MATURE TREES ALONG NORTHERN BOUNDARY

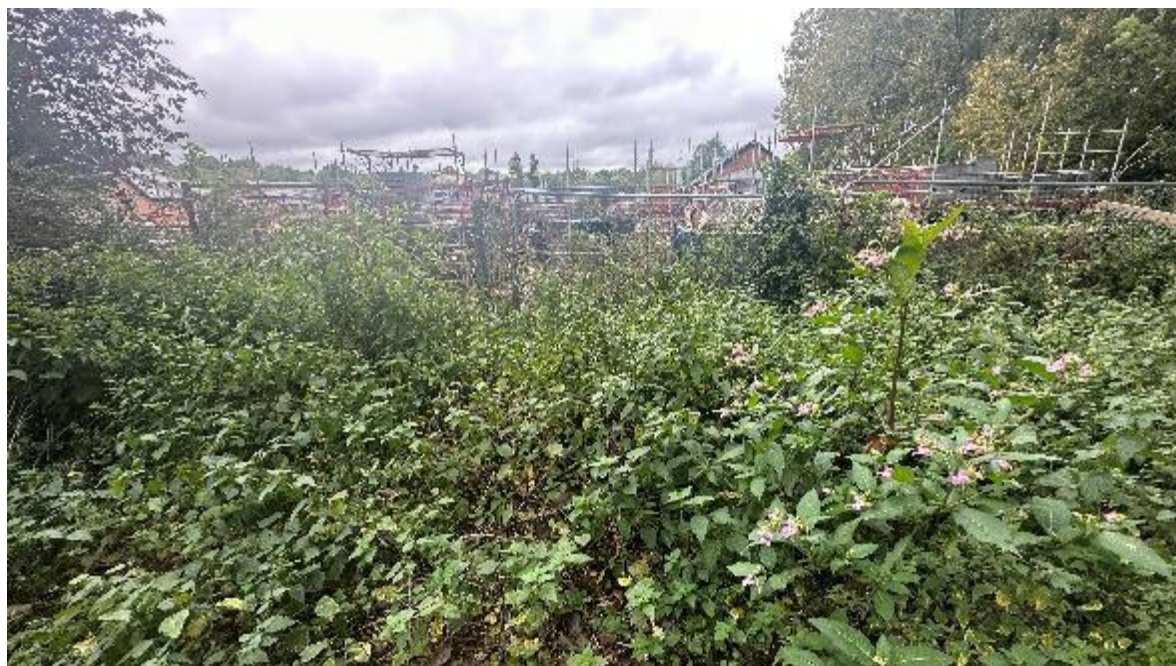
PLATE 5      INVASIVE PLANTS – SOUTHEAST SECTOR

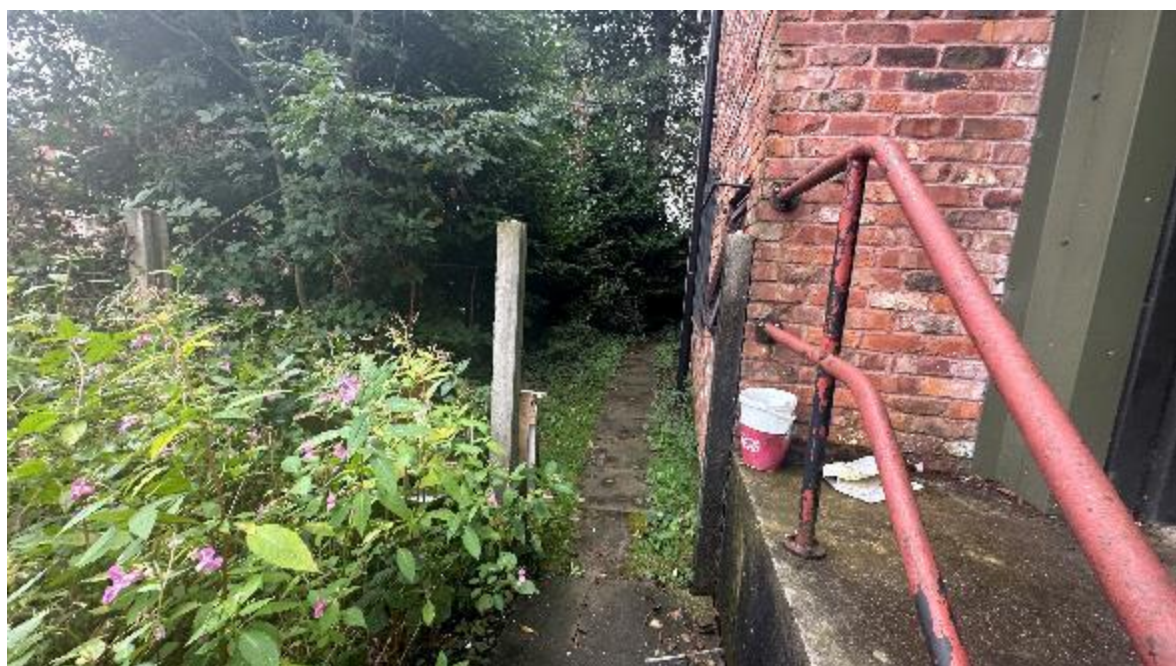
PLATE 6      INVASIVE PLANTS – SOUTHEAST SECTOR
