## Report on Survey of Asbestos Materials at

**Former Limelight Amusements**  
**9**

**Dale Street**  
**Radcliffe**  
**Manchester**  
**M261AB**

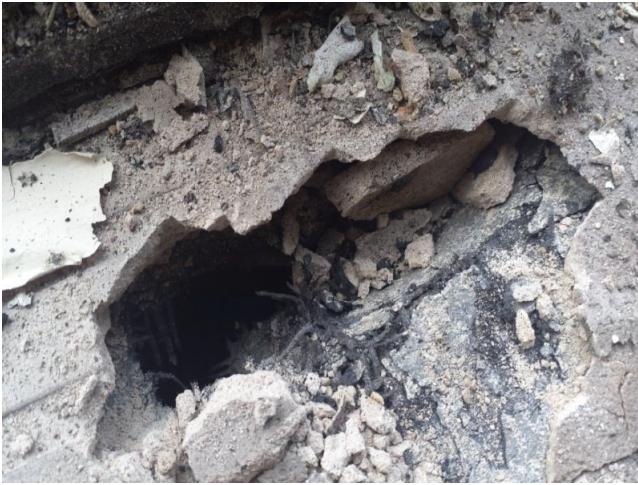
Sample No: 22/12/B/12/MBK10  
External  
External walls  
Bitumen damp barrier felt  
**No Asbestos Detected**

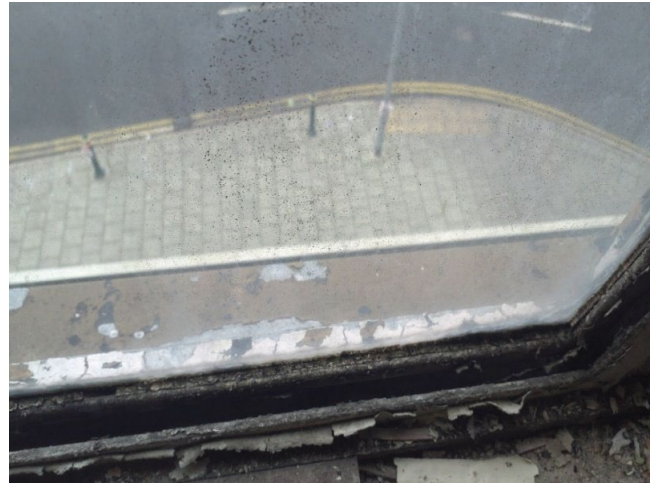
Sample No: 22/12/B/12/MBK11  
External  
Metal windows  
Putty  
**No Asbestos Detected**

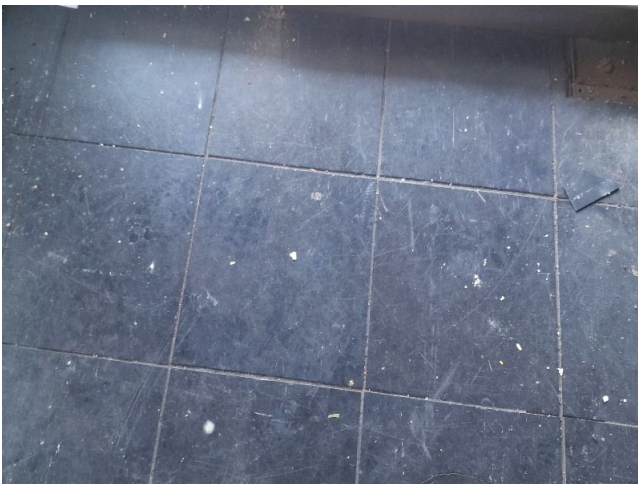
Sample No: 22/12/B/12/MBK1  
G.01 Main shop floor  
Floor  
Vinyl Floor Tiles  
**No Asbestos Detected**

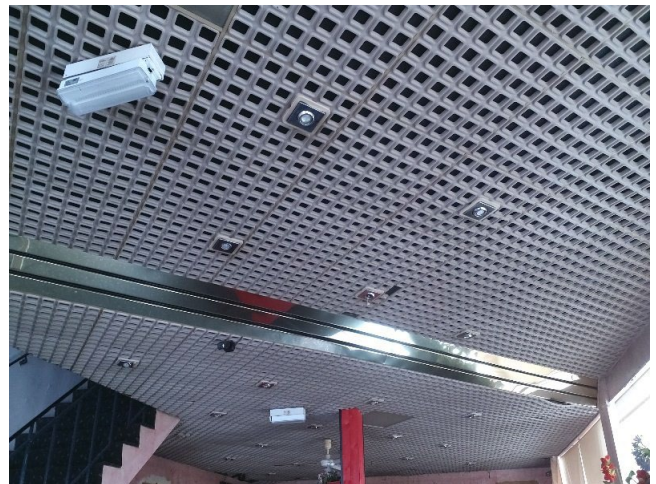
Sample No: 22/12/B/12/MBK2  
G.01 Main shop floor  
Ceiling  
Suspended insulation tiles  
**No Asbestos Detected**

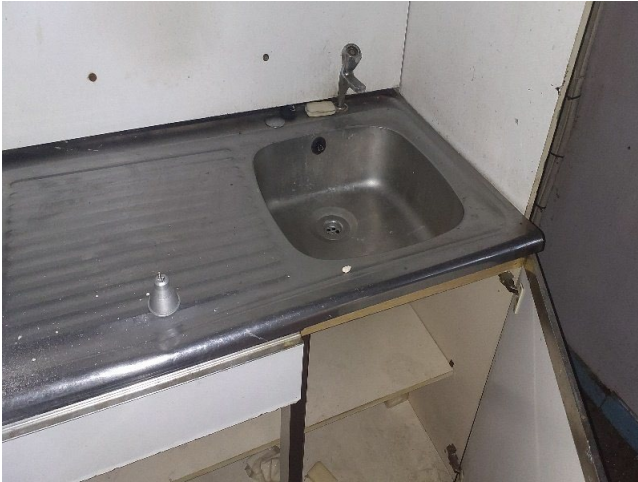
Sample No: 22/12/B/12/MBK3  
G.02 Kitchen  
Sink  
Bitumen pad  
**No Asbestos Detected**

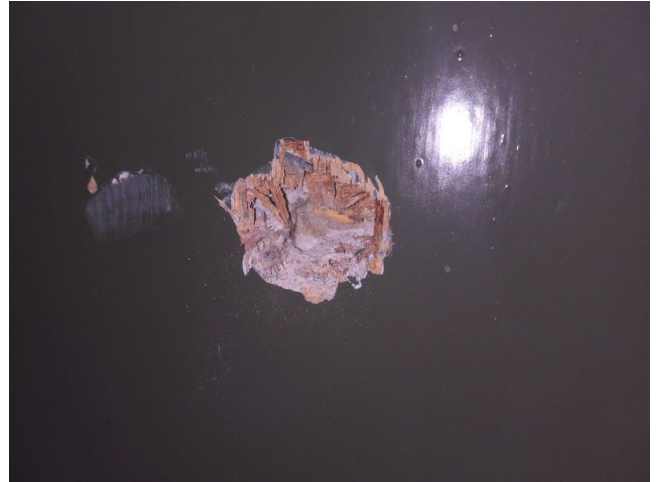
Sample No: 22/12/B/12/MBK6  
1.01 Stairs / Landing  
Double fire door internal lining  
Insulation board  
**No Asbestos Detected**

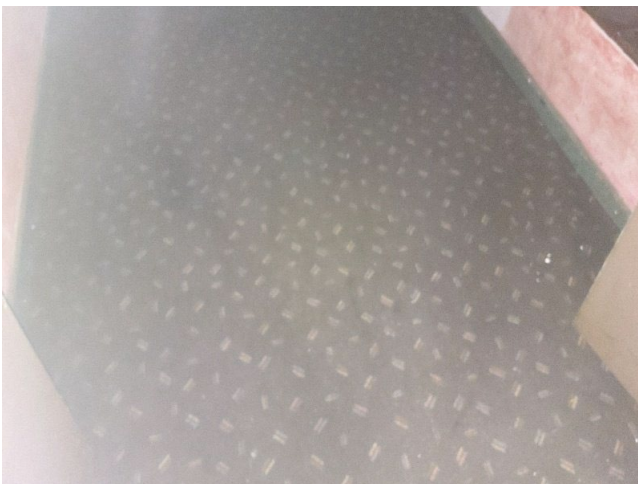
| Sample Number | Location | ACM Type | Material Risk Score | Recommendation |
|---|---|---|---|---|
| Refer to Sample 22/12/B/12/MBK4 | 1.01 - Stairs / Landing - Floor / Under carpet | Vinyl Floor Tiles | 3 | Remove |

Sample No: Refer to Sample 22/12/B/12/MBK4  
1.01 Stairs / Landing  
Floor / Under carpet  
Vinyl Floor Tiles containing:  
**Chrysotile (In tile only)**

| <b>Recommendation</b> | These materials should be removed and disposed of prior to demolition, by suitably trained and equipped personnel only, working under the guidance of a safe working procedure and in accordance with the requirements of The Control of Asbestos Regulations 2012 and The Hazardous Waste (England and Wales) Regulations 2005 (as amended in 2009). |

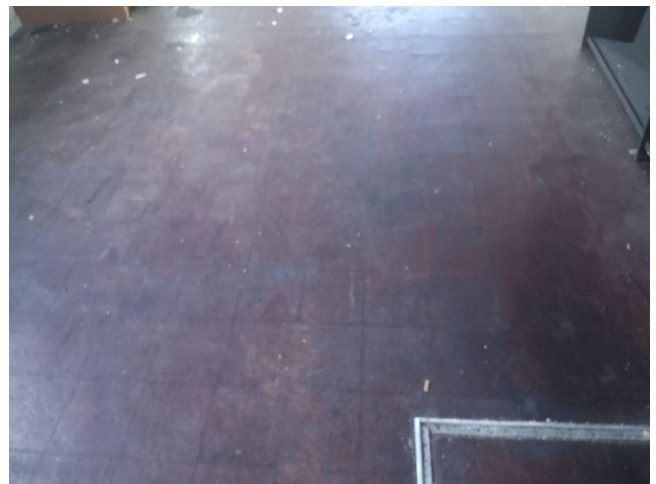
| Sample Number | Location | ACM Type | Material Risk Score | Recommendation |
|---|---|---|---|---|
| 22/12/B/12/MBK4 | 1.02 - Open plan storage space - Floor | Vinyl Floor Tiles | 3 | Remove |

| <b>Condition</b> | Sample No: 22/12/B/12/MBK4<br>Fair |

Sample No: 22/12/B/12/MBK4  
1.02 Open plan storage space  
Floor  
Vinyl Floor Tiles containing:  
**Chrysotile (In tile only)**

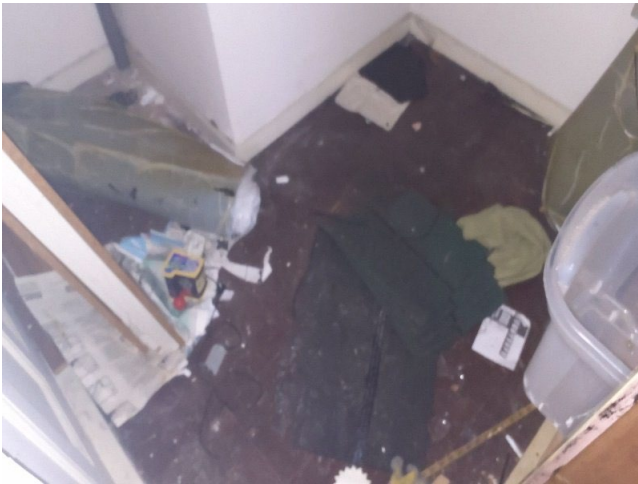
| Sample Number | Location | ACM Type | Material Risk Score | Recommendation |
|---|---|---|---|---|
| Refer to Sample 22/12/B/12/MBK4 | 1.03 - Store - Floor | Vinyl Floor Tiles | 3 | Remove |

Sample No: Refer to Sample 22/12/B/12/MBK4  
1.03 Store  
Floor  
Vinyl Floor Tiles containing:  
**Chrysotile (In tile only)**

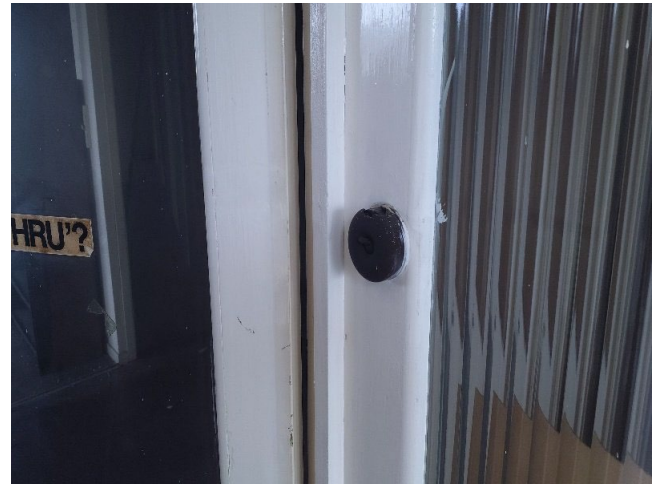
Sample No: 22/12/B/12/MBK5  
1.04 Store  
Partition wall adjacent door  
Thermoplastic switch  
**No Asbestos Detected**

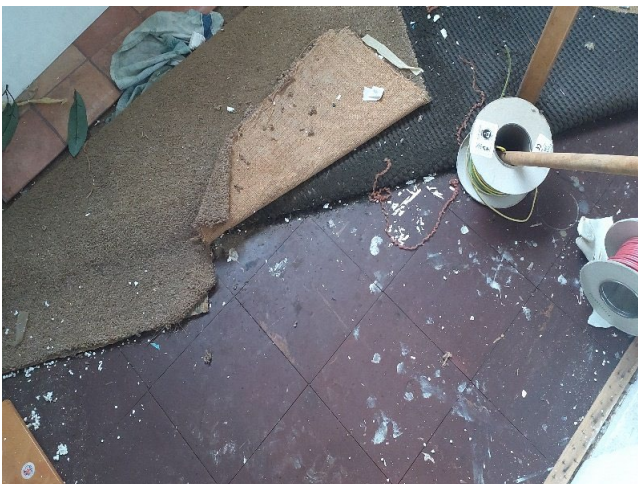
| Sample Number | Location | ACM Type | Material Risk Score | Recommendation |
|---|---|---|---|---|
| Refer to Sample 22/12/B/12/MBK4 | 1.04 - Store - Floor | Vinyl Floor Tiles | 3 | Remove |

Sample No: Refer to Sample 22/12/B/12/MBK4  
1.04 Store  
Floor  
Vinyl Floor Tiles containing:  
**Chrysotile (In tile only)**

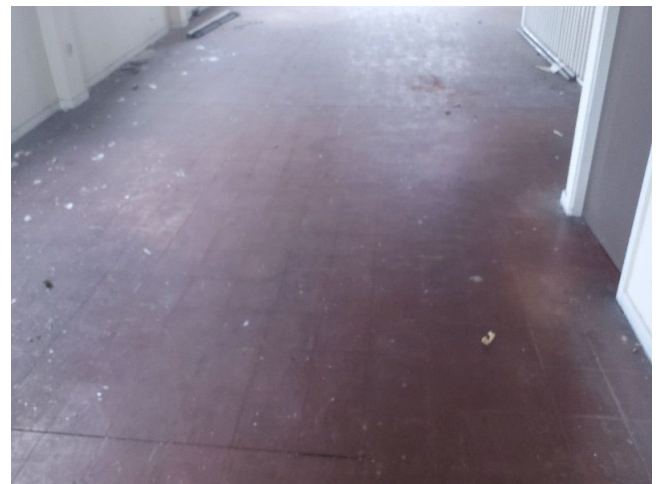
| Sample Number | Location | ACM Type | Material Risk Score | Recommendation |
|---|---|---|---|---|
| 22/12/B/12/MBK7 | 2.01 - Open plan storage space - Floor | Vinyl Floor Tiles and Bitumen Adhesive | 3 | Remove |

| <b>Condition</b> | Sample No: 22/12/B/12/MBK7<br>Fair |

Sample No: 22/12/B/12/MBK7  
2.01 Open plan storage space  
Floor  
Vinyl Floor Tiles and Bitumen Adhesive containing:  
**Chrysotile (In both tile and bitumen)**

| <b>Recommendation</b> | These materials should be removed and disposed of prior to demolition, by suitably trained and equipped personnel only, working under the guidance of a safe working procedure and in accordance with the requirements of The Control of Asbestos Regulations 2012 and The Hazardous Waste (England and Wales) Regulations 2005 (as amended in 2009). |

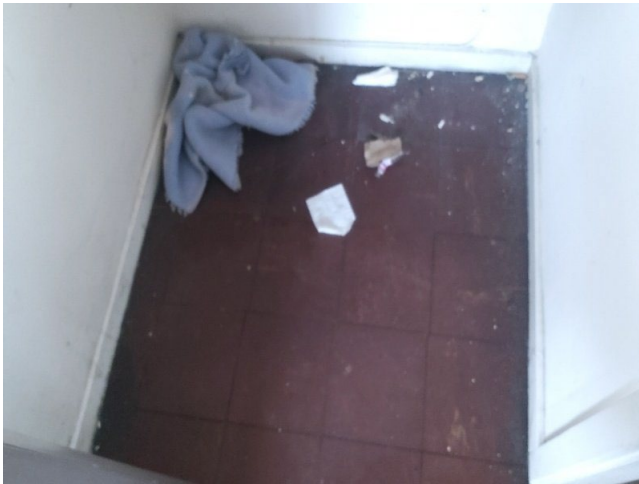
| Sample Number | Location | ACM Type | Material Risk Score | Recommendation |
|---|---|---|---|---|
| Refer to Sample 22/12/B/12/MBK7 | 2.02 - Gents toilet lobby - Floor | Vinyl Floor Tiles and Bitumen Adhesive | 3 | Remove |

Sample No: Refer to Sample 22/12/B/12/MBK7  
2.02 Gents toilet lobby  
Floor

Vinyl Floor Tiles and Bitumen Adhesive containing:  
**Chrysotile (In both tile and bitumen)**

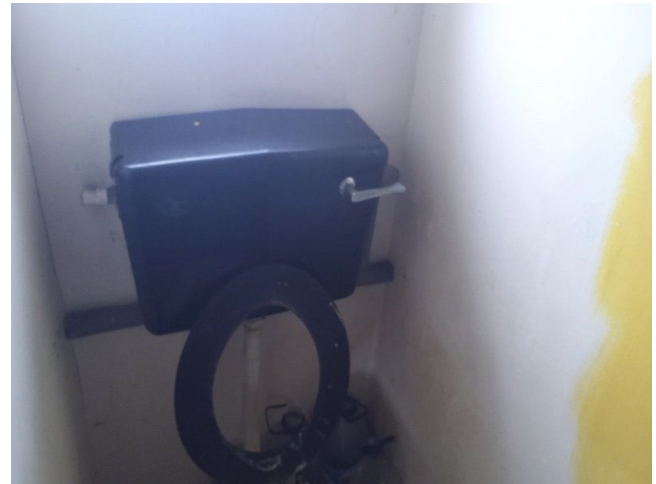
| Sample Number | Location | ACM Type | Material Risk Score | Recommendation |
|---|---|---|---|---|
| 22/12/B/12/MBK8 | 2.03 - Gents toilet - Toilet Cistern | Thermoplastic | 4 | Remove |

| <b>Condition</b> | Sample No: 22/12/B/12/MBK8<br>Fair |

Sample No: 22/12/B/12/MBK8  
2.03 Gents toilet  
Toilet Cistern

Thermoplastic containing:  
**Amosite**

| <b>Recommendation</b> | These materials should be removed and disposed of prior to demolition, by suitably trained and equipped personnel only, working under the guidance of a safe working procedure and in accordance with the requirements of The Control of Asbestos Regulations 2012 and The Hazardous Waste (England and Wales) Regulations 2005 (as amended in 2009). |

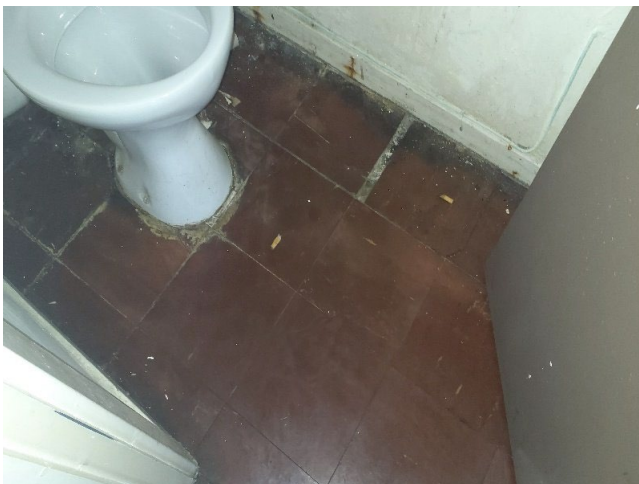
| Sample Number | Location | ACM Type | Material Risk Score | Recommendation |
|---|---|---|---|---|
| Refer to Sample 22/12/B/12/MBK7 | 2.03 - Gents toilet - Floor | Vinyl Floor Tiles and Bitumen Adhesive | 3 | Remove |

Sample No: Refer to Sample 22/12/B/12/MBK7  
2.03 Gents toilet  
Floor

Vinyl Floor Tiles and Bitumen Adhesive containing:  
**Chrysotile (In both tile and bitumen)**

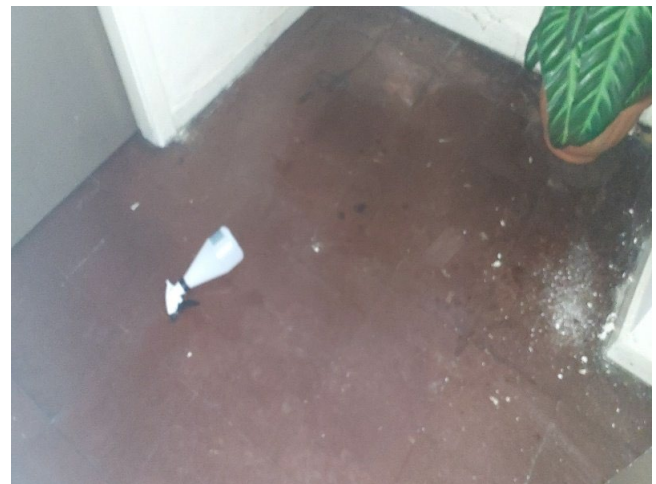
| Sample Number | Location | ACM Type | Material Risk Score | Recommendation |
|---|---|---|---|---|
| Refer to Sample 22/12/B/12/MBK7 | 2.04 - Ladies toilet lobby - Floor | Vinyl Floor Tiles and Bitumen Adhesive | 3 | Remove |

Sample No: Refer to Sample 22/12/B/12/MBK7  
2.04 Ladies toilet lobby  
Floor

Vinyl Floor Tiles and Bitumen Adhesive containing:  
**Chrysotile (In both tile and bitumen)**

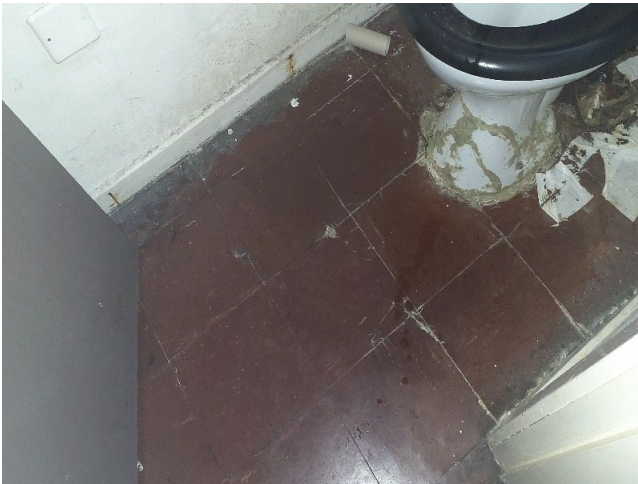
| Sample Number | Location | ACM Type | Material Risk Score | Recommendation |
|---|---|---|---|---|
| Refer to Sample 22/12/B/12/MBK7 | 2.05 - Ladies toilet - Floor | Vinyl Floor Tiles and Bitumen Adhesive | 3 | Remove |

Sample No: Refer to Sample 22/12/B/12/MBK7  
2.05 Ladies toilet  
Floor  
Vinyl Floor Tiles and Bitumen Adhesive containing:  
**Chrysotile (In both tile and bitumen)**

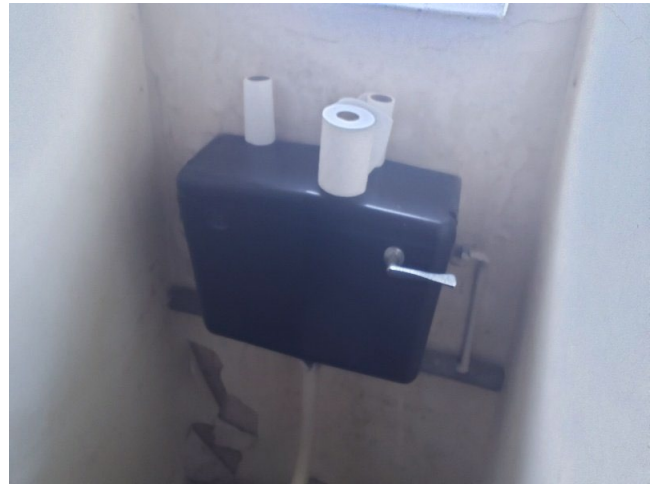
| Sample Number | Location | ACM Type | Material Risk Score | Recommendation |
|---|---|---|---|---|
| Refer to Sample 22/12/B/12/MBK8 | 2.05 - Ladies toilet - Toilet Cistern | Thermoplastic | 4 | Remove |

Sample No: Refer to Sample 22/12/B/12/MBK8  
2.05 Ladies toilet  
Toilet Cistern  
Thermoplastic containing:  
**Amosite**

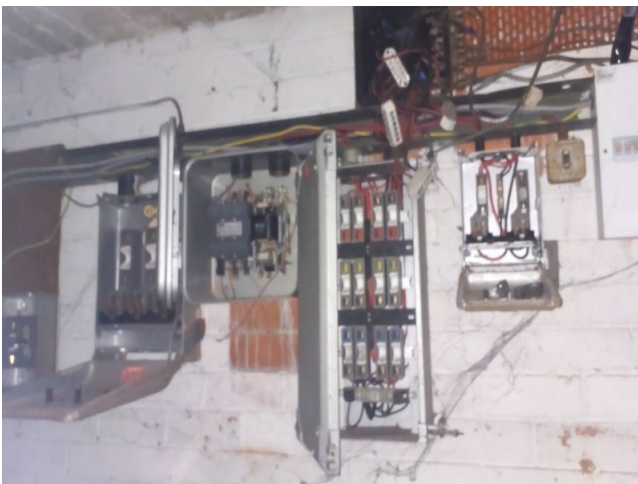
| Sample Number | Location | ACM Type | Material Risk Score | Recommendation |
|---|---|---|---|---|
| 22/12/B/12/MBK9 | B.01 - Store room /<br>Electrics room - Fuse boxes | Woven fuse guards | 5 | Remove |

| <b>Condition</b> | Sample No: 22/12/B/12/MBK9<br>Fair |

Sample No: 22/12/B/12/MBK9  
B.01 Store room / Electrics room  
Fuse boxes  
Woven fuse guards containing:  
**Chrysotile**

| <b>Recommendation</b> | These materials should be removed and disposed of prior to demolition, by suitably trained and equipped personnel only, working under the guidance of a safe working procedure and in accordance with the requirements of The Control of Asbestos Regulations 2012 and The Hazardous Waste (England and Wales) Regulations 2005 (as amended in 2009). |

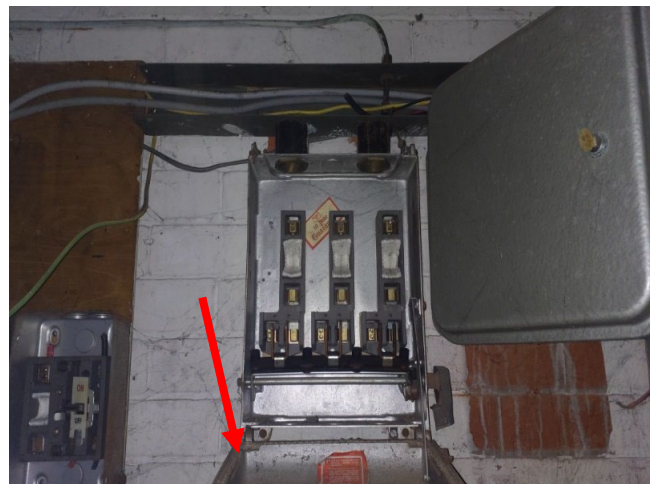
Sample No: 22/12/B/12/MBK12  
B.01 Store room / Electrics room  
Fuse boxes  
Woven rope seal  
**No Asbestos Detected**
