## Report on Survey of Asbestos Materials at

**Redds**  
**5 Dale Street**  
**Radcliffe**  
**M26 1AB**

**Redds, 5, Dale Street, Radcliffe M26 1AB**

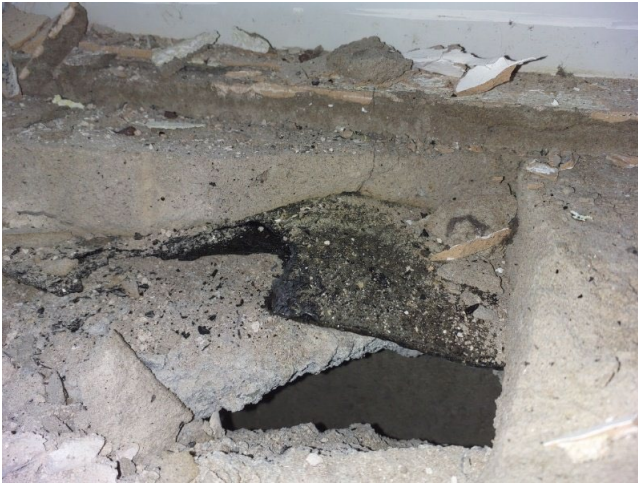
Sample No: 22/12/B/12/SAW9  
External  
Windows  
Bitumen vapour barrier to wall cavities  
**No Asbestos Detected**

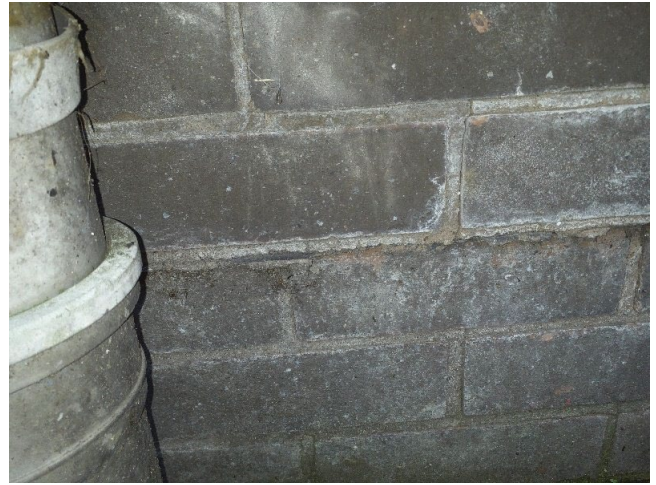
Sample No: 22/12/B/12/SAW10  
External  
Damp proof course  
Bitumen Layer  
**No Asbestos Detected**

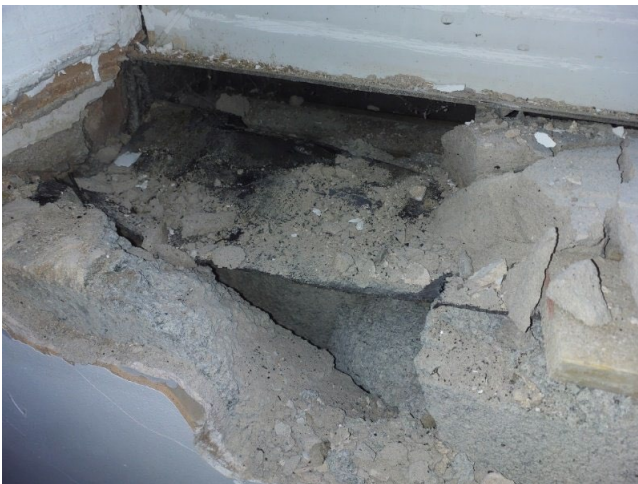
Sample No: Refer to Sample 22/12/B/12/SAW9  
External  
Windows  
Bitumen vapour barrier to wall cavities  
**No Asbestos Detected**

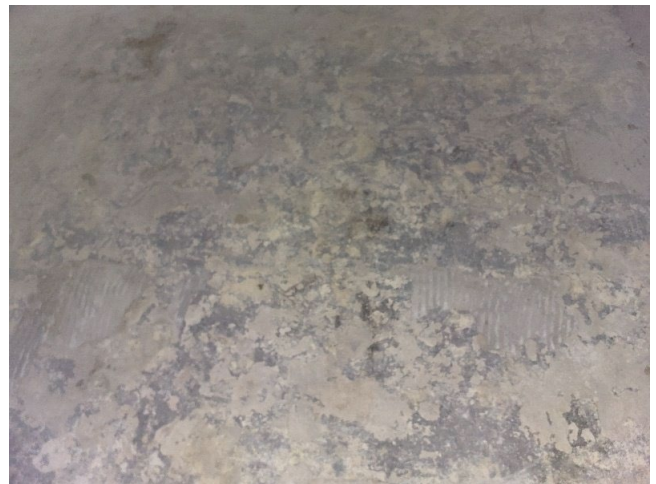
| Sample Number | Location | ACM Type | Material Risk Score | Recommendation |
|---|---|---|---|---|
| 22/12/B/12/SAW6 | G.01 - Shop area - Floor beneath screed | Bitumen residuals | 3 | Remove |

| <b>Condition</b> | Sample No: 22/12/B/12/SAW6, 22/12/B/12/SAW7<br>Fair |

Sample No: 22/12/B/12/SAW6  
G.01 Shop area  
Floor beneath screed  
Bitumen residuals containing:  
**Chrysotile**

| <b>Recommendation</b> | These materials should be removed and disposed of prior to demolition, by suitably trained and equipped personnel only, working under the guidance of a safe working procedure and in accordance with the requirements of The Control of Asbestos Regulations 2012 and The Hazardous Waste (England and Wales) Regulations 2005 (as amended in 2009). |

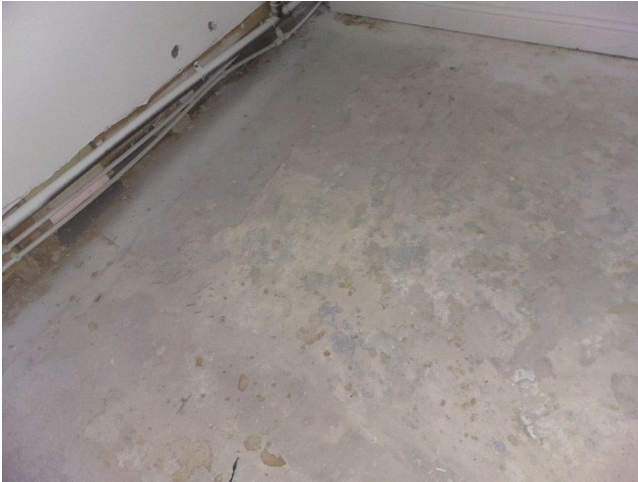
| Sample Number | Location | ACM Type | Material Risk Score | Recommendation |
|---|---|---|---|---|
| Refer to Sample 22/12/B/12/SAW6 | G.02 - Office - Floor beneath screed | Bitumen residuals | 3 | Remove |

Sample No: Refer to Sample 22/12/B/12/SAW6  
G.02 Office  
Floor beneath screed  
Bitumen residuals containing:  
**Chrysotile**

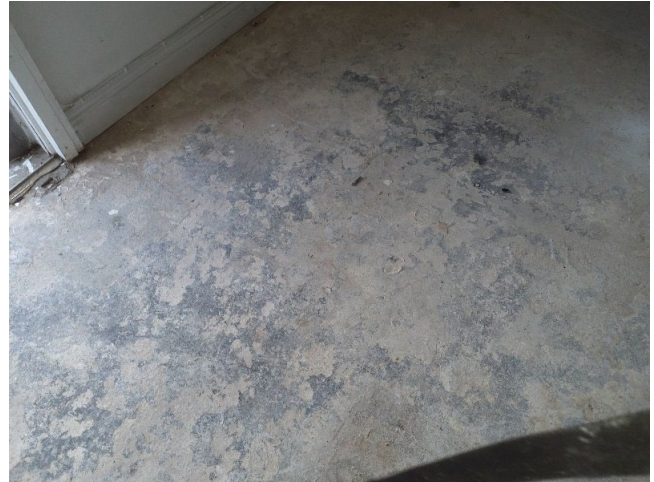
| Sample Number | Location | ACM Type | Material Risk Score | Recommendation |
|---|---|---|---|---|
| Refer to Sample 22/12/B/12/SAW6 | G.04 - Circulation area - Floor beneath screed | Bitumen residuals | 3 | Remove |

Sample No: Refer to Sample 22/12/B/12/SAW6  
G.04 Circulation area  
Floor beneath screed  
Bitumen residuals containing:  
**Chrysotile**

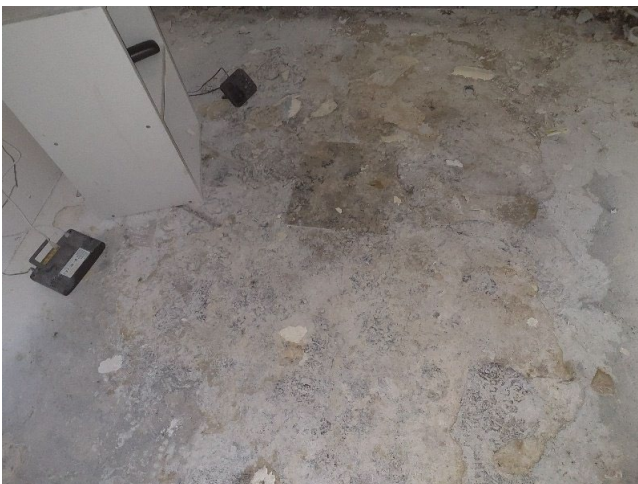
| Sample Number | Location | ACM Type | Material Risk Score | Recommendation |
|---|---|---|---|---|
| Refer to Sample 22/12/B/12/SAW6 | G.05 - Office - Floor beneath screed | Bitumen residuals | 3 | Remove |

Sample No: Refer to Sample 22/12/B/12/SAW6  
G.05 Office  
Floor beneath screed  
Bitumen residuals containing:  
**Chrysotile**

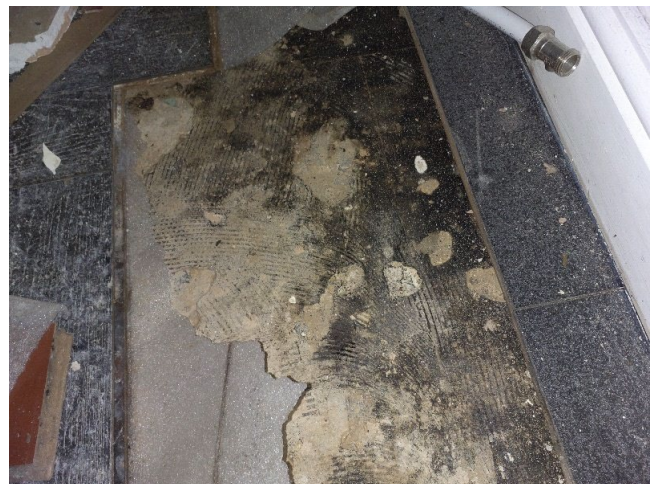
| Sample Number | Location | ACM Type | Material Risk Score | Recommendation |
|---|---|---|---|---|
| Refer to Sample 22/12/B/12/SAW6 | G.06 - Toilet - Floor | Bitumen residuals | 3 | Remove |

Sample No: Refer to Sample 22/12/B/12/SAW6  
G.06 Toilet  
Floor  
Bitumen residuals containing:  
**Chrysotile**

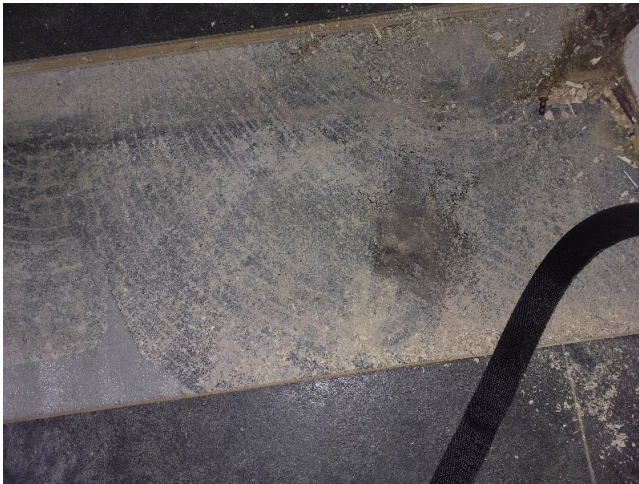
| Sample Number | Location | ACM Type | Material Risk Score | Recommendation |
|---|---|---|---|---|
| 22/12/B/12/SAW7 | 1.01 - Landing - Floor | Bitumen residuals | 3 | Remove |

Sample No: 22/12/B/12/SAW7  
1.01 Landing  
Floor  
Bitumen residuals containing:  
**Chrysotile**

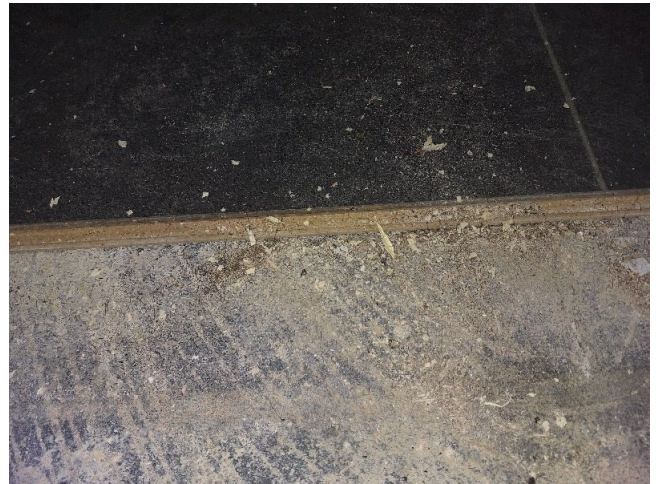
| Sample Number | Location | ACM Type | Material Risk Score | Recommendation |
|---|---|---|---|---|
| Refer to Sample 22/12/B/12/SAW7 | 1.02 - Tanning room - Floor | Bitumen residuals | 3 | Remove |

Sample No: Refer to Sample 22/12/B/12/SAW7  
1.02 Tanning room  
Floor  
Bitumen residuals containing:  
**Chrysotile**

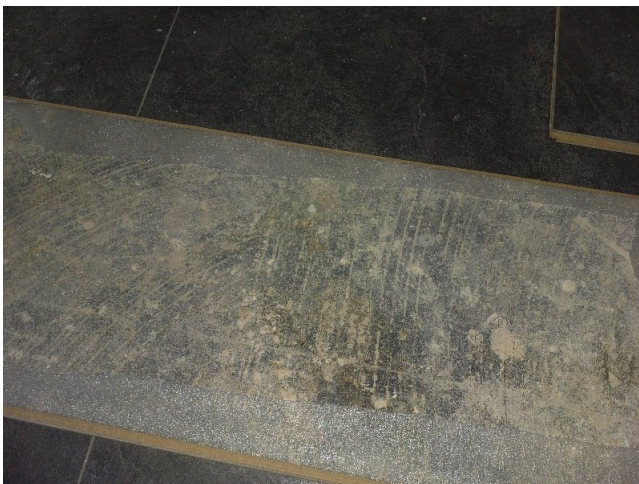
| Sample Number | Location | ACM Type | Material Risk Score | Recommendation |
|---|---|---|---|---|
| Refer to Sample 22/12/B/12/SAW7 | 1.03 - Circulation - Floor | Bitumen residuals | 3 | Remove |

Sample No: Refer to Sample 22/12/B/12/SAW7  
1.03 Circulation  
Floor  
Bitumen residuals containing:  
**Chrysotile**

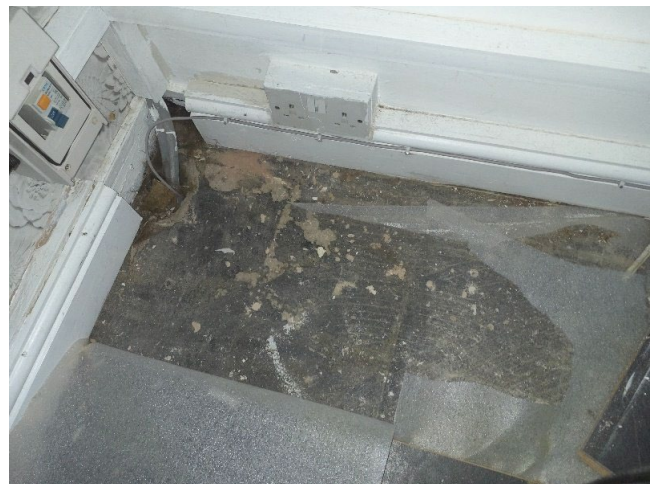
| Sample Number | Location | ACM Type | Material Risk Score | Recommendation |
|---|---|---|---|---|
| Refer to Sample 22/12/B/12/SAW7 | 1.04 - Sunbed room - Floor | Bitumen residuals | 3 | Remove |

Sample No: Refer to Sample 22/12/B/12/SAW7  
1.04 Sunbed room  
Floor  
Bitumen residuals containing:  
**Chrysotile**

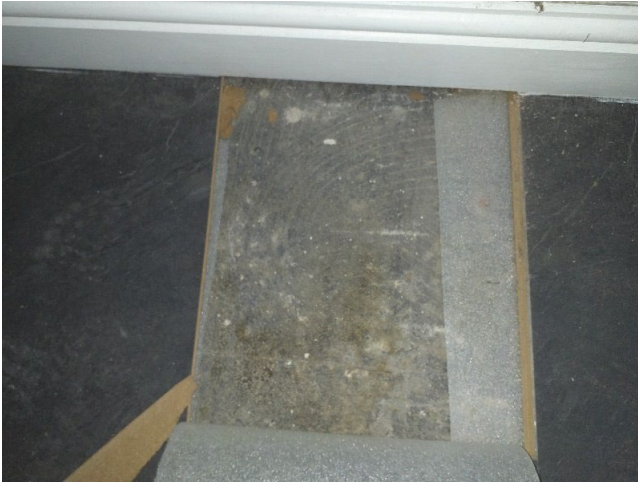
| Sample Number | Location | ACM Type | Material Risk Score | Recommendation |
|---|---|---|---|---|
| Refer to Sample 22/12/B/12/SAW7 | 1.05 - Sunbed room - Floor | Bitumen residuals | 3 | Remove |

Sample No: Refer to Sample 22/12/B/12/SAW7  
1.05 Sunbed room  
Floor  
Bitumen residuals containing:  
**Chrysotile**

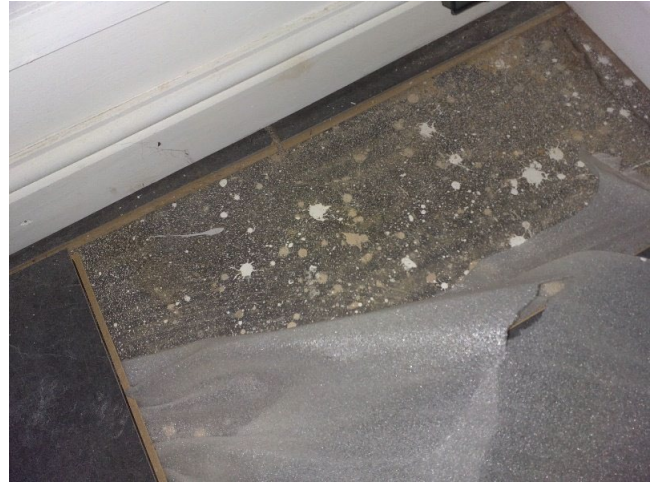
| Sample Number | Location | ACM Type | Material Risk Score | Recommendation |
|---|---|---|---|---|
| Refer to Sample 22/12/B/12/SAW7 | 1.06 - Office - Floor | Bitumen residuals | 3 | Remove |

Sample No: Refer to Sample 22/12/B/12/SAW7  
1.06 Office  
Floor  
Bitumen residuals containing:  
**Chrysotile**

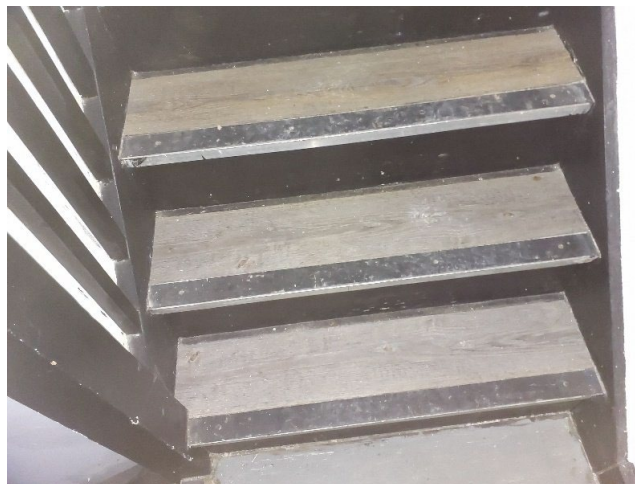
Sample No: 22/12/B/12/SAW8  
1.07 Stairs  
Staircase  
Nose edging  
**No Asbestos Detected**
