| <b>Client:</b> Bury Metropolitan Borough Council<br>Town Hall<br>Knowsley Street<br>Bury<br>BL9 0SW | <b>Lead Surveyor:</b> S. Warburton<br><b>Assistant Surveyor(s):</b> N/A<br><b>Date of Survey(s):</b> 12th December 2022<br><b>Report Reference:</b> CH.22.12.167.LW<br><b>Date Report Issued:</b> 6 <sup>th</sup> January 2023<br><b>Purpose of Survey:</b><br>(Refer to Section 2.2<br>of this report for<br>clarification) |

## Report on Survey of Asbestos Materials at

**FME**  
**7 Dale Street**  
**Radcliffe**  
**M26 1AB**

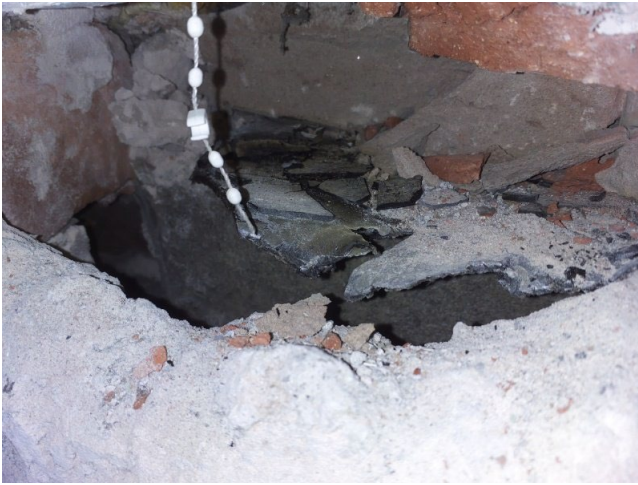
Sample No: 22/12/B/12/SAW4  
External  
Windows  
Bitumen vapour barrier to wall cavities  
**No Asbestos Detected**

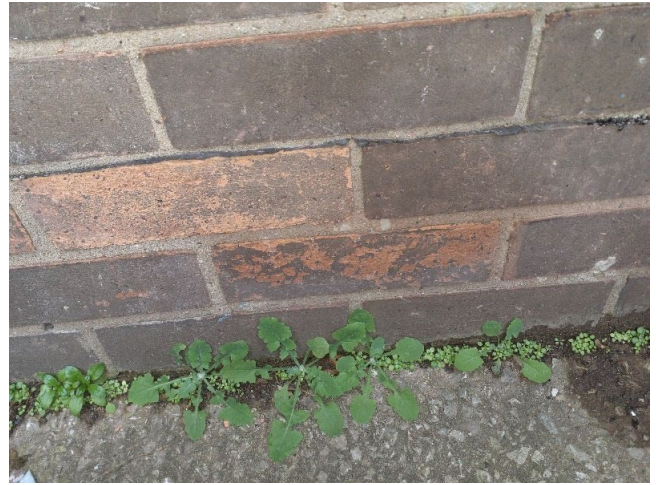
Sample No: 22/12/B/12/SAW5  
External  
Damp proof course  
Bitumen Layer  
**No Asbestos Detected**

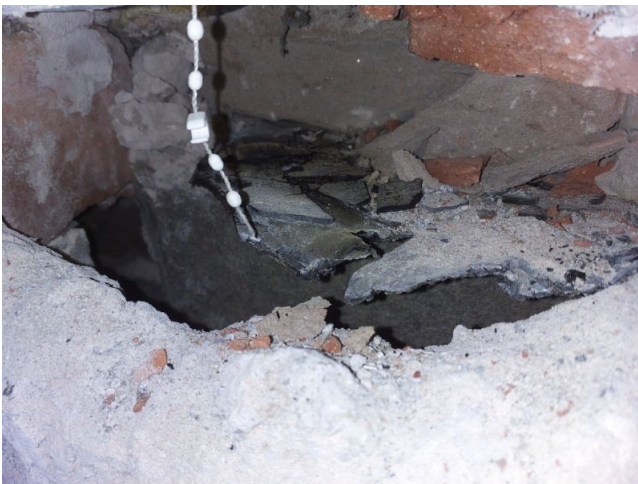
Sample No: Refer to Sample 22/12/B/12/SAW4  
External  
Windows  
Bitumen vapour barrier to wall cavities  
**No Asbestos Detected**

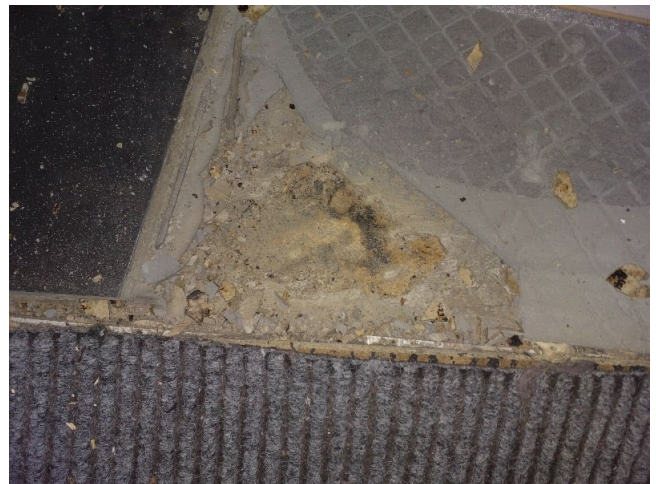
| Sample Number | Location | ACM Type | Material Risk Score | Recommendation |
|---|---|---|---|---|
| 22/12/B/12/SAW1 | G.01 - Shop area - Floor beneath screed | Bitumen residuals | 3 | Remove |

Sample No: 22/12/B/12/SAW1  
G.01 Shop area  
Floor beneath screed  
Bitumen residuals containing:  
**Chrysotile**

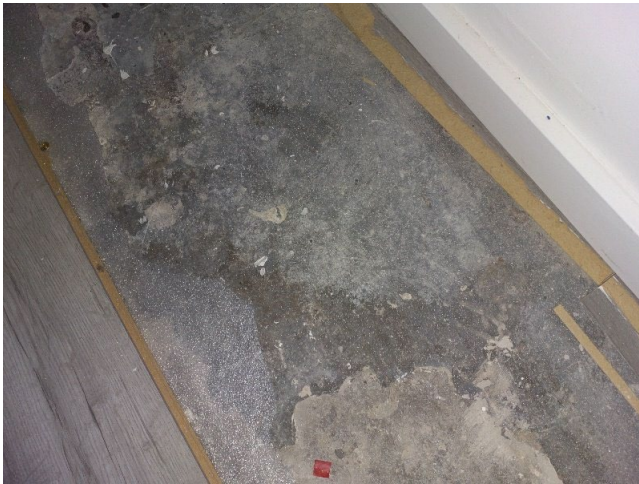
| Sample Number | Location | ACM Type | Material Risk Score | Recommendation |
|---|---|---|---|---|
| Refer to Sample 22/12/B/12/SAW1 | G.02 - Rear Shop area - Floor beneath screed | Bitumen residuals | 3 | Remove |

Sample No: Refer to Sample 22/12/B/12/SAW1  
G.02 Rear Shop area  
Floor beneath screed  
Bitumen residuals containing:  
**Chrysotile**

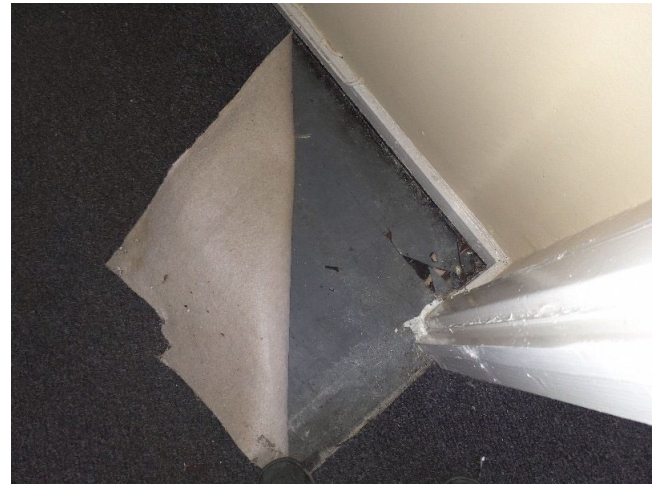
| Sample Number | Location | ACM Type | Material Risk Score | Recommendation |
|---|---|---|---|---|
| 22/12/B/12/SAW2 | 1.01 - Landing - Floor | Vinyl floor tiles with bitumen adhesive | 3 | Remove |

Sample No: 22/12/B/12/SAW2  
1.01 Landing  
Floor  
Vinyl floor tiles with bitumen adhesive containing:  
**Chrysotile (In both tile and bitumen)**

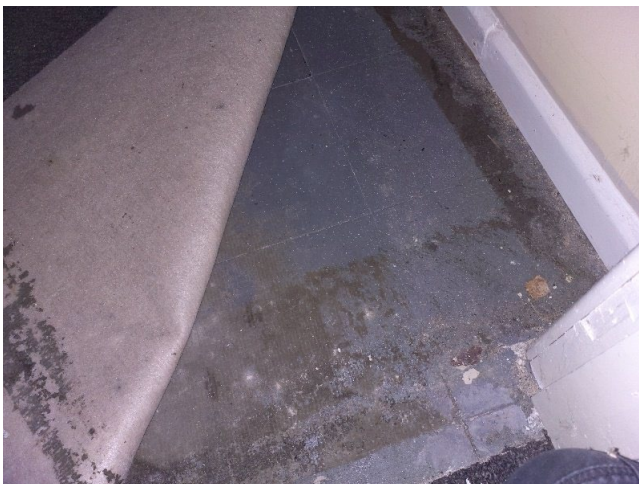
| Sample Number | Location | ACM Type | Material Risk Score | Recommendation |
|---|---|---|---|---|
| Refer to Sample 22/12/B/12/SAW2 | 1.02 - Circulation - Floor | Vinyl floor tiles with bitumen adhesive | 3 | Remove |

Sample No: Refer to Sample 22/12/B/12/SAW2  
1.02 Circulation  
Floor  
Vinyl floor tiles with bitumen adhesive containing:  
**Chrysotile (In both tile and bitumen)**

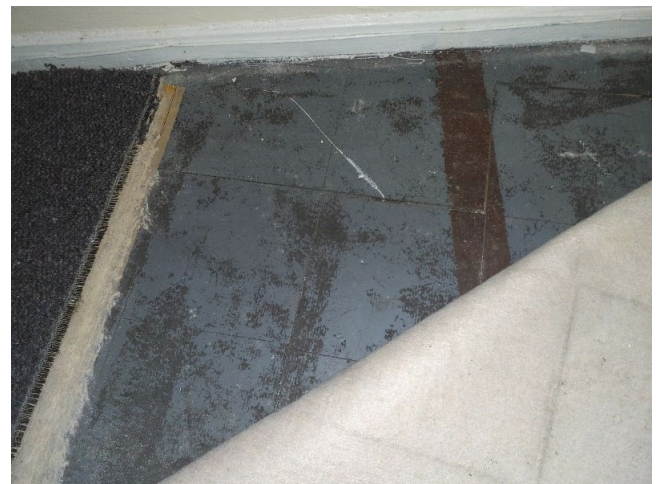
| Sample Number | Location | ACM Type | Material Risk Score | Recommendation |
|---|---|---|---|---|
| Refer to Sample 22/12/B/12/SAW2 | 1.04 - Office - Floor | Vinyl floor tiles with bitumen adhesive | 3 | Remove |

Sample No: Refer to Sample 22/12/B/12/SAW2  
1.04 Office  
Floor  
Vinyl floor tiles with bitumen adhesive containing:  
**Chrysotile (In both tile and bitumen)**

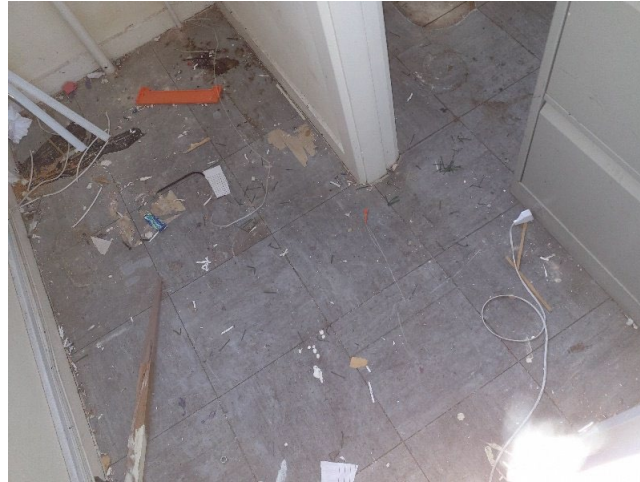
Sample No: 22/12/B/12/SAW3  
2.04 Toilets  
Floor  
Vinyl floor tiles  
**No Asbestos Detected**
