**Lead Surveyor:** Doug Burgess  
**Assistant Surveyor(s):** N/A  
**Date of Survey(s):** 13th December 2022  
**Report Reference:** CH.22.12.223.LW  
**Date Report Issued:** 6<sup>th</sup> January 2023  
**Purpose of Survey:**  
(Refer to Section 2.2  
of this report for  
clarification)

## Report on Survey of Asbestos Materials at

**21 Blackburn Street  
Radcliffe  
Greater Manchester  
M26 1NN**

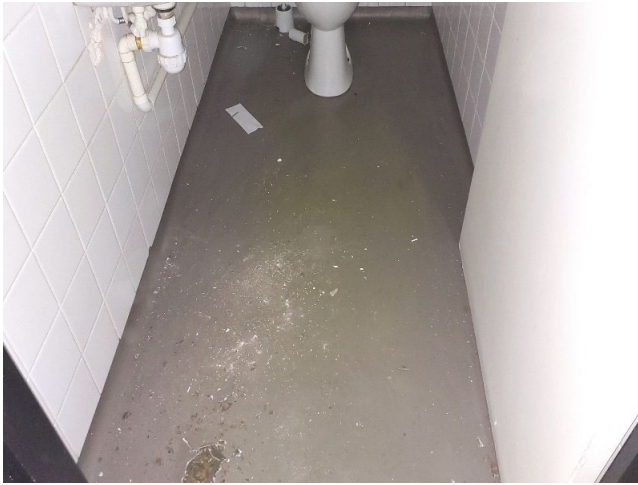
Sample No: 22/12/B/13/DAB14  
G.02 Toilet  
Floor  
Bitumen adhesive below modern vinyl flooring  
**No Asbestos Detected**

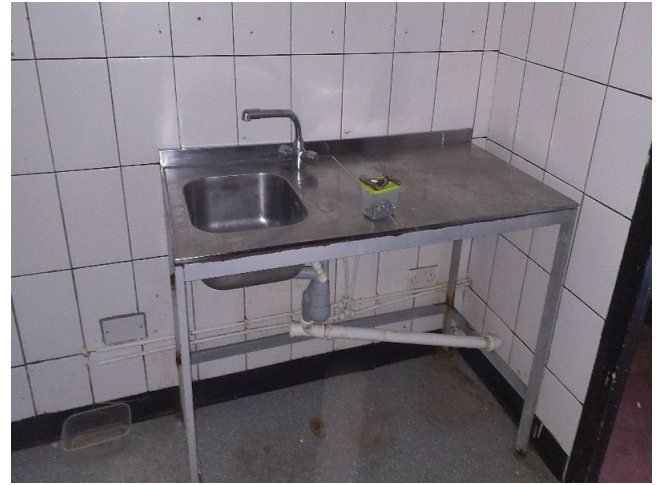
Sample No: 22/12/B/13/DAB15  
G.03 Kitchen  
Sink  
Bitumen sink pad  
**No Asbestos Detected**
