**Client:** Bury Metropolitan Borough Council  
Town Hall  
Knowsley Street  
Bury  
BL9 0SW

**Lead Surveyor:** M. Crompton  
**Assistant Surveyor(s):** N/A  
**Date of Survey(s):** 13th December 2022  
**Report Reference:** CH.22.12.225.LW  
**Date Report Issued:** 6<sup>th</sup> January 2023

**Report on Survey of Asbestos Materials  
at  
15  
Blackburn Street  
Radcliffe  
M26 1NN**

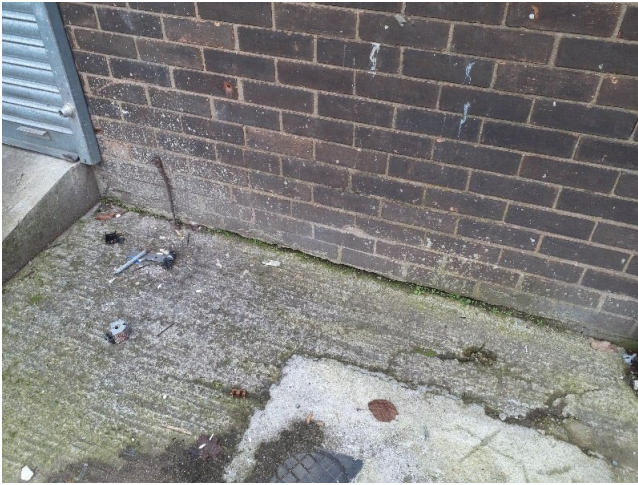
Sample No: 22/12/B/13/MAC14  
External  
Walls  
Bitumen DPC  
**No Asbestos Detected**

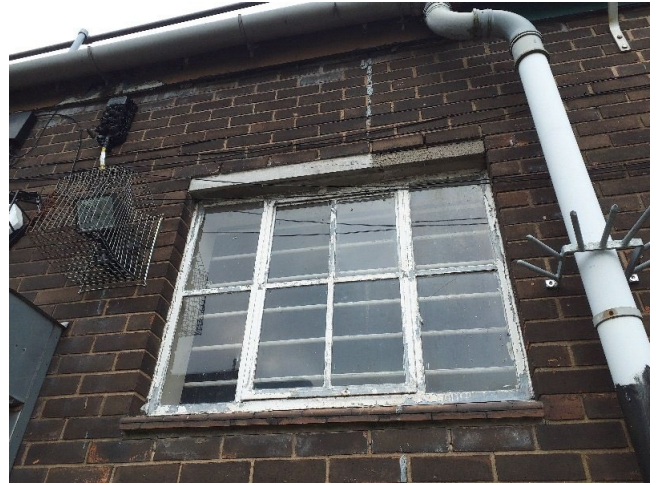
Sample No: 22/12/B/13/MAC15  
External  
Window sills and frames  
Bitumen vapour barrier  
**No Asbestos Detected**

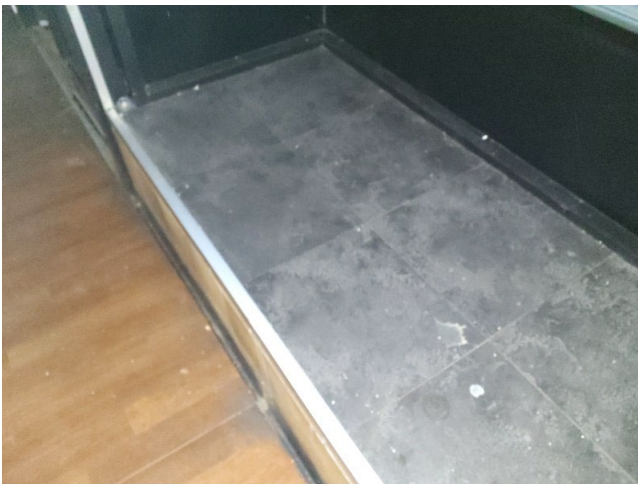
Sample No: 22/12/B/13/MAC5  
G.01 Front of shop  
Front window display floor  
Vinyl floor tiles  
**No Asbestos Detected**

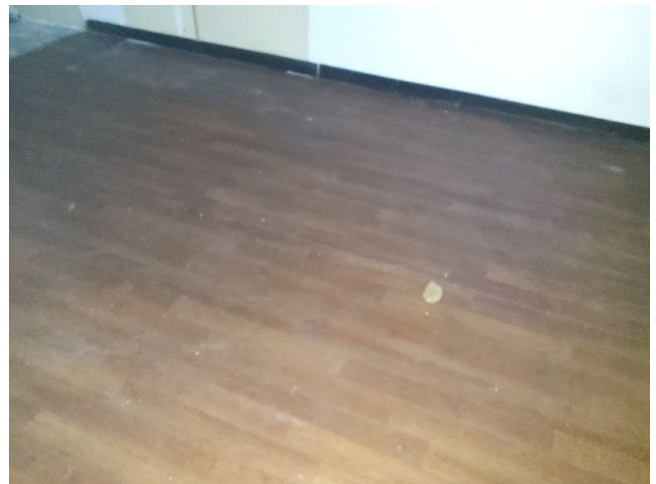
Sample No: 22/12/B/13/MAC6  
G.01 Front of shop  
Floor  
Vinyl floor covering  
**No Asbestos Detected**

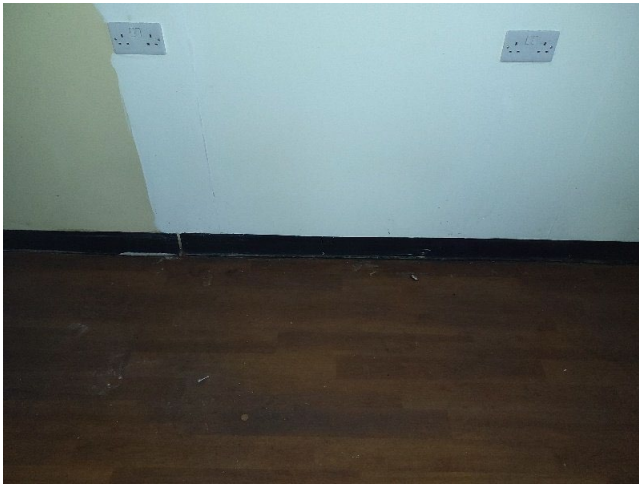
Sample No: 22/12/B/13/MAC7  
G.01 Front of shop  
Walls  
Vinyl skirting  
**No Asbestos Detected**

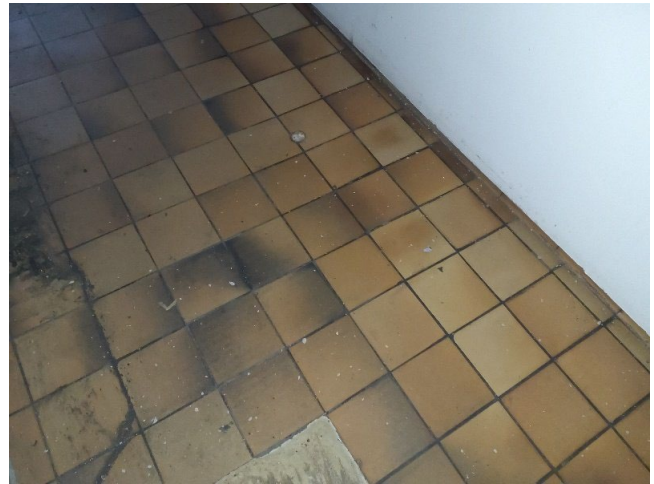
| Sample Number | Location | ACM Type | Material Risk Score | Recommendation |
|---|---|---|---|---|
| Refer to Sample 22/12/B/13/MAC8 | G.01 - Front of shop - Floor below ceramic tiles | Residual bitumen adhesive | 3 | Remove |

Sample No: Refer to Sample 22/12/B/13/MAC8  
G.01 Front of shop  
Floor below ceramic tiles  
Residual bitumen adhesive containing:  
**Chrysotile**

| <b>Recommendation</b> | These materials should be removed and disposed of prior to demolition, by <u>suitably trained and equipped personnel only</u> , working under the guidance of a safe working procedure and in accordance with the requirements of The Control of Asbestos Regulations 2012 and The Hazardous Waste (England and Wales) Regulations 2005 (as amended in 2009). |

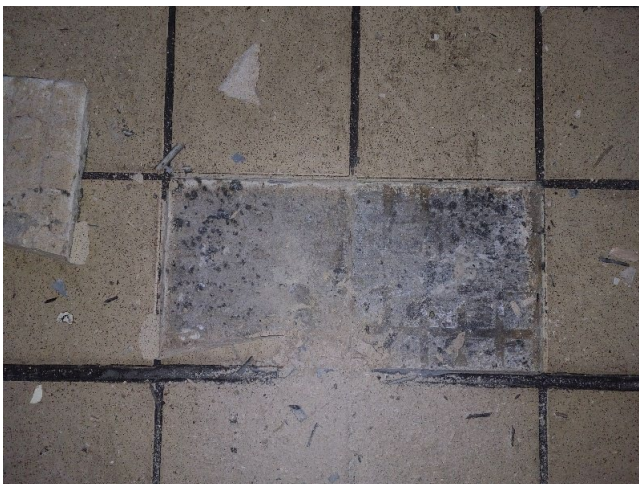
| Sample Number | Location | ACM Type | Material Risk Score | Recommendation |
|---|---|---|---|---|
| 22/12/B/13/MAC8 | G.02 - Rear of shop - Floor below ceramic tiles | Residual bitumen adhesive | 3 | Remove |

| <b>Condition</b> | Sample No: 22/12/B/13/MAC8<br>Fair |

Sample No: 22/12/B/13/MAC8  
G.02 Rear of shop  
Floor below ceramic tiles  
Residual bitumen adhesive containing:  
**Chrysotile**

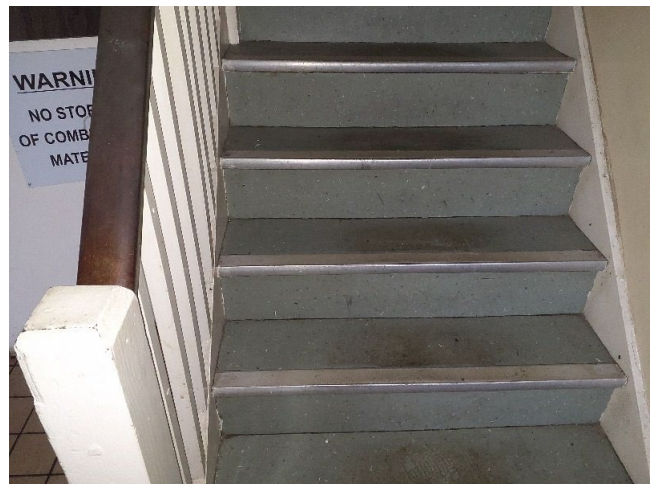
| Sample Number | Location | ACM Type | Material Risk Score | Recommendation |
|---|---|---|---|---|
| 22/12/B/13/MAC9 | G.02 - Rear of shop - Stairs | Nose edging | 3 | Remove |

| <b>Condition</b> | Sample No: 22/12/B/13/MAC9<br>Fair |

Sample No: 22/12/B/13/MAC9  
G.02 Rear of shop  
Stairs  
Nose edging containing:  
**Chrysotile**

| <b>Recommendation</b> | These materials should be removed and disposed of prior to demolition, by <u>suitably trained and equipped personnel only</u> , working under the guidance of a safe working procedure and in accordance with the requirements of The Control of Asbestos Regulations 2012 and The Hazardous Waste (England and Wales) Regulations 2005 (as amended in 2009). |

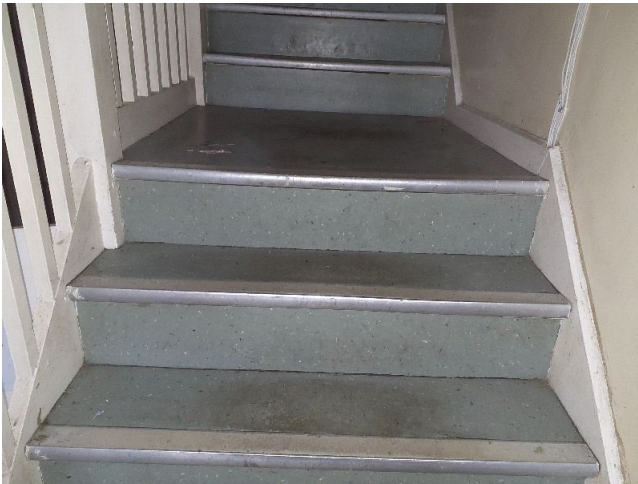
Sample No: 22/12/B/13/MAC10  
G.02 Rear of shop  
Stairs  
Vinyl floor covering  
**No Asbestos Detected**

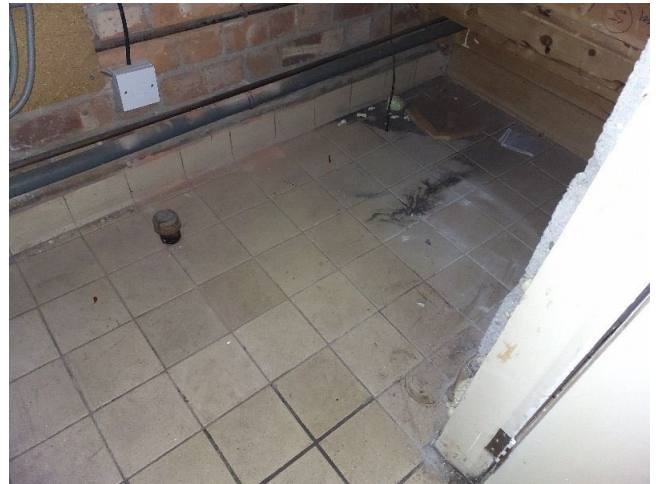
| Sample Number | Location | ACM Type | Material Risk Score | Recommendation |
|---|---|---|---|---|
| Refer to Sample 22/12/B/13/MAC8 | G.03 - Understairs cupboard - Floor below ceramic tiles | Residual bitumen adhesive | 3 | Remove |

Sample No: Refer to Sample 22/12/B/13/MAC8  
G.03 Understairs cupboard  
Floor below ceramic tiles  
Residual bitumen adhesive containing:  
**Chrysotile**

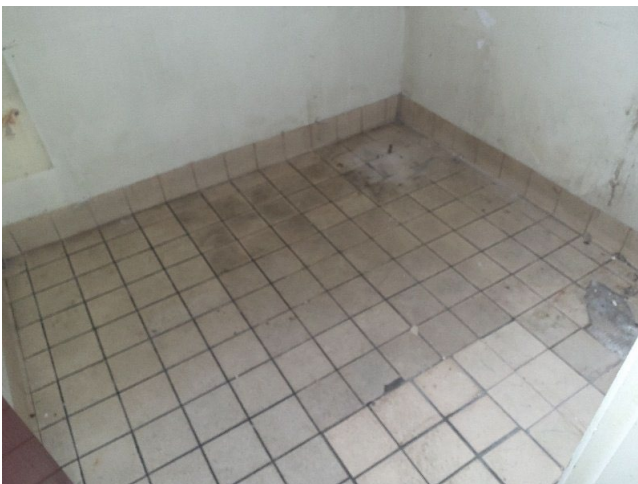
| Sample Number | Location | ACM Type | Material Risk Score | Recommendation |
|---|---|---|---|---|
| Refer to Sample 22/12/B/13/MAC8 | G.04 - Cloakroom - Floor below ceramic tiles | Residual bitumen adhesive | 3 | Remove |

Sample No: Refer to Sample 22/12/B/13/MAC8  
G.04 Cloakroom  
Floor below ceramic tiles  
Residual bitumen adhesive containing:  
**Chrysotile**

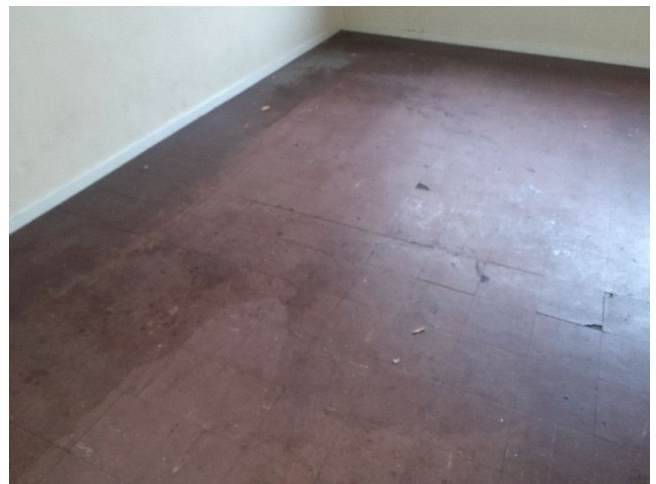
| Sample Number | Location | ACM Type | Material Risk Score | Recommendation |
|---|---|---|---|---|
| 22/12/B/13/MAC11 | 1.01 - Staff room - Floor | Vinyl floor tiles and bitumen adhesive | 3 | Remove |

| <b>Condition</b> | Sample No: 22/12/B/13/MAC11<br>Fair |

Sample No: 22/12/B/13/MAC11  
1.01 Staff room  
Floor  
Vinyl floor tiles and bitumen adhesive containing:  
**Chrysotile (In both tile and bitumen)**

| <b>Recommendation</b> | These materials should be removed and disposed of prior to demolition, by <u>suitably trained and equipped personnel only</u> , working under the guidance of a safe working procedure and in accordance with the requirements of The Control of Asbestos Regulations 2012 and The Hazardous Waste (England and Wales) Regulations 2005 (as amended in 2009). |

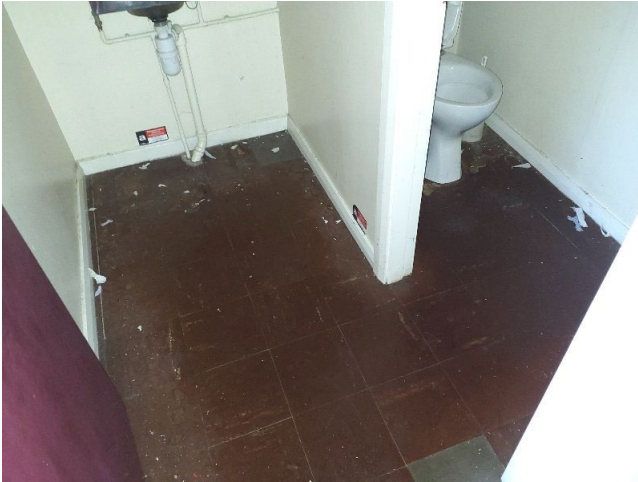
| Sample Number | Location | ACM Type | Material Risk Score | Recommendation |
|---|---|---|---|---|
| Refer to Sample 22/12/B/13/MAC11 | 1.02 - Toilets - Floor | Vinyl floor tiles and bitumen adhesive | 3 | Remove |

Sample No: Refer to Sample 22/12/B/13/MAC11  
1.02 Toilets  
Floor  
Vinyl floor tiles and bitumen adhesive containing:  
**Chrysotile (In both tile and bitumen)**

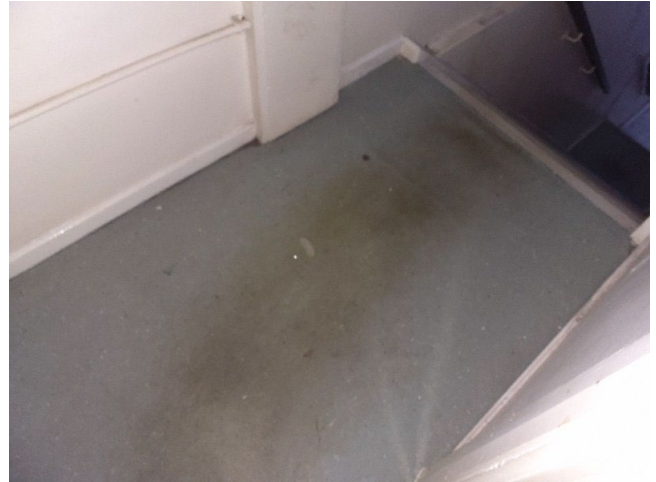
Sample No: Refer to Sample 22/12/B/13/MAC10  
1.03 Landing  
Stairs  
Vinyl floor covering  
**No Asbestos Detected**

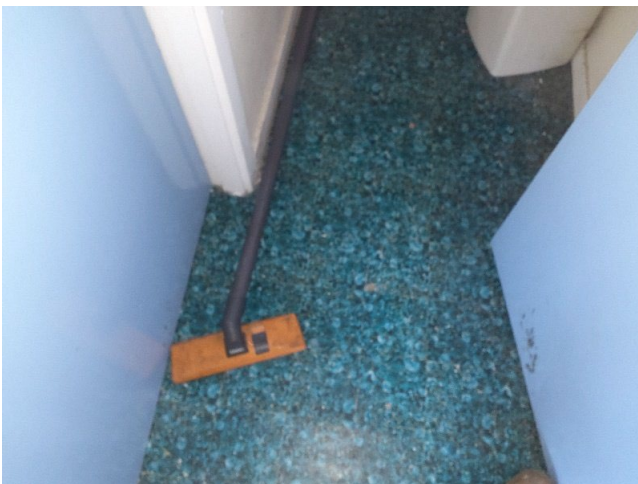
Sample No: 22/12/B/13/MAC12  
2.02 Toilets  
Floor  
Vinyl floor covering  
**No Asbestos Detected**

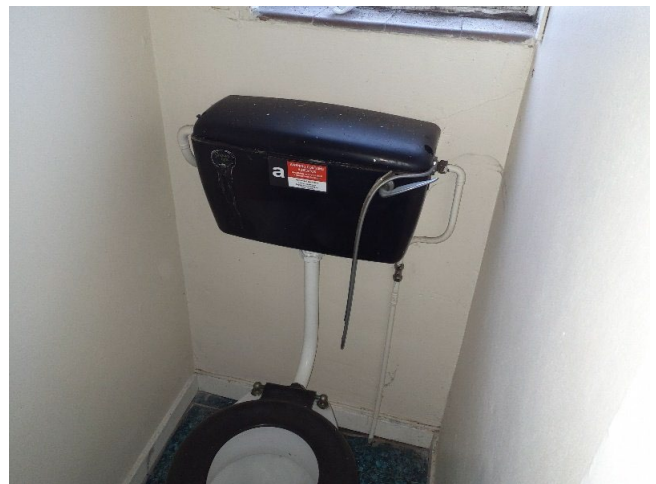
| Sample Number | Location | ACM Type | Material Risk Score | Recommendation |
|---|---|---|---|---|
| 22/12/B/13/MAC13 | 2.02 - Toilets - Cistern | Thermoplastic | 5 | Remove |

| <b>Condition</b> | Sample No: 22/12/B/13/MAC13<br>Fair |

Sample No: 22/12/B/13/MAC13  
2.02 Toilets  
Cistern  
Thermoplastic containing:  
**Amosite**

| <b>Recommendation</b> | These materials should be removed and disposed of prior to demolition, by <u>suitably trained and equipped personnel only</u> , working under the guidance of a safe working procedure and in accordance with the requirements of The Control of Asbestos Regulations 2012 and The Hazardous Waste (England and Wales) Regulations 2005 (as amended in 2009). |

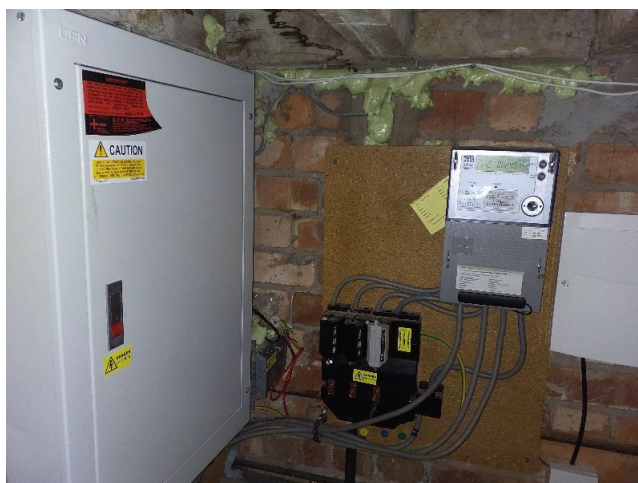
Modern electrics
