**ARBORICULTURAL REPORT  
to BS 5837:2012  
at  
34 Ringley Road  
Whitefield  
Prestwich  
Greater Manchester  
M45 7LE**

Michael Ainsworth  
Design Partnership

21926/AJB

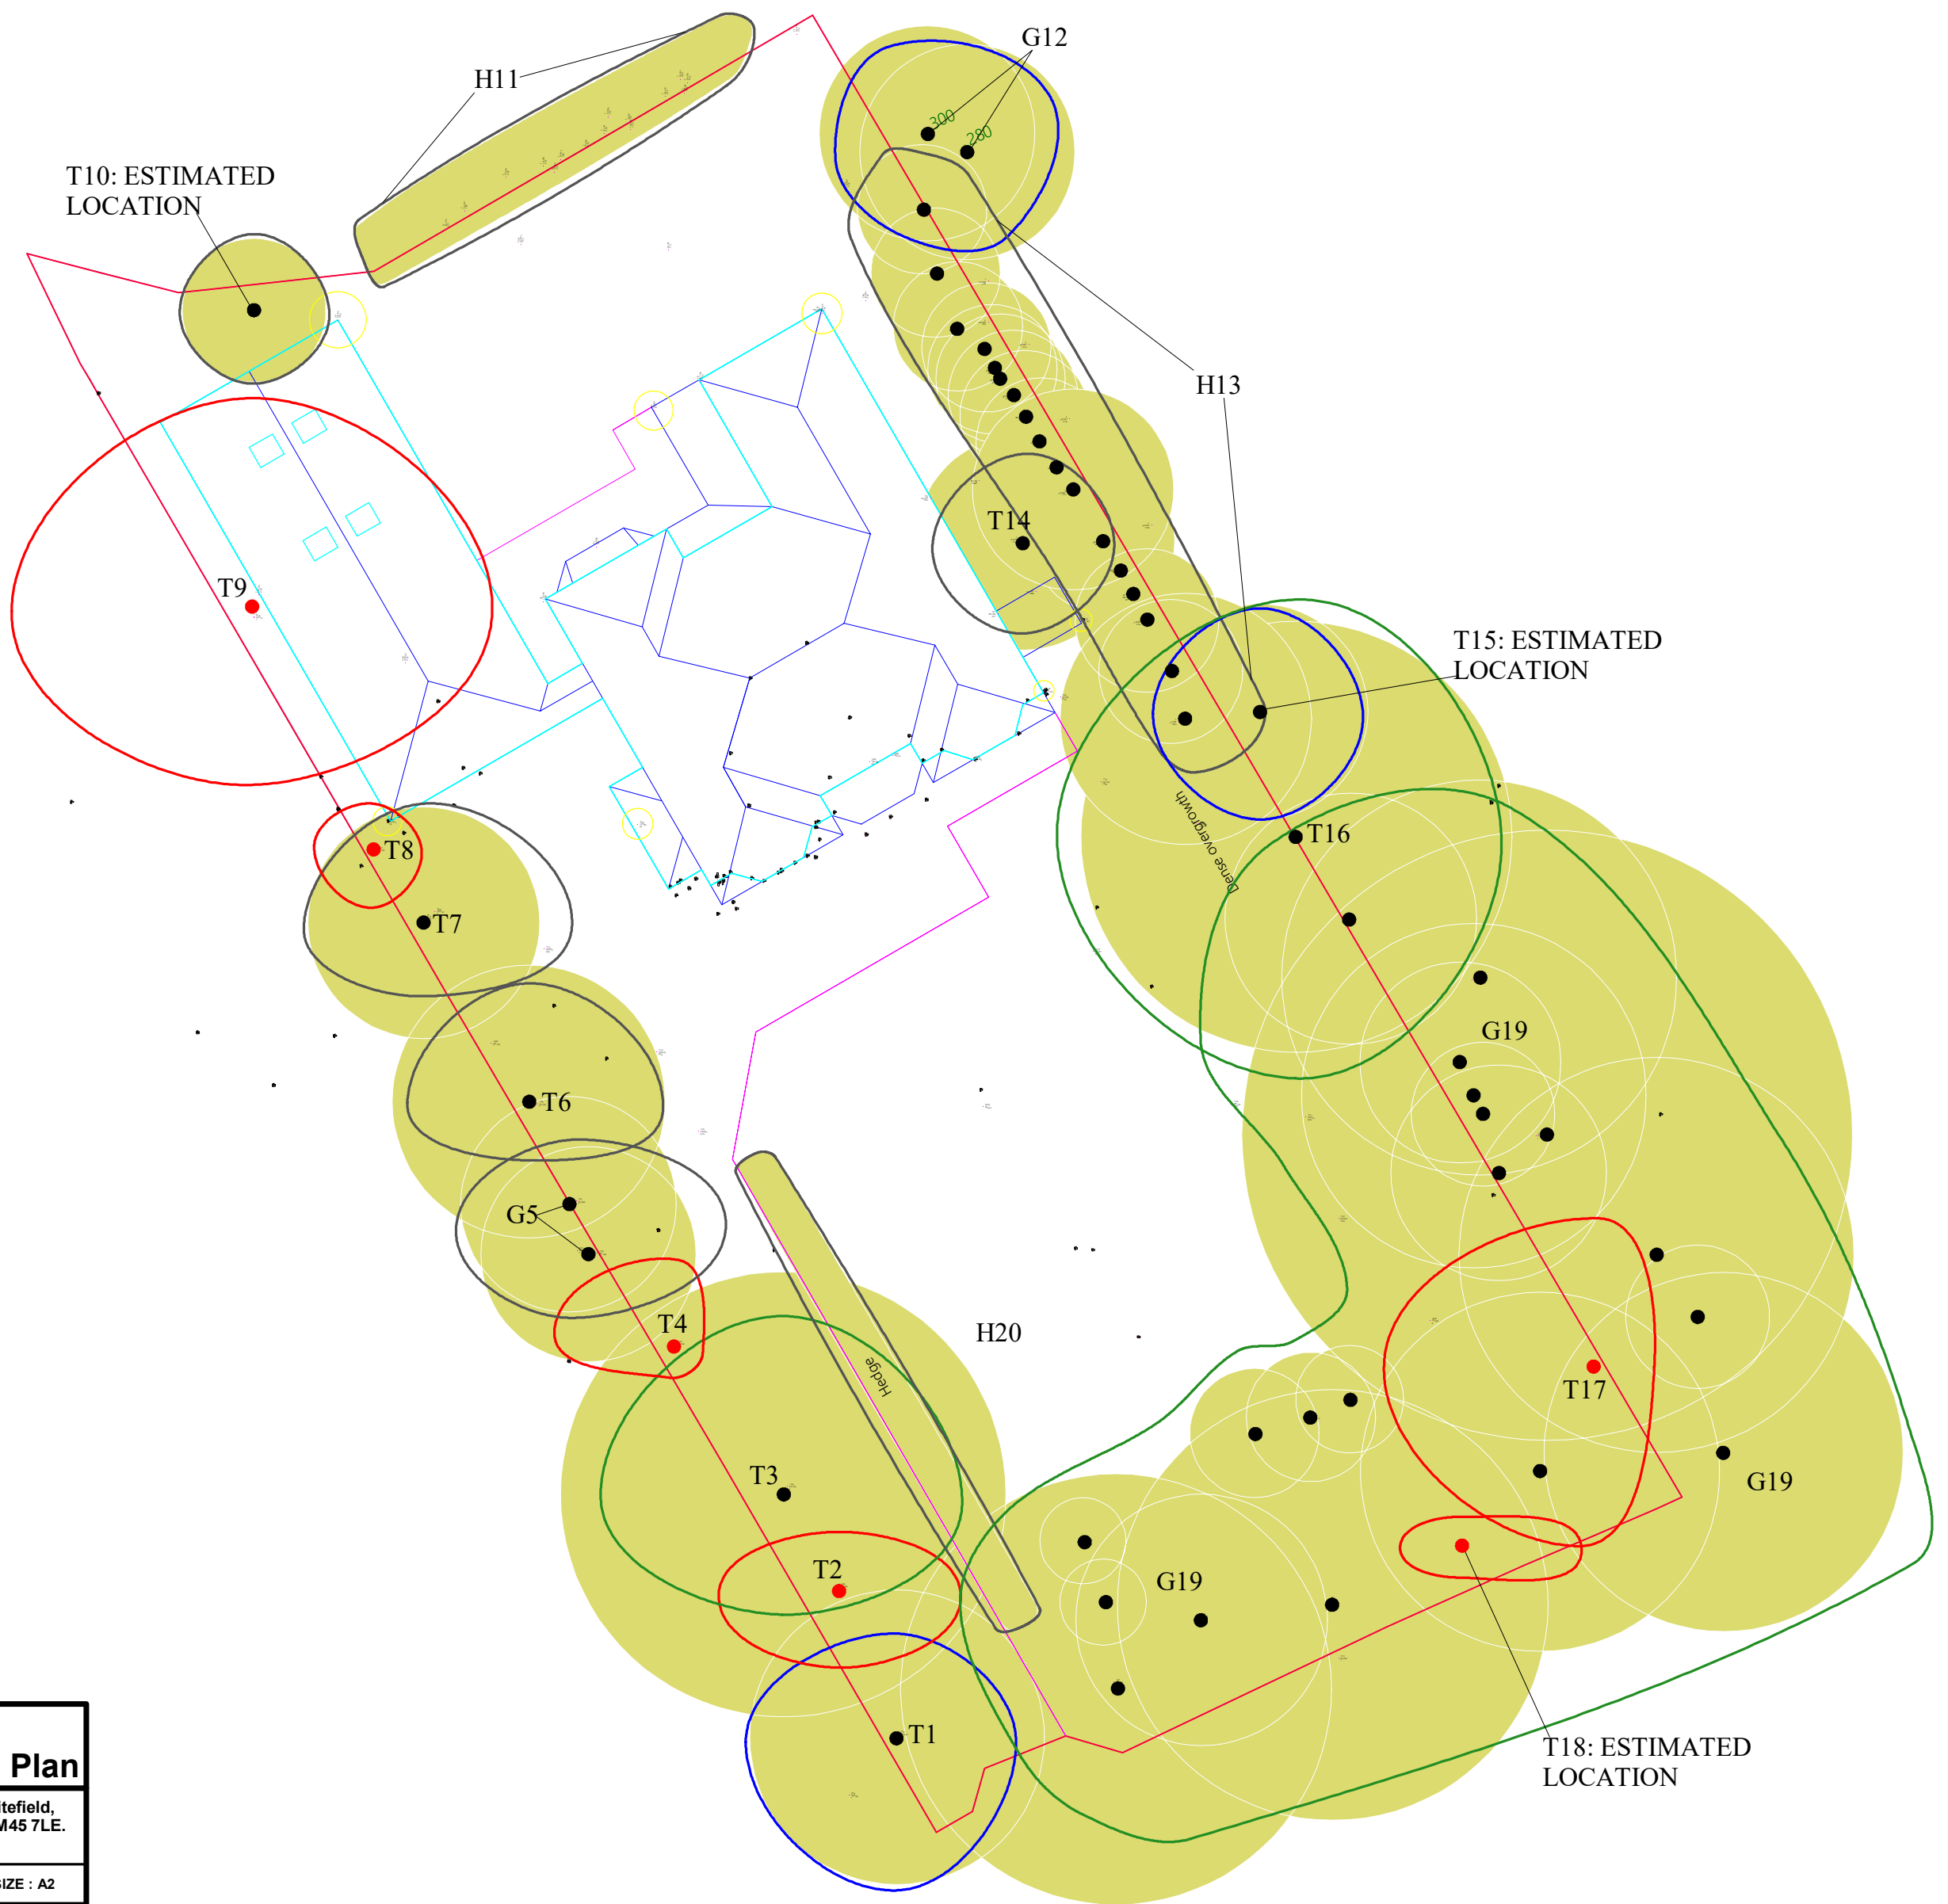
**Appendix 5:  
Tree Constraints Plan**

- 4.1 The location of each tree is plotted on the Tree Constraints Plan at **Appendix 5**. The canopy spread of each surveyed item is colour coded as follows; Retention Category A: **Green**, Retention Category B: **Blue**, Retention Category C: **Grey**, Retention Category U: **Red**. The associated Root Protection Area (RPA) is also shown in **Gold**.
