R4240

CLOUGH FARMHOUSE, CLOUGH LANE  
PRESTWICH

JANUARY 2025

# REPORT ON STRUCTURE

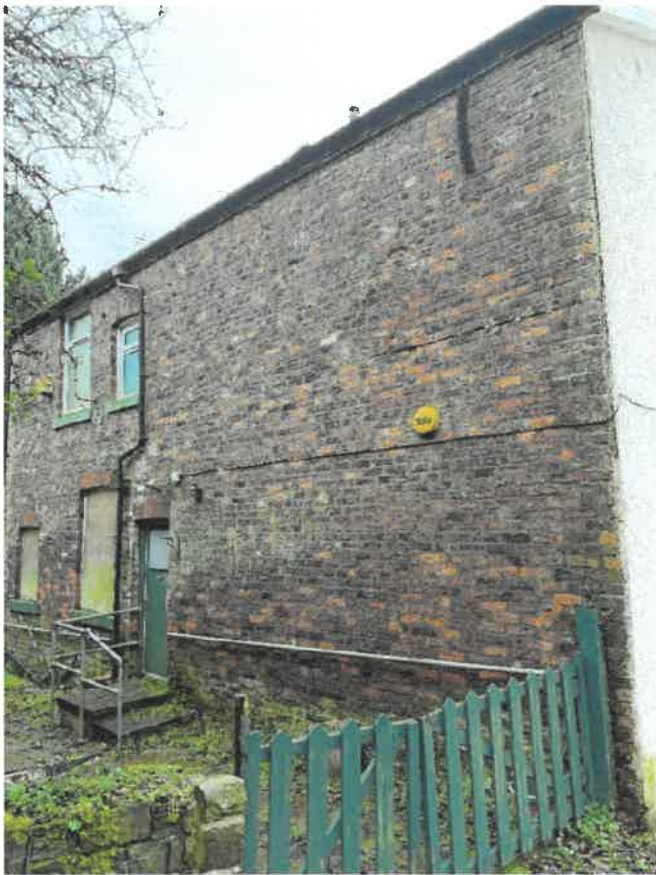
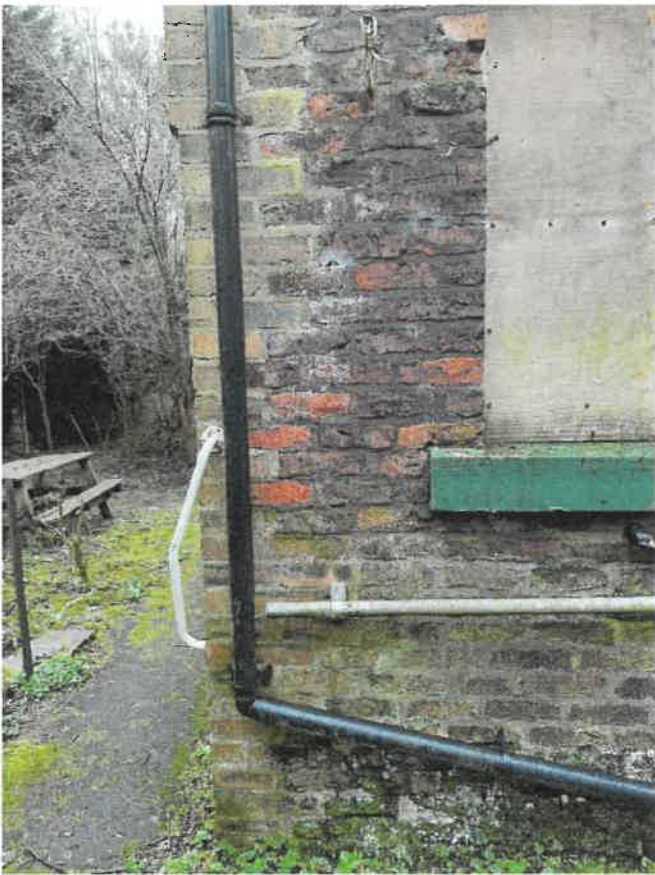
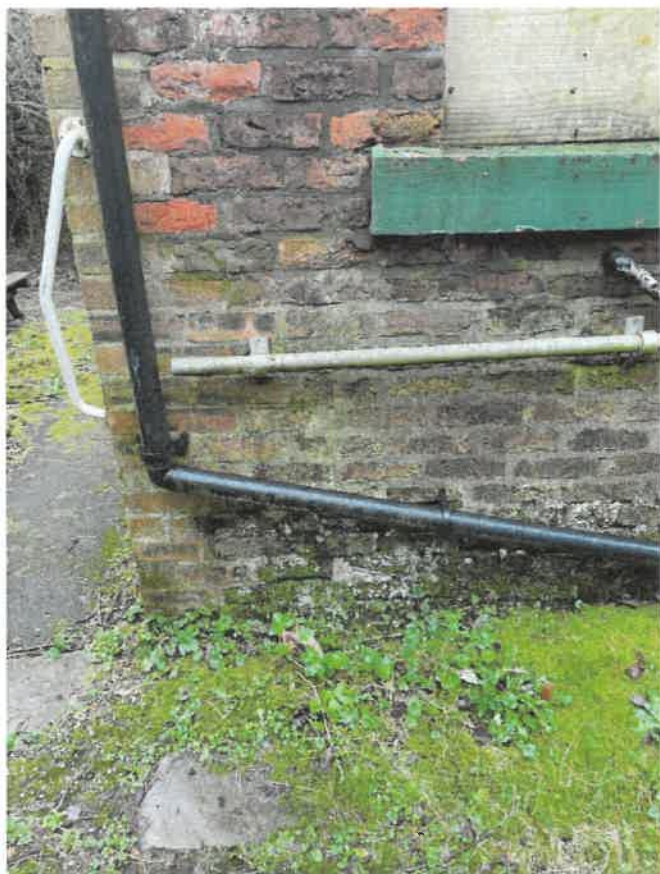
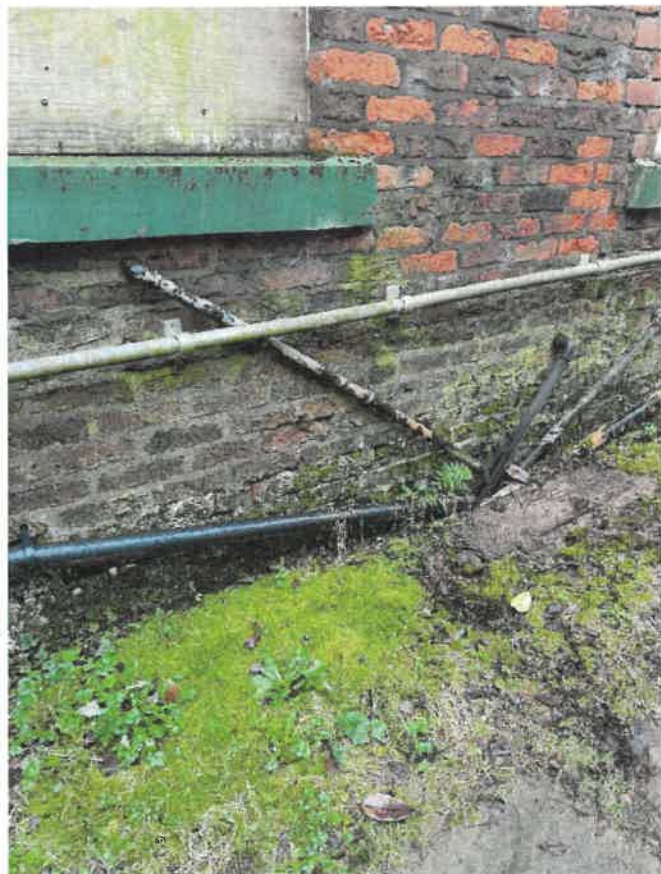
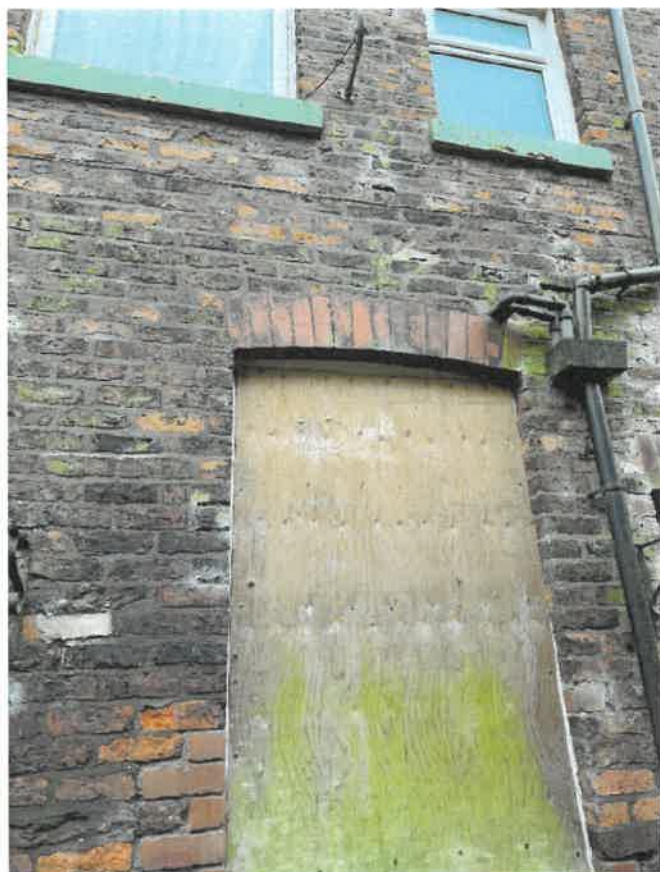
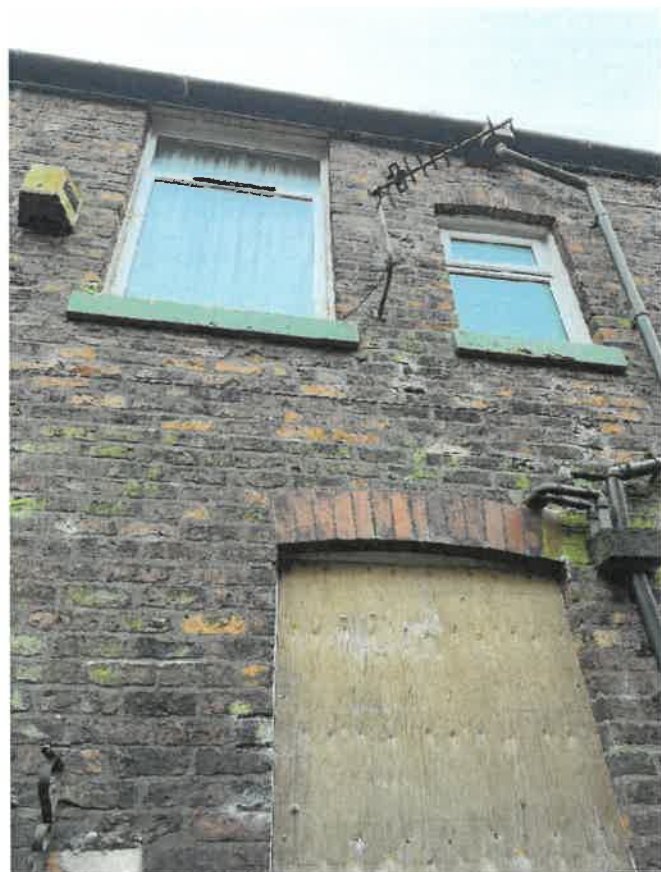
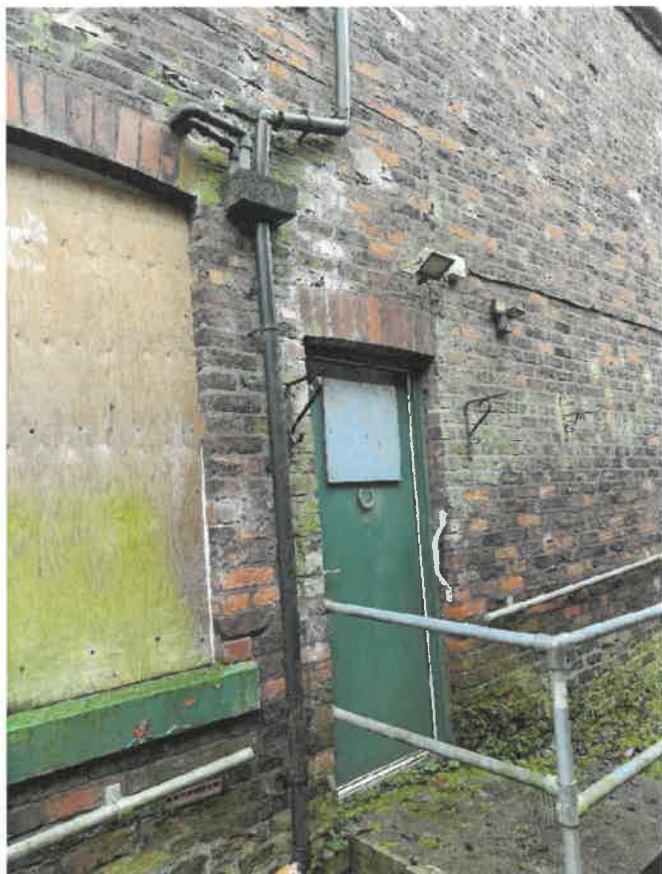
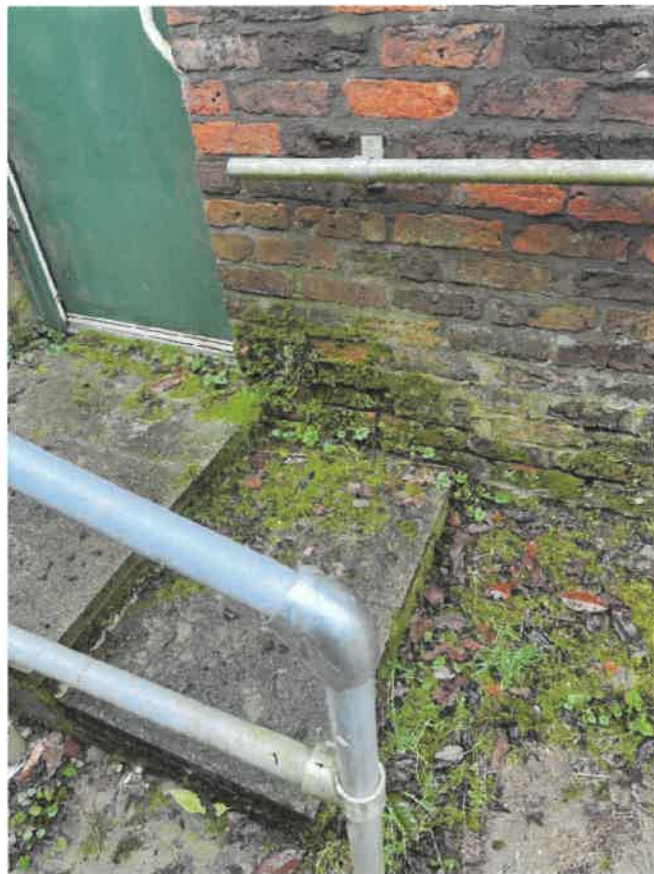
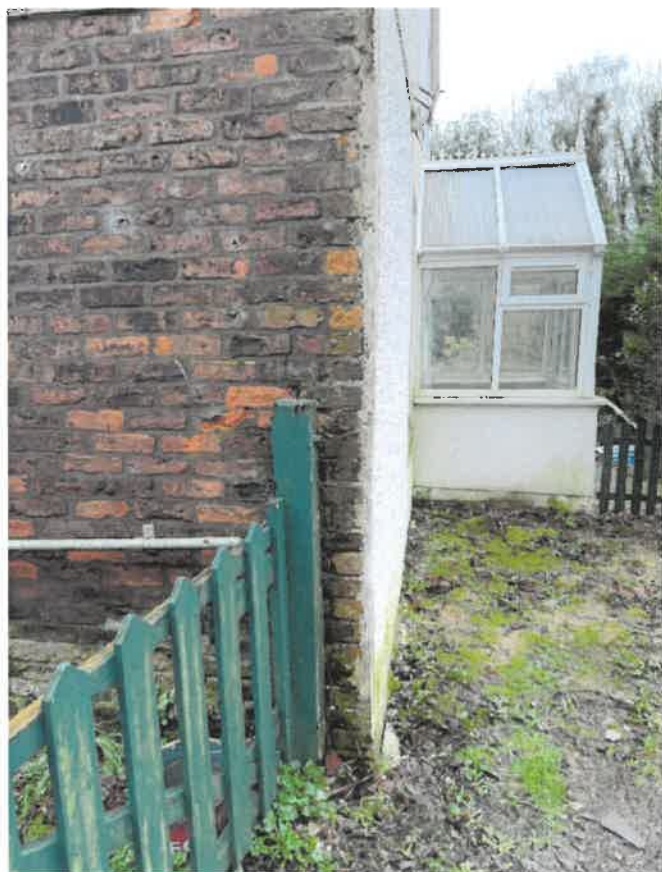
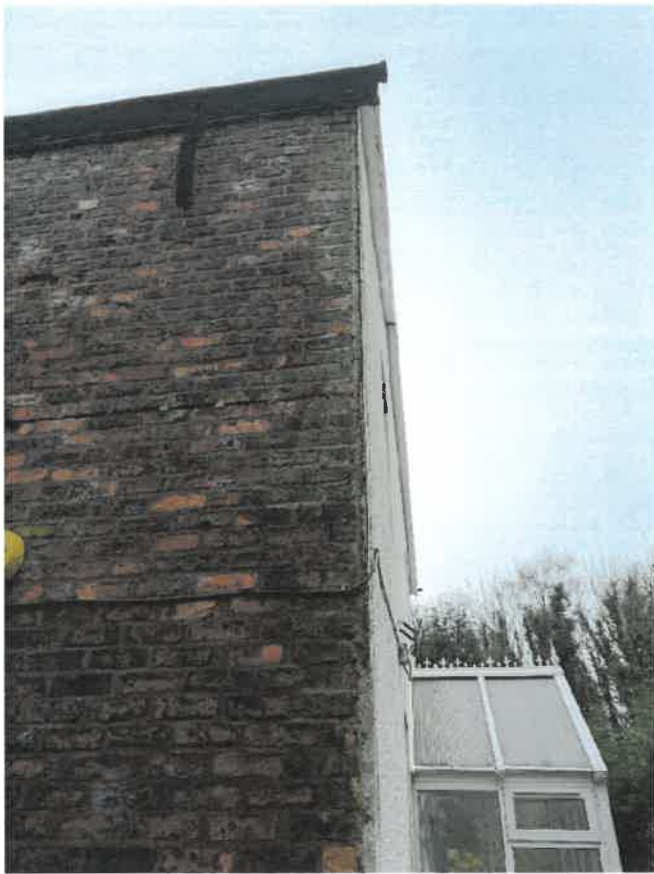
**North-Facing Elevation (Photographs 5 – 17):** This elevation is constructed in brickwork, presumed to be cavity wall construction. The masonry has been historically repointed and is largely free from cracking. Occasional bricks show surface erosion attributable to weathering. The elevation is generally plumb with only mild outward bellying at mid-height. Significant moss growth is present at low level, indicating persistent damp conditions.

Several of the ground-floor openings within the north-facing elevation are detailed with brick arched soldier-course heads, providing structural load distribution over the openings and reflecting traditional construction detailing. Associated window openings incorporate projecting stone cills, some of which exhibit surface weathering consistent with age and exposure. No distress cracking was observed emanating from these arched heads at the time of inspection.

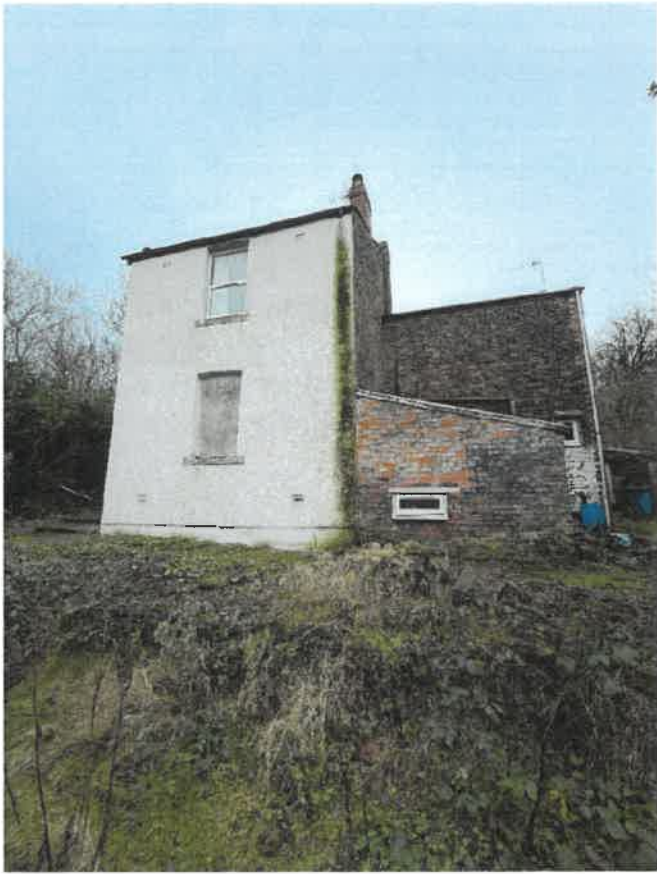
Photograph 18

South-Facing Elevation – Main Building (Photographs 18 & 19): The rear elevation of the principal dwelling is rendered. The render is in very good condition and free from cracking, suggesting the underlying masonry is also largely intact. Green staining is evident toward the right-hand corner, attributed to the absence of effective rainwater drainage.

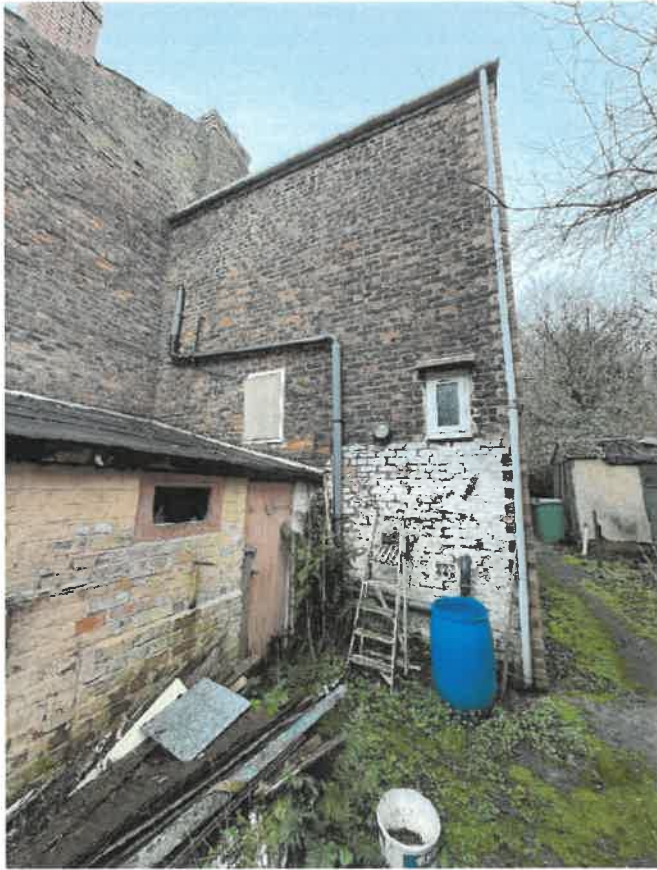
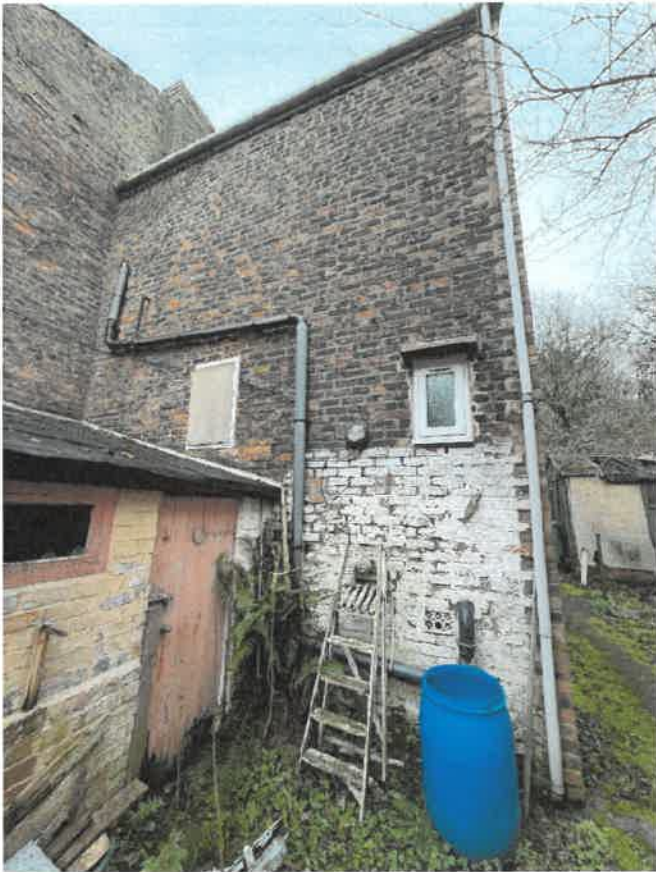
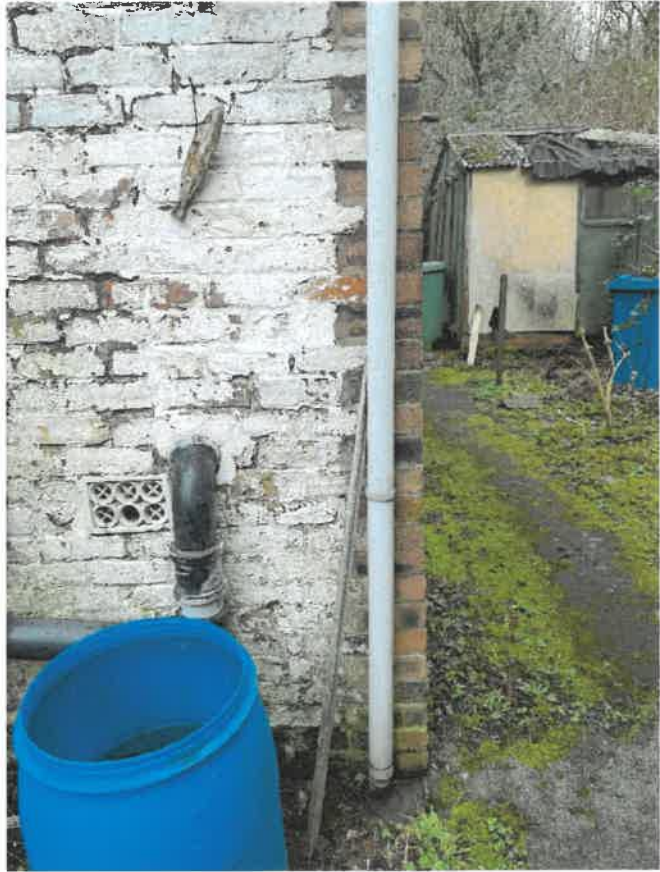
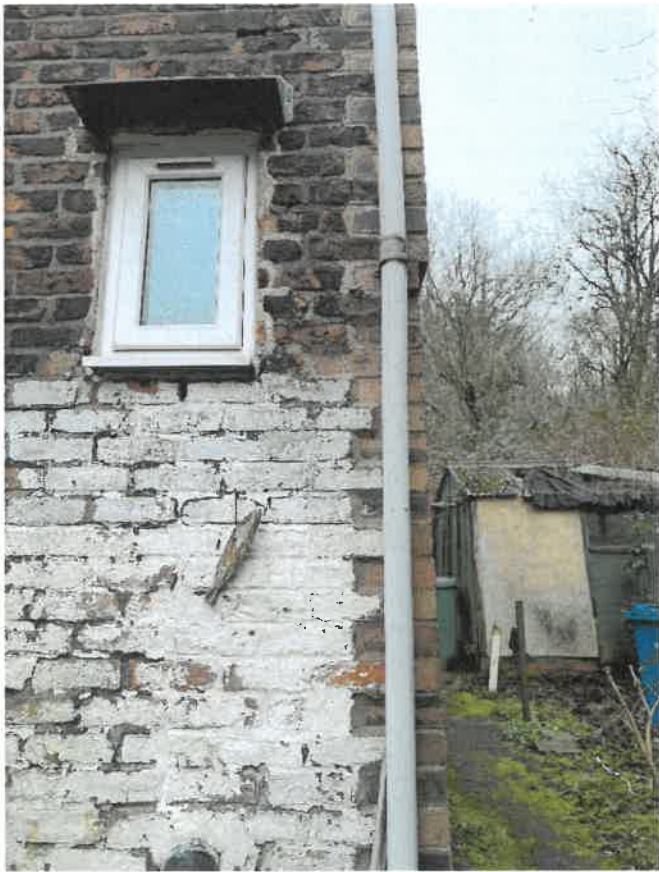
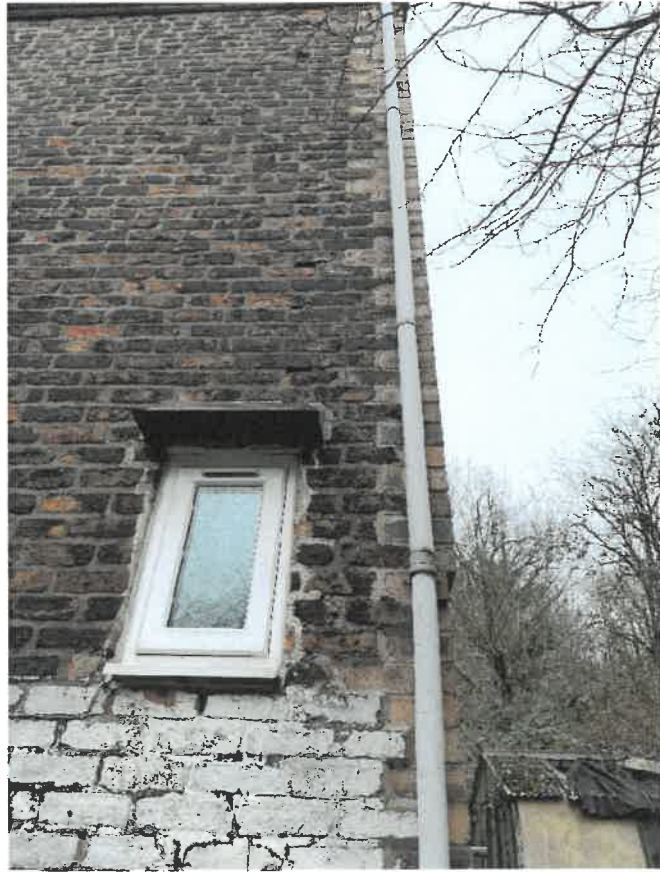
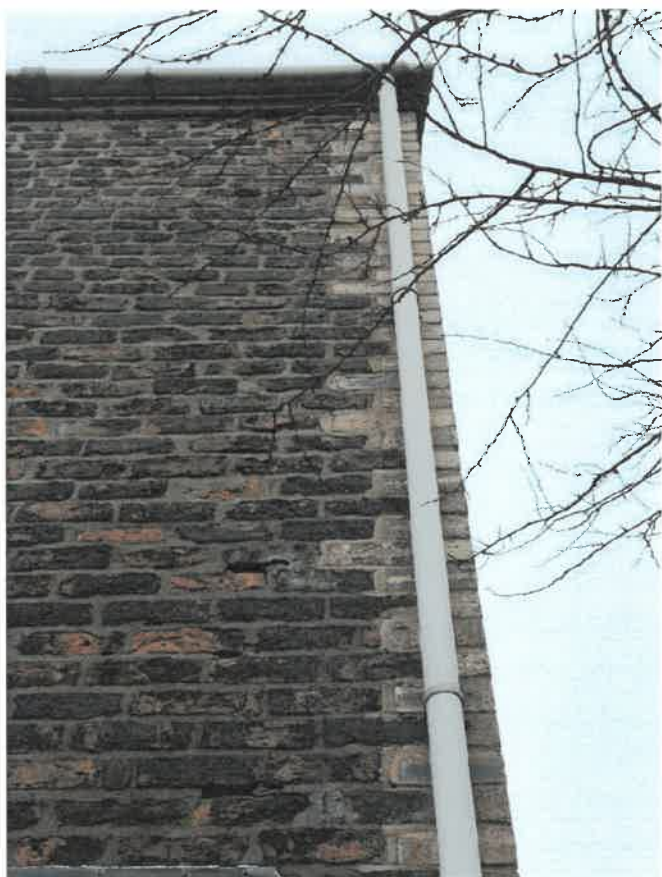
South-Facing Elevation – Right-Hand Two-Storey Section (Photographs 20 - 25): This elevation is brick-faced and presumed to be cavity wall construction. The brickwork exhibits surface erosion consistent with age and exposure but remains free from significant cracking. The rebuilt right-hand elevation is well toothed into this section, indicating reasonable construction practice. (Photographs 22 – 25).

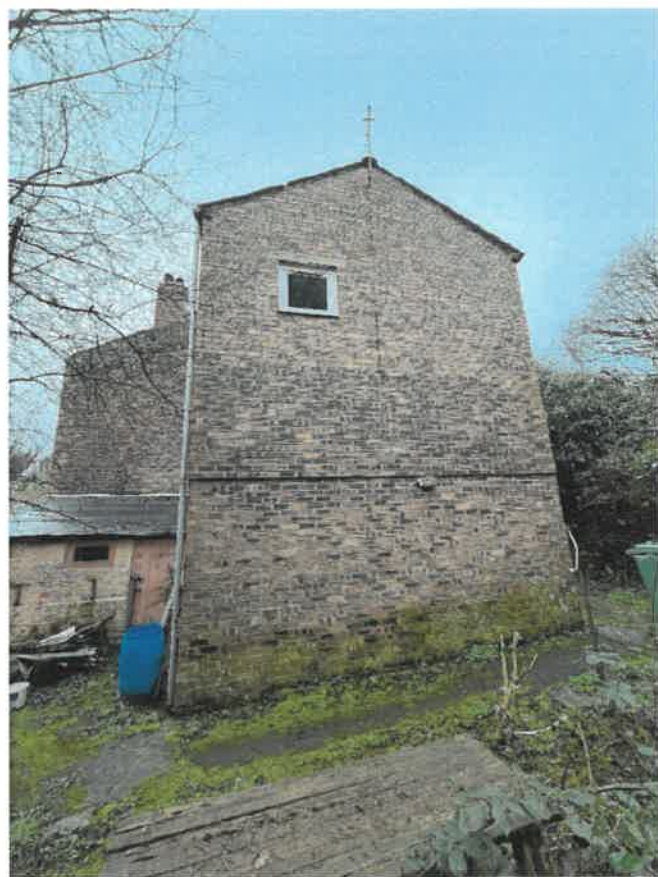
Photograph 26

East-Facing Elevation (Far Right Gable) (Photograph 26): This gable appears to have been rebuilt using newer brickwork. The elevation is broadly plumb but exhibits an unusual outward projection of the outer leaf at mid-high level (photograph 23) and slight outward bellying at mid upper storey-height, likely reflecting construction detailing rather than active movement. A single first-floor window serves Bedroom 2.

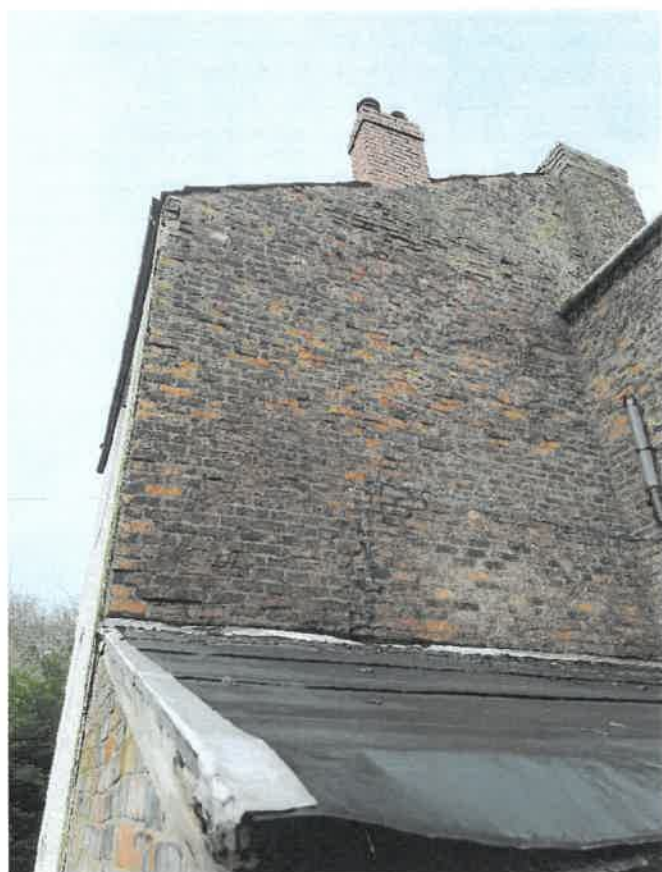
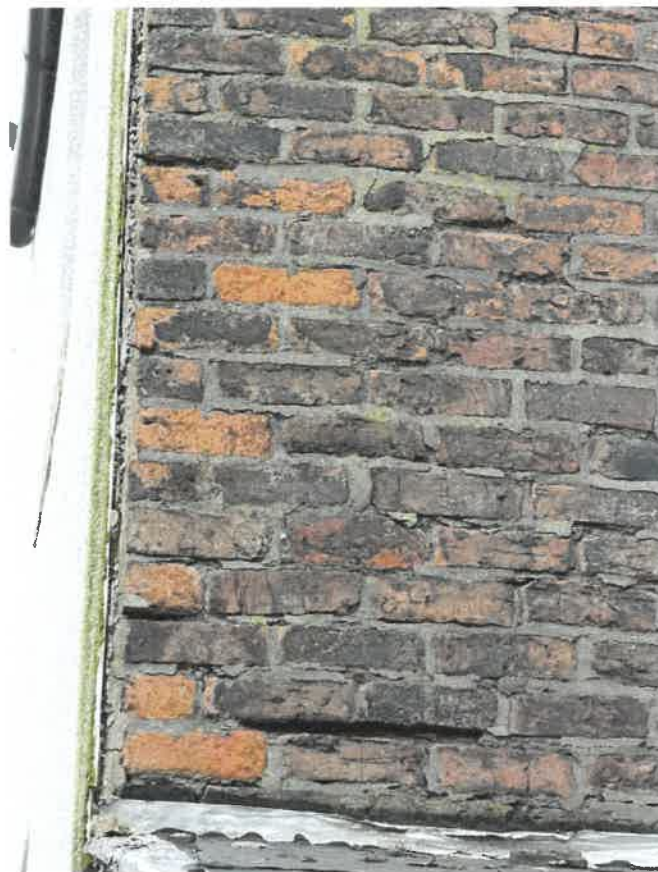
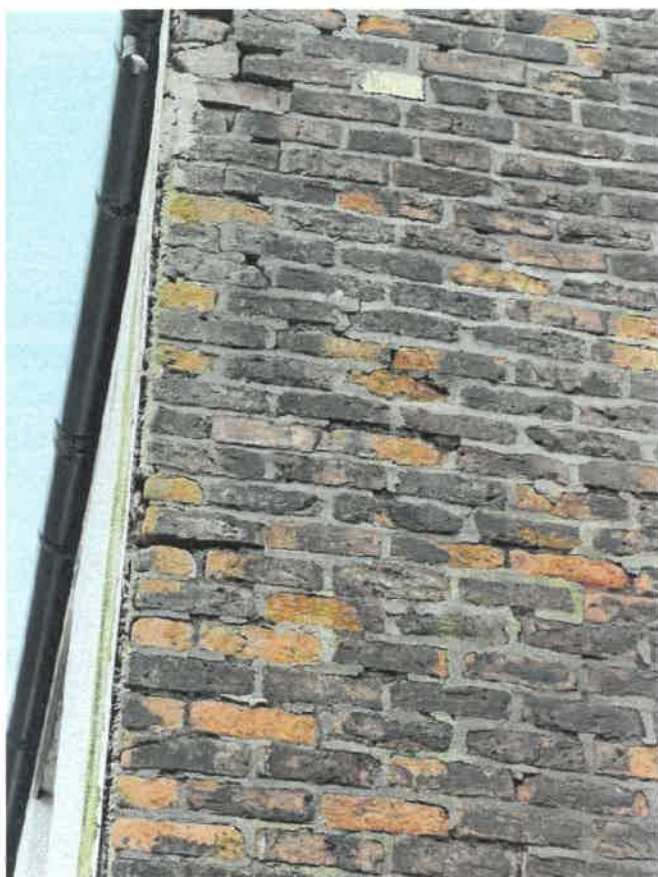
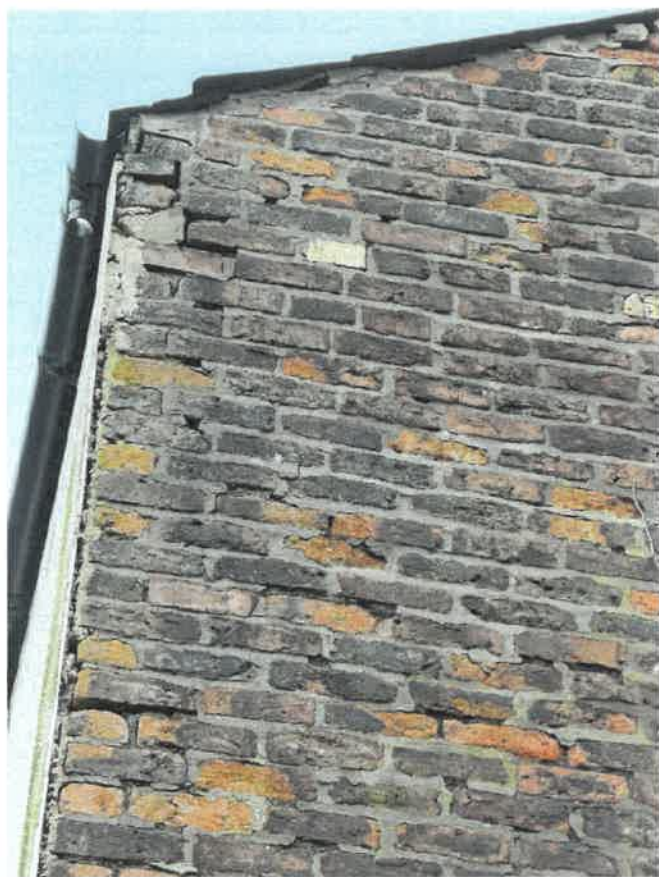
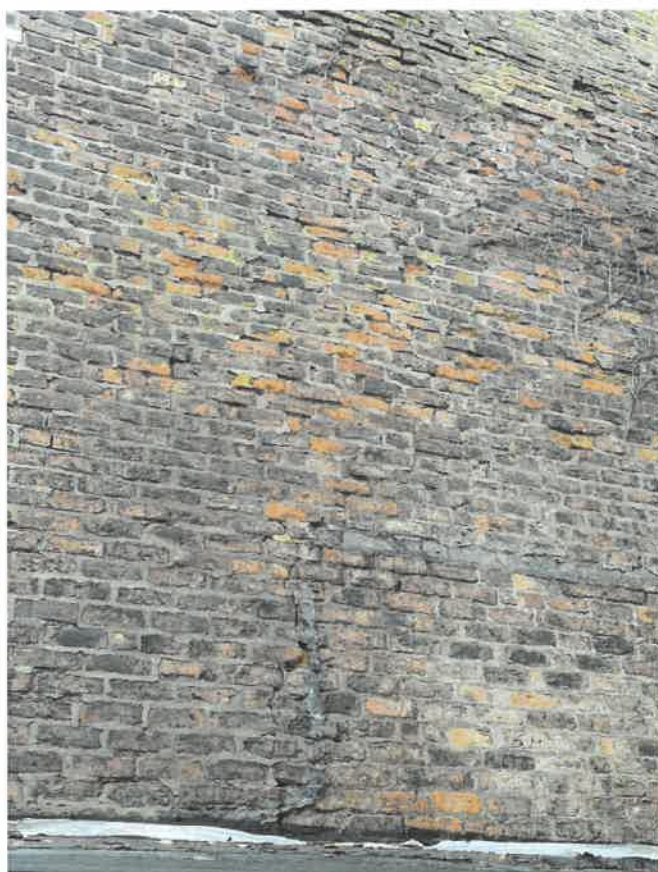
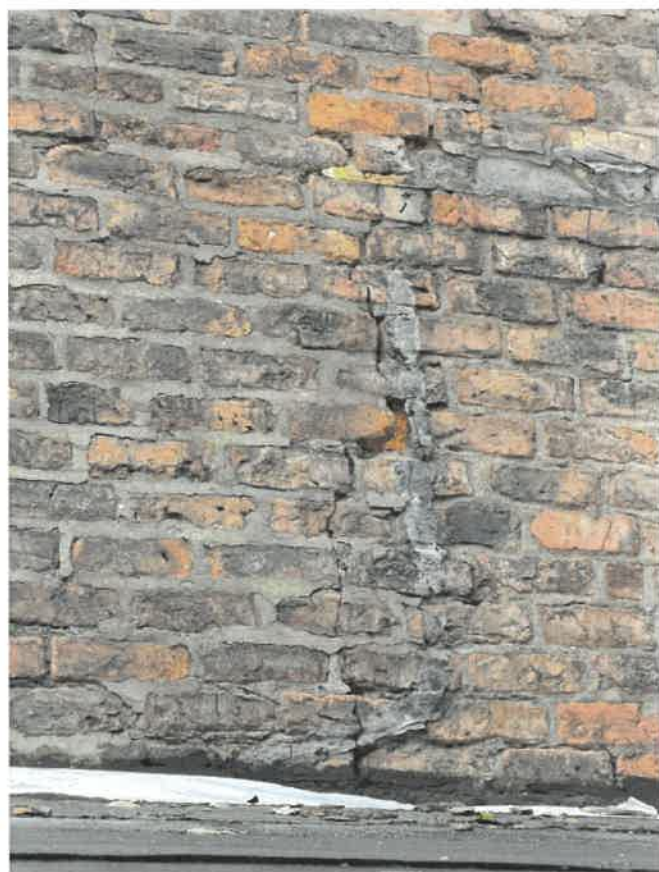
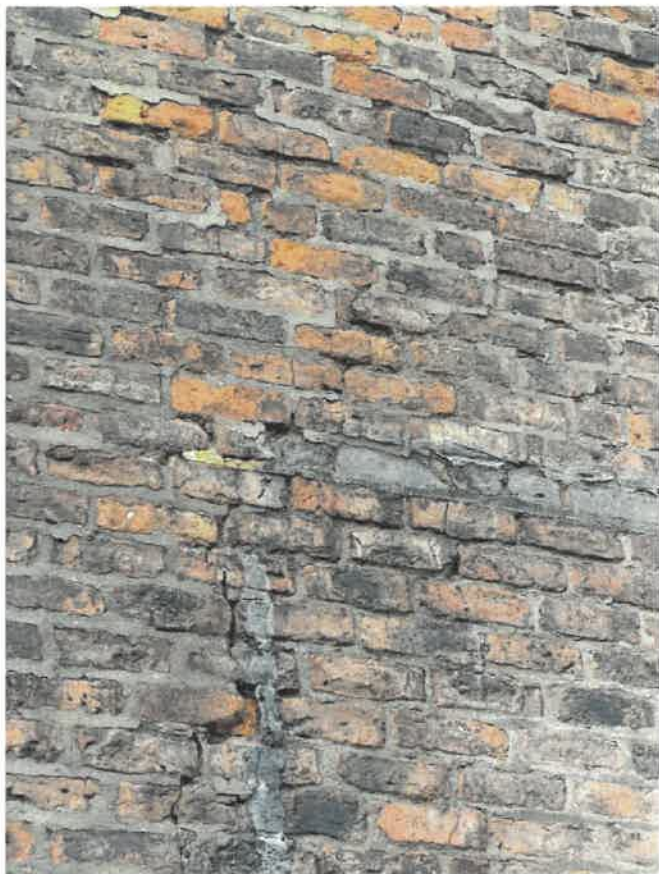
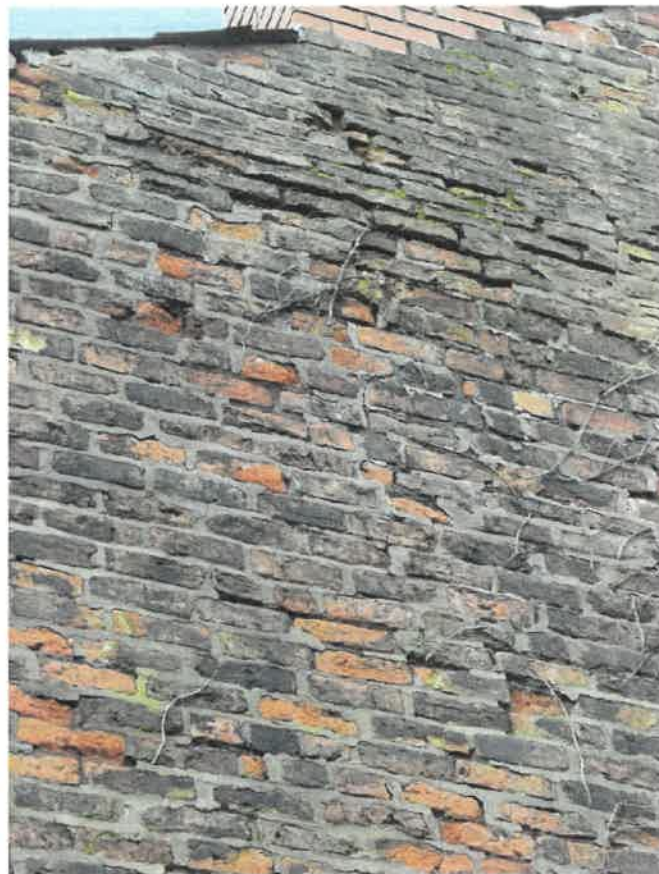
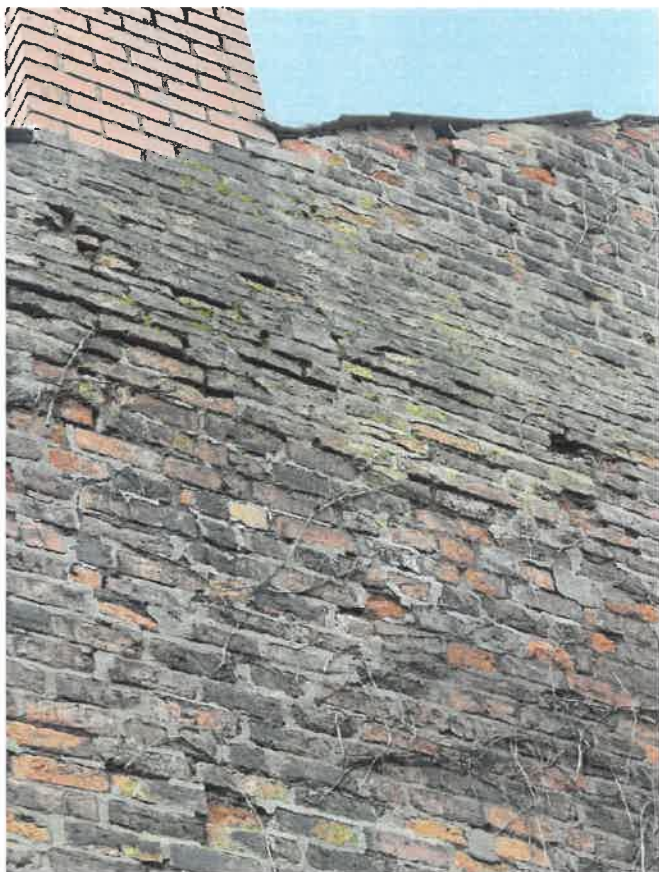
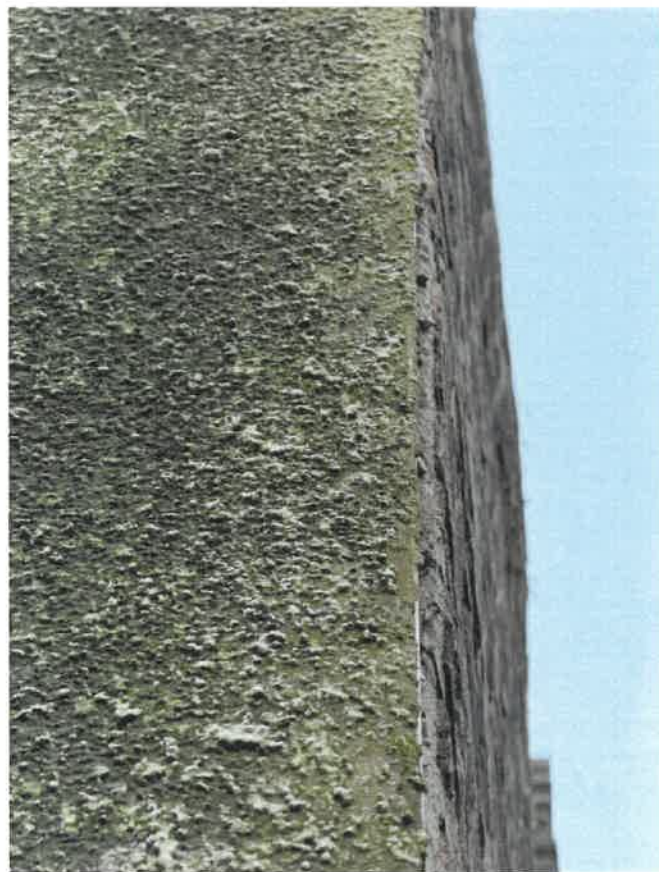
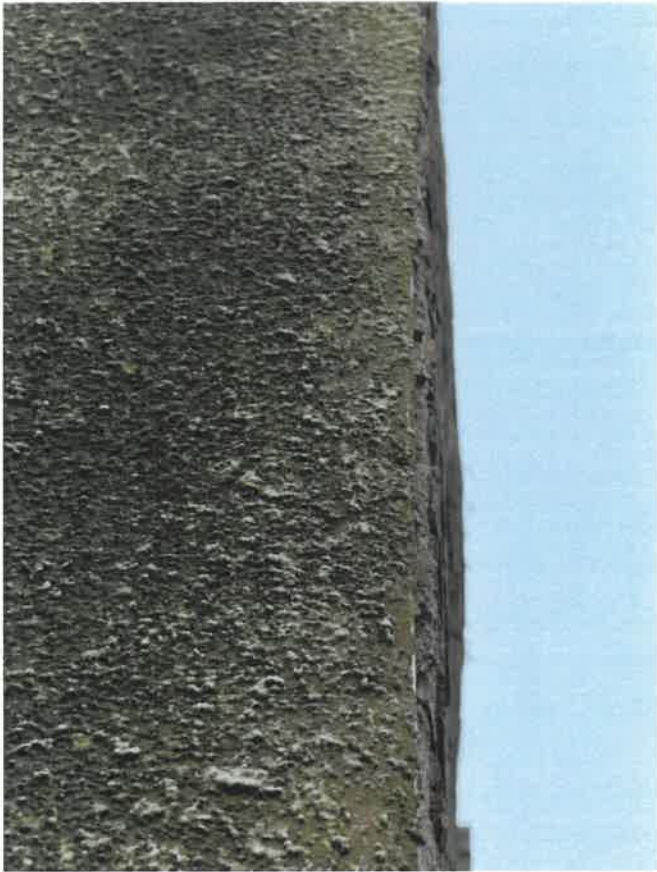
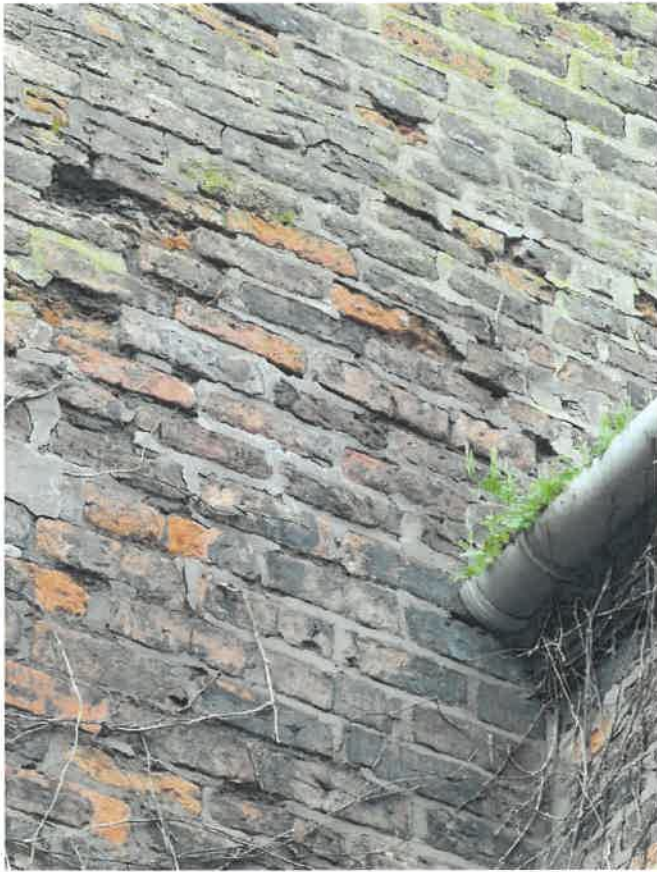
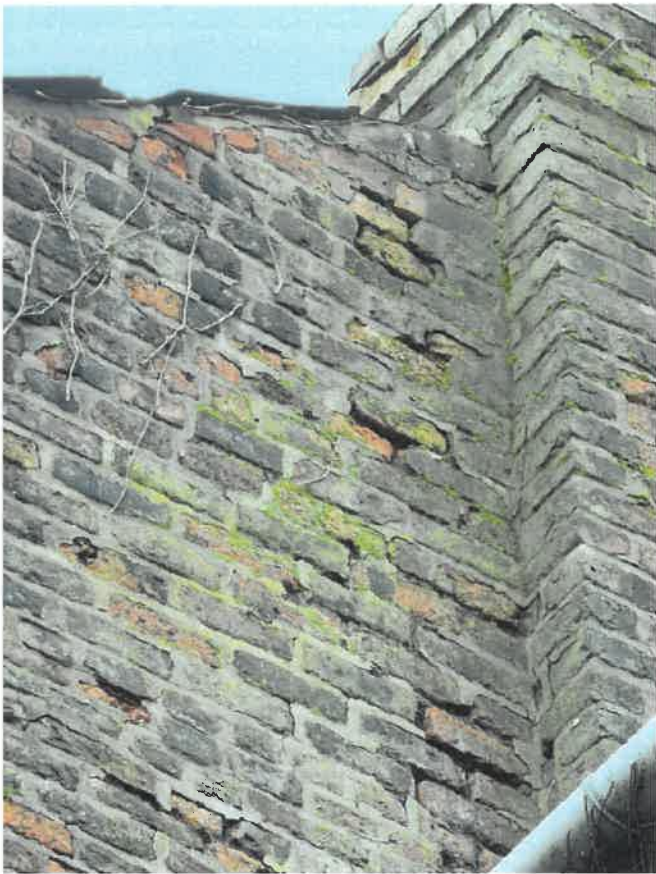
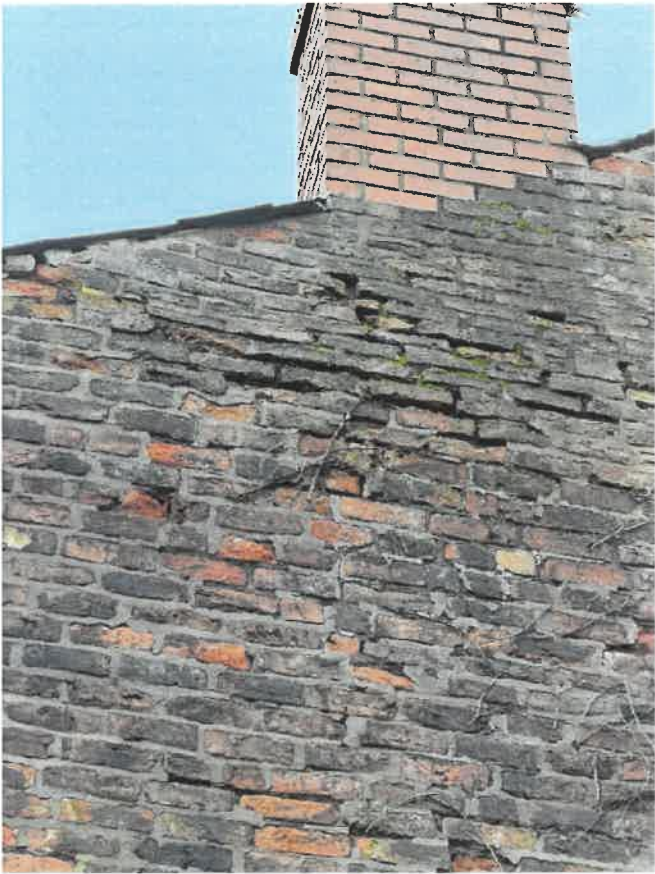
Right-Hand Main / Principal Gable (Photographs 27 - 44): The principal right-hand gable exhibits severe structural distress, including vertical and stepped cracking extending to mid-height, advanced masonry weathering, distortion at the junction with the rear elevation, and a pronounced and destabilising outward bulge at the apex.

In contrast, the right-hand main gable elevation exhibits structurally significant distress, including vertical and stepped cracking, advanced masonry weathering, distortion at junctions, and pronounced outward displacement at high level. These features indicate a loss of stability and represent a significant material structural concern.

**4.05** Externally, while several elevations perform reasonably, the right-hand gable elevation exhibits structurally significant defects, including stepped and vertical cracking, advanced masonry weathering, and a pronounced outward displacement at high level near the roof apex. The associated chimney

structures are also in poor condition. Stabilisation of this part of the building would necessitate major dismantling and rebuilding works, together with extensive temporary works and consequential disturbance to adjacent structural elements.

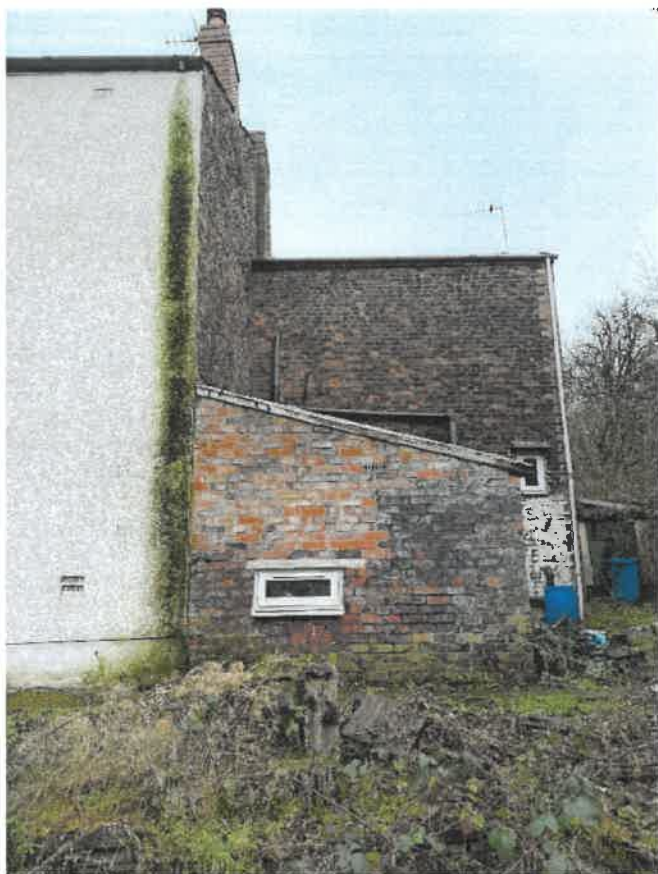
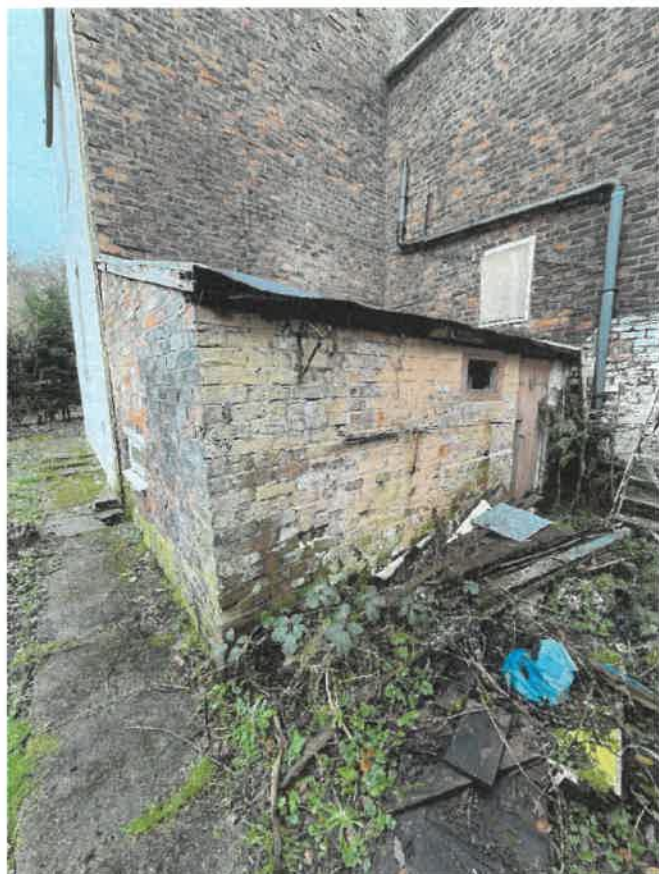
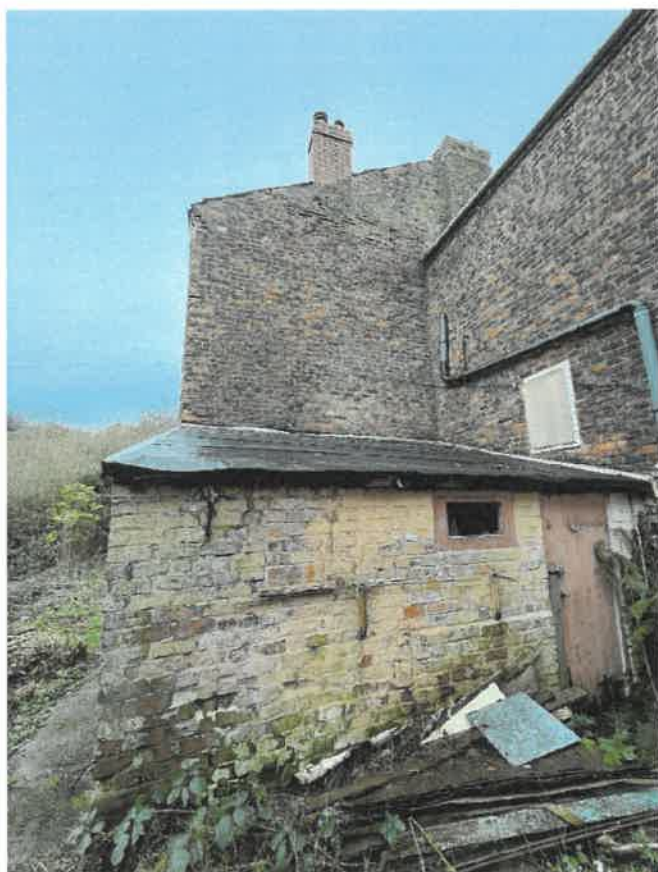
Single storey rear outrigger (photographs 45 – 47). The lean-to extension comprises single skin brick construction with a lean-to roof. The roof is covered with a felt fabric. This structure is considered to be of poor quality and of limited to no amenity value.

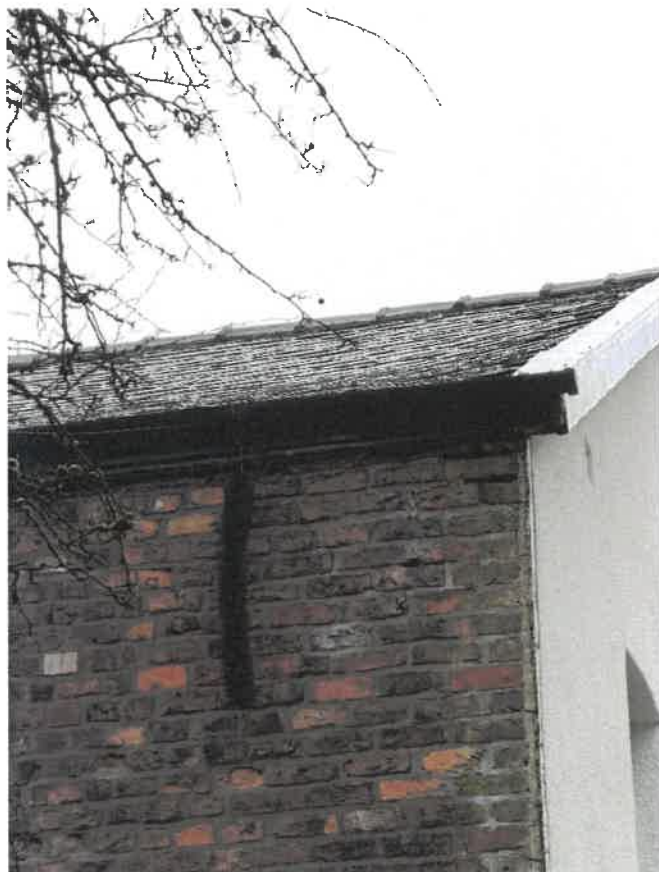
*Photograph 48*

Roof and Chimneys (Photographs 48 – 50, 43 & 44): The roof is pitched and slate-covered. The north-facing slope exhibits sagging at mid-slope and slate kick-up near the left-hand gable. (Photograph 48). Chimney stacks are in poor condition, including a rebuilt engineering brick stack with pronounced lean and a ridge-straddling chimney exhibiting advanced deterioration. Both these structures are considered generally unstable.

Roof distortions, particularly sagging to the north-facing slope, are consistent with traditional roof construction and deterioration of restraint and excessive sagging distortion of the principal elements of the roof structure. The absence of an under-slate membrane increases the risk of moisture ingress and associated degradation of roof timbers.

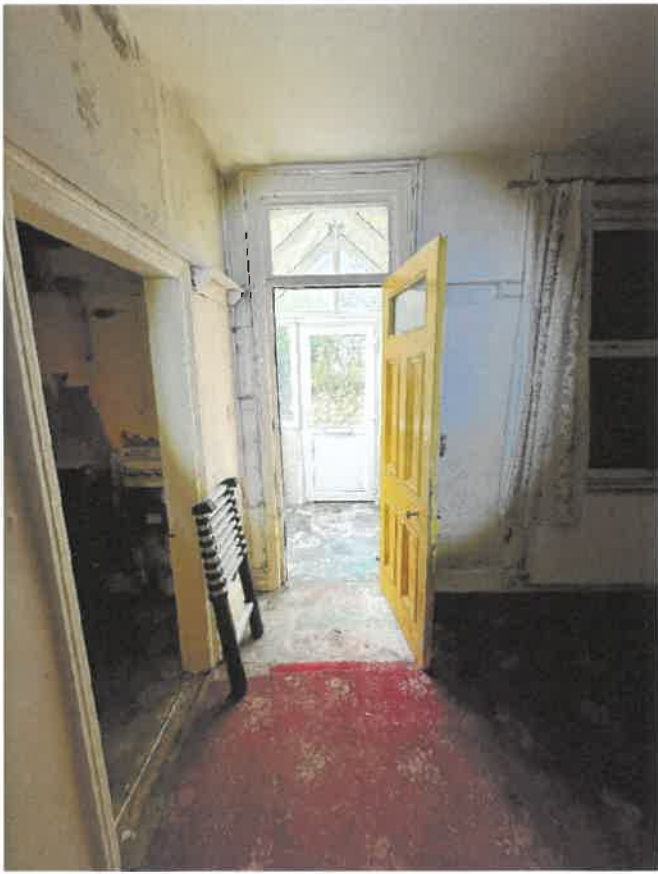
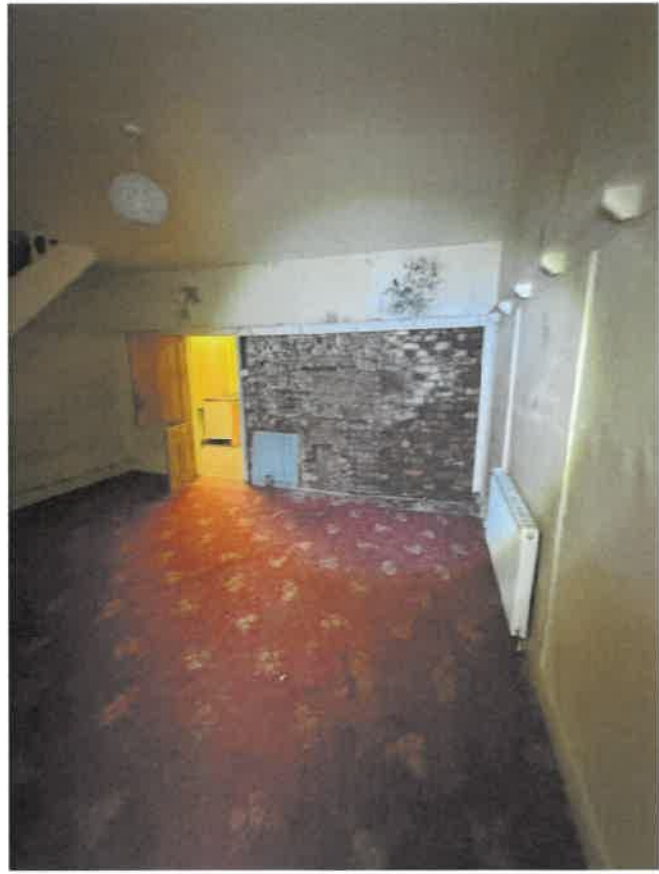
Ground Floor – General Arrangement: Access is gained via the front entrance porch into a reception / dining room (photograph 51) positioned at the North of the property. This room contains a chimney breast located within the internal wall (photograph 52) and a timber staircase rising left to right against the north-facing elevation. (Photographs 53).

Reception / Dining Room (Photograph 51 – 53): The reception/dining room incorporates a solid ground-bearing floor. A door opening on the right-hand side provides access into the kitchen, while a further opening to the (South) leads into the lounge.
