R4240

CLOUGH FARMHOUSE, CLOUGH LANE  
PRESTWICH

JANUARY 2025

# REPORT ON STRUCTURE

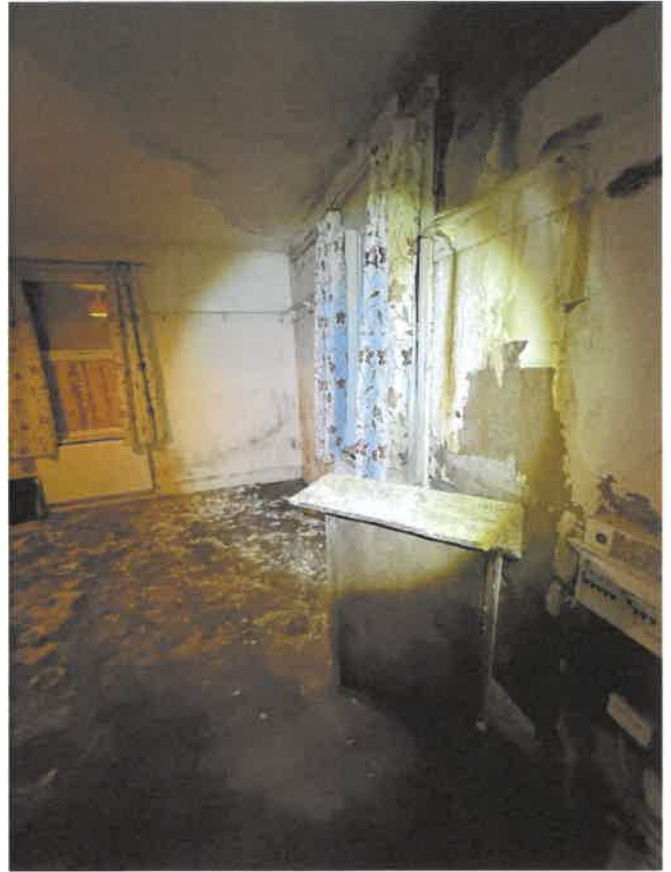
Photograph 54

Lounge (Photographs 54 & 55): The lounge is located to the rear South of the property and incorporates both left-facing and South-facing windows, providing dual aspect daylight. A chimney breast is located against the right-hand side wall.

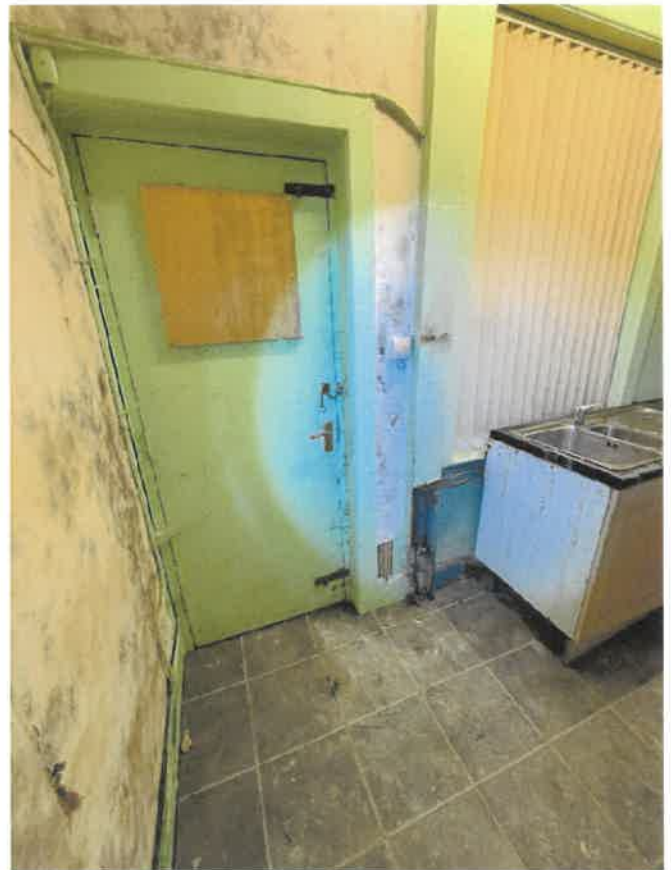
Photograph 56

Kitchen (Photographs 56 – 59): The kitchen is accessed from the reception / dining room and contains a large chimney breast along the left-hand wall, separating it from the reception space. The room incorporates North and South-facing windows together with a forward access door. A further door provides access to a store and WC.

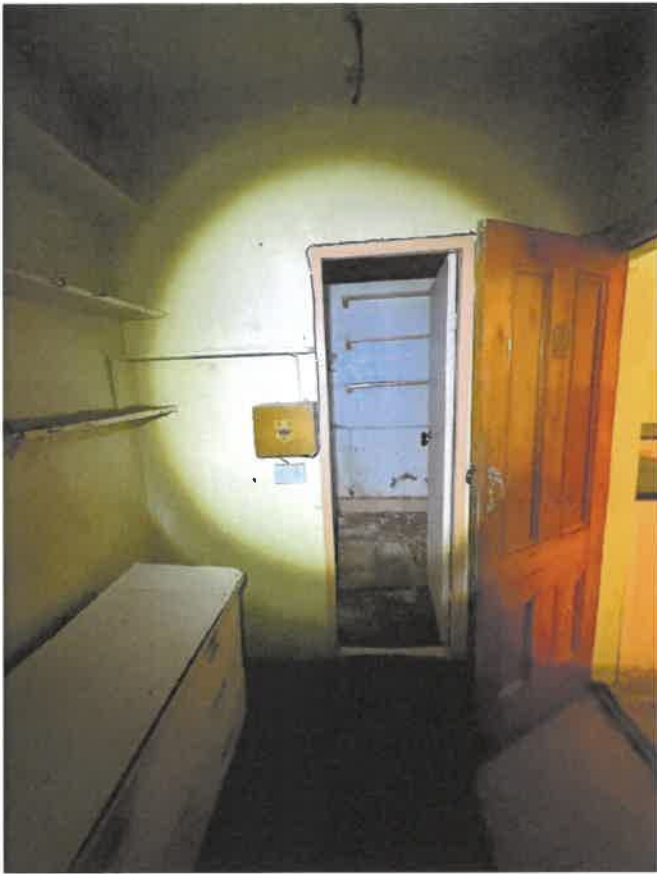
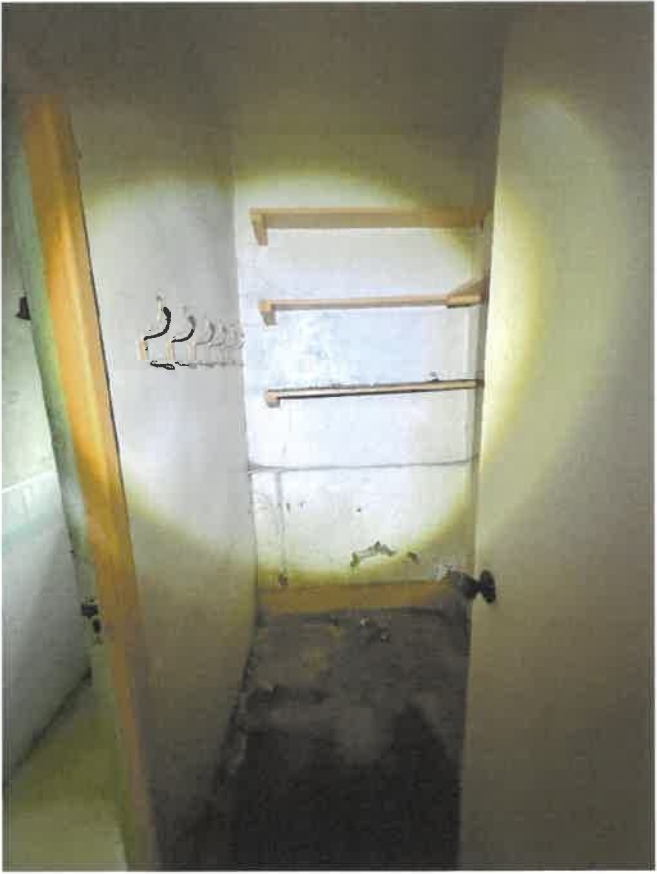
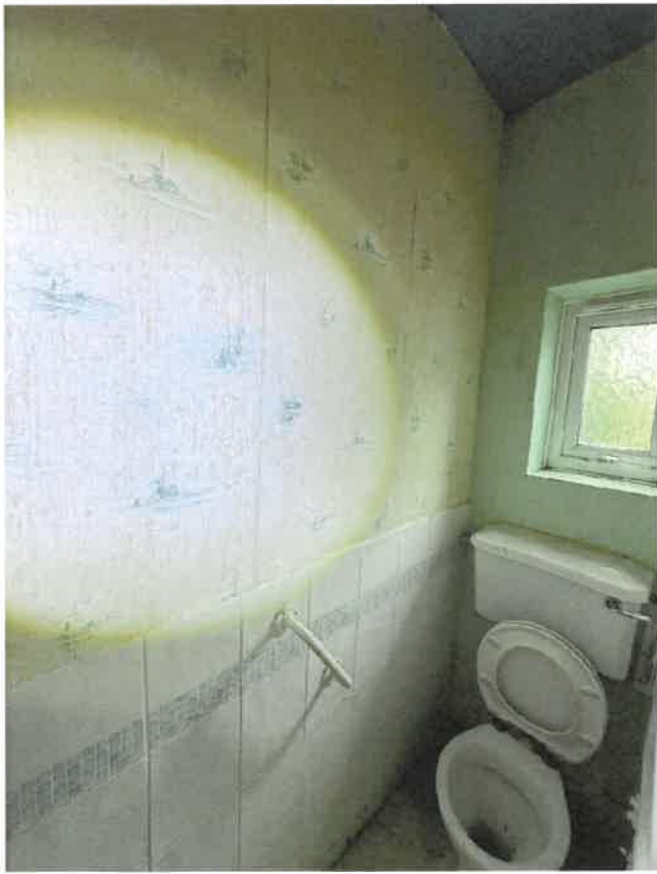
Store and WC Areas (Photographs 60 – 63): The storeroom and WC occupy the far right-hand side (East) of the property. These spaces include north and south facing windows. Walls and ceilings exhibit cracked plaster finishes throughout, i.e. failure of finishes probably due to damp.

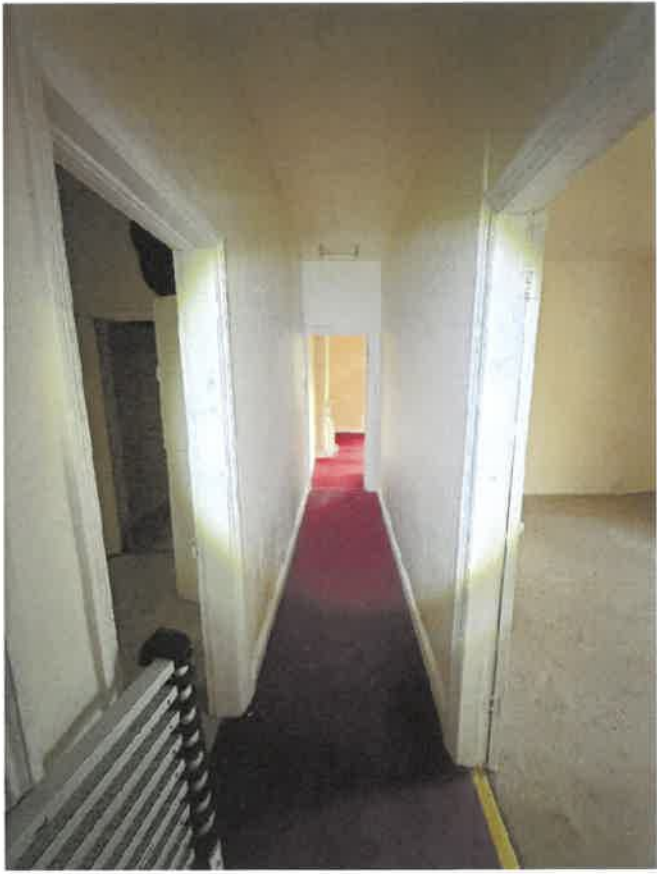
Photograph 64

First Floor – General Arrangement: The first floor is arranged around a central landing corridor running in a north to south direction (photograph 64). This provides access to three bedrooms, a bathroom, and a WC via intermediate lobby spaces. Ceiling finishes are predominantly lath and plaster. The hall ceiling exhibits multiple cracks associated with sagging distortion of the ceiling joists.

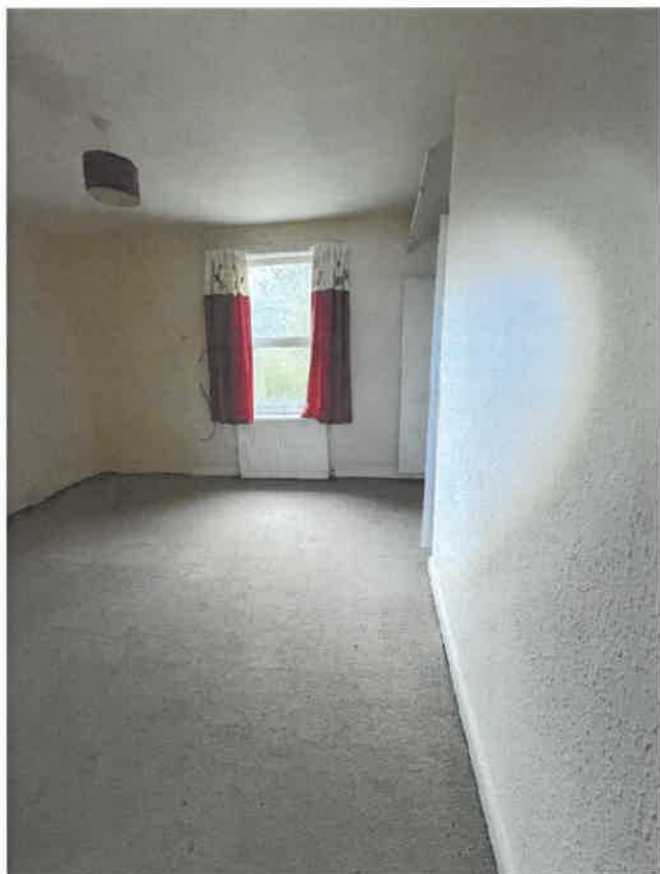
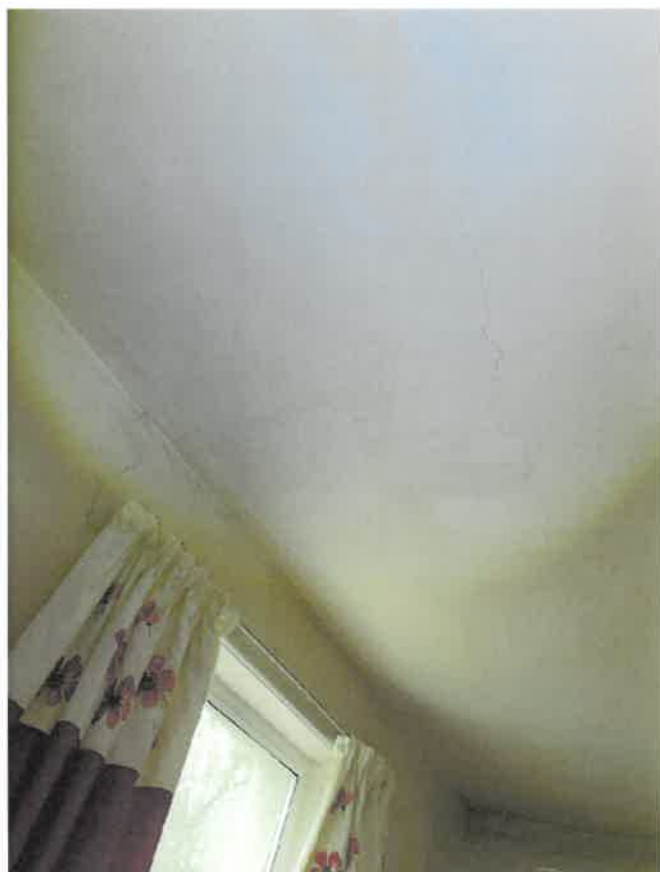
Bedroom 1 (Photographs 65 – 69): Located at the front North-West corner of the property, incorporates suspended timber flooring. The left facing window opening exhibits slight falls consistent with historic settlement in a North to South direction.

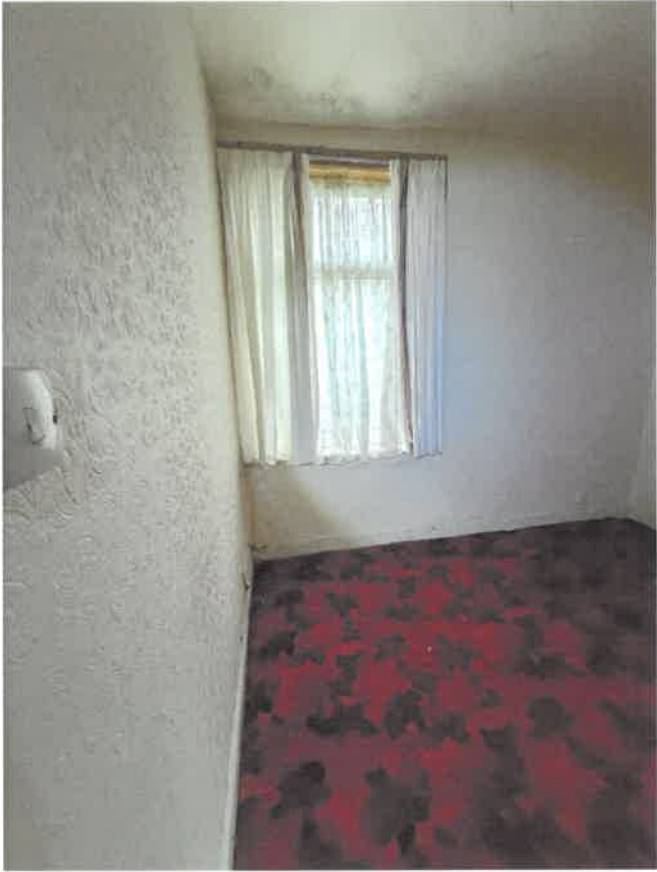
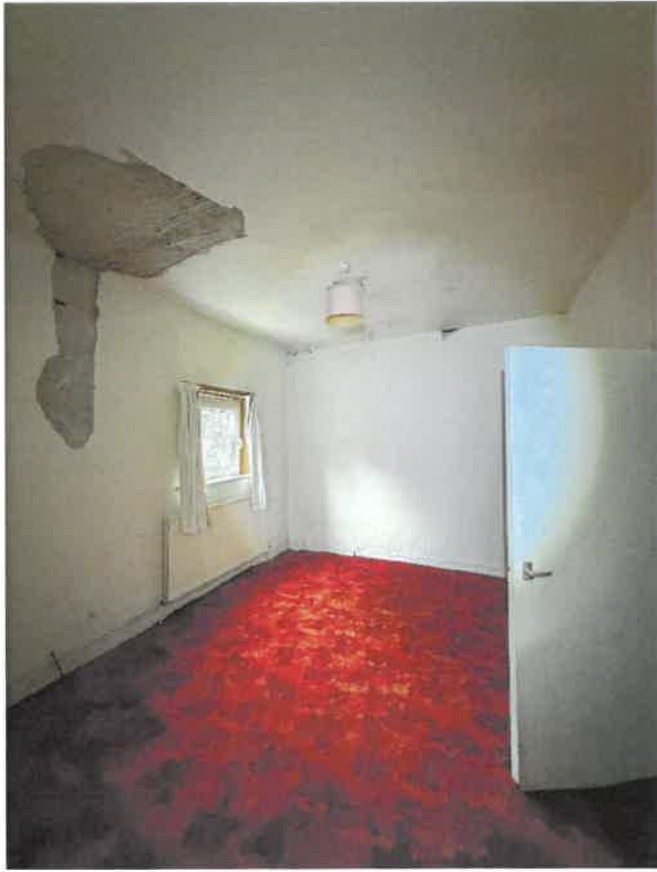
Bedroom 2 (Photographs 70 – 72): Bedroom 2 is located toward the right-hand (East) side of the property and is accessed via a small internal lobby. (Photographs 73 & 74). The room incorporates suspended timber flooring and is served by the rebuilt east-facing gable. The ceilings are suffering from partial collapse.

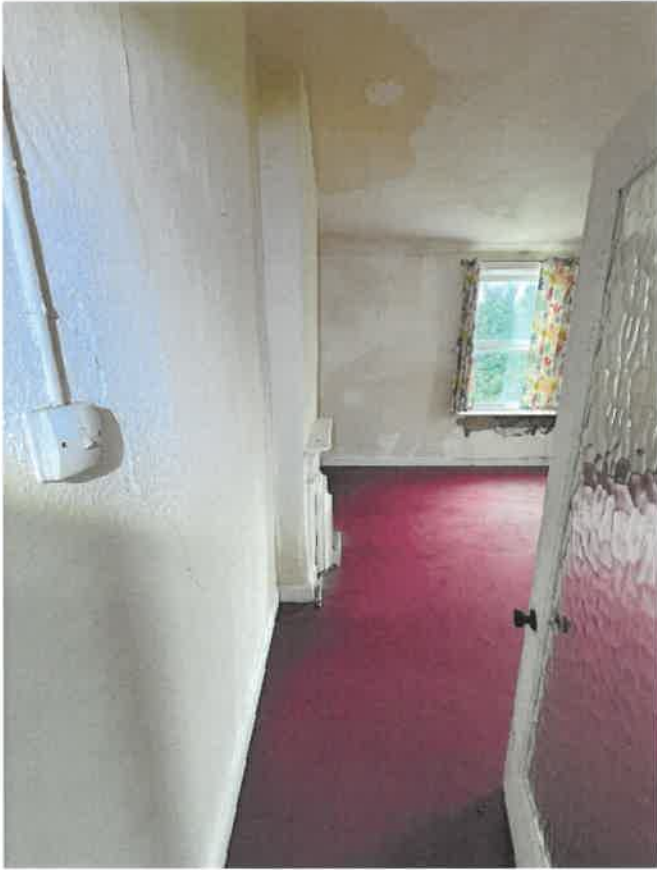
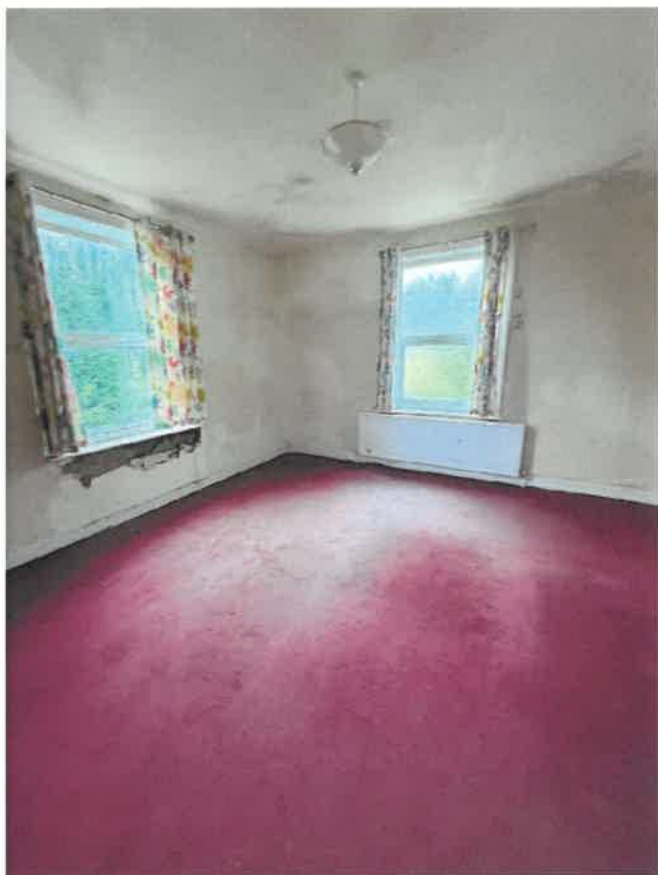
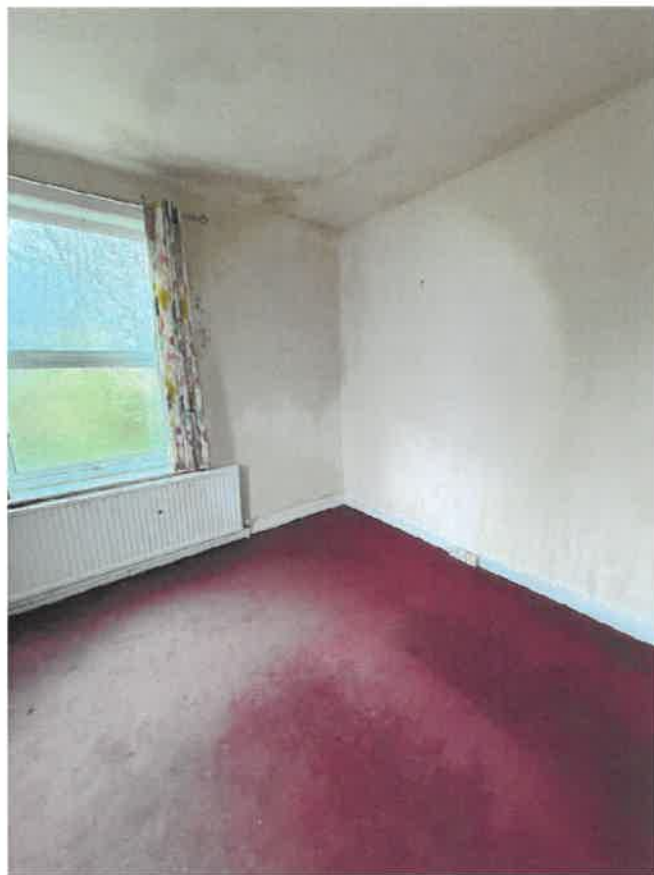
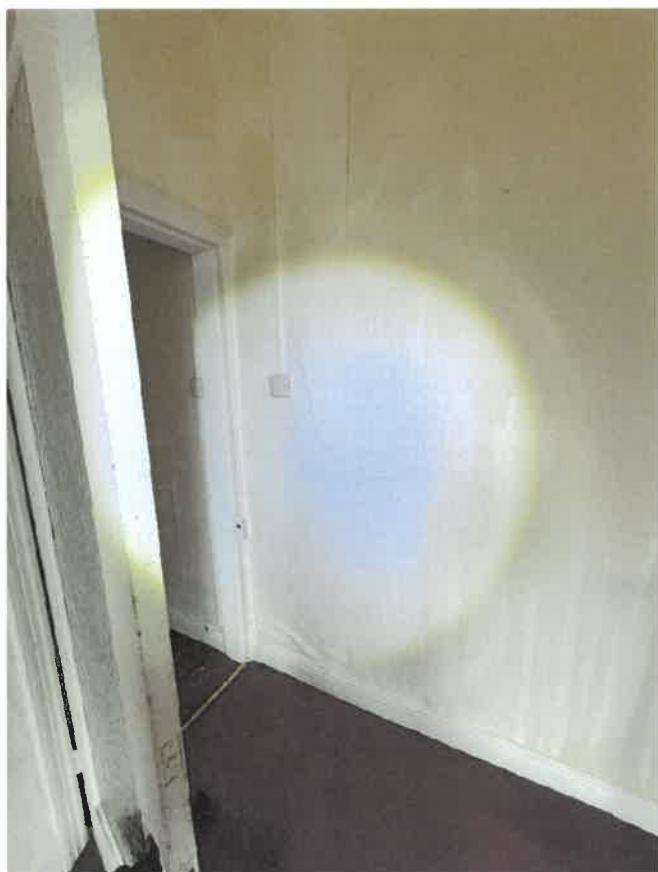
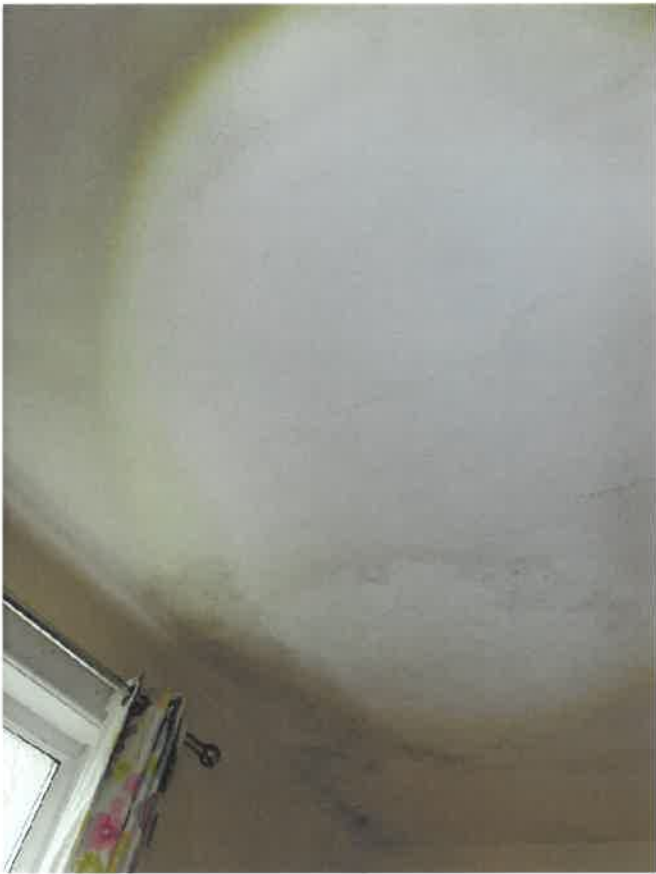
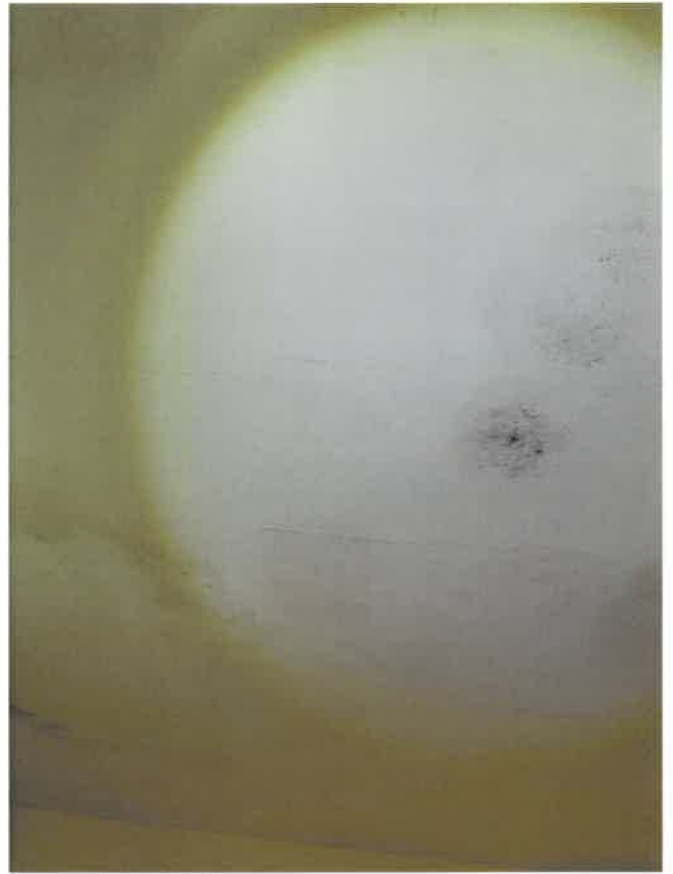
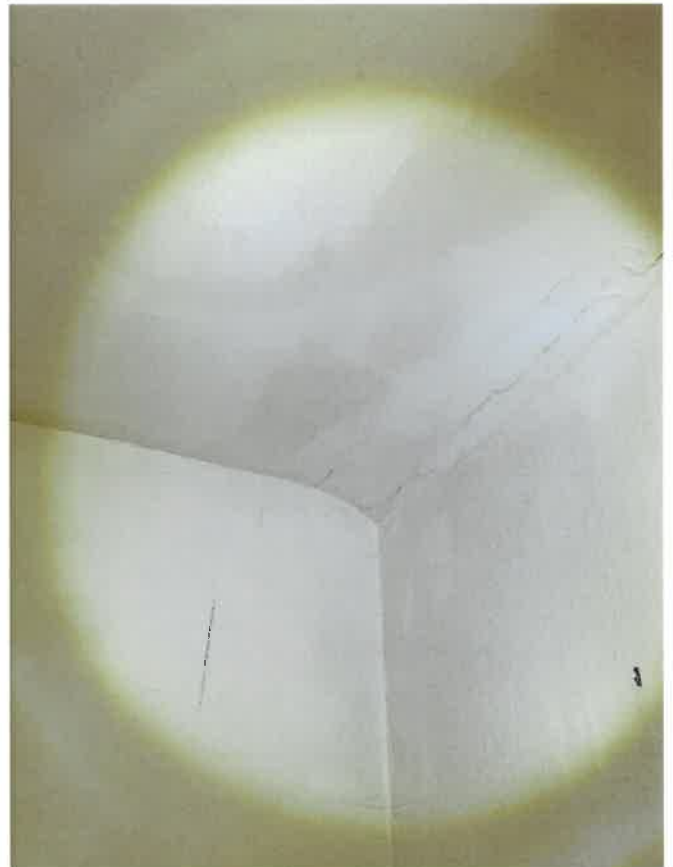
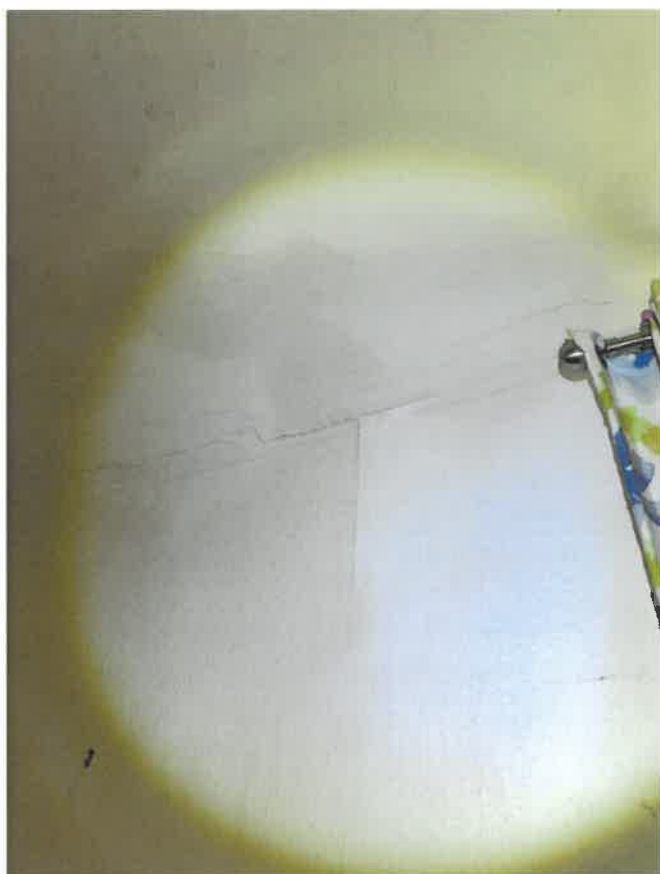
Bedroom 3 (Photographs 75 – 85): Bedroom 3 occupies the south-west corner of the property and incorporates west-facing and South-facing windows together with a chimney breast on the right-hand wall. A slight vaulted ceiling is present along the South elevation, reflecting the underside of the roof slope, presumably uninsulated. There is damp staining evident, collapsed plaster finish beneath the South facing window cill and a crack north of the chimney breast. (Photograph 79). Ceiling cracking is commensurate with ceiling joists exhibiting excessive sagging distortion.

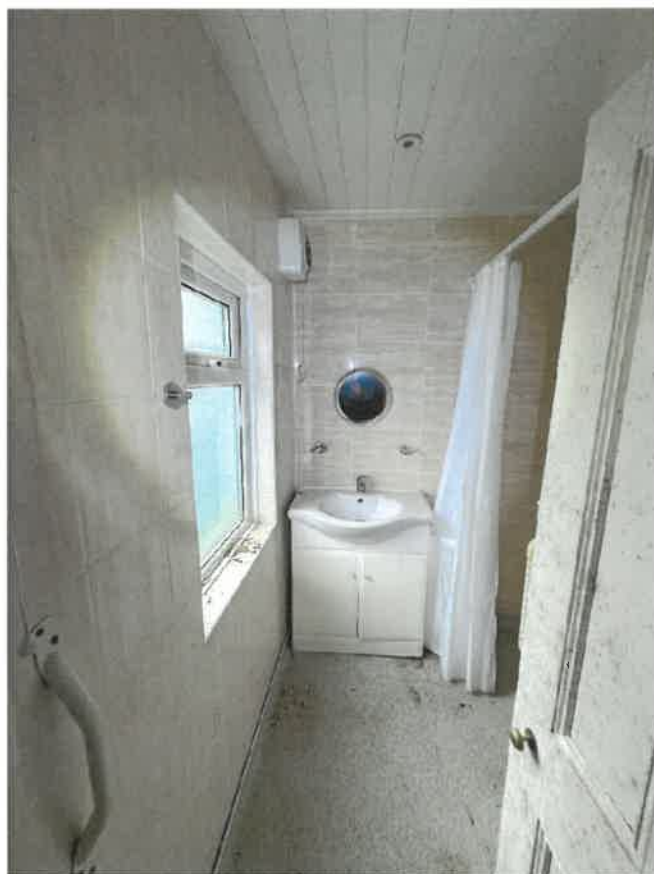
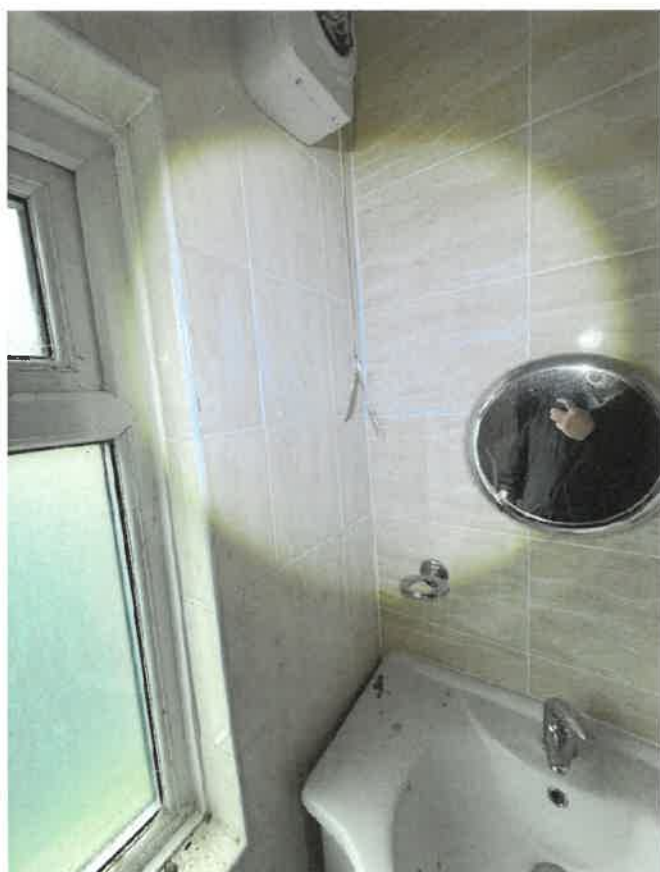
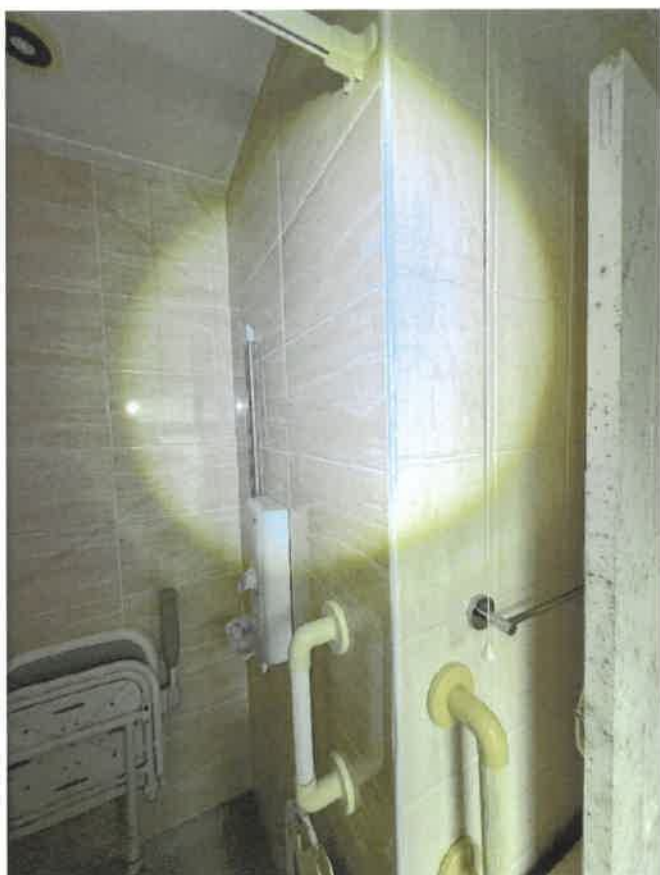
Bathroom and WC (Photographs 86 – 89): The bathroom is located centrally along the north elevation at first-floor level and is finished with ceramic wall tiling. The main bathroom walls are free from cracking at the time of the survey.

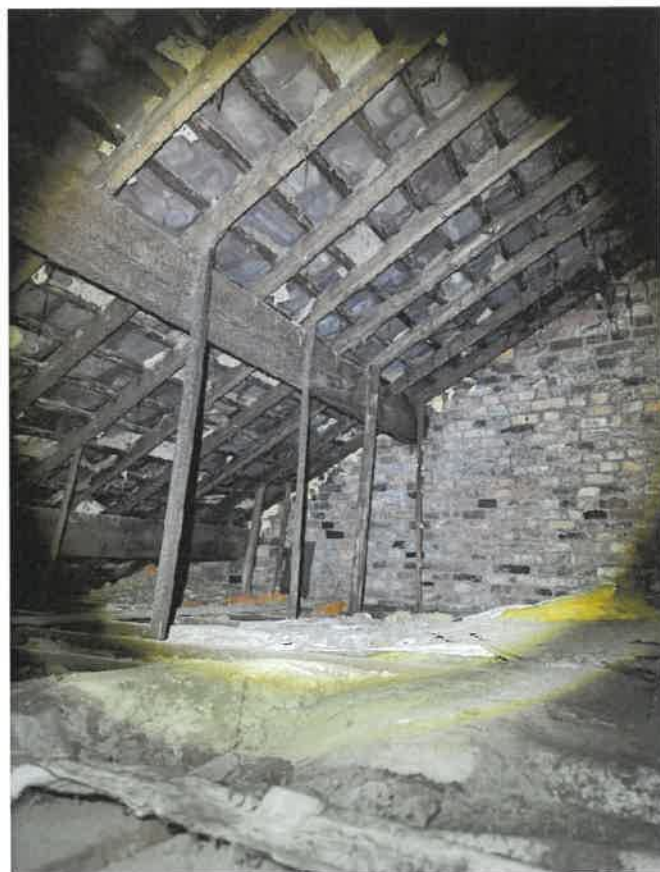
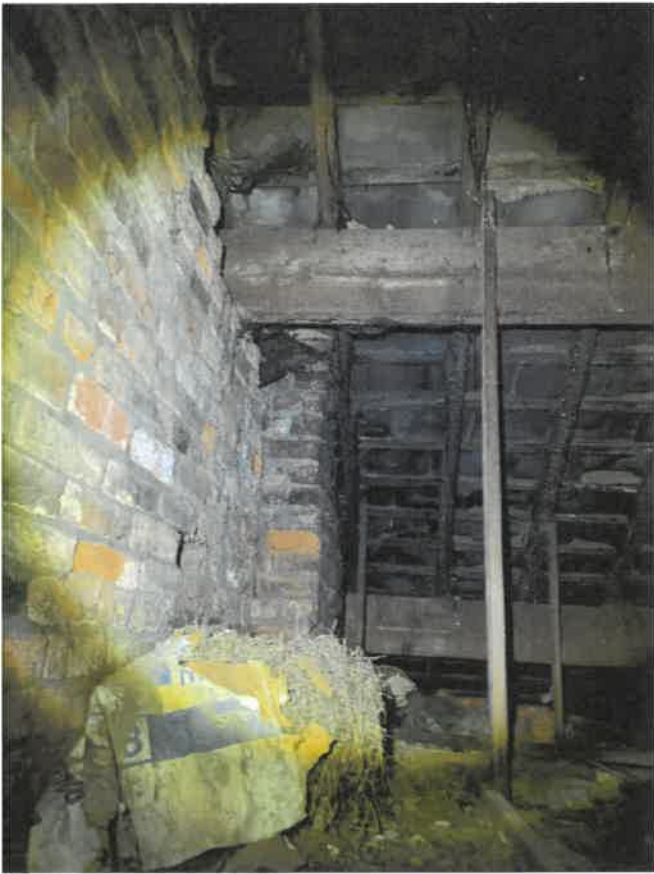
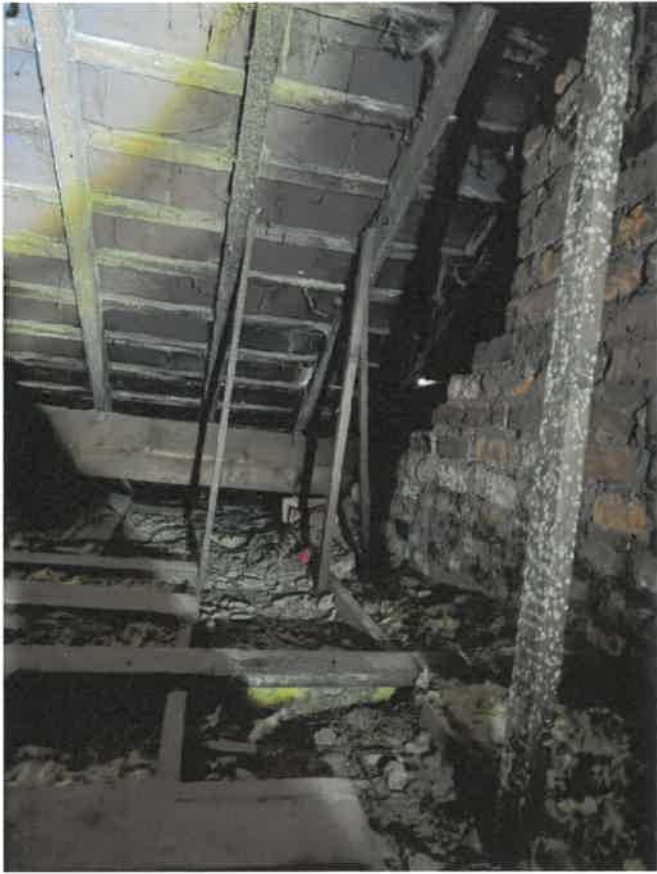
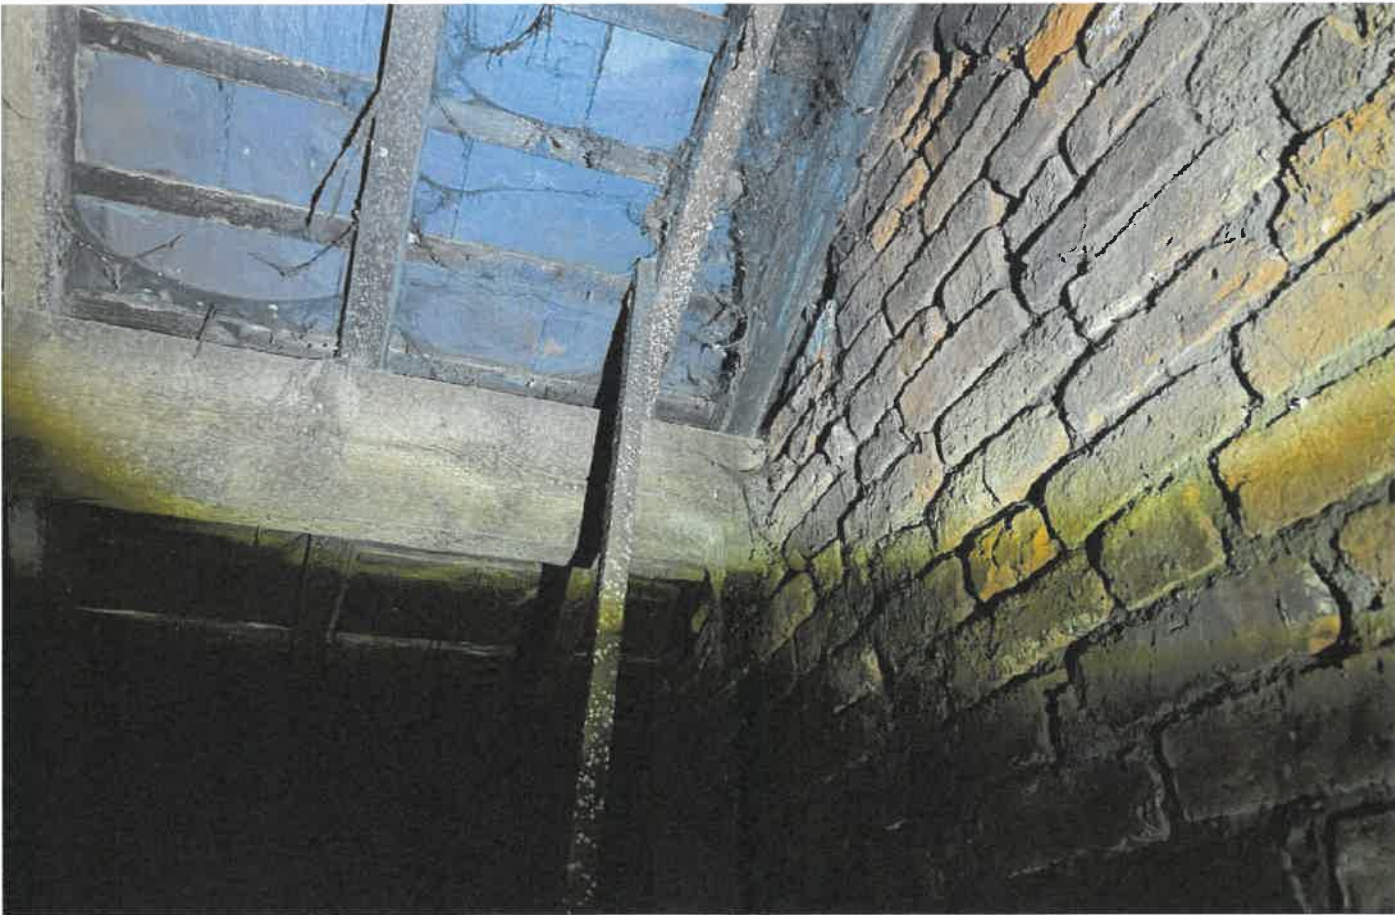
The roof structure (photographs 90 – 95) is of traditional form with a nominal ridge board and reliance on ceiling joists for restraint. Although the roof space appeared relatively dry at the time of inspection, the combination of roof sagging, chimney instability, lack of under-slate membrane, and internal damp staining indicates that comprehensive roof reconstruction would be required. There were a few areas of the roof where daylight was visible.

- 4.06** The roof structure is of traditional form, reliant on ceiling joist tie action with a nominal ridge board and no under-slate membrane. Evidence of roof sagging, moisture ingress, and internal ceiling distress indicates that the roof would require a comprehensive overhaul or replacement to achieve acceptable standards of structural performance, durability, and weather resistance.
