# Contaminated Land Phase Three Report; Validation of Remedial Works undertaken in Relation to potential contamination for Proposed Residential Development at, Land adjacent 6 Bentley Lane, Bury, BL9 6RZ.

August 2025

## GeoShield Verification Report 001

PROJECT: Land Adjacent to 6 Bentley Lane

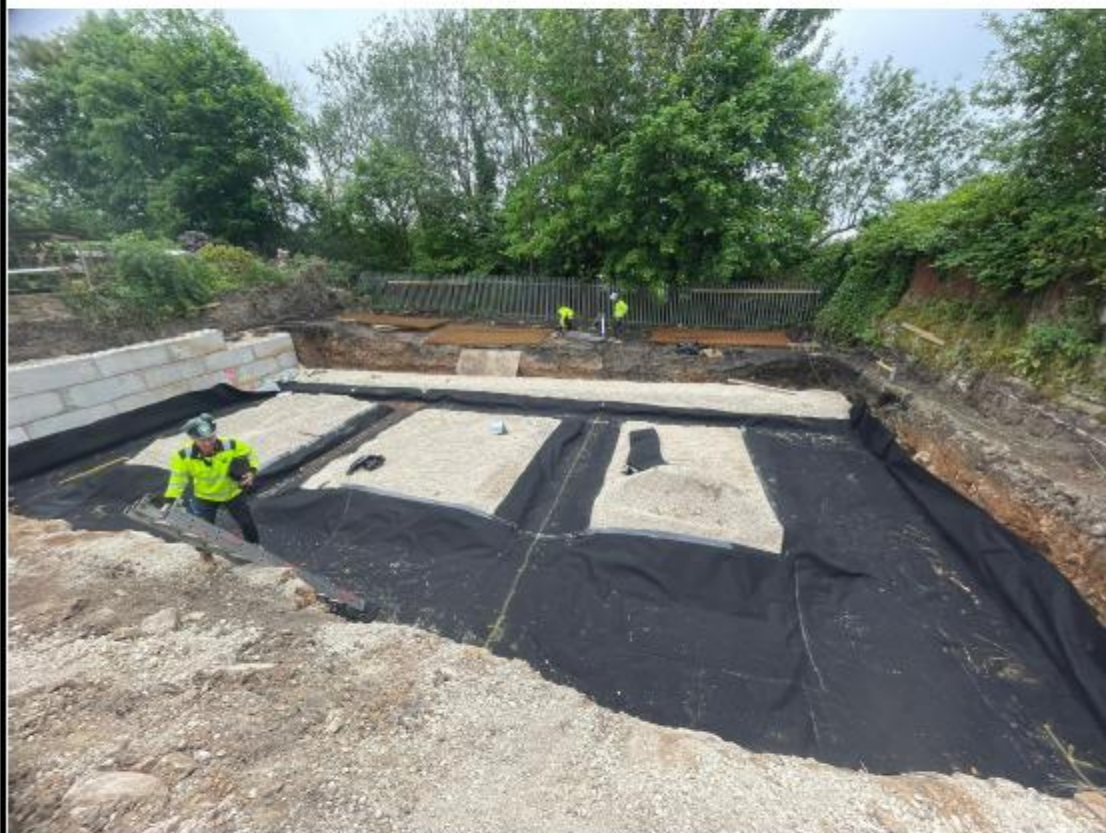
This is an overview image where today's verification was undertaken and the Titanbond Membrane was installed on the land Adjacent to 6 Bentley Lane

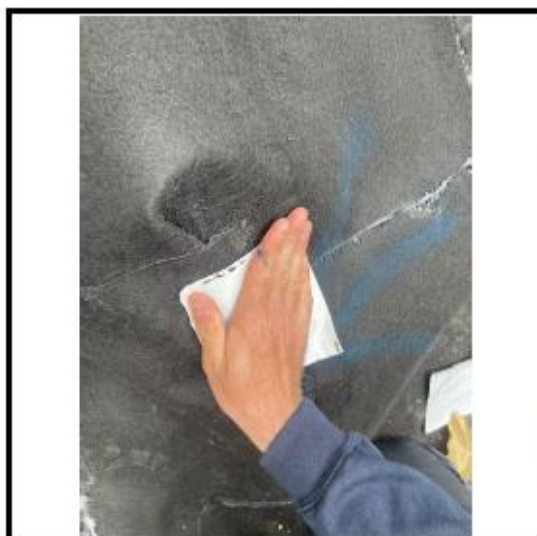
Internal/External Corner Detailing

The various internal and external corners had all been initially formed using additional patches of Titanbond membrane. These corners were reinforced and heat welded using a hot air tool and a silicone roller to gain the correct pressure needed for the Titanbond to create a strong bond.

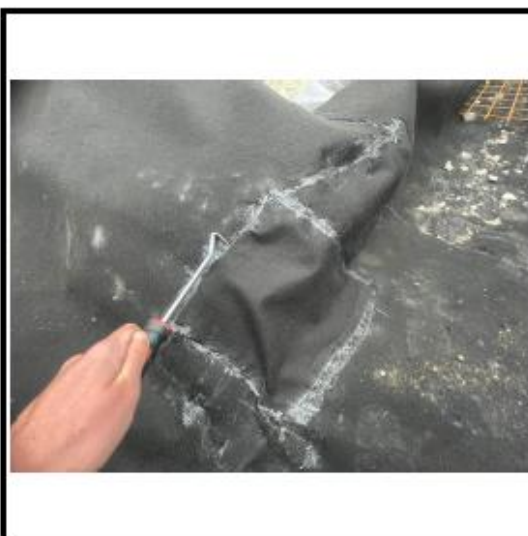
The bond was confirmed via the Mechanical Point Stress Test as seen in the image above. The metal point was ran along the welded edges of all reinforced corners to ensure the correct bond was adhered. During this process 2 faults were found and remediated using GR SAM.

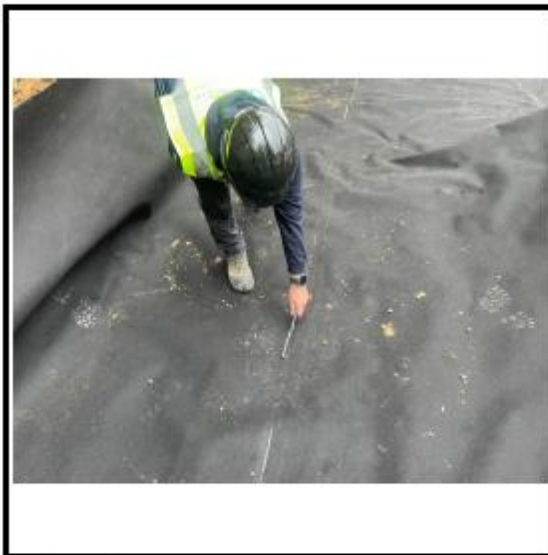
100mm Welded lap joints

Upon arrival installers had completed the installation of Juta Titanbond to the foundation thickenings. Adjacent sheets of Titanbond had been overlapped a minimum 100mm and welded using a combination of Twin welding and hand welding with a hot air tool and silicone roller.

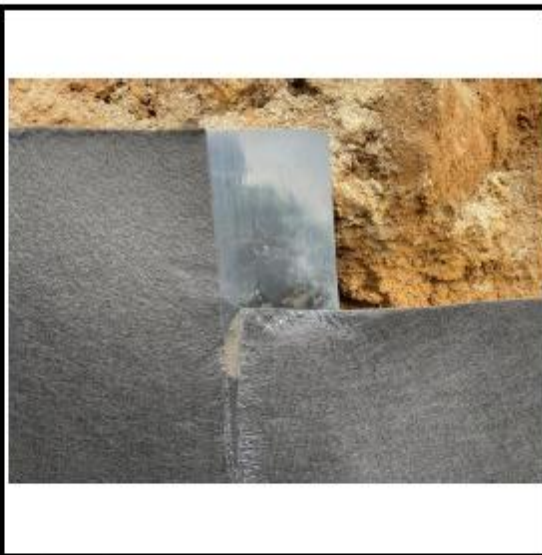
The Twin weld and hand weld lap joints were confirmed via the Mechanical Point Stress Test as seen in the image above. The metal point was ran along all Twin/hand welded lap joints to ensure the correct bond was adhered. During this process 4 faults were found and remediated using GR SAM.

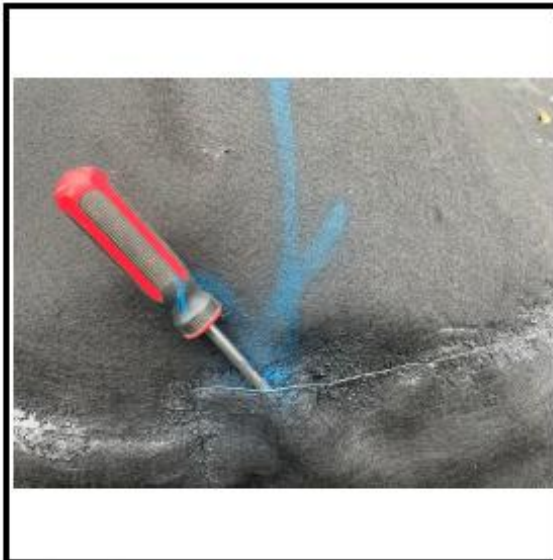
#### Faults Found and Remediated

During the verification process 6 faults were found on lap joints and internal/external corners, which were brought to the attention of the installers on site and were remediated using GR SAM. This was done by removing any fleece lining and applying patches of GR SAM to any faults found.

| Date | Nr | Remediation Description | Y/N |
|---|---|---|---|
| 20/05/2024 | 001 | There were six faults found within lap joints and Internal/external | ✓ |

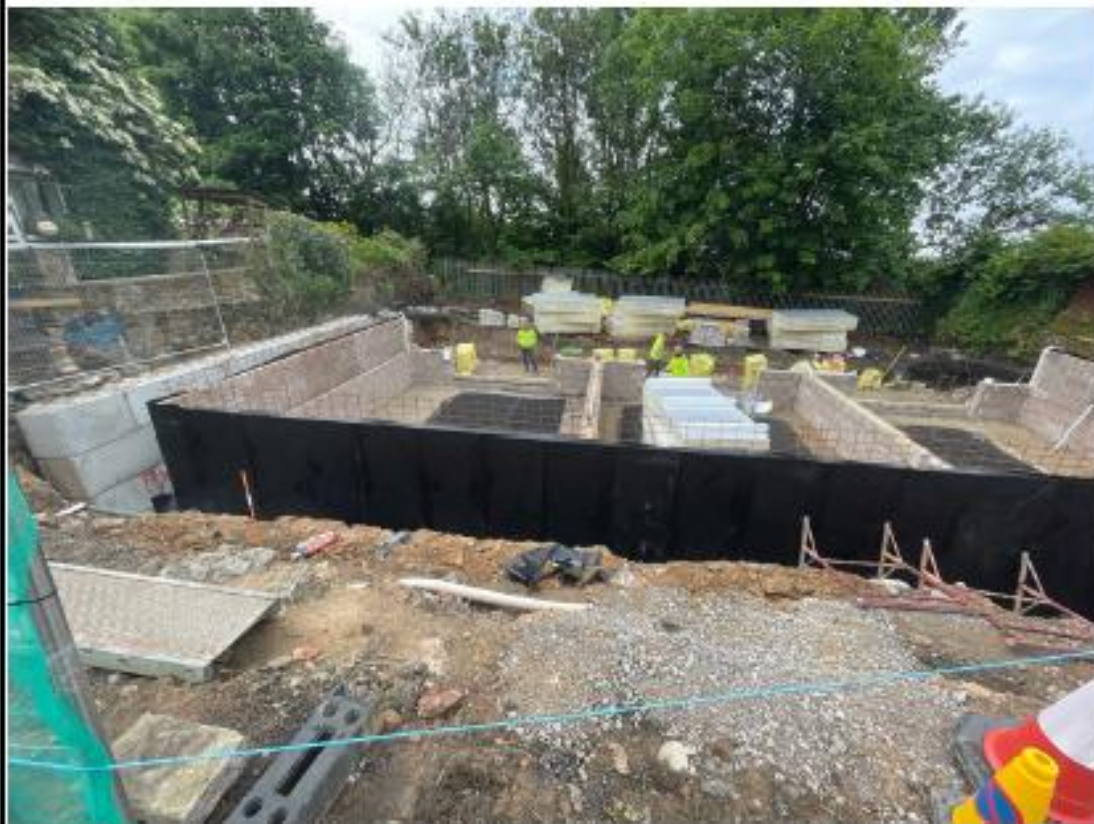
This is an overview image where today's verification took place on the basement walls

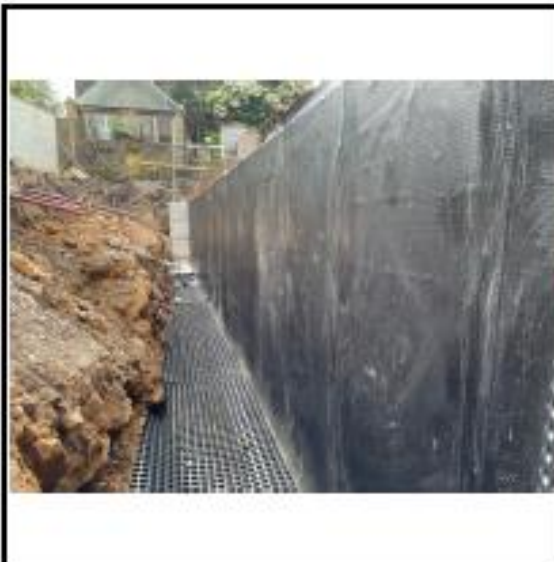
Installation of JUTA GP1 SAM

The basement walls of the property had been tanked using sheets JUTA GP1 SAM installed by M&D Membranes. Firstly the walls are primed with a bitumen primer and left to cure, this aids the adhesion process when installing sheets of SAM, once cured the sheet of GP1 SAM are heated to activate

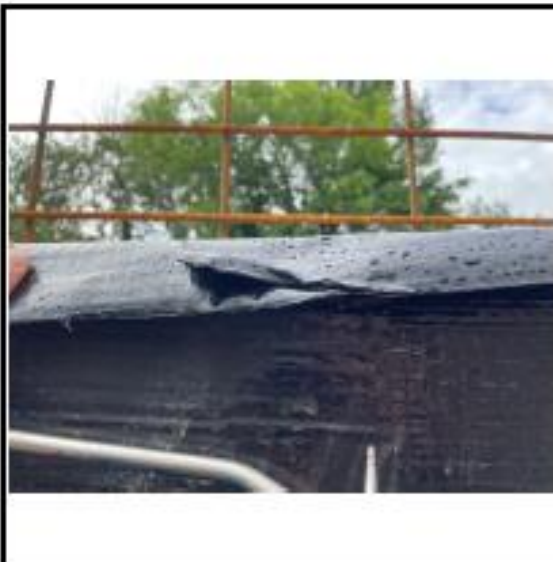
the bitumen backing and rolled into position with applied pressure to ensure a robust seal is achieved. Adjacent sheets of SAM are overlapped a minimum of 100mm and overlaps are subjected to mechanical point stress testing to ensure no faults are found.

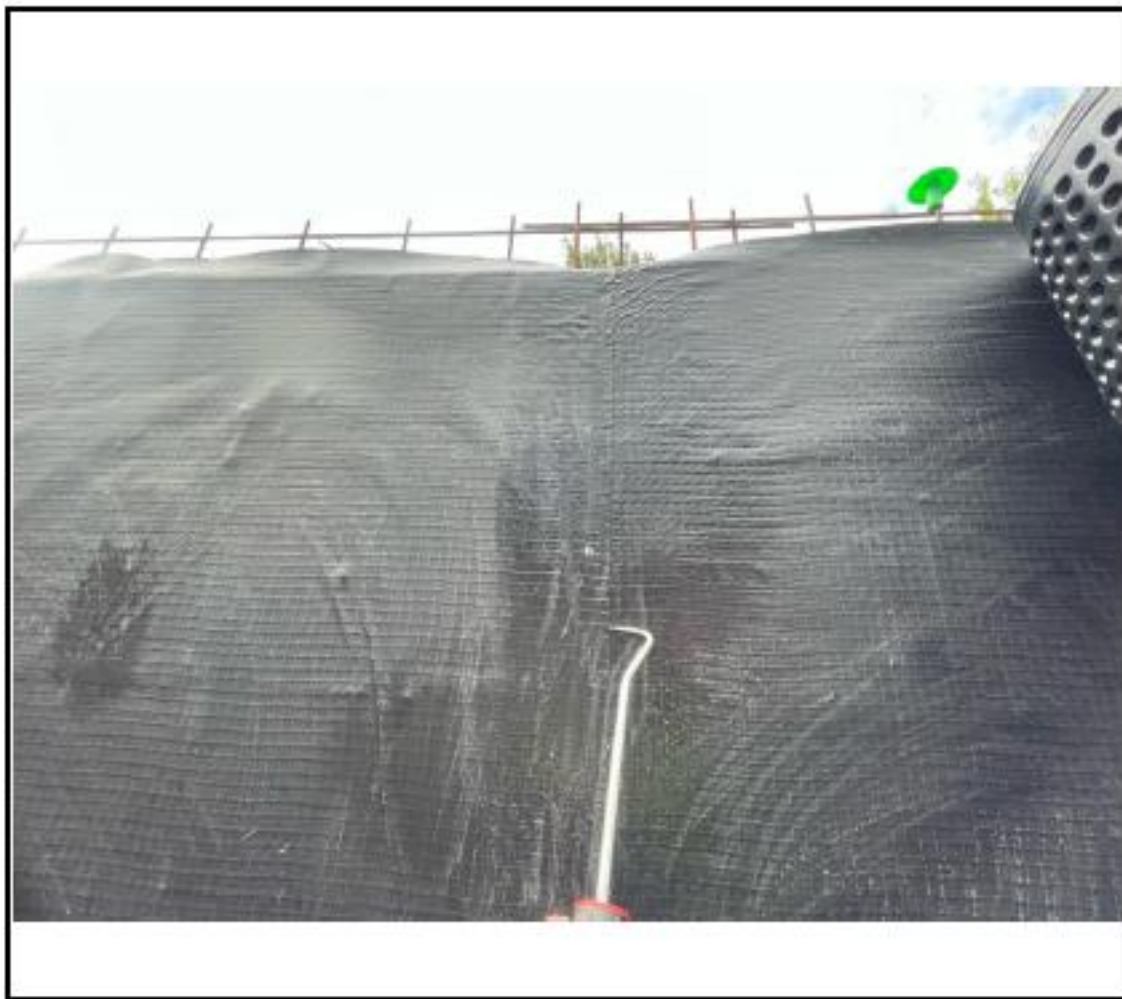
The overview photograph above shows a mechanical point stress test being conducted on a welded overlap of JUTA GP1 SAM, where a metal probe is run along the edges of the welds to identify any miswelds. There were 2 miswelds found during testing and these were brought to the attention of installers and remediated with extra patches of GP1 SAM

...: Mechanical Point Stress Test to all twin hand welded overlaps achieving minimum 100mm overlaps 2 faults found, remediated using Juta GP1 SAM

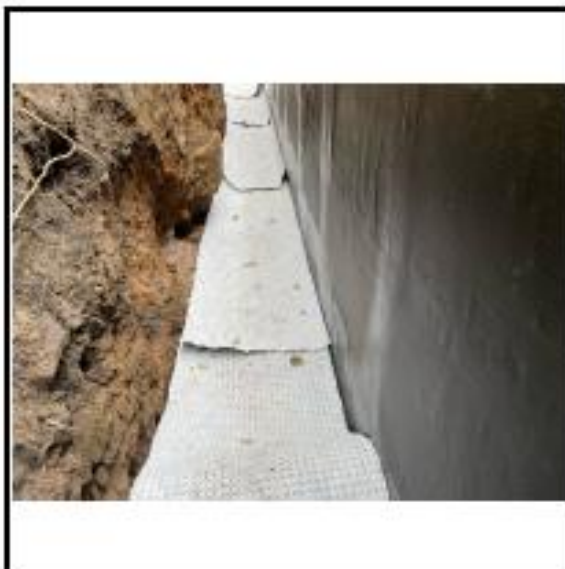
PD1700 Protection Drainage Boards

After the testing procedures were completed and any faults remediated, PD1700 Protection drainage were installed across the entire face of the basement walls. These protection boards will stop the damage of the GP1 SAM when backfilling but also work as another form of drainage.

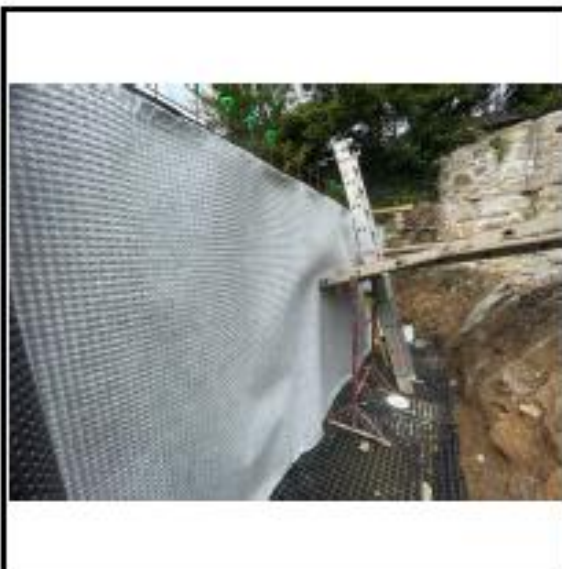
The drainage board are rolled out to cover the whole face of all the basement walls in preparation for backfilling and are tacked into position to hold them in place.
