## **BUILDING SURVEY REPORT AND REPAIR STATEMENT**

### **LOWER CHESHAM HALL BURY**

**Dated June 2020**

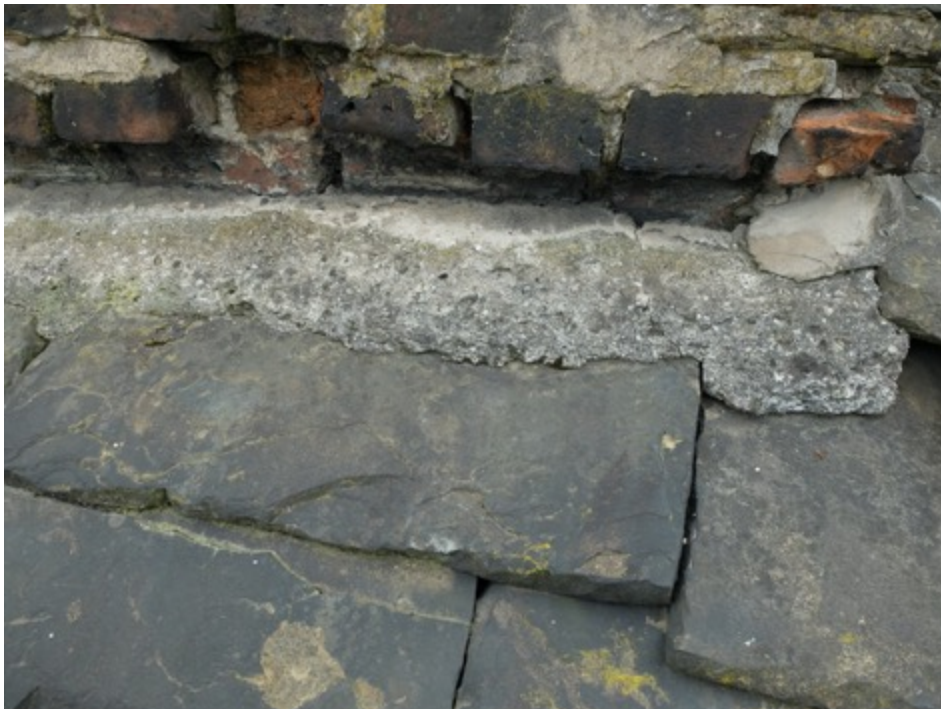
All four chimneys are of a brick construction. The oldest chimneys appear to be the two main chimneys which are located to the ridge of the main Hall. These would appear to have been constructed in an older handmade clay brick. There are three flues to each of the stacks and at the base of the stack there is a projecting brick course which is designed to provide weathering over the tops of the stone slates. It is evident that over time both chimneys have been repointed using sand and cement materials. On the left stack one of the clay chimney pots is missing and the flashing has been damaged. There is evidence of sulphate attack to both stacks and this has caused bulging in particular to the rear face of the left-hand stack.

Photo, failed mortar parging

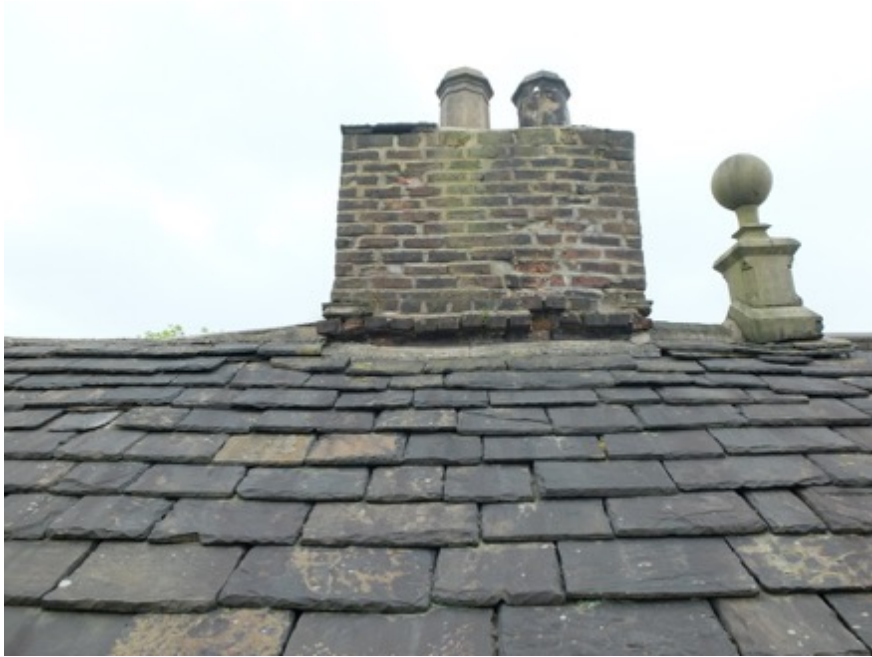
Photo, sulphate attack left chimney

Sulphate attack is where the chemicals generated from the past or present burning of fossil fuels react with the mortar to cause a volumetric expansion of the joints.

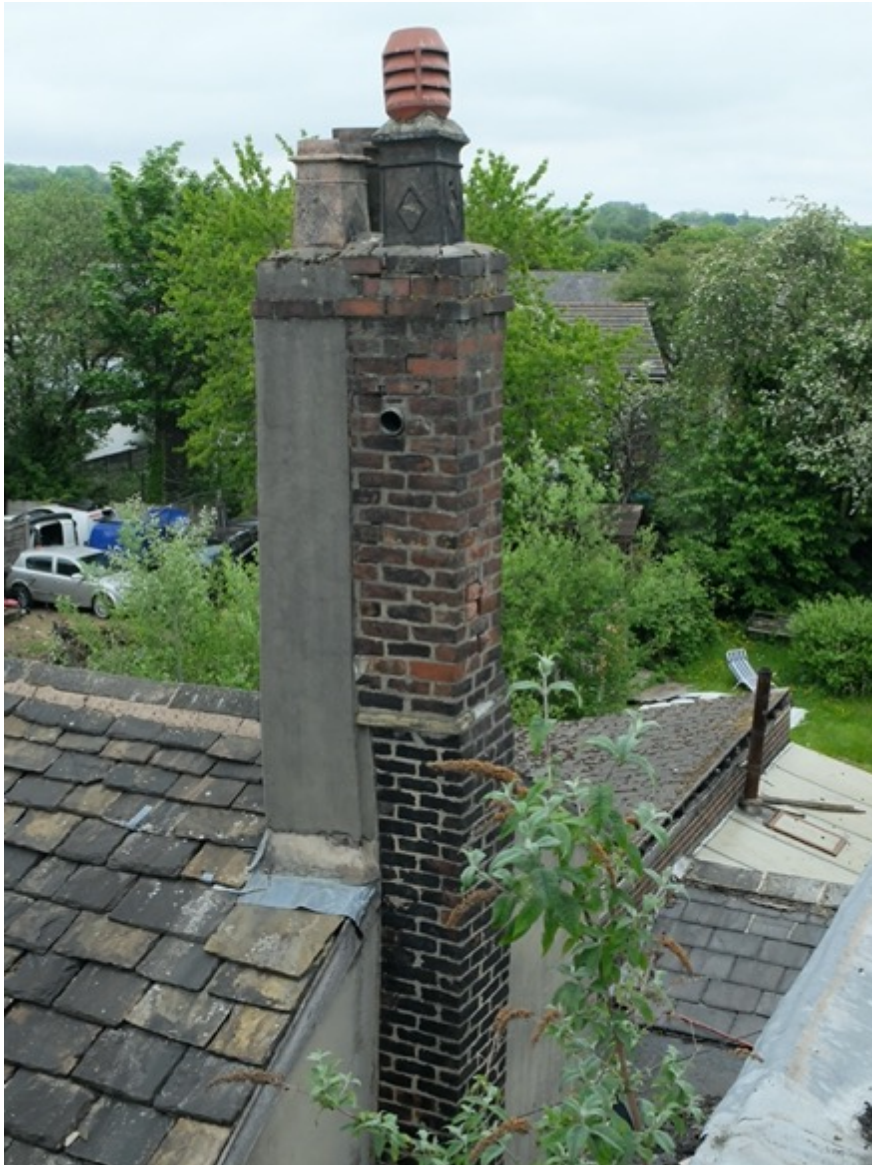
The brick chimney which services the fireplace within the dining room extends up the two-storey gable to the adjoining cottage to the same height as the chimney to the gable of the cottage. This is constructed in what appears to be two types of brick with an older brick being located to the lower levels. At high level there is evidence of some sulphate attack, deterioration of the flashing and some cracking within the brickwork.

Photo, chimney from dining room

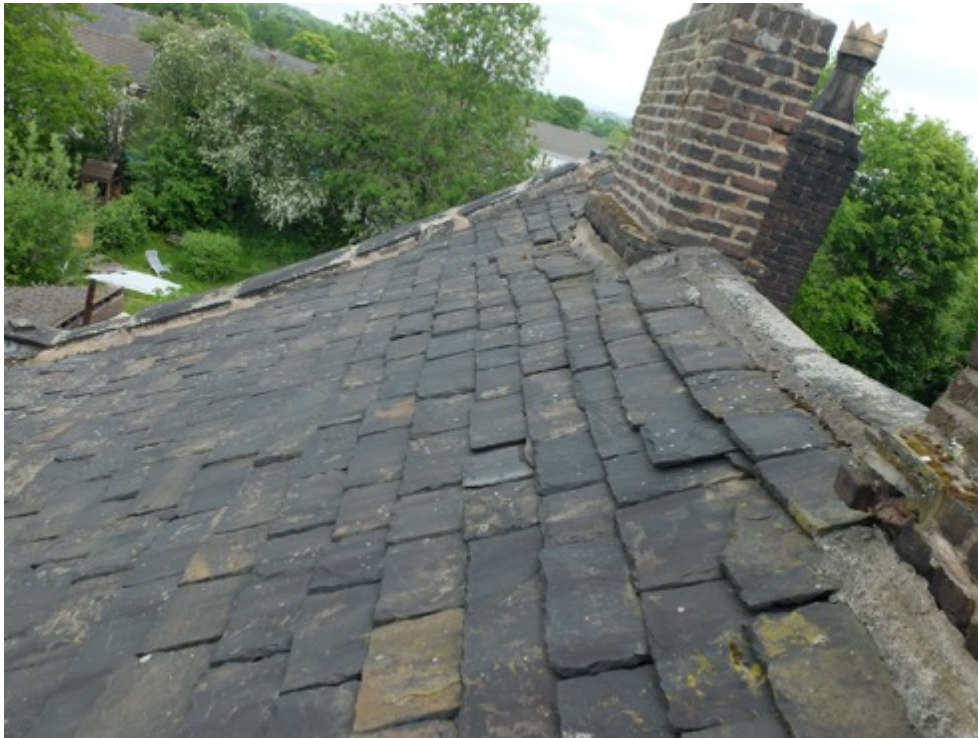
Photo, rear slope

One of the problems with this type of under felt is that it is impermeable and therefore will support condensation on the underside of the felt during colder weather and sometimes this can run down the slope of the roof causing staining to ceilings at the eaves. At present the level of insulation within the attic ceiling is not sufficient to prevent the heat from rising from the living quarters and therefore the roof space area will be somewhat warmer. However, should measures be undertaken to provide greater insulation levels at ceiling level as is recommended, the effect of this may support more condensation to the underside of the roof felt as the roof structure would be colder. This could encourage decay within timbers.

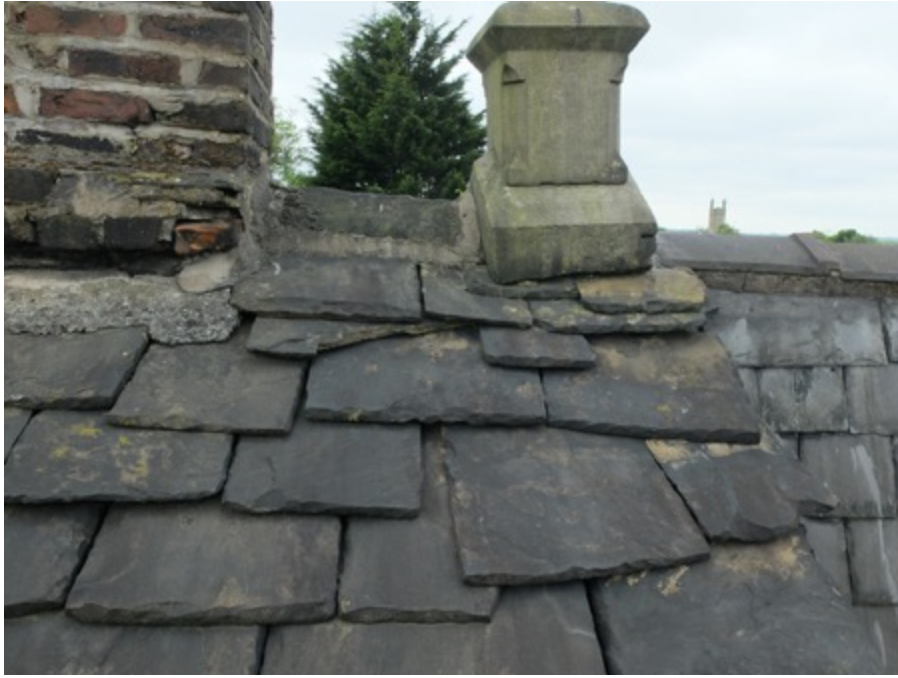
There is evidence of slipped broken and tabbed stone slates to both slopes.

Photo, slipped tiles to rear

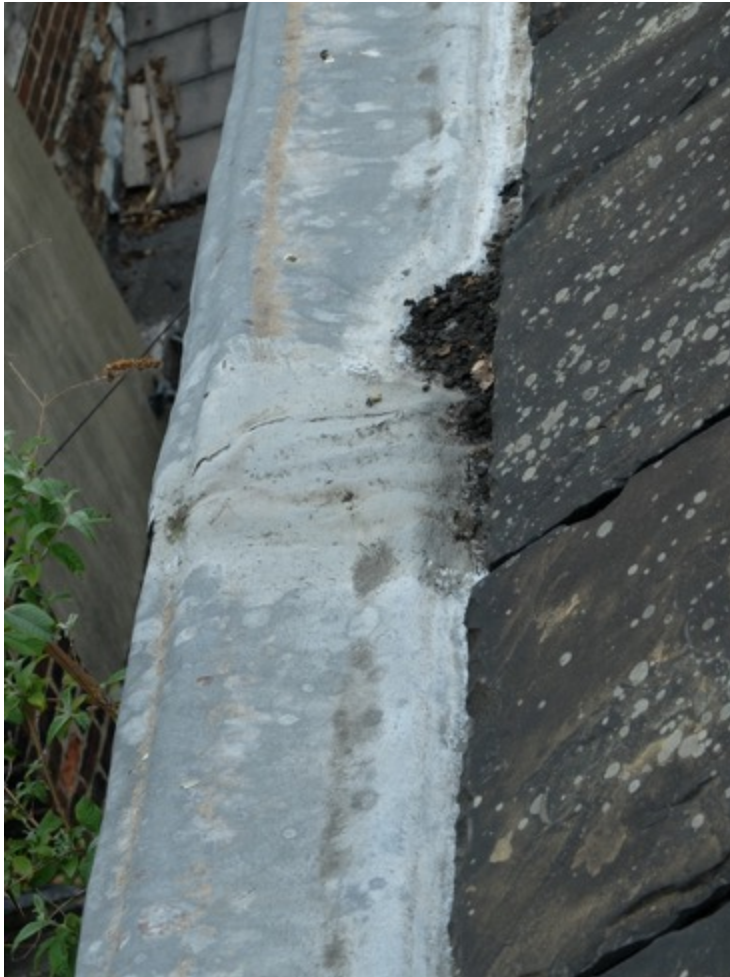
Along the rear elevation the roof discharges into lead lined stone gutters. It would appear that the lead lining has been laid in one complete length which is too long to restrict thermal movement within the lead sheet. Due to excessive thermal movement the lead sheet has split and will allow water ingress into the building.

Photo, ingress at joint in rear gutter

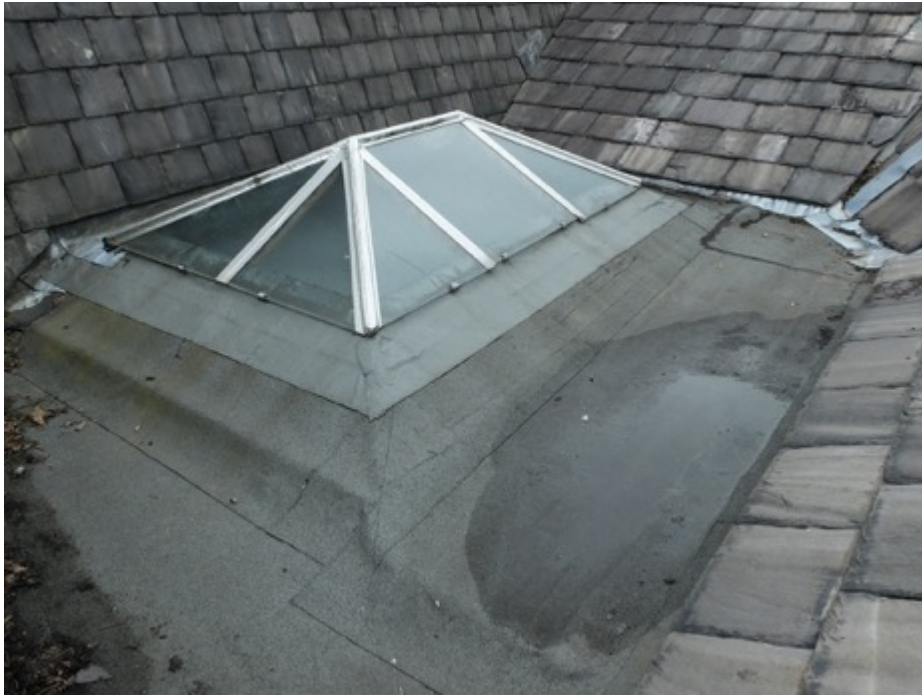
It was noted that rear gutter services the main rear slope roof and flat roof of the adjoining building, however, there is no visible rainwater outlet to any sections of the gutter. The rainwater appears to flow over the stone gutter and down the rear elevation walls.

Photo, flat roof to adjoining buildings discharges into gutter on rear elevation

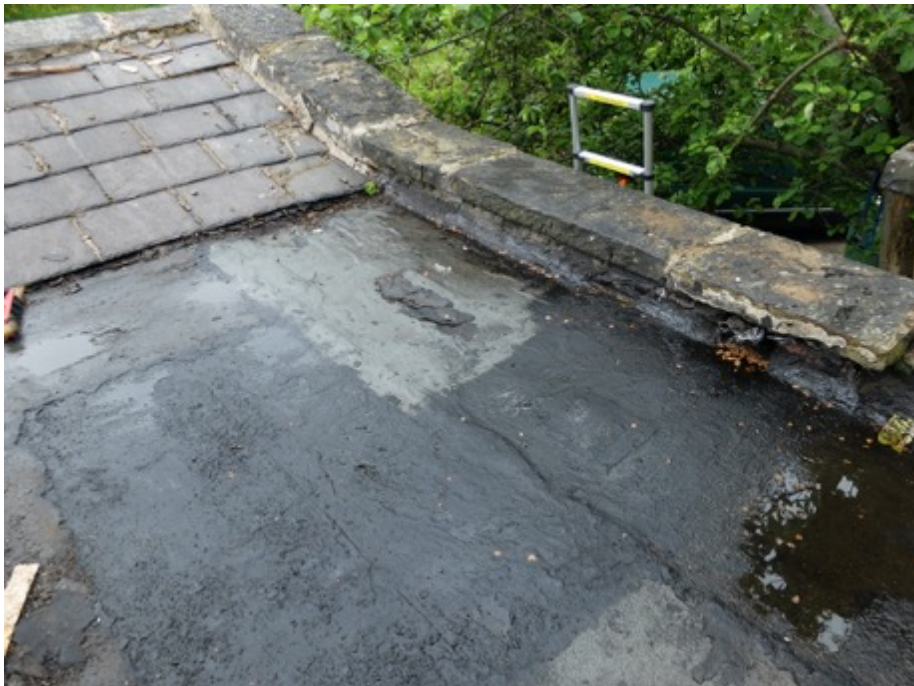
The felt up stand of the flat roof with the cottage was poor. The outlet detail on the front elevation from the flat roof was poor.

Photo, flat roof and upstands

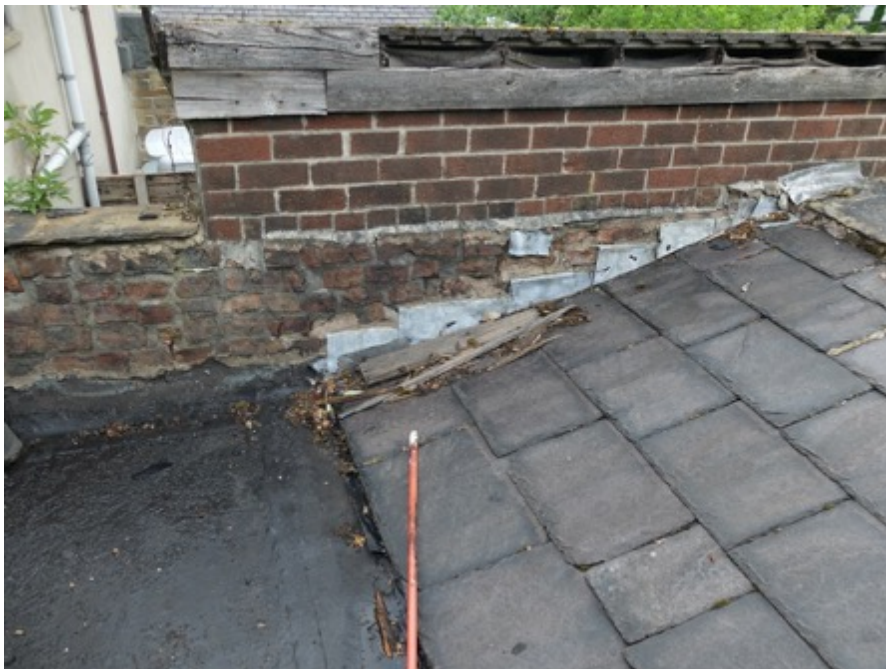
There was evidence of broken and tabbed slates to both slated slopes. The slated abutment detail with the rear cottage is poor.

Photo, abutment with wall

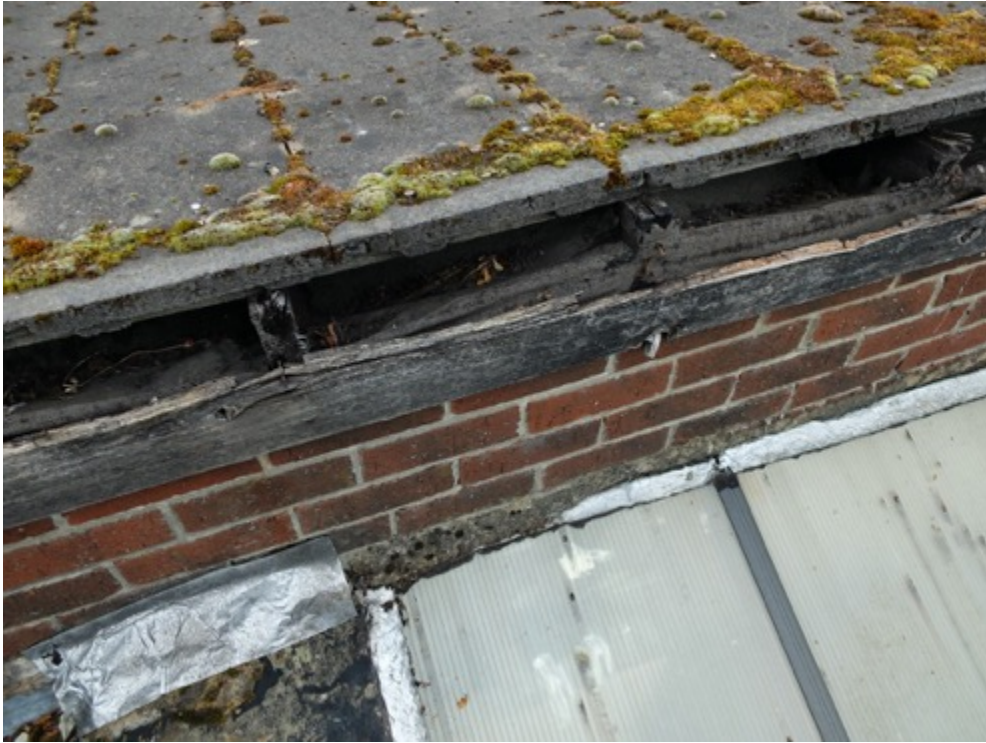
The roof over the garage was a modern concrete interlocking tile. It was noted that the verge and ridge details were open, and this had allowed the sun to cause damage to the exposed roofing felt. Timber decay was also evident in barge board and fascias.

Photo, decay to eaves timbers

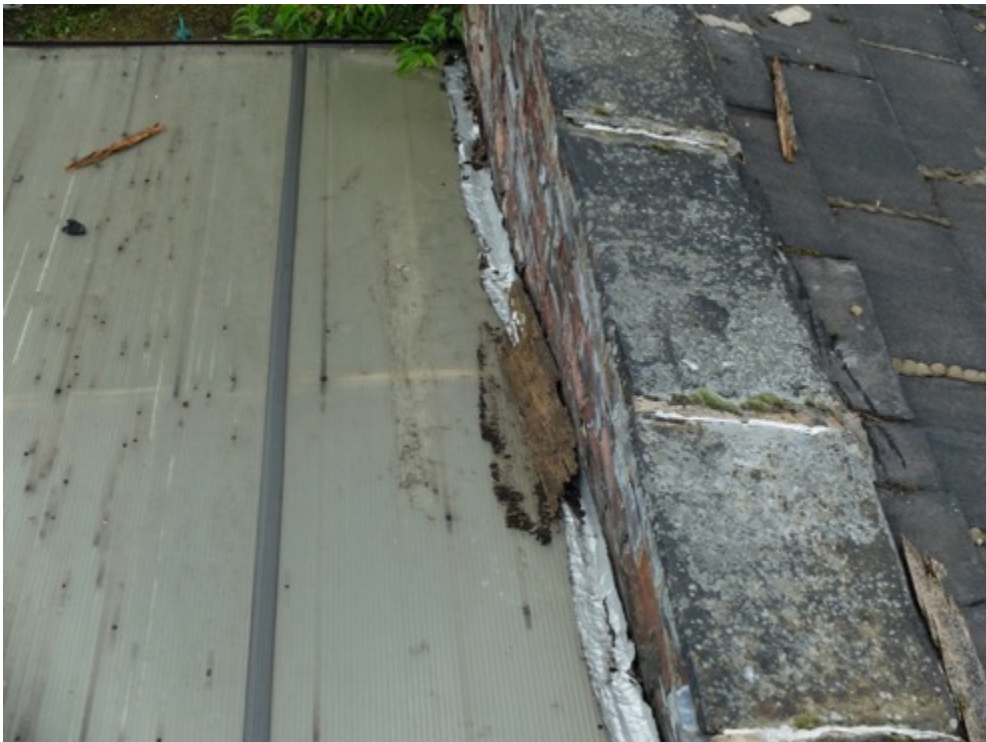
The weathering to the roof over the workshop was poor

Photo, workshop roof

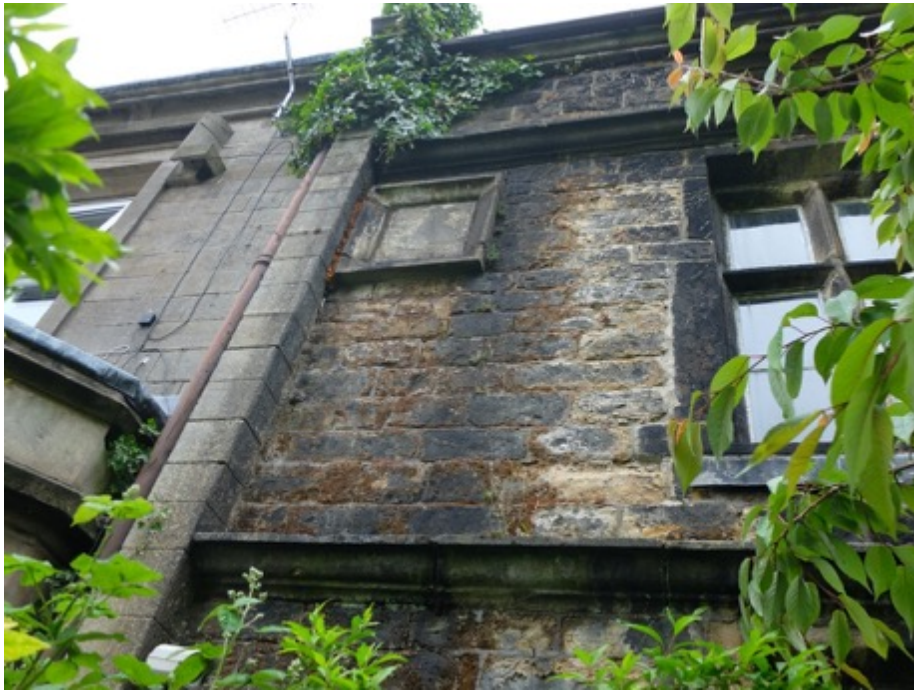
On the front and rear elevations of the main Hall there are no rainwater outlets to discharge water from the ground and water is percolating over the edge of the plastic gutter to the front and lead lined stone gutter to the rear.

Photo, water percolating down from front gutter

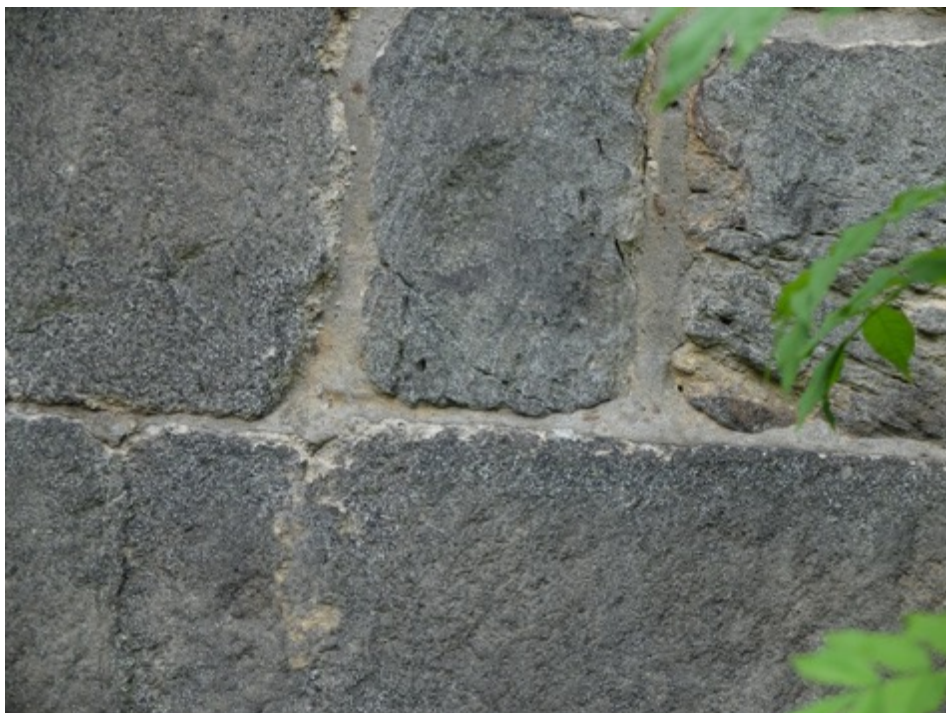
There is evidence of repointing to all areas using a hard sand and cement material.

Photo, examples of sand and cement pointing

The general principle in relation to the use of mortar with porous historic building materials is that the mortar and render should act as a valve and aid the escape of residual moisture when the masonry structure gets wet. Hard cementitious mortars when used, serve to trap residual moisture within the masonry structure and accelerate frost damage and decay during the winter freeze and thaw cycles.

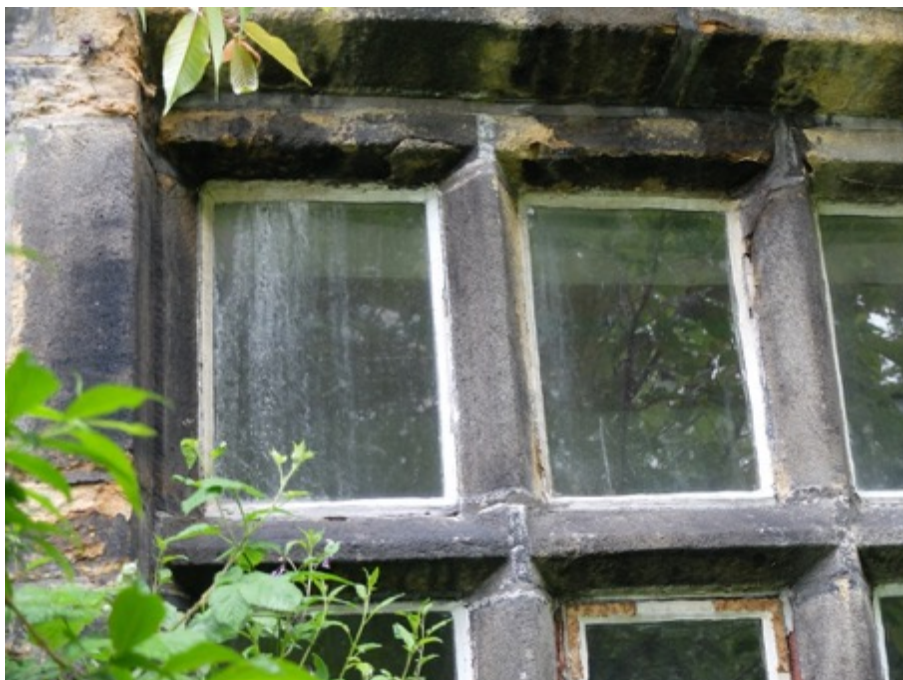
There is some cracking evident to the stone mullions. The cracking is evident near the vertical joints of the mullions which is indicative of corrosion and expansion of ferrous metal pins. These would require careful removal and indent repairs or replacement of the stone sections .

Photo, cracking of stone mullions

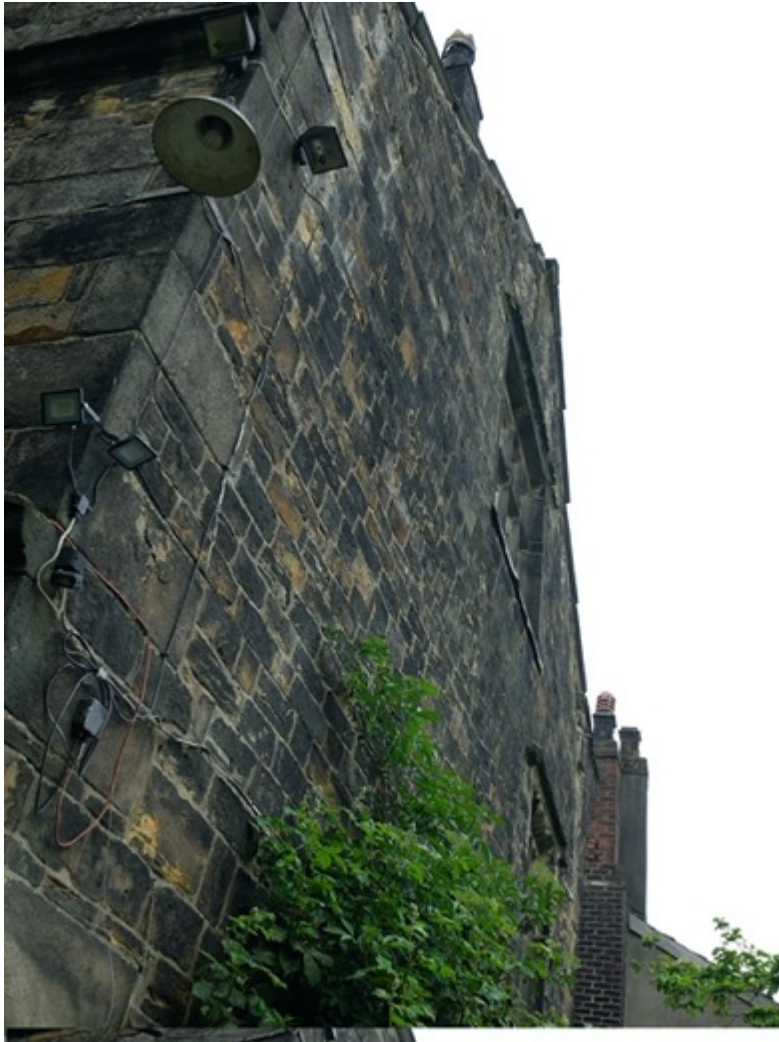
There is a significant outward bow within the gable this extends from the front and rear corners and is more significant at first floor level. The likely cause of this is due to the gable wall not being restrained by the floors, as the timber joists at first and second floor levels bear directly onto the front and rear elevations therefore providing no lateral restraint to the gable.

Photo, outward bow to gable

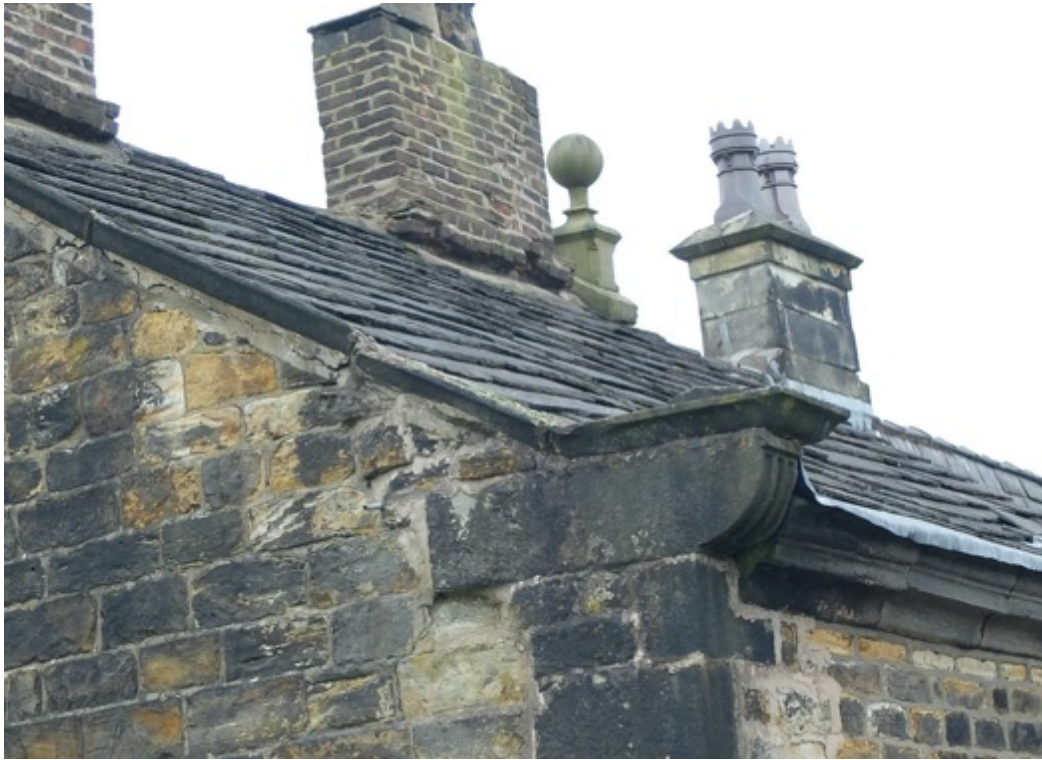
Photo, cracking around rear kneeler

The ball finials to the centre pike and rear kneeler are missing. There is still evidence of a ferrous metal dowel noted to 1 of the remaining kneelers which indicates that the finials may have been lost due to cracking caused by corrosion of the dowel.

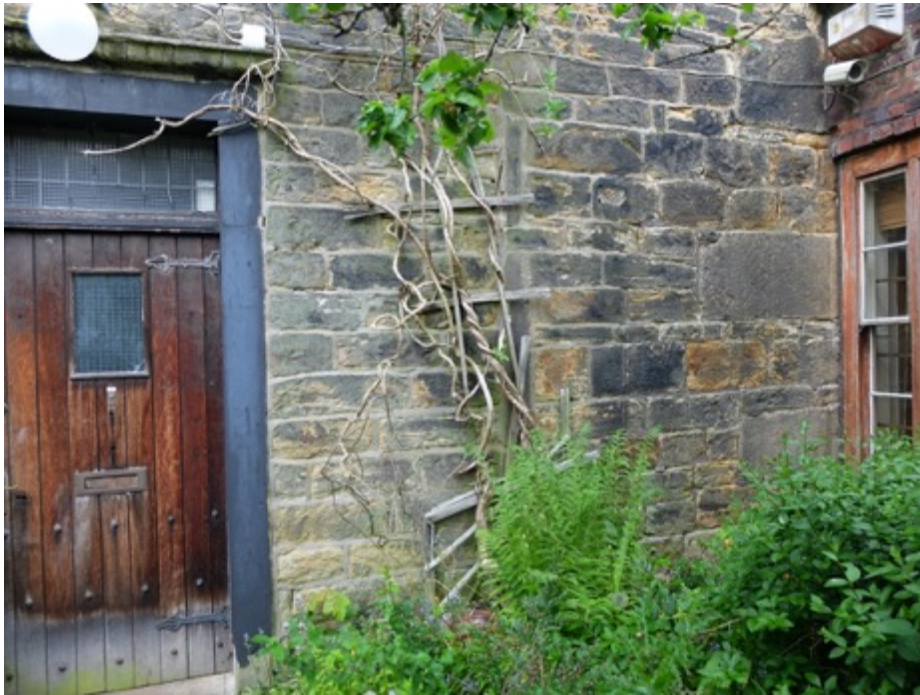
At ground floor level there is evidence to suggest an original door opening which was directly beneath the window to the first floor has been moved towards the front elevation. The new stonework panel is slightly different and has been cement strap pointed, I am informed that this alteration was made around 1910 when the original building was split into dwellings.

Photo, original door opening

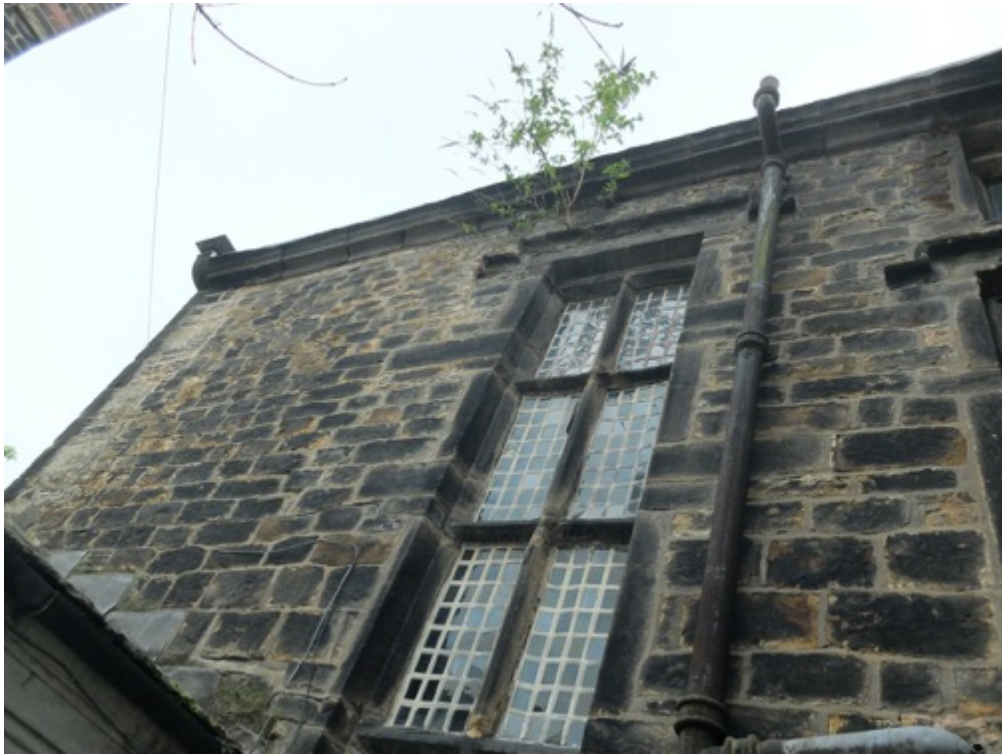
There was large buddleia growth around the stone hood mould above the high level window which has been fuelled by water flowing from the gutters.

Photo, plant growth rear elevation

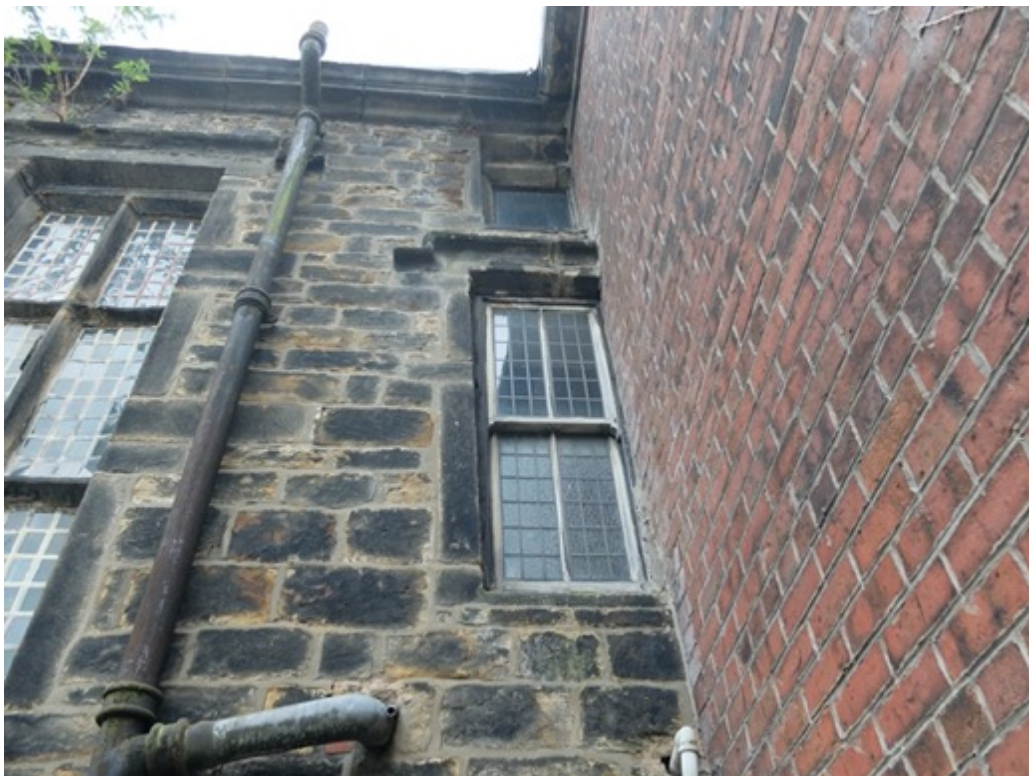
Photo, overflowing of gutters

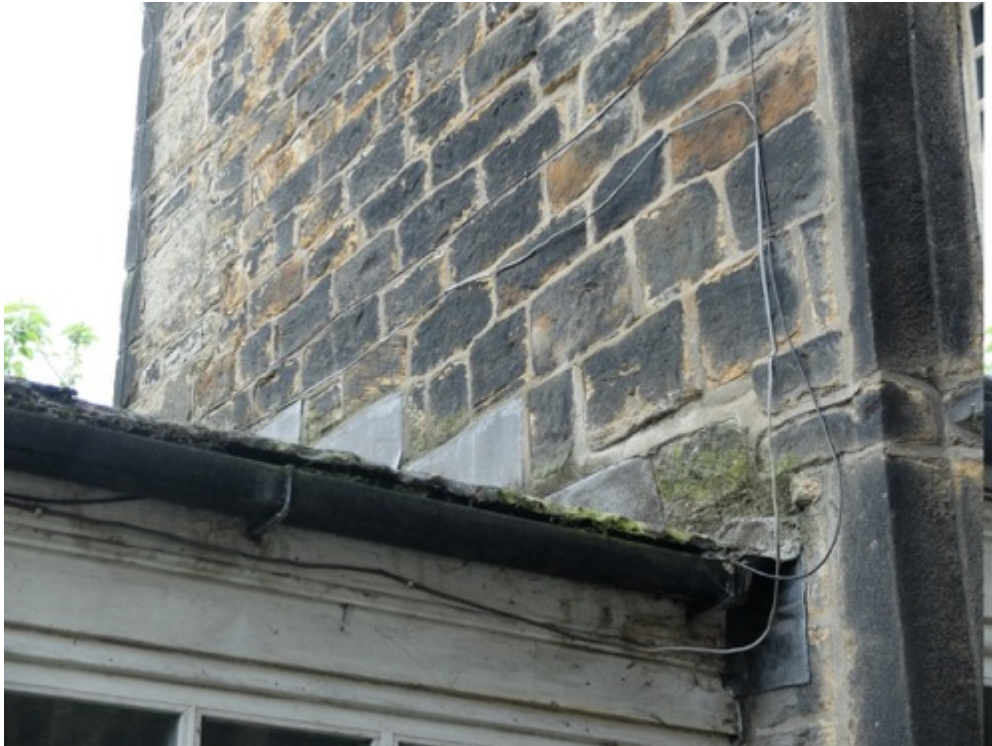
There was stepped cracking and movement within the stonework to wall areas directly above the roof over the dining room. In this location a section of ground floor wall below has been removed and the wall above is now supported on timber beams. There is concern that timber decay within the beams is causing this movement and further investigation is required.

Photo, stepped cracking over roof

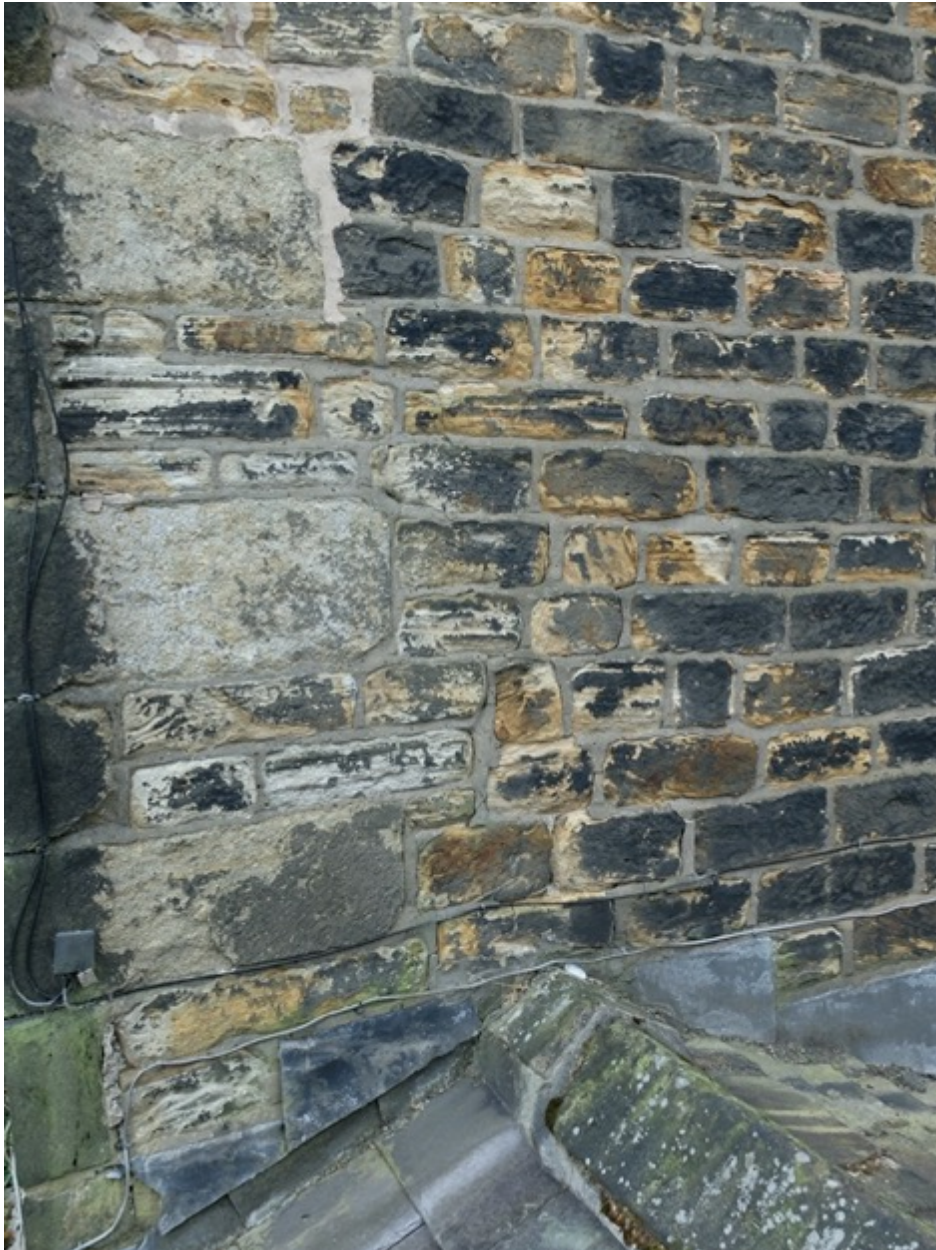
Photo, stepped cracking over dining room

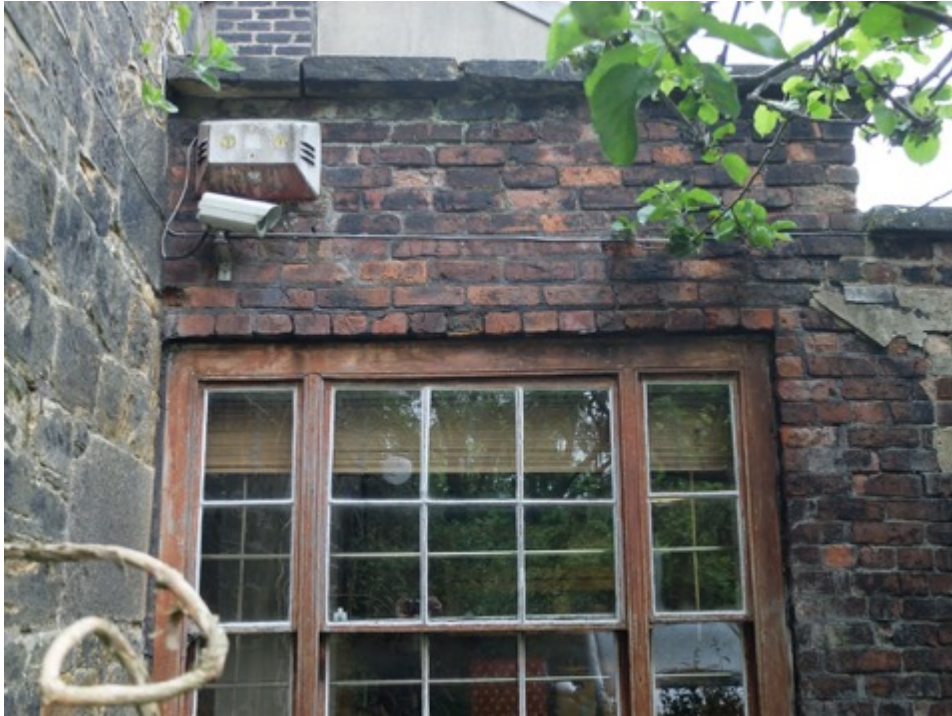
There is limited evidence of a lintel over the large window to the kitchen and there is concern that this may be supported onto the timber window which is in a poor condition.

Photo, Large window over kitchen

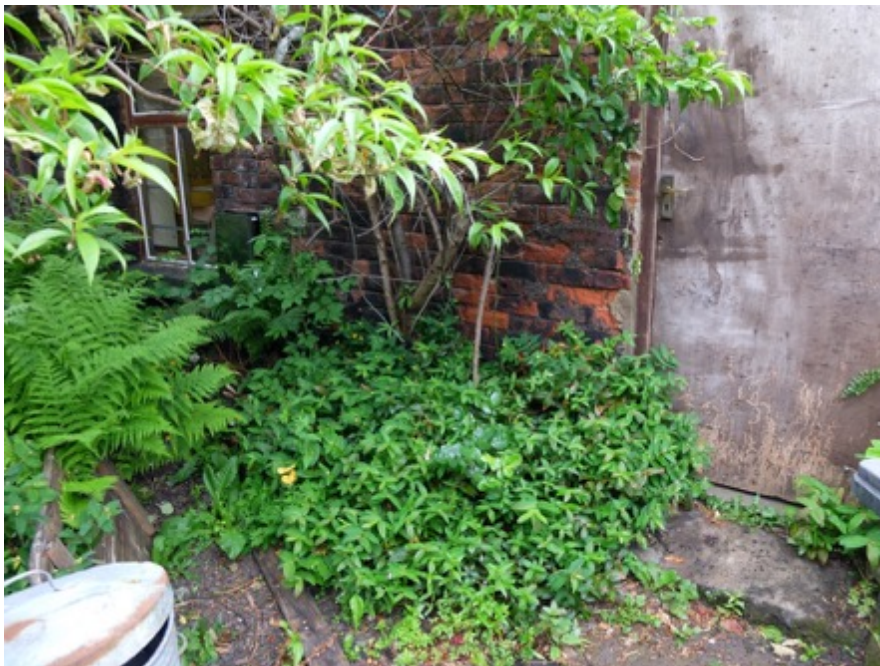
There is evidence of frost damaged brickwork and replacements are necessary.

Photo, frost damaged brickwork

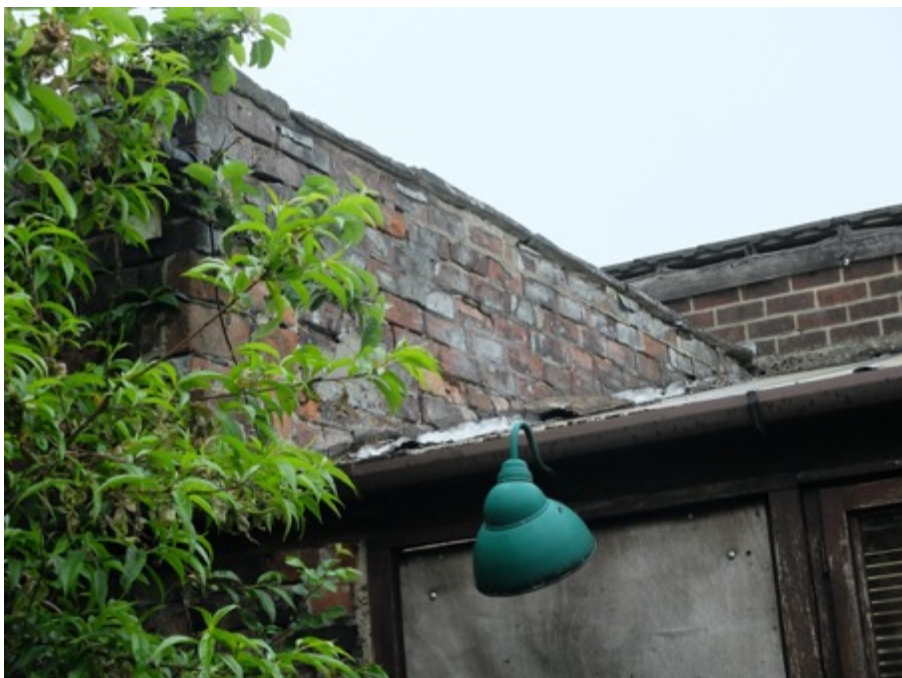
At high level there is considerable frost damage to the roof parapet wall which extends over the roof to the workshop. This is constructed in original brickwork and is capped with a rough York stone coping. The mortar repointing would appear to be too hard for the porosity of the brick and is accelerating damage and decay.

Photo, Frost damage and poor brickwork to high level wall

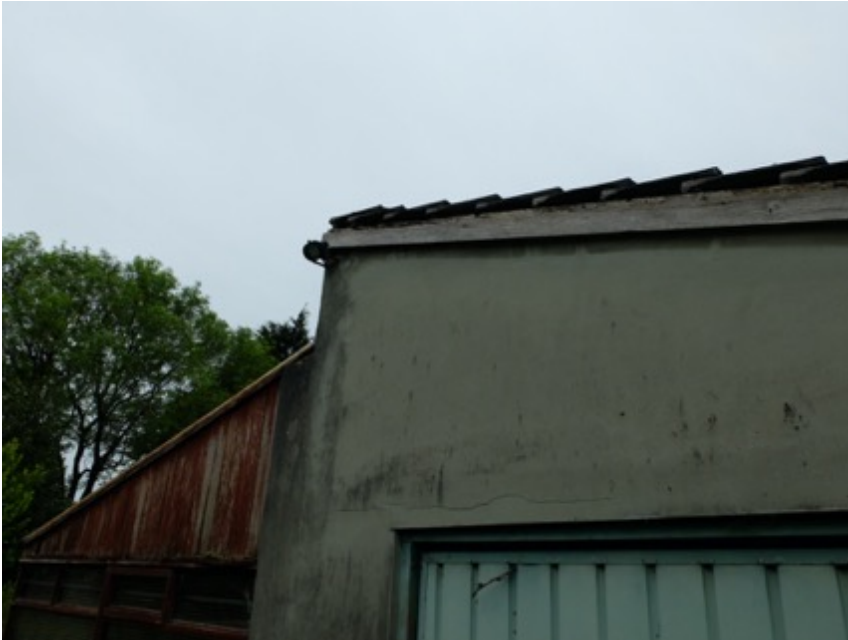
There is evidence of cracking to the render over the garage door this would require further investigation.

Photo, cracking over garage

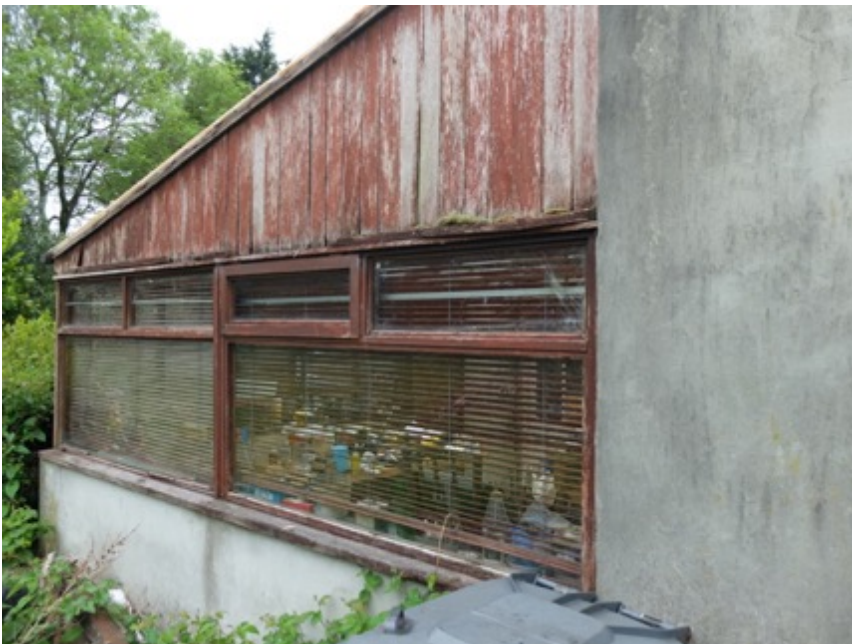
The upper sections of the workshop above the windows have been formed using timber frame and vertical softwood match board cladding. The drip detail at the head of the windows poor and provides no water run-off. This has promoted decay within the timber sections.

Photo, timber decay to window and matchboard

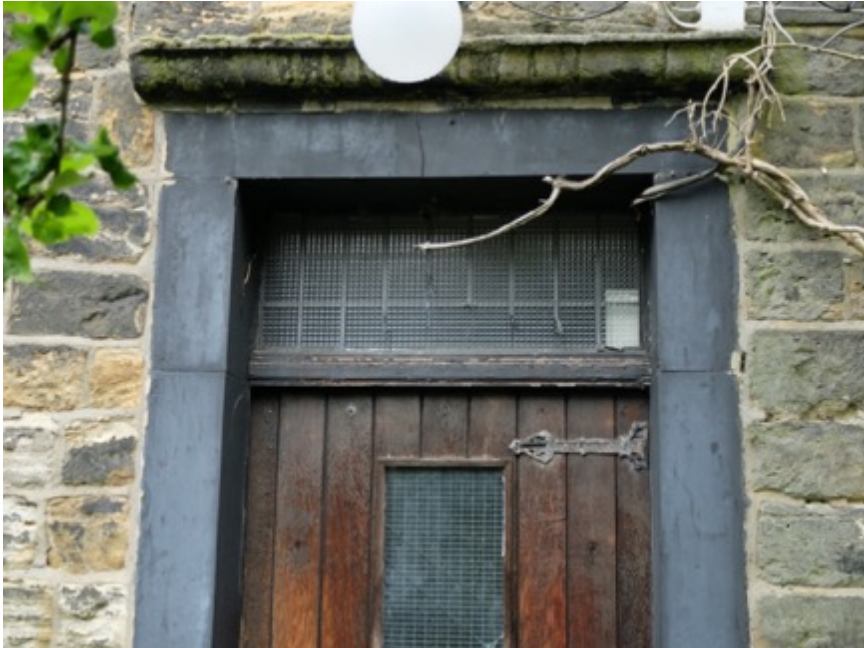
Photo, stuck on lead tape and crack to lintel

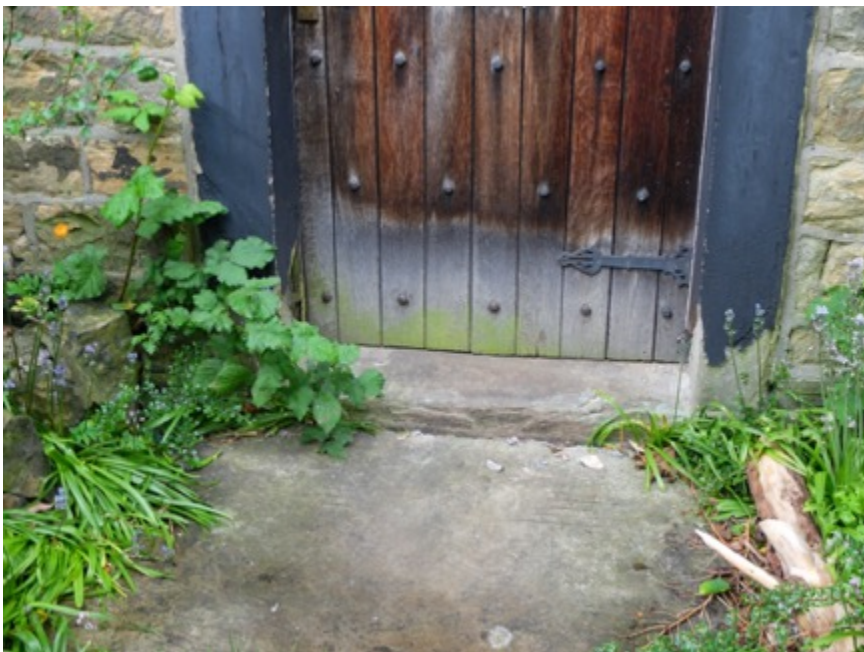
There is evidence of lichen moss at the base of the door. This requires decoration and repair.

Photo, Erosion of stone and lichen moss to main door

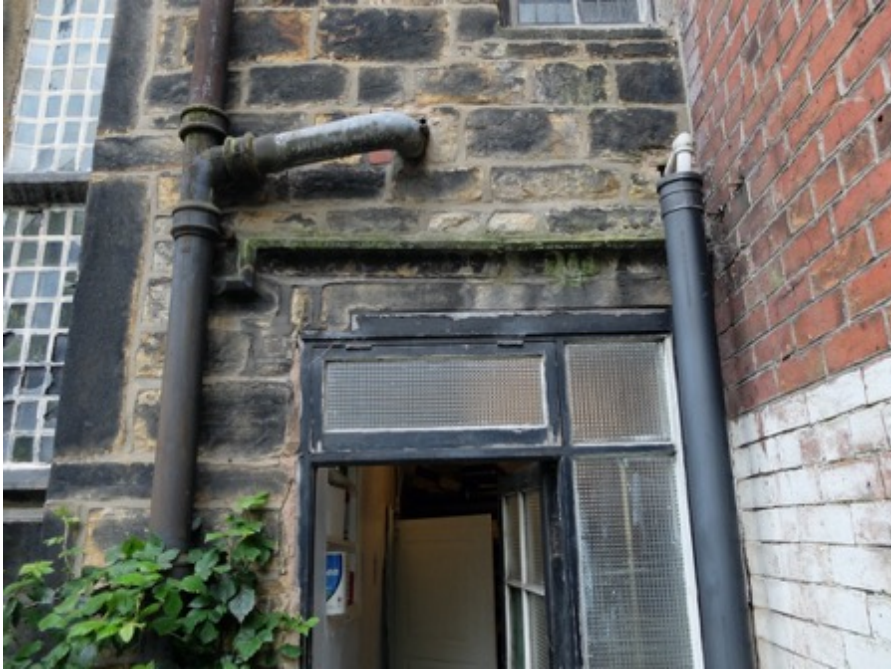
The rear door to the hall would appear to be contemporary to the building has been installed almost flush with the external surface of the elevation. This is a flag frame and has a crudely built brick panel beneath the window section. This is in a poor condition and requires maintenance and repair.

Photo, rear door

There was no door threshold and water will blow through the underside of the door in wet and windy conditions.

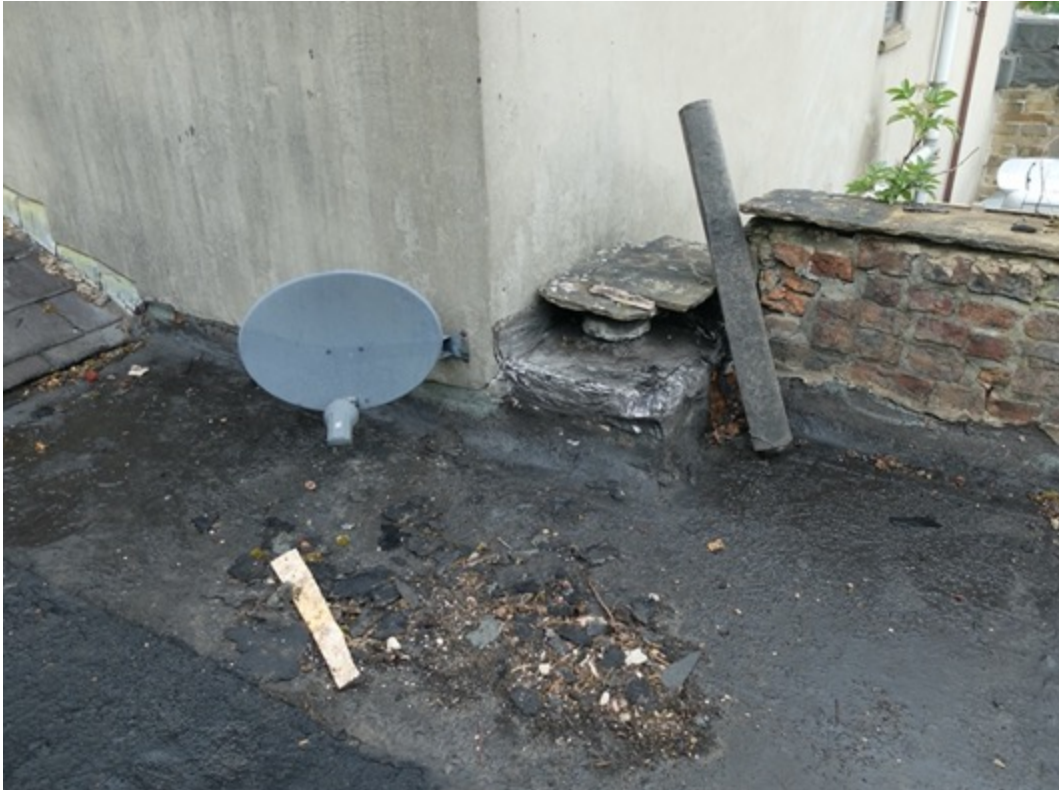
In the kitchen the flue is being used to extract cooking air via a roof vent above. The weathering of the vent was noted to be poor.

Photo, weathering around cooker extract to roof
