## **BUILDING SURVEY REPORT AND REPAIR STATEMENT**

### **LOWER CHESHAM HALL BURY**

**Dated June 2020**

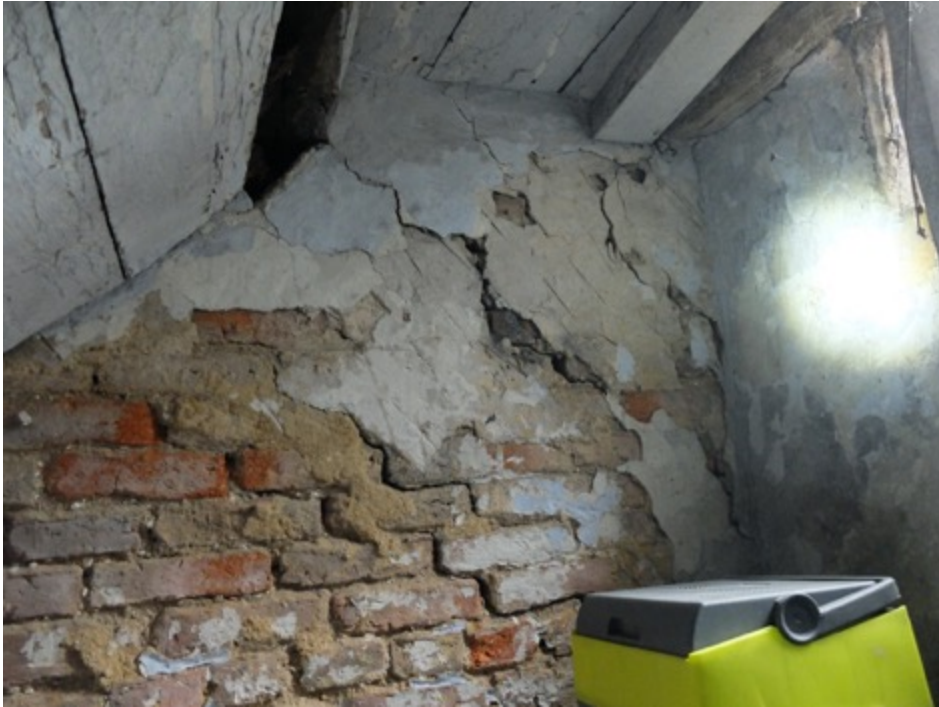
On the left hand wall under the stairs, there is evidence of settlement to the brickwork. This could be contributory to movement to the door casing to the lounge.

Photo, cracking to brickwork further investigation required

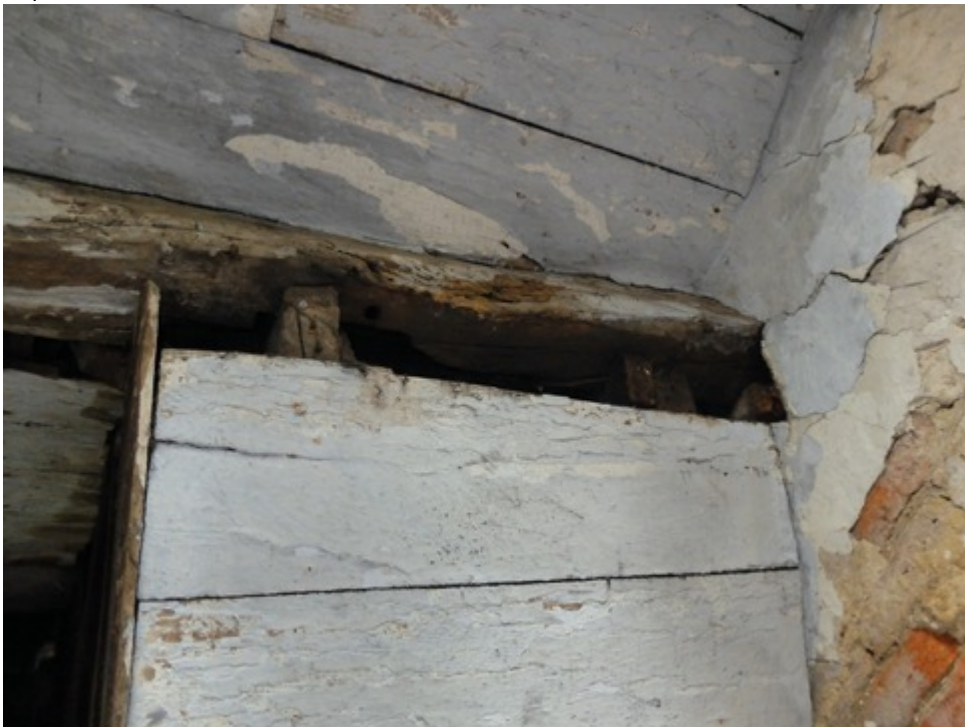
There is evidence of some insect decay to the stair support timbers and further analysis and investigation is required.

Photo, decay to stair timbers

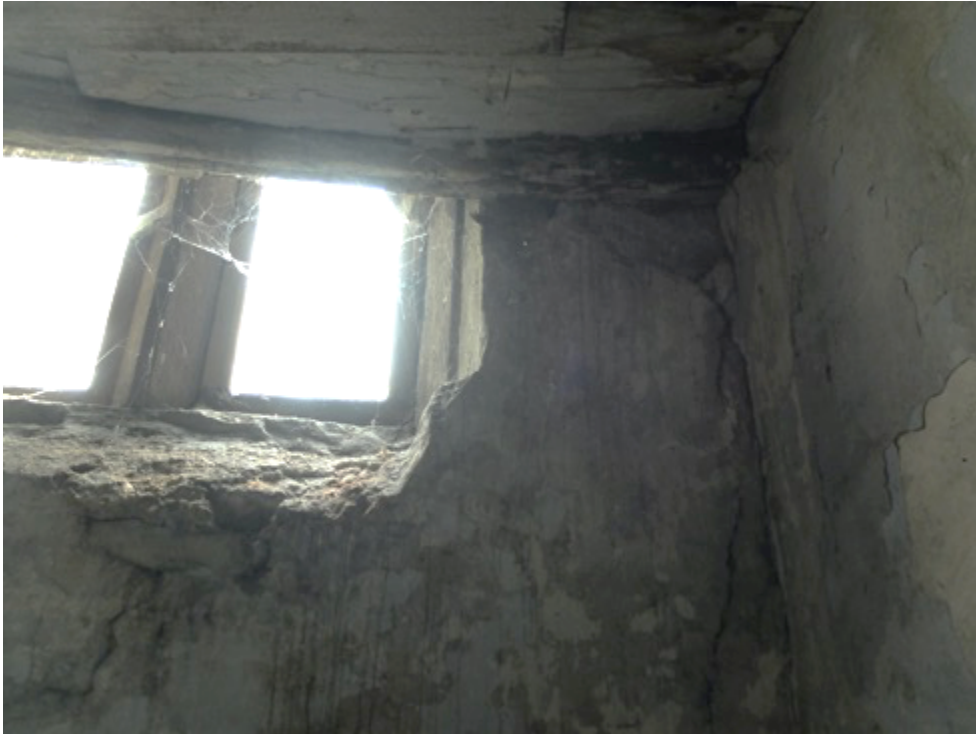
There is decay to the bearer of the half landing which abuts the rear elevation wall.

Photo, half landing investigation and repair

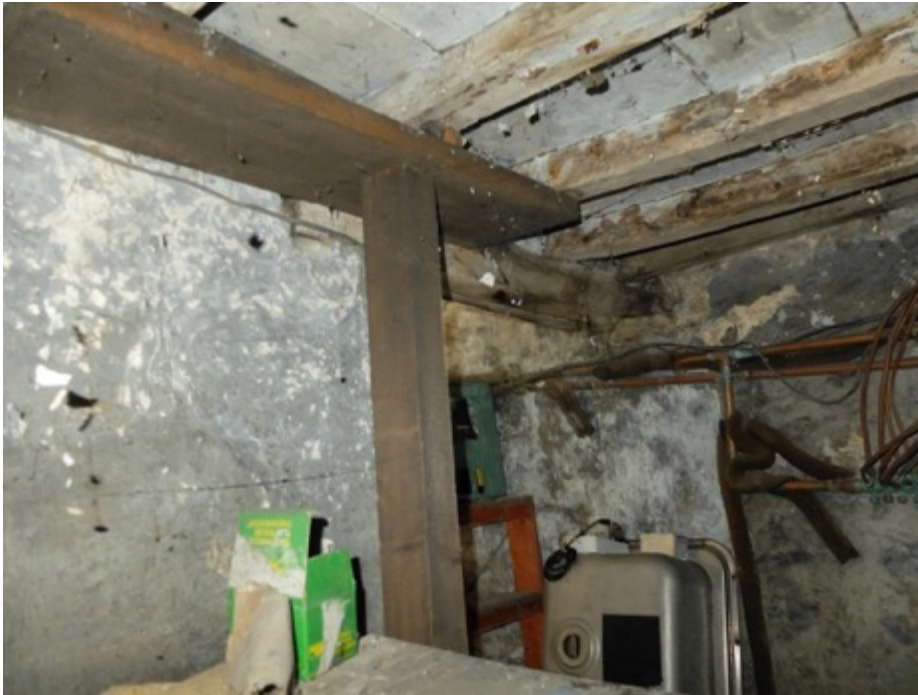
Timber props have been used to provide extra support to the floors. The bases of the props are in contact with the cold damp floor and will be prone to timber decay.

Photo, timber props supporting floors

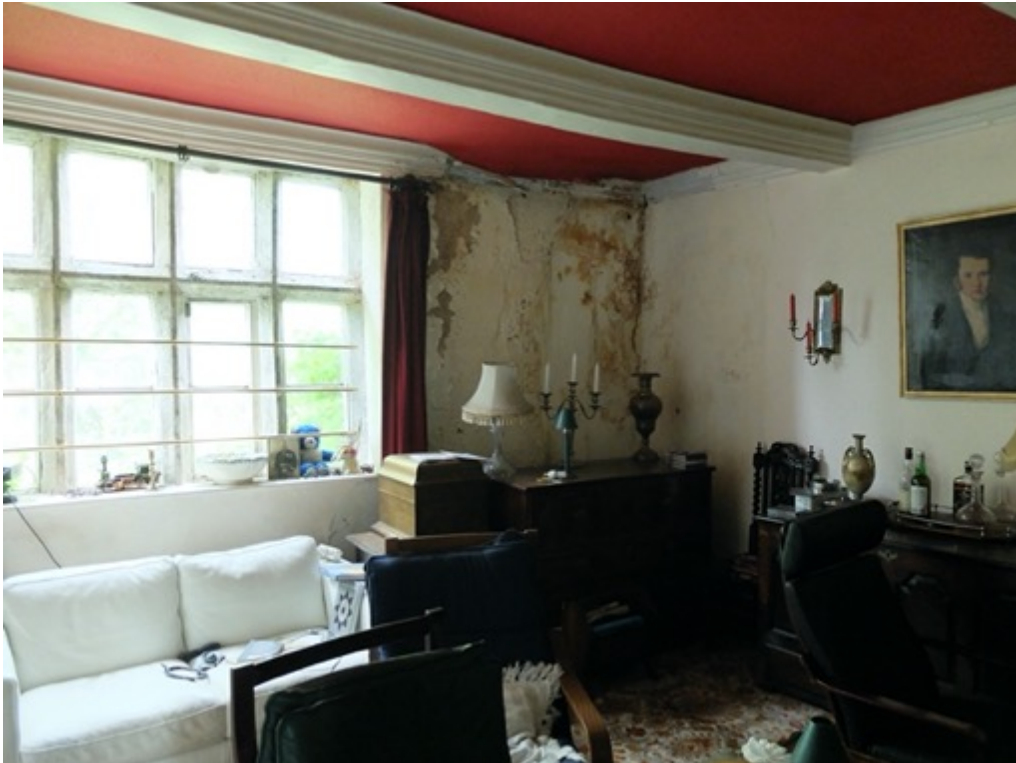
Photo, lounge with leaks to front corner

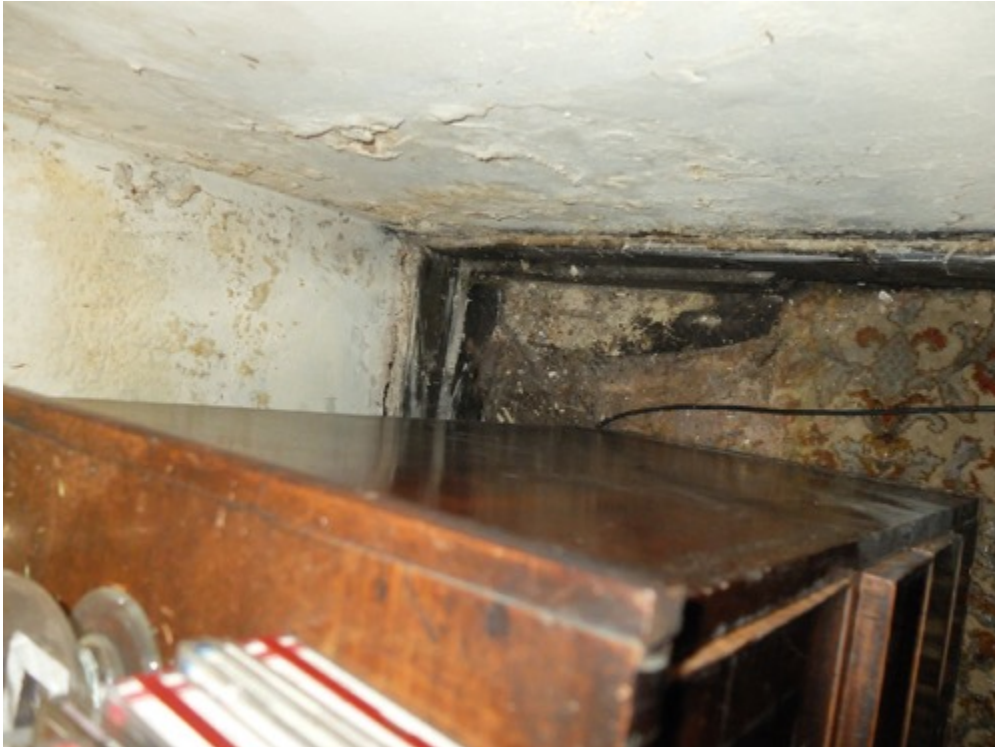
The floors are of a suspended timber construction, the joists appear to run from front to rear. In the front left hand corner due to leaks there is evidence of plants growing on the surface of the floorboards and urgent repairs and investigation is required.

Photo, plant growing on floor front left corner

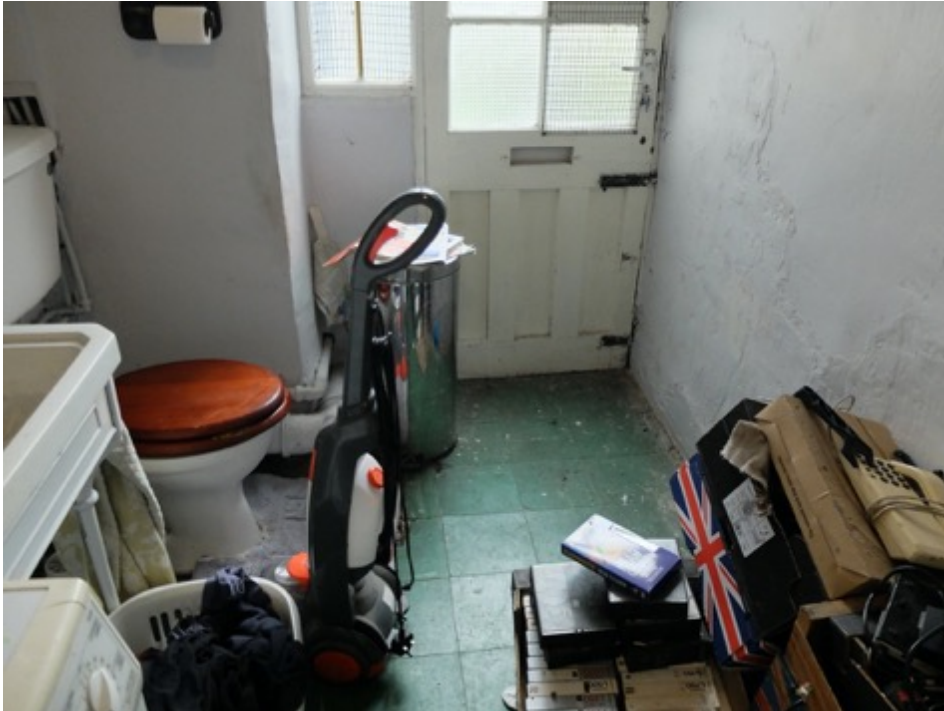
Walls would appear to be hard plaster and masonry. There is evidence of low-level deterioration plaster along the right-hand wall where repairs have been undertaken.

Photo, deterioration of wall plaster right wall

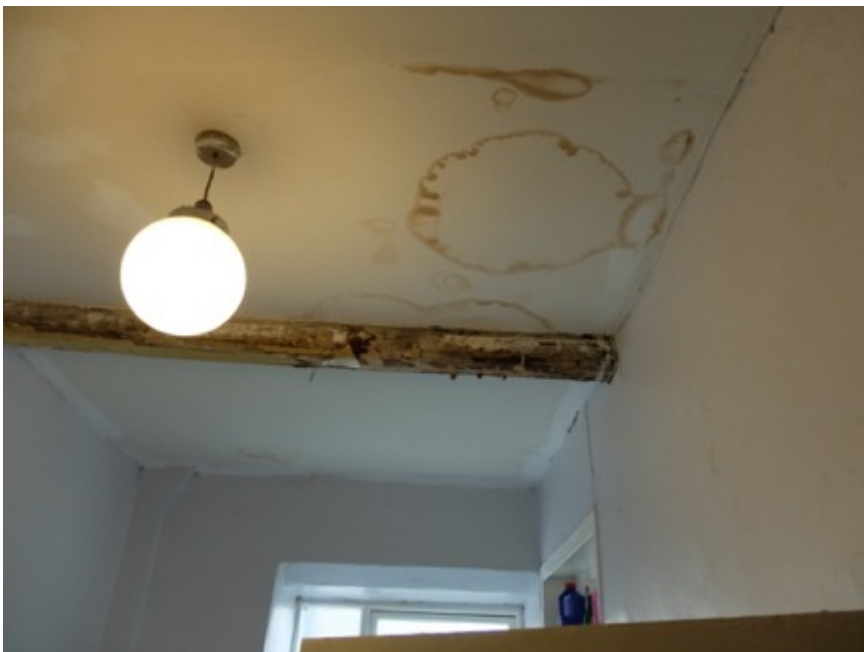
There are two down stand timber ceiling beams. The ceiling panels either side of these are plasterboard and there is evidence of staining due to water leaks as this is directly below the bathroom.

Photo, leaks to ceilings

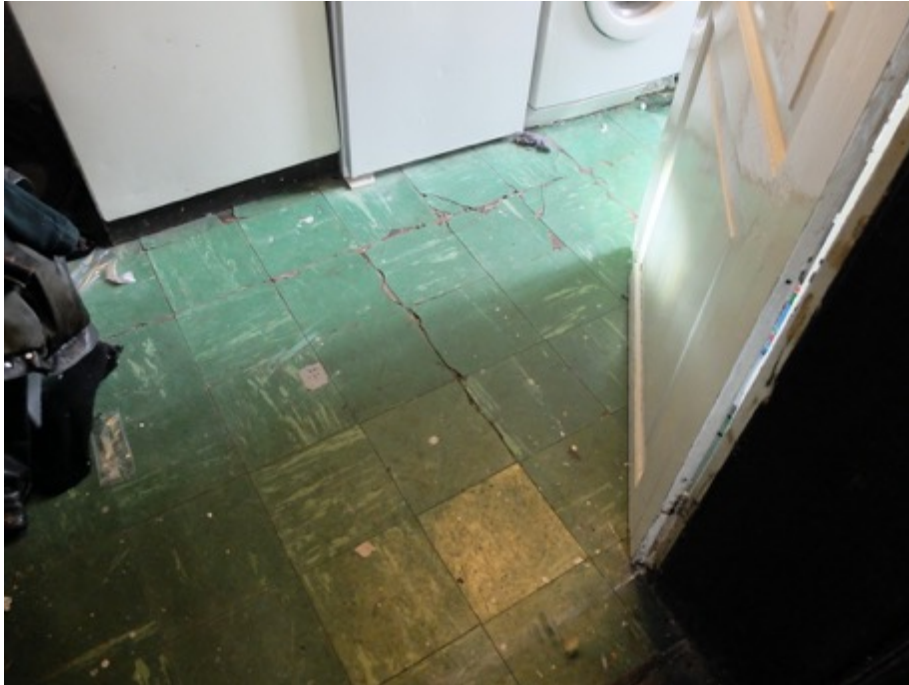
The cracking is indicative of the joints between York stone flags. York stone flags are likely to be the original materials for the floors to kitchen and domestic areas for a building of this age. Further investigation is required.

Photo, cracking to floors

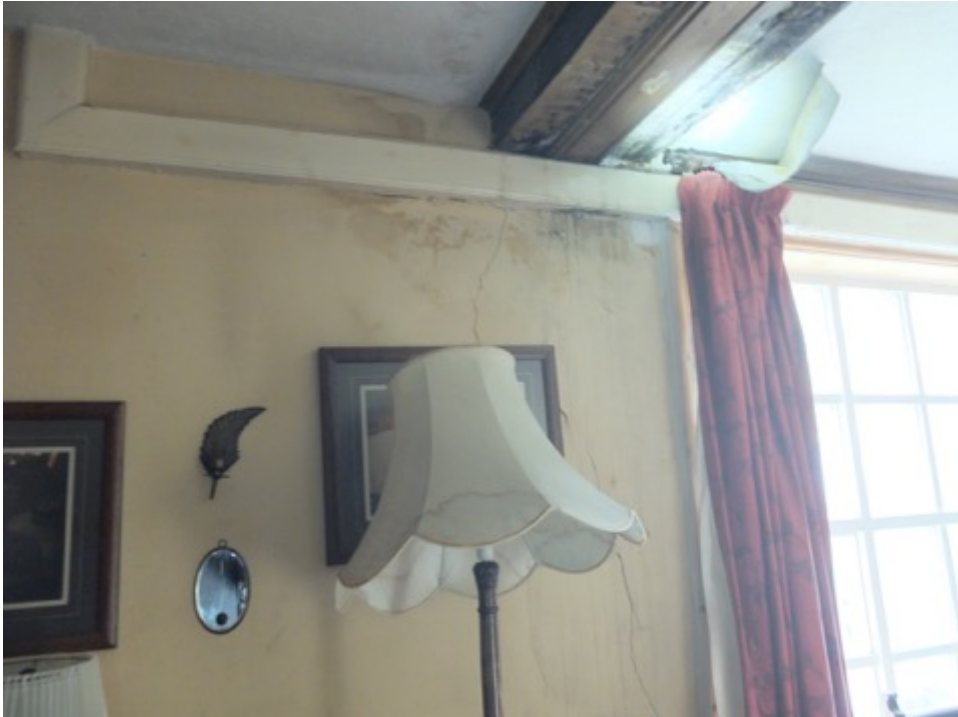
The walls would appear to be hard plastered and painted, there is staining and deterioration evident to several walls most prominently to the left-hand wall at the intersection with the original rear elevation where there is evidence of cracking. This is in the location where the original rear elevation wall has been removed and is now supported on two timber beams.

Photo, cracking under beams

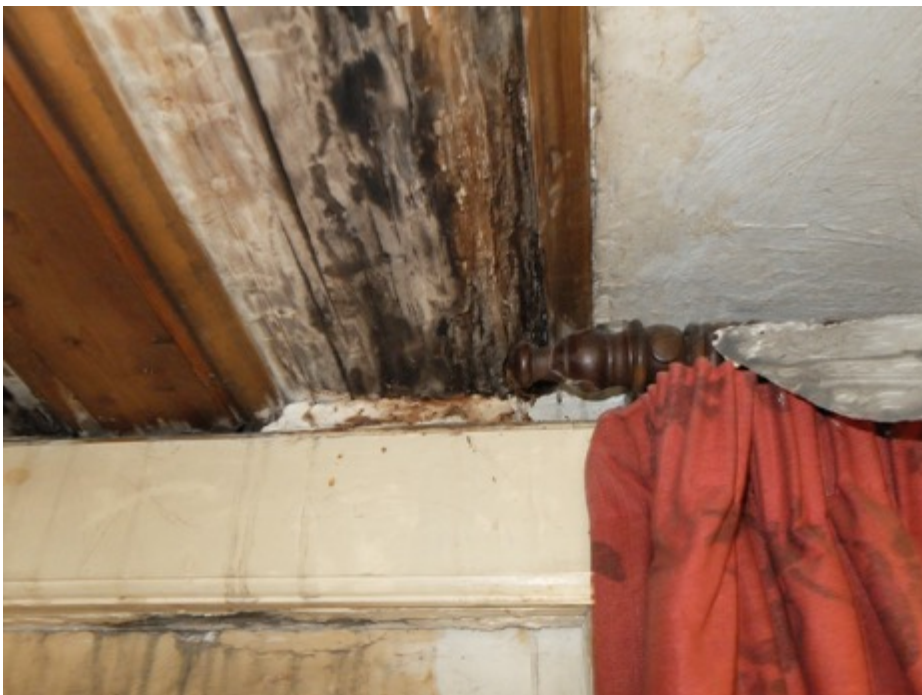
There is concern regarding the condition of the timber beams as these appear to be affected by decay. Along the right-hand bearing and there is an additional angular strut which would appear to be timber which has been fixed into the beam to provide extra support.

Photo, decay to beams supporting external wall

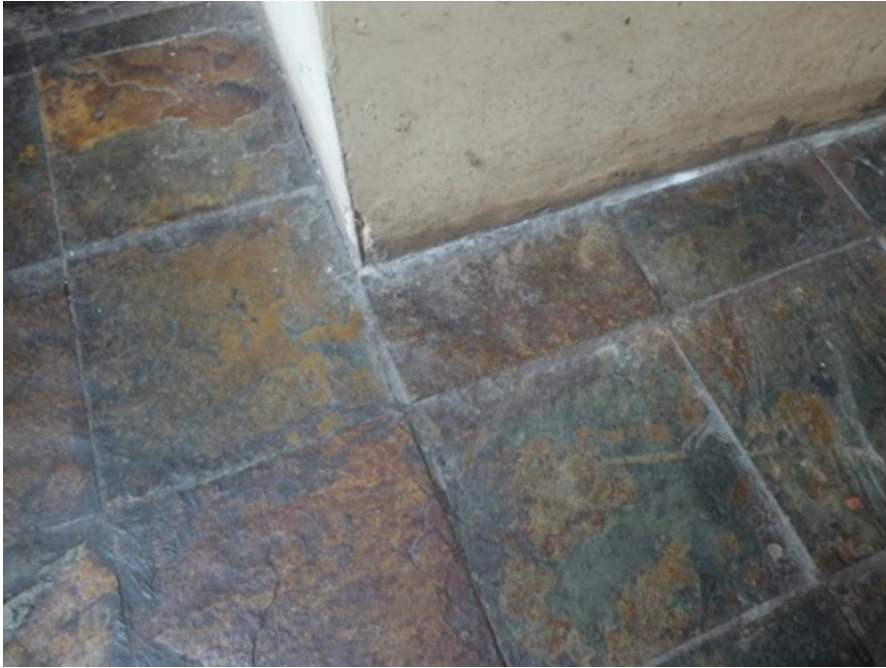
The walls would appear to be hard plaster and painted, there is staining, and deterioration noted to several areas of wall in particular along the front elevation beneath the flat roof section and around the cooker along the rear wall. Some of the plaster would appear to be lightweight plaster and therefore is not compatible with walls to older buildings. It was noted that in some areas of wall plaster touch the solid floors this will encourage moisture from around the margins of the solid floor into the low-level wall plaster.

Photo, plaster down to ground level

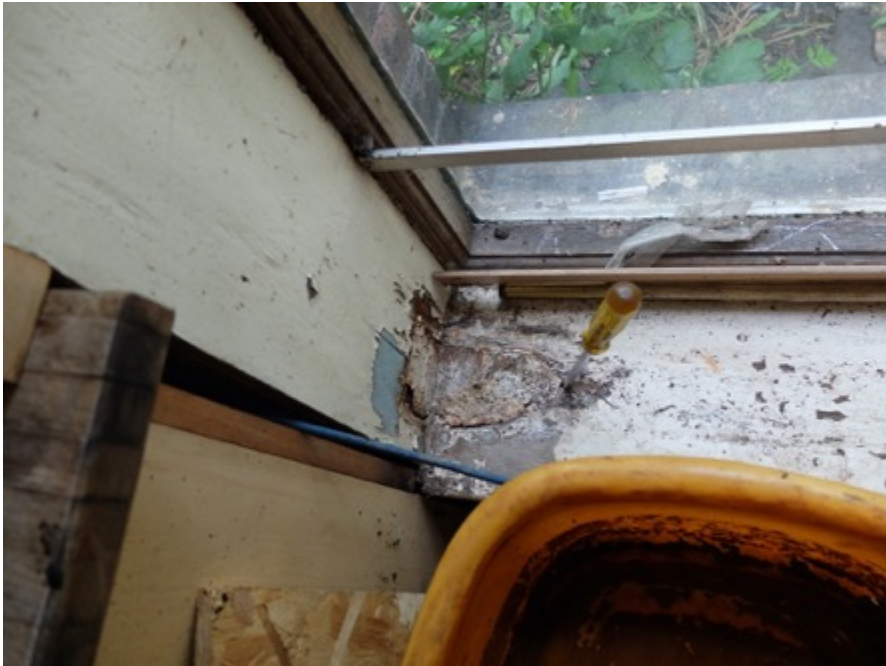
There is evidence of decay to the timber window board of the front right hand window.

Photo, decay to window board

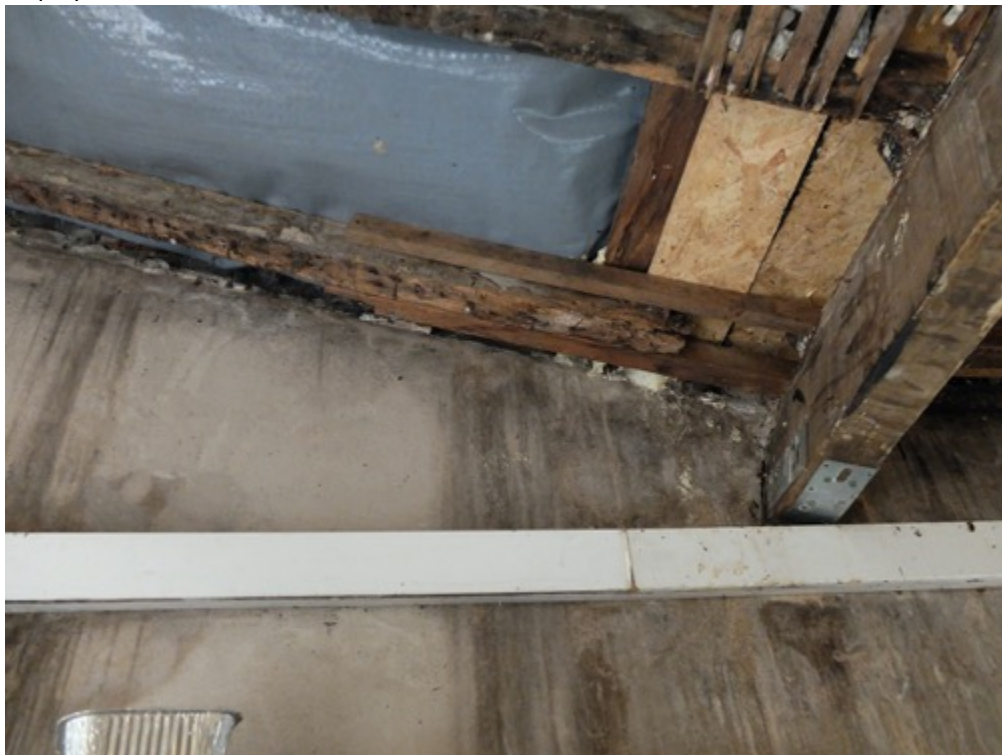
Photo, collapsed ceiling in kitchen under east section

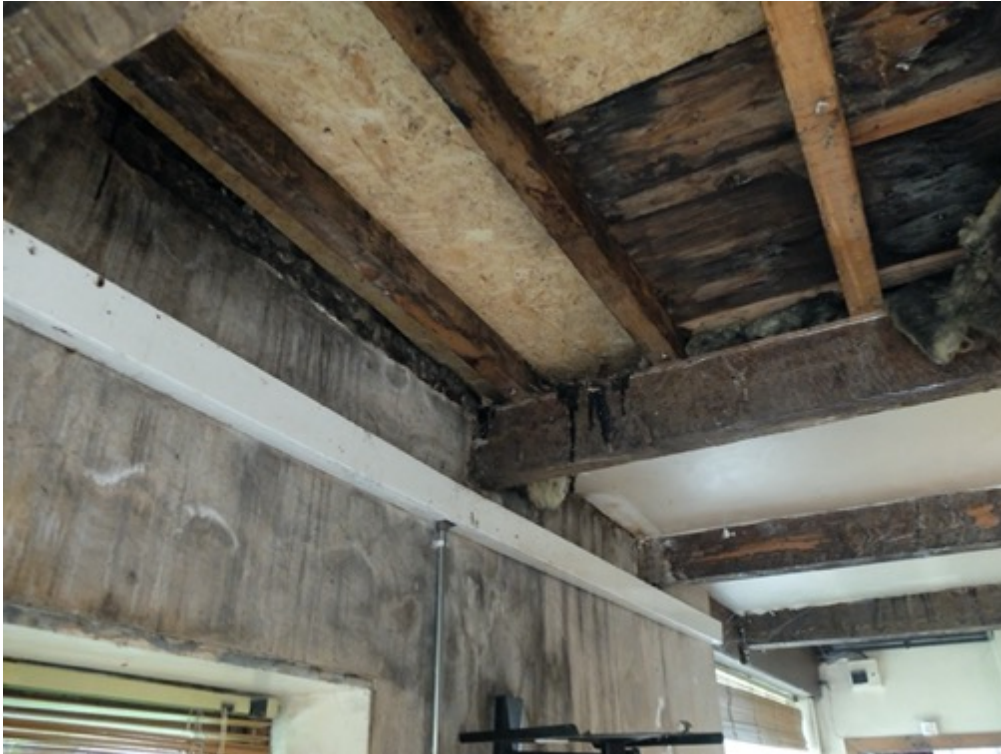
Photo, collapsed ceiling under flat roof section

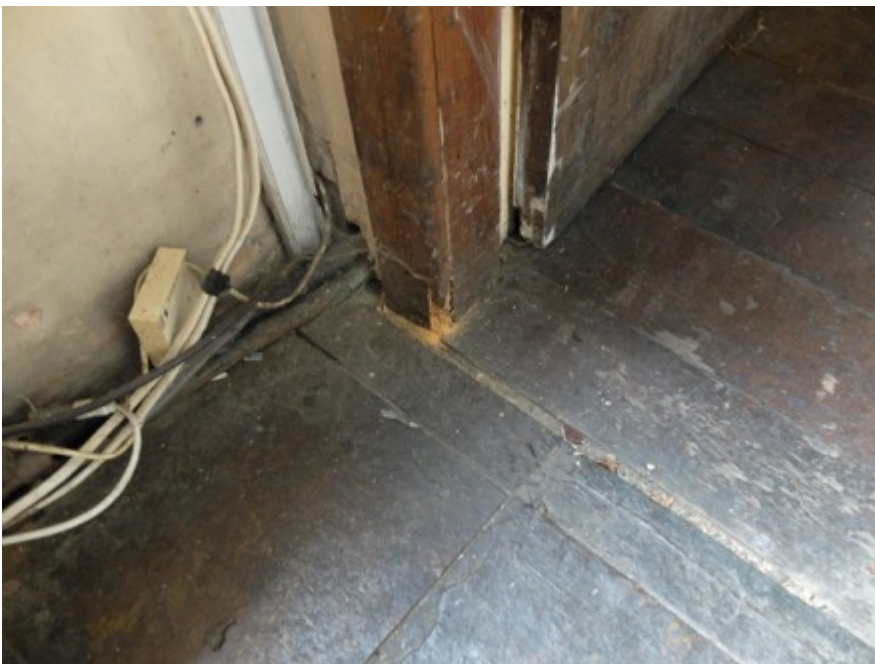
There was evidence of wood boring weevil to the door casing of the door with the dining room. It should be noted that wood boring weevil will only attack timber in conjunction with a high moisture content which indicates that there could be trapped moisture within the tiles.

Photo, weevil to door casing

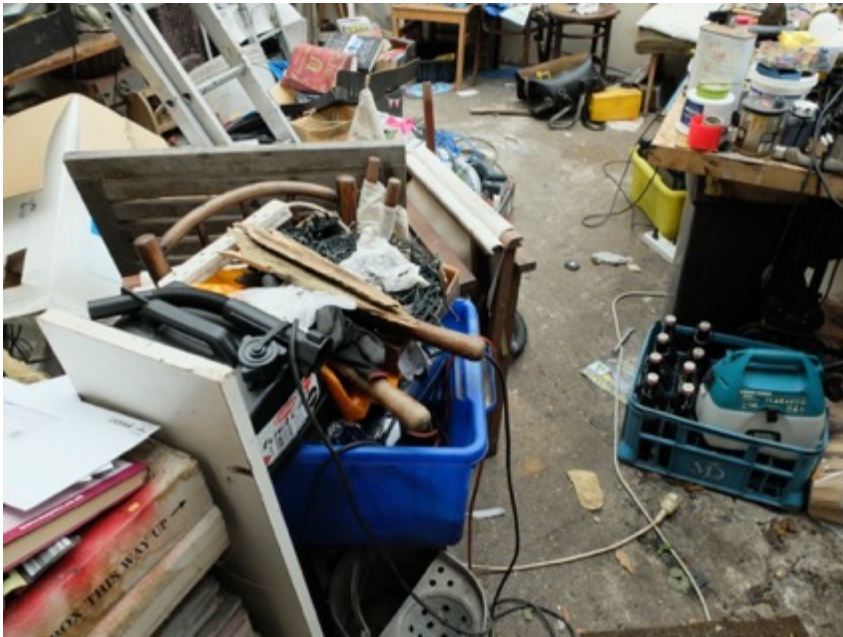
The floor is of a solid concrete construction. There is cracking and deterioration evident to some locations.

Photo, damage to concrete floor

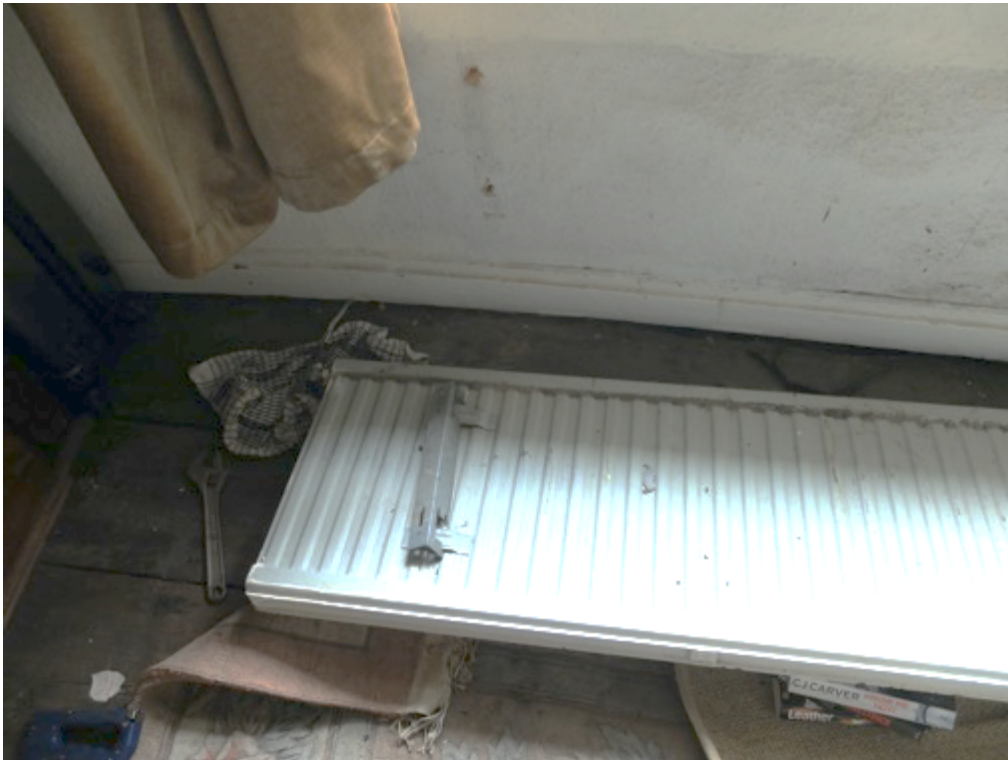
The front wall appears to have bowed outwards slightly away from the edges of the floorboards and a gap has been created. This requires further investigation.

Photo, radiator fallen off wall, gap between floor and skirting

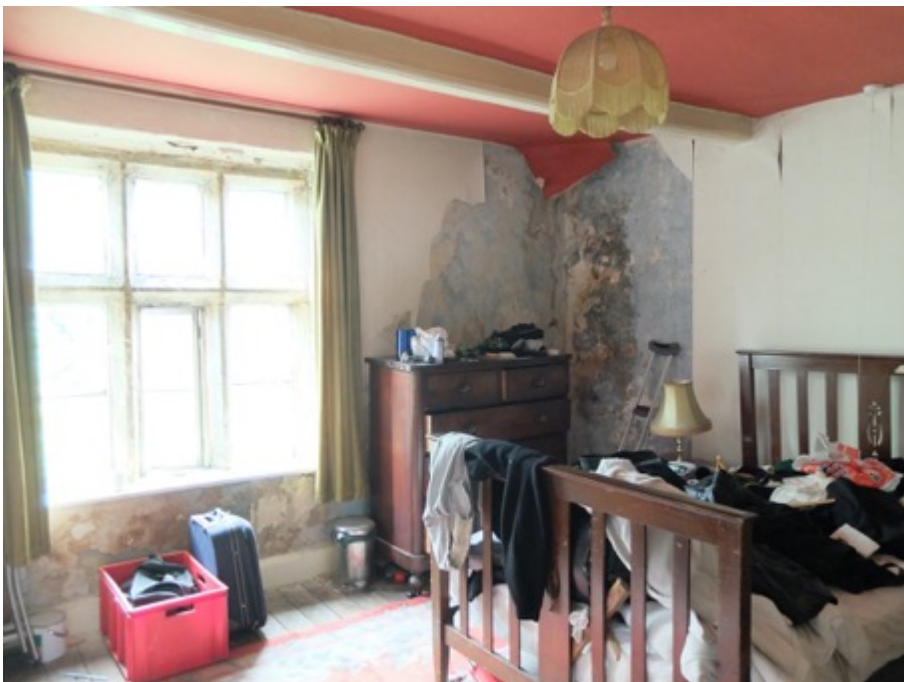
The walls would appear to be hard plastered and decorated. There is water ingress and plaster deterioration along the front wall and within the front left hand corner.

Photo, front left bedroom, ingress to front left corner

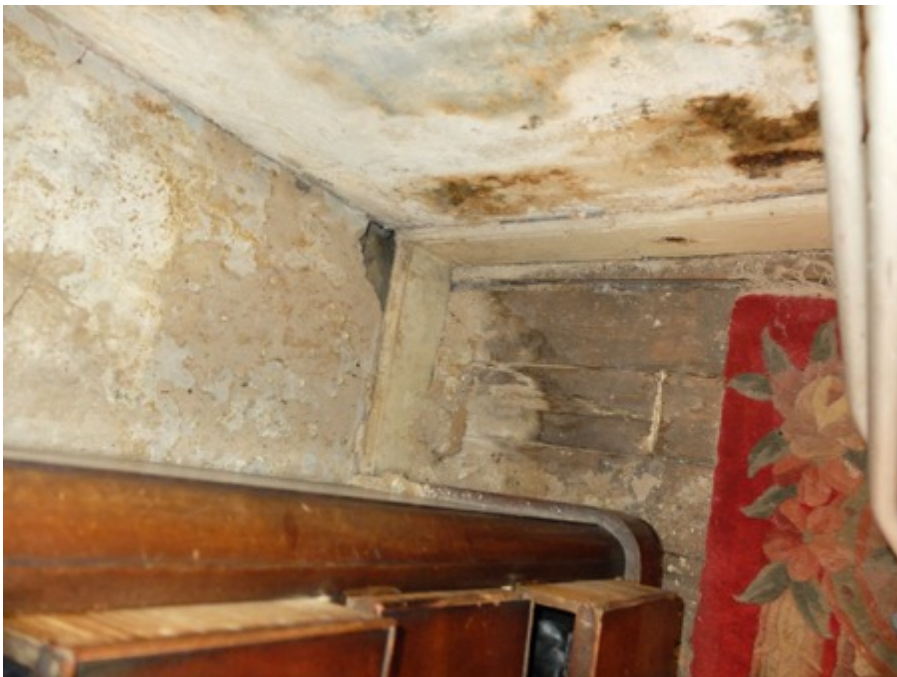
Photo, dampness to floors

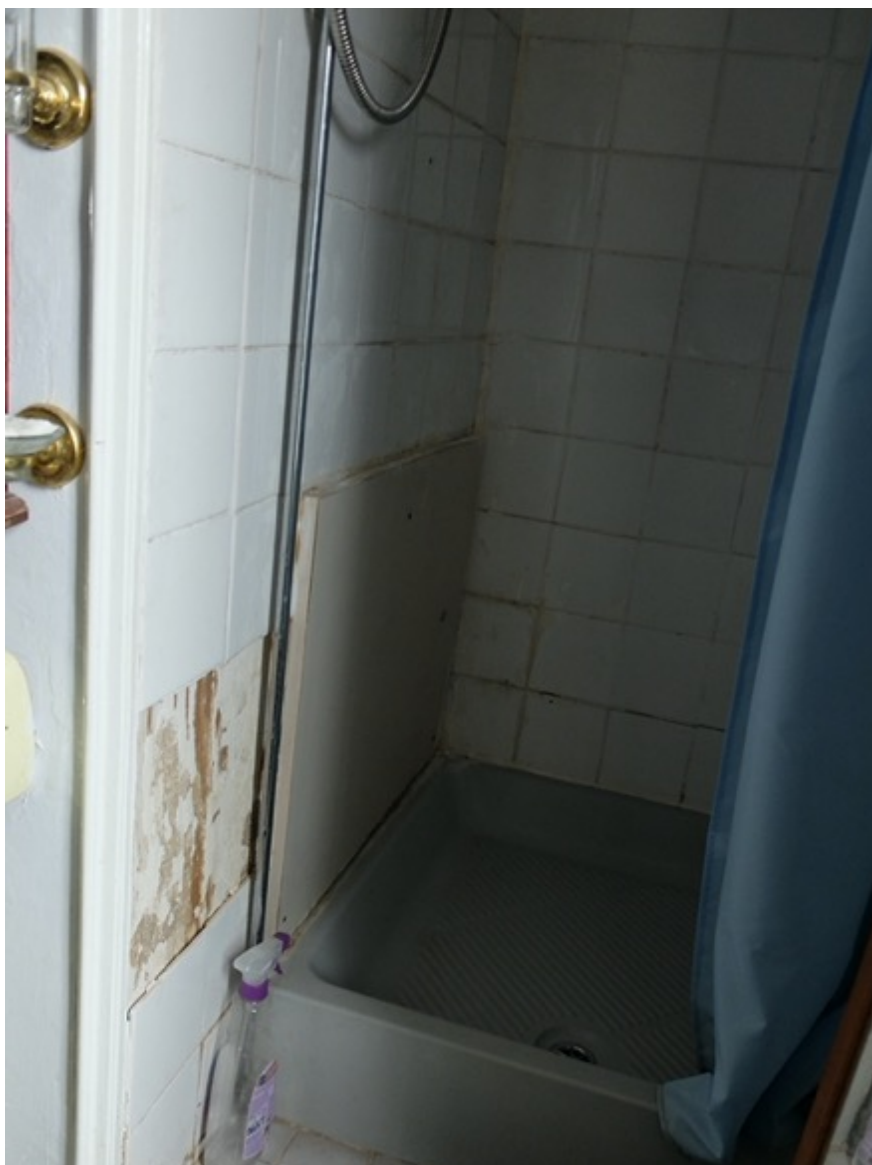
Photo, missing tiles to shower

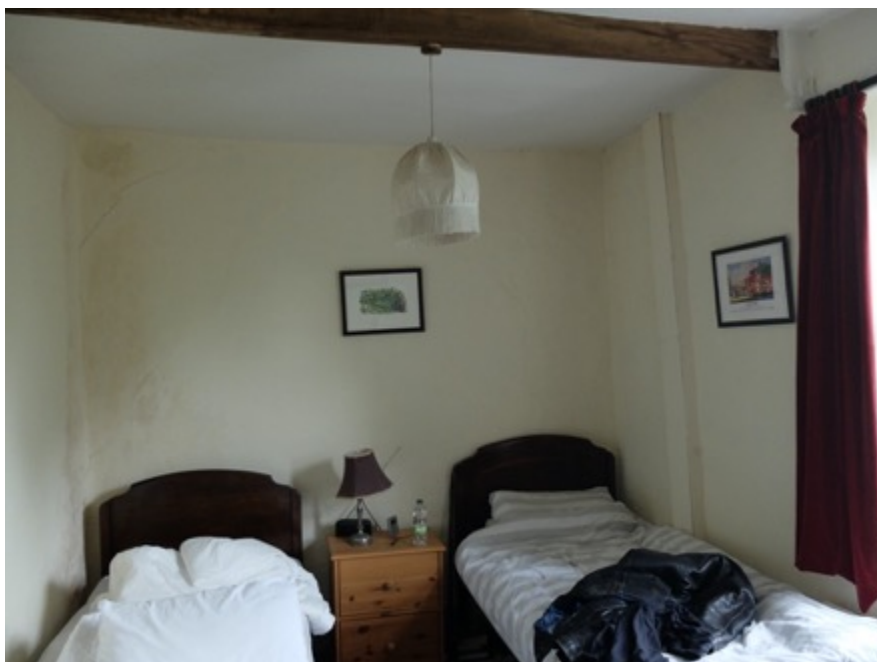
Photo, cracking to rear elevation wall

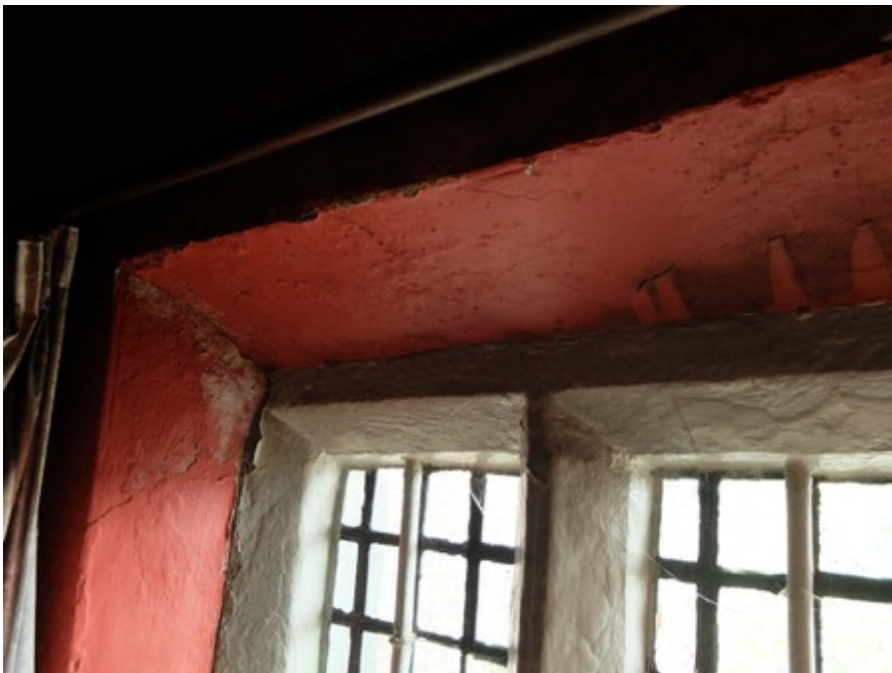
Photo, ingress around top of window

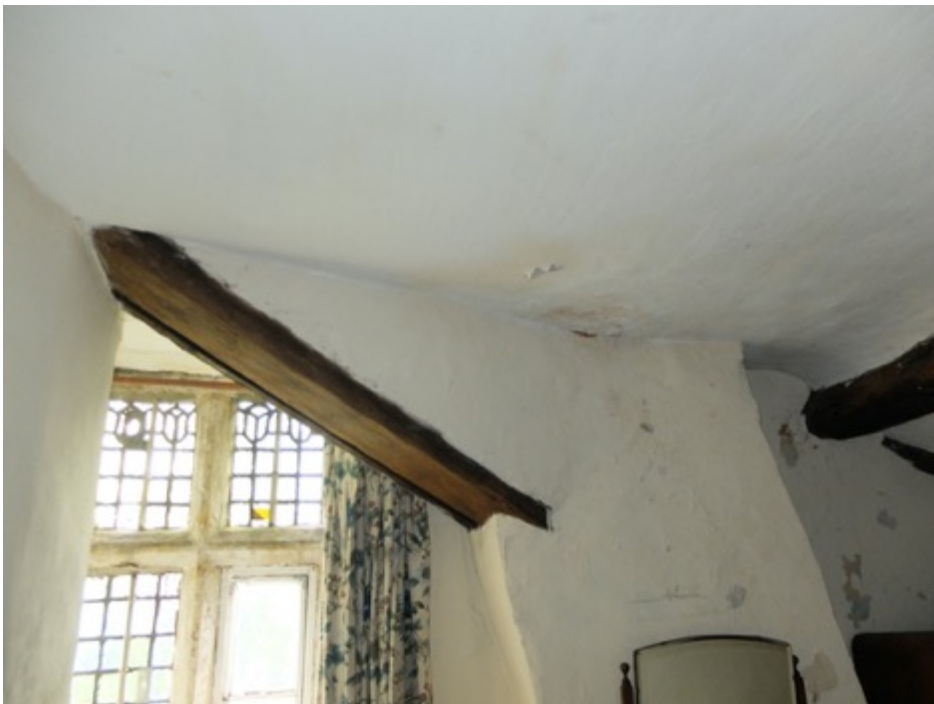
Photo, beam supporting flue and leaks around chimney

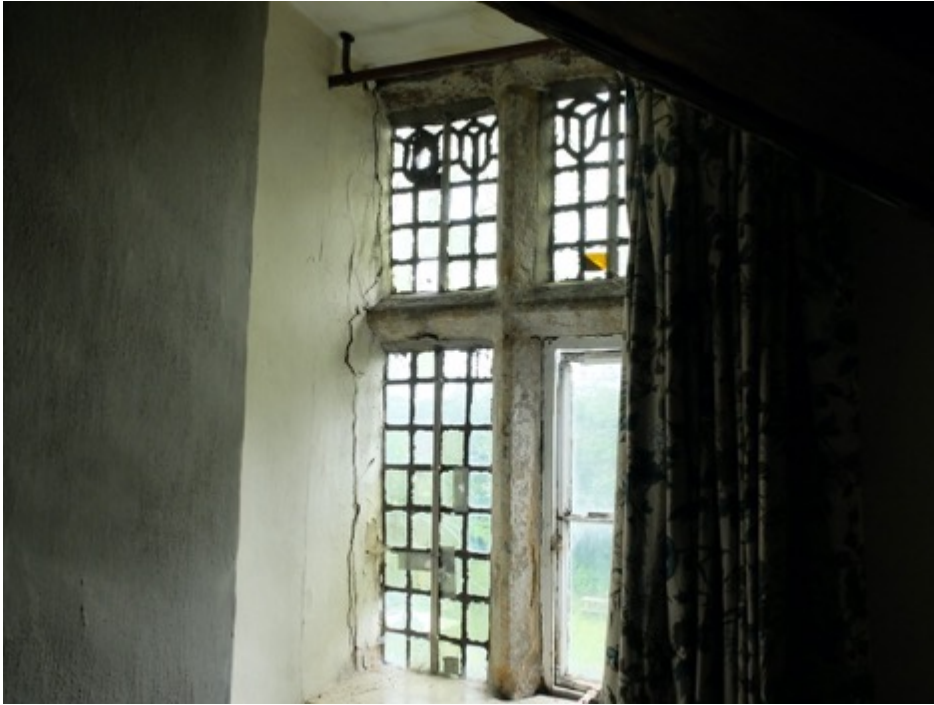
There is cracking on the rear wall where it abuts the stone mullion window.

Photo, mullion window

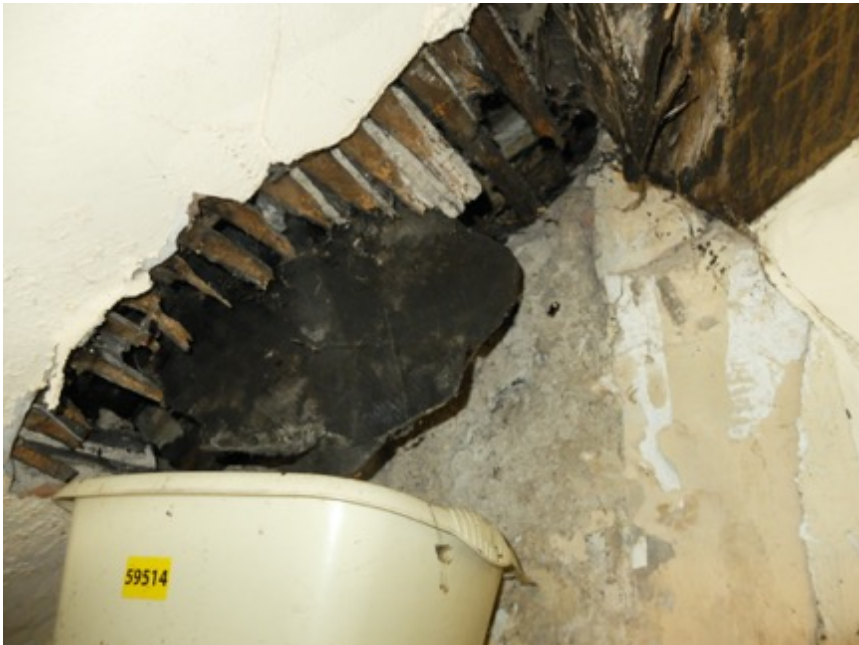
Photo, leaks to ceiling
