# **COMBINED HERITAGE AND DESIGN AND ACCESS STATEMENT**

**In connection with proposed remodelling of existing outbuildings at  
Higher House, Moor Road, Holcombe, BL8 4NX**

A non-intrusive structural survey was carried out by Booth King which highlights the poor structural condition of the outbuildings. The full report can be found in Appendix 2 but in summary the main defects are as follows:

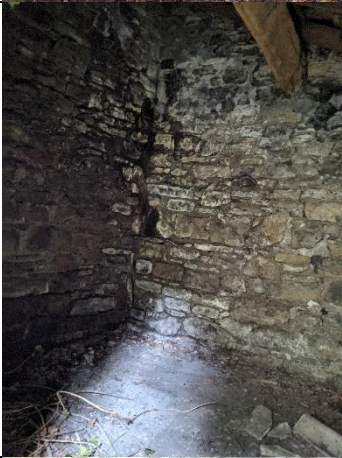
| 4. Inside shed-broken purlin | |

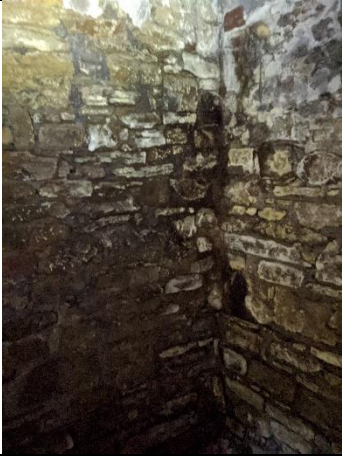
| 5. Inside shed- white bloom, possibly fungus on wall | |

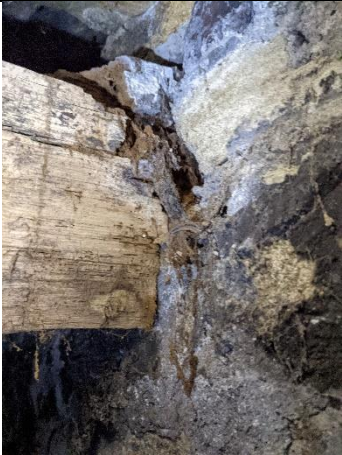
| <p>6. Close up on broken roof timber</p> | |

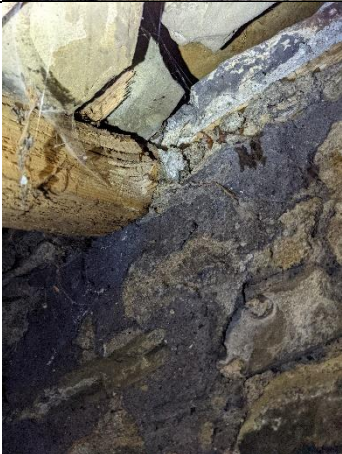
| <p>7. Broken and displaced roof timber</p> | |

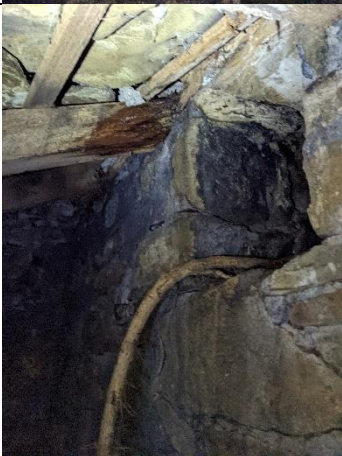
| <p>8. Broken and displaced roof timber</p> | |

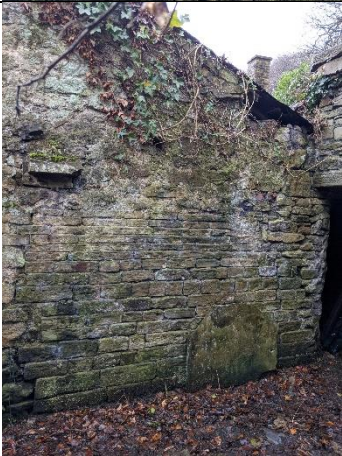
| <p>11. South wall of north courtyard-<br/>missing stones at verge on RHS.</p> | |

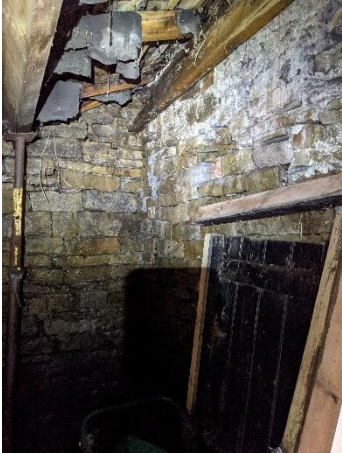
11. The passageway has a stone flag roof which is leaking.
12. The lean-to shed to the west is considered dangerous due to the very poor condition of the roof timbers, numbers of which have broken, presumably due to rot. There is a white efflorescence which could be fungus. Timber purlins have broken, one is currently supported on an Acro prop. A rafter is broken. There is a stone flag roof which is damp. The rear wall is a stone retaining wall which is bulging and wet. There are a number of rafters which appear modern replacements and treated timber. The south wall is a lime mortar pointed random rubble wall, which generally appears structurally sound, although it is wet where it is in contact with the retaining wall.

| <p>14. Lean to shed-broken roof purlins</p> | |

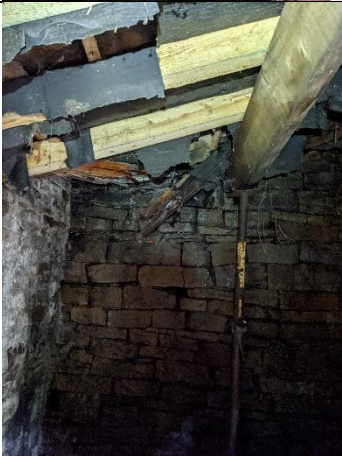
| <p>15. Lean to shed-broken purlin propped- recent treated rafters</p> | |

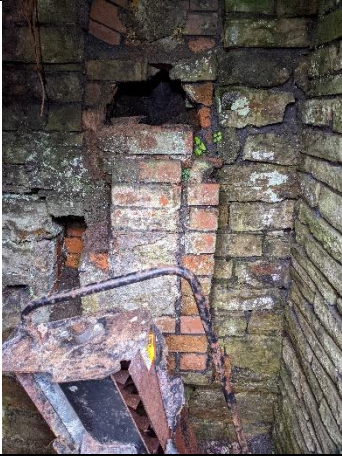
| <p>17. Outside WC- brick flue built into retaining wall</p> | |

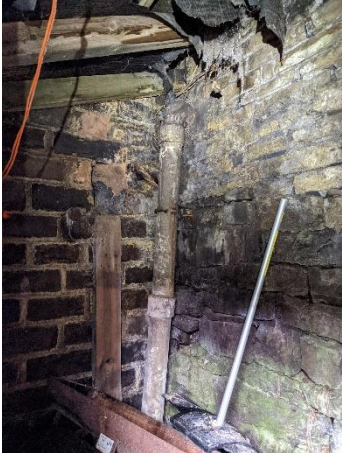
| <p>18. Outside WC- damp rafters.</p> | |

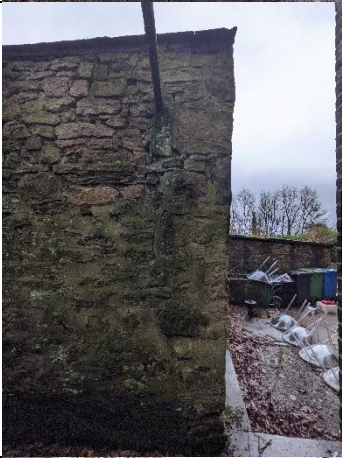
- *The outbuilding roof appears in satisfactory condition.*
- *The east wall of the outbuilding has undergone some movement in the past, a lean and a bulge has developed at high level. This is due to the unrestrained height of the wall and the irregular nature of the masonry. This can be reinforced with a steel frame to the rear. Poor bond between the front and return walls can be restored by installing remedial ties.*

| <p>20. View on corner of outbuilding, slight lean apparent</p> | |

21. The return walls should be tied to the east wall with Thor helical ties or similar to instate the bond which appears lacking.
22. The south west corner of the out building may need to be locally rebuilt.

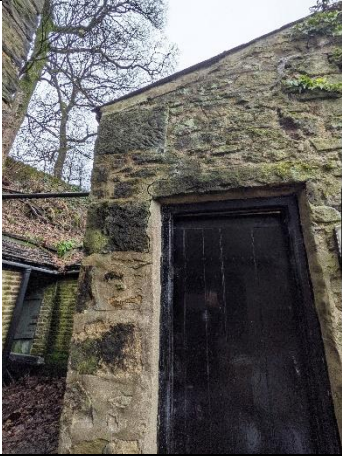
- *The south west corner of the outbuilding has undergone movement, due to loss of pointing to the stones at low level allowing outwards rotation resulting in a crack up the inside of the wall from the lintel bearing. This should be repaired by propping the lintel and locally dismantling the defective stone work and rebuilding off a sound foundation.*

| <p>21. Outbuilding door-vertical crack upwards from left hand lintel bearing</p> | |

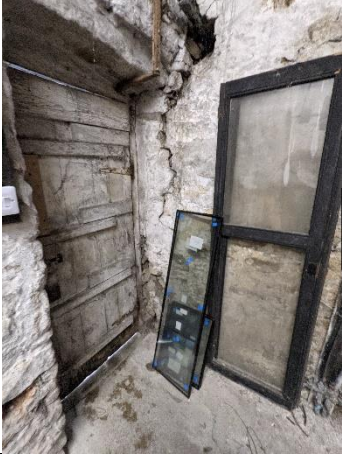
| <p>23. Interior of outbuilding, crack under lintel bearing resulting from outwards rotation of stones above. This corner to be rebuilt.</p> | |

- The south west corner of the outbuilding has undergone movement, due to loss of pointing to the stones at low level allowing outwards rotation resulting in a crack up the inside of the wall from the lintel bearing. This should be repaired by propping the lintel and locally dismantling the defective stone work and rebuilding off a sound foundation.
- The issue of temporary works to the embankment will be complicated by the access. Advice of a specialist sheet piling contractor should be sought in order to assess the feasibility of this work. Alternatively, it could be considered to build a retaining wall in front of the stone retaining wall.
- This work will be subject to the outcome of a geotechnical investigation.

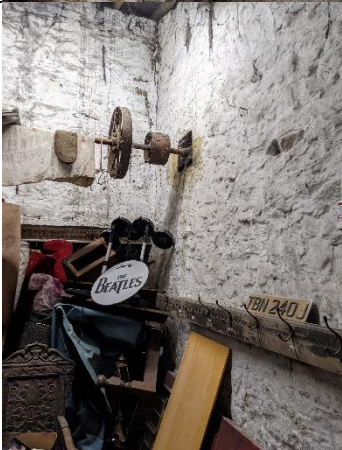
| <p>25. Machine shaft in out building, crack in corner between walls, getting wider with height.</p> | |

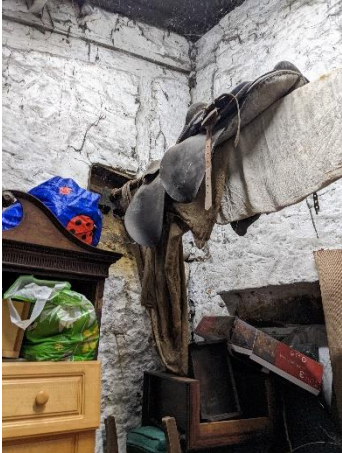
| <p>26. Timber truss visible within stone dividing wall. Crack between front and cross wall. This cross wall is proposed for removal. Truss to be inspected by specialist for timber condition and to determine if it is structurally suitable for the weight of the roof. If not, additional steel beams will be required.</p> | |

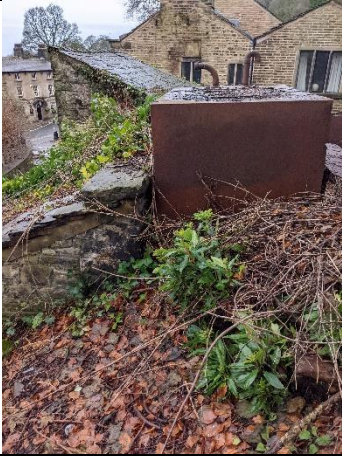
| <p>29. Old oil tank at top of retaining wall</p> | |

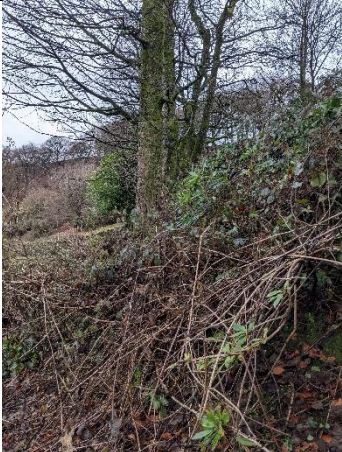
| 31. Tree growing at top of retaining wall behind lean to shed | |
