# REDDISH VALE

## REFURBISHMENT / DEMOLITION ASBESTOS SURVEY

| <b>Project site Address:</b> | Spurr House Residential Care home, 243 Pole Lane, Bury.<br>BL9 8QL |
| <b>Project Reference:</b> | Asbs12544 |

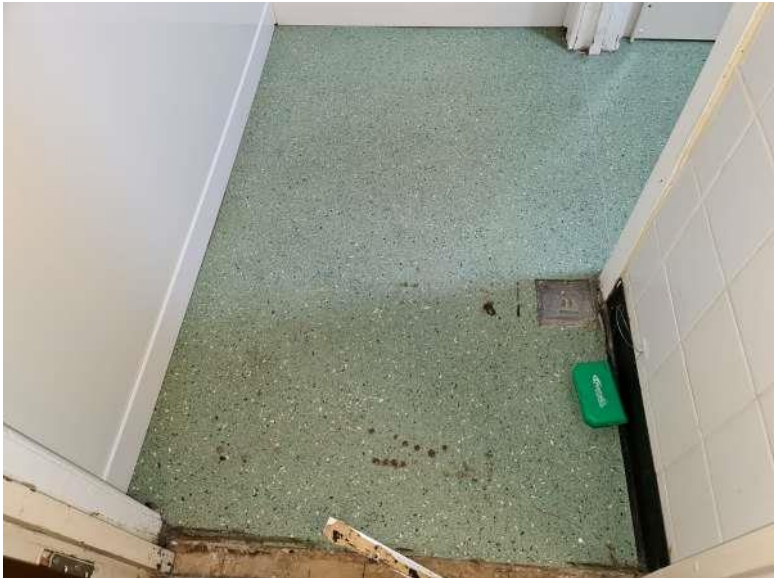
| Extent / Quantity of material | 5m <sup>2</sup> | | |
| <b>RISK BAND SCORE</b> - The risk band score assigned to this sample based on the surveyors assessment of the materials condition / location and possibility of exposure to any occupants of the site | | | <b>3</b> |

| <b>Recommendations</b> | Label and manage the material with regular and pre planned inspection. Prior to any refurbishment or demolition work the material should be removed in accordance with the Control of Asbestos Regulations 2012 | | |

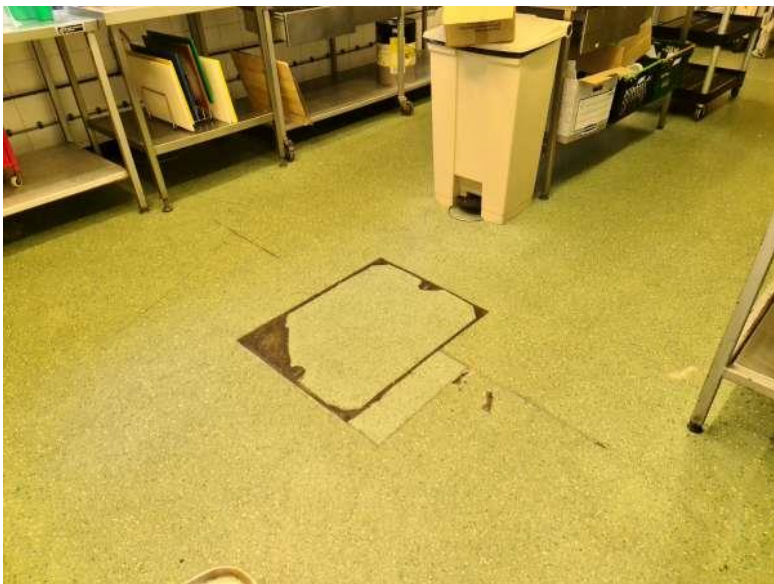
| Extent / Quantity of material | 50m <sup>2</sup> | | |
| <b>RISK BAND SCORE</b> - The risk band score assigned to this sample based on the surveyors assessment of the materials condition / location and possibility of exposure to any occupants of the site | | | 3 |

| Recommendations | Label and manage the material with regular and pre planned inspection. Prior to any refurbishment or demolition work the material should be removed in accordance with the Control of Asbestos Regulations 2012 | | |

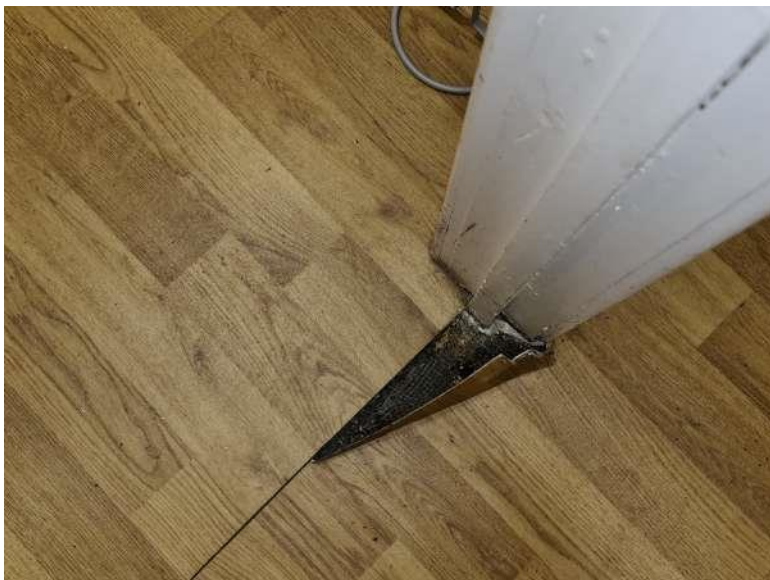
| Extent / Quantity of material | | 3m <sup>2</sup> | |
| <b>RISK BAND SCORE</b> - The risk band score assigned to this sample based on the surveyors assessment of the materials condition / location and possibility of exposure to any occupants of the site | | | <b>3</b> |

| <b>Recommendations</b> | Label and manage the material with regular and pre planned inspection. Prior to any refurbishment or demolition work the material should be removed in accordance with the Control of Asbestos Regulations 2012 | | |

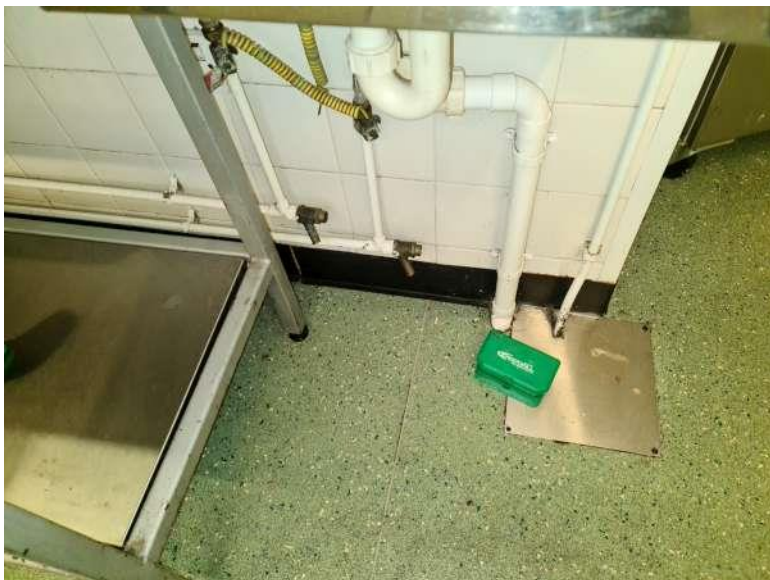
| Extent / Quantity of material | 25 linear metres | | |
| <b>RISK BAND SCORE</b> - The risk band score assigned to this sample based on the surveyors assessment of the materials condition / location and possibility of exposure to any occupants of the site | | | N/A |

| Recommendations | None required as no Asbestos detected within sample<br>NAD – No Asbestos Detected<br>N/A – Not applicable | | |

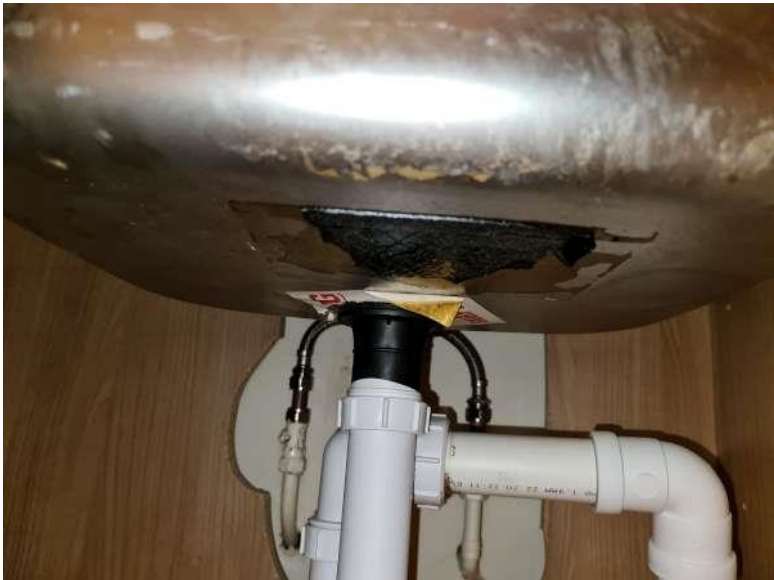
| Extent / Quantity of material | 1 item | | |
| <b>RISK BAND SCORE</b> - The risk band score assigned to this sample based on the surveyors assessment of the materials condition / location and possibility of exposure to any occupants of the site | | | N/A |

| Recommendations | None required as no Asbestos detected within sample<br>NAD – No Asbestos Detected<br>N/A – Not applicable | | |

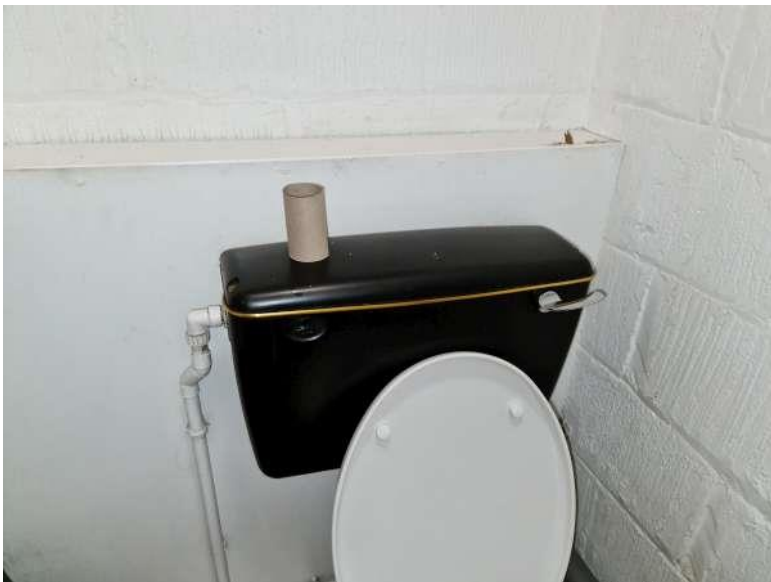
| Extent / Quantity of material | 1 Cistern | | |
| <b>RISK BAND SCORE</b> - The risk band score assigned to this sample based on the surveyors assessment of the materials condition / location and possibility of exposure to any occupants of the site | | | 3 |

| Recommendations | Label and manage the material with regular and pre planned inspection. Prior to any refurbishment or demolition work the material should be removed in accordance with the Control of Asbestos Regulations 2012 | | |

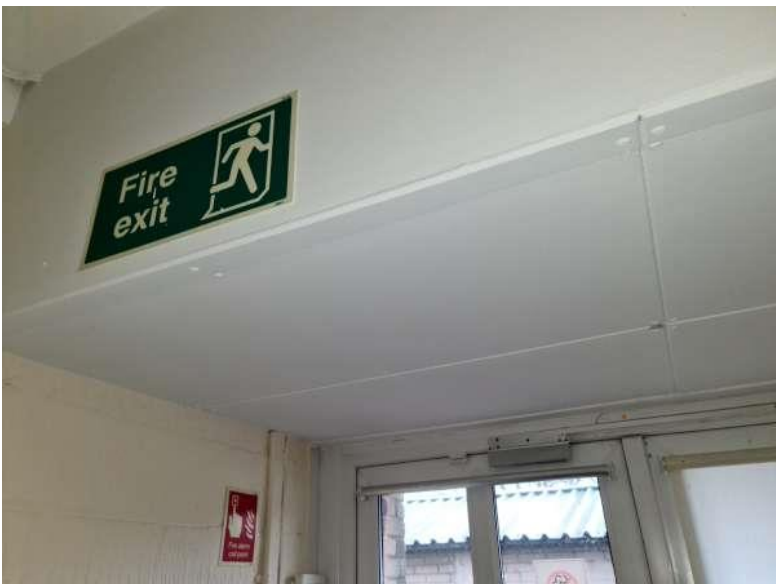
| Extent / Quantity of material | 4m <sup>2</sup> | | |
| <b>RISK BAND SCORE</b> - The risk band score assigned to this sample based on the surveyors assessment of the materials condition / location and possibility of exposure to any occupants of the site | | | 3 |

| Recommendations | Label and manage the material with regular and pre planned inspection. Prior to any refurbishment or demolition work the material should be removed under full conditions using a licensed contractor in accordance with the Control of Asbestos Regulations 2012 | | |

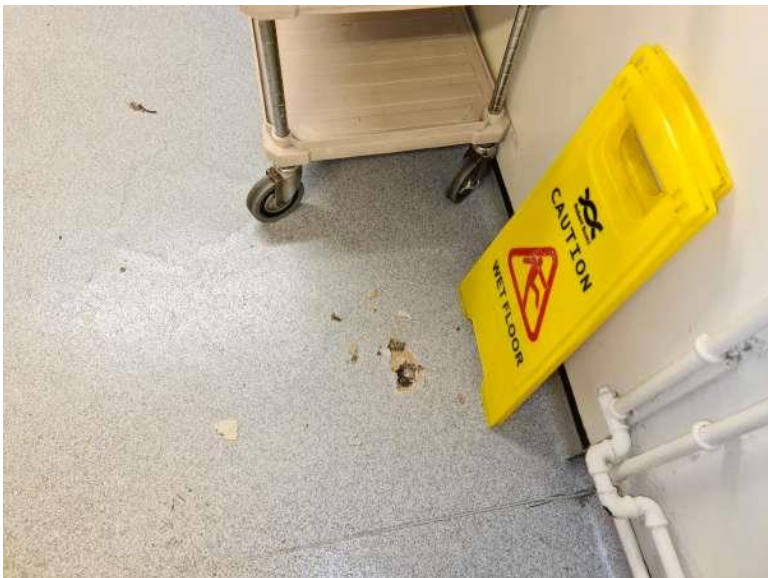
| Extent / Quantity of material | 25m <sup>2</sup> | | |
| <b>RISK BAND SCORE</b> - The risk band score assigned to this sample based on the surveyors assessment of the materials condition / location and possibility of exposure to any occupants of the site | | | 3 |

| Recommendations | Label and manage the material with regular and pre planned inspection. Prior to any refurbishment or demolition work the material should be removed in accordance with the Control of Asbestos Regulations 2012 | | |

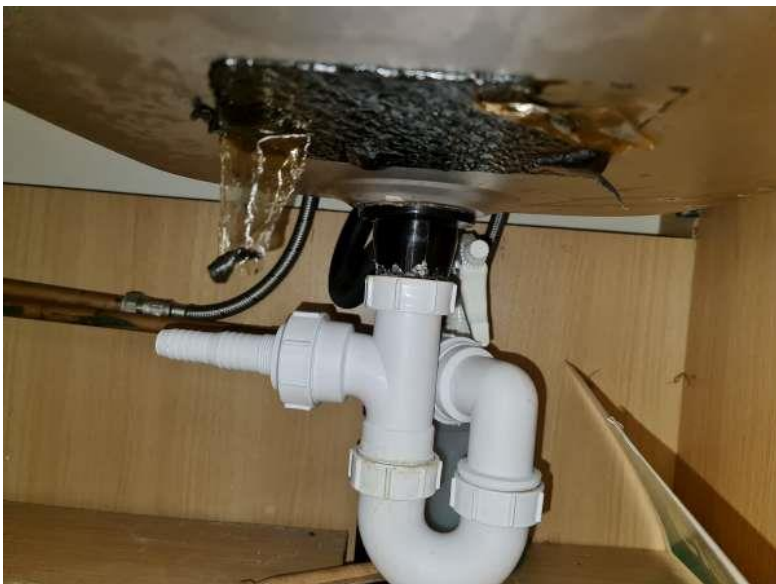
| Extent / Quantity of material | 1 item | | |
| <b>RISK BAND SCORE</b> - The risk band score assigned to this sample based on the surveyors assessment of the materials condition / location and possibility of exposure to any occupants of the site | | | N/A |

| Recommendations | None required as no Asbestos detected within sample<br>NAD – No Asbestos Detected<br>N/A – Not applicable | | |

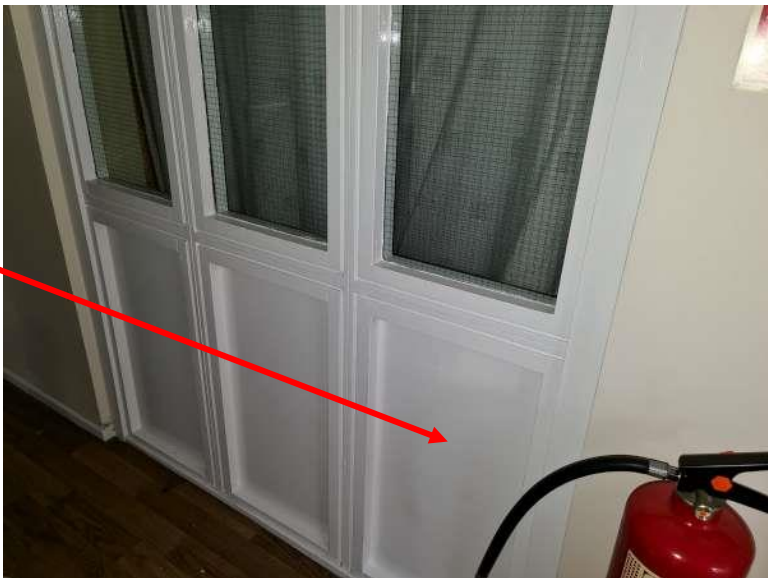
| Extent / Quantity of material | 1m <sup>2</sup> x 5 panels | | |
| <b>RISK BAND SCORE</b> - The risk band score assigned to this sample based on the surveyors assessment of the materials condition / location and possibility of exposure to any occupants of the site | | | 3 |

| Recommendations | Label and manage the material with regular and pre planned inspection. Prior to any refurbishment or demolition work the material should be removed under full conditions using a licensed contractor in accordance with the Control of Asbestos Regulations 2012 | | |

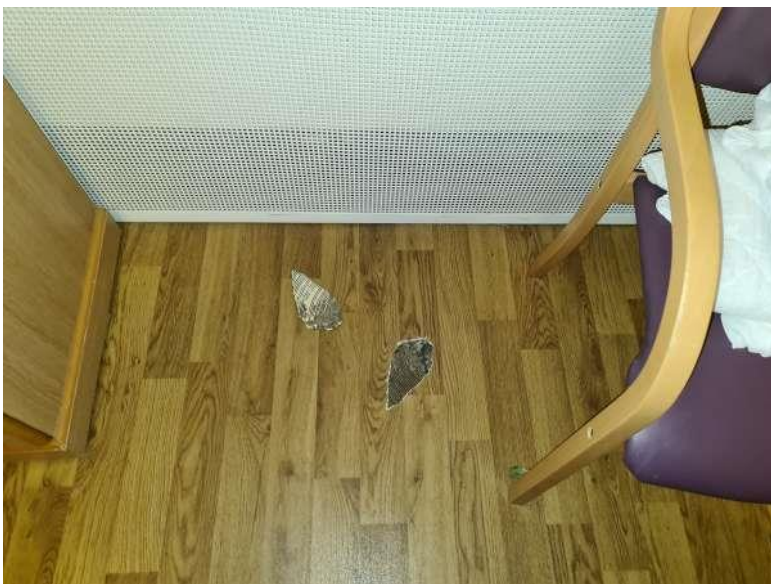
| <b>RISK BAND SCORE</b> - The risk band score assigned to this sample based on the surveyors assessment of the materials condition / location and possibility of exposure to any occupants of the site | | <b>3</b> | |

| <b>Recommendations</b> | | Label and manage the material with regular and pre planned inspection. Prior to any refurbishment or demolition work the material should be removed in accordance with the Control of Asbestos Regulations 2012 | |
