# REDDISH VALE

## RE-INSPECTION ASBESTOS SURVEY

Spurr House Residential Care Home, 243  
Pole Lane, Bury. BL9 8QL

Asbs12751

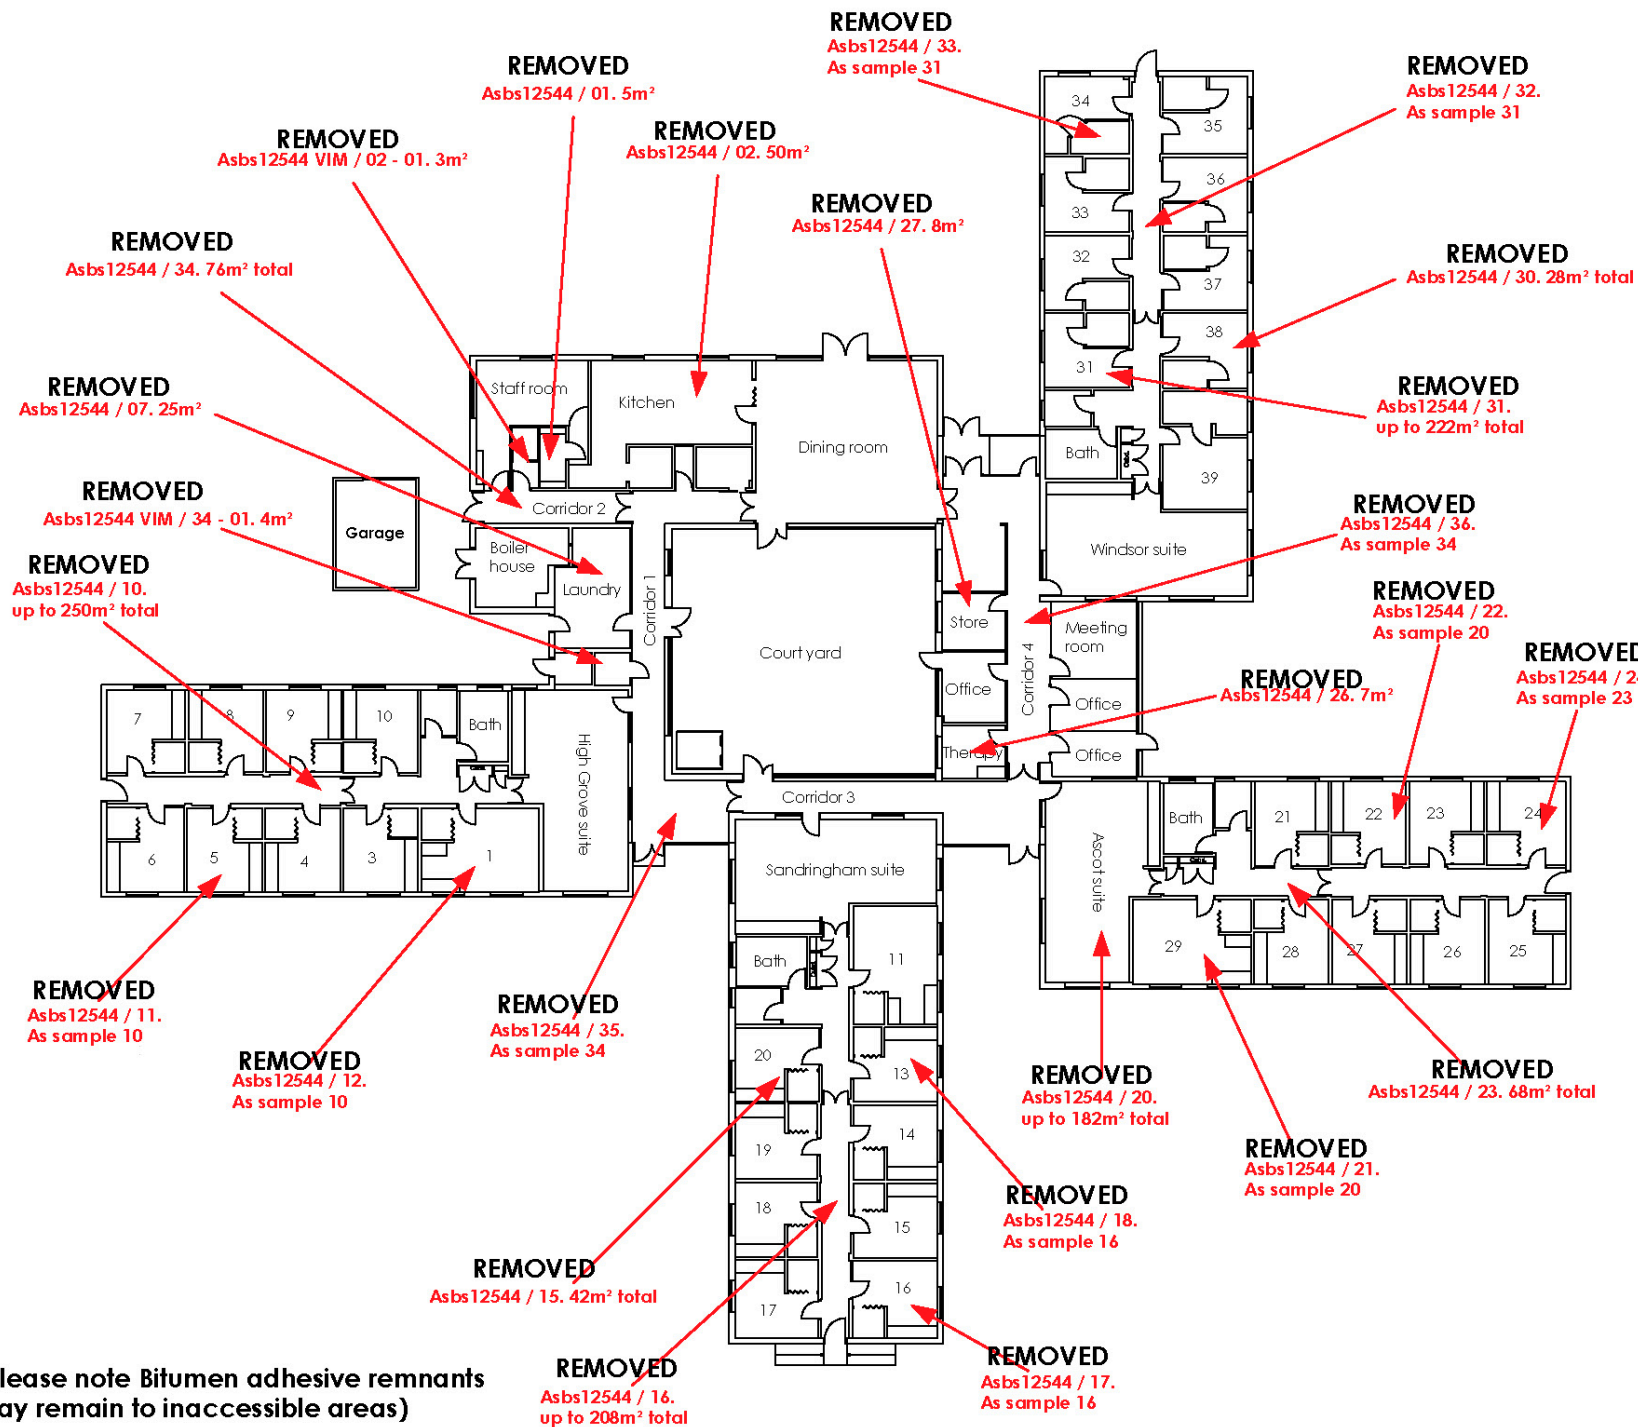
**(please note Bitumen adhesive remnants may remain to inaccessible areas)**
