## CCTV Inspection Report

**Stand Golf Club, Ashbourne Grove, Whitefield, Manchester M45 7NL**

**19/12/2024**

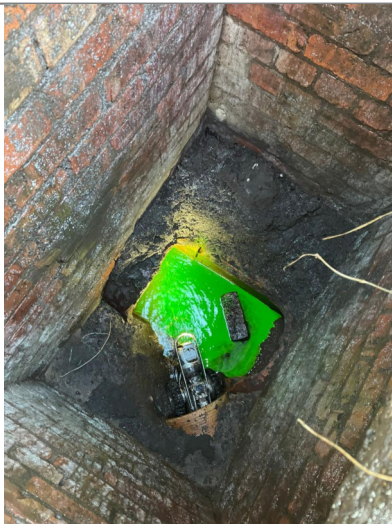
**Other Site Photos: MH02 DS MH03 - DYE TEST PROVEN FOR  
CONNECTIVITY**

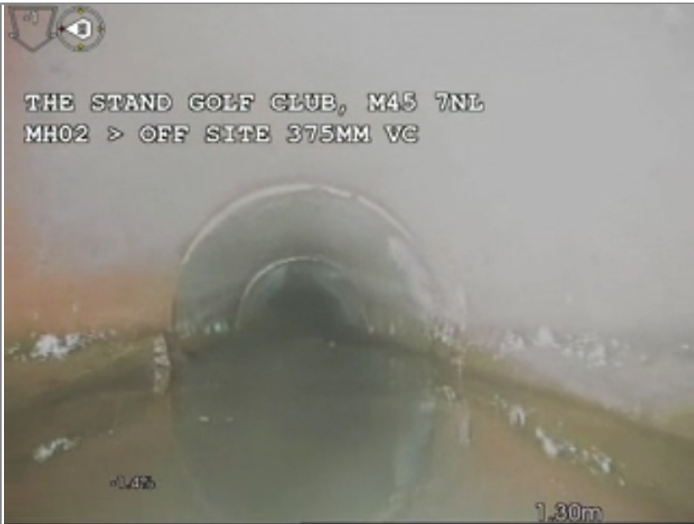
| Position | Code | Description | Photo | Type/Grade |
|---|---|---|---|---|
| 1.30 | DER (S1) | Settled deposits coarse 15% cross-sectional area loss, Start - Remark: Debris under water level | 10977276 | Service / 3 |

| Job Number<br>Site A Stand Golf Club, Ashbourne<br>Grove, Whitefield, Manchester M45<br>7NL | Surveyed by (Operator)<br>Aden | Base Unit<br>2JYX7NX9SK | Date<br>19/12/2024 |
|---|---|---|---|
| Settled deposits coarse 15% cross-sectional area loss, Start - Remark: Debris under water level | | | |

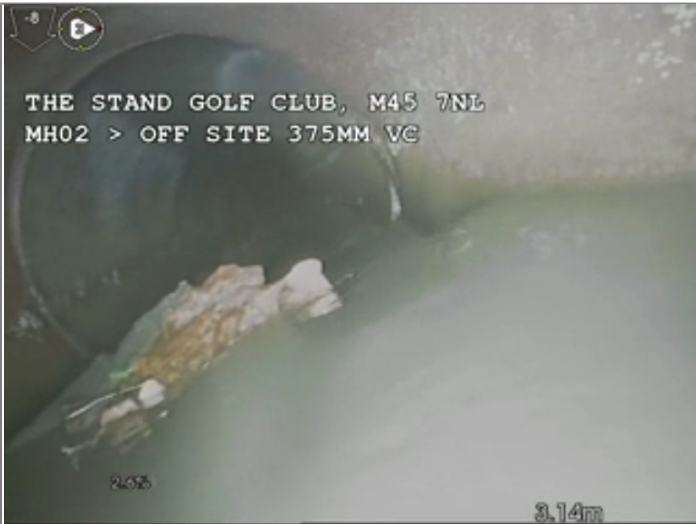
| Position | Code | Description | Photo | Type/Grade |
|---|---|---|---|---|
| 3.14 | DER (S2) | Settled deposits coarse 20% cross-sectional area loss, Start | 10977284 | Service / 3 |

| Job Number<br>Site A Stand Golf Club, Ashbourne<br>Grove, Whitefield, Manchester M45<br>7NL | Surveyed by (Operator)<br>Aden | Base Unit<br>2JYX7NX9SK | Date<br>19/12/2024 |
|---|---|---|---|
| Settled deposits coarse 20% cross-sectional area loss, Start | | | |

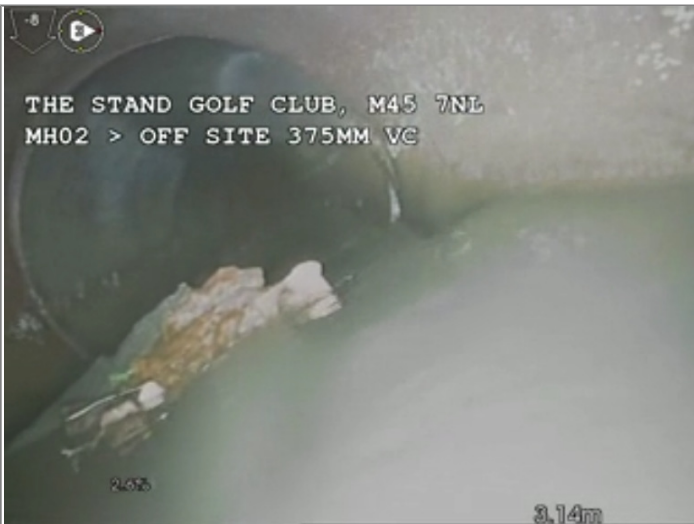
| Position | Code | Description | Photo | Type/Grade |
|---|---|---|---|---|
| 3.14 | DER (F1) | Settled deposits coarse 15% cross-sectional area loss, Finished - Remark: Debris under water level | 10977286 | Service / 3 |

| Job Number<br>Site A Stand Golf Club, Ashbourne<br>Grove, Whitefield, Manchester M45<br>7NL | Surveyed by (Operator)<br>Aden | Base Unit<br>2JYX7NX9SK | Date<br>19/12/2024 |
|---|---|---|---|
| Settled deposits coarse 15% cross-sectional area loss, Finished - Remark: Debris under water level | | | |

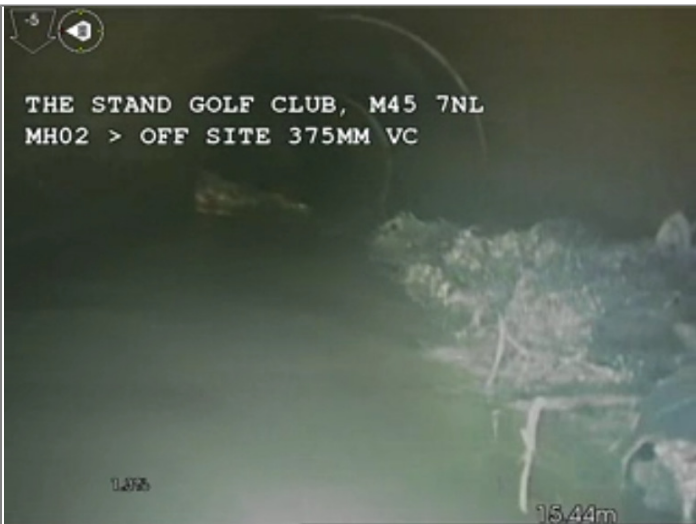
| Position | Code | Description | Photo | Type/Grade |
|---|---|---|---|---|
| 15.44 | DER | Settled deposits coarse 30% cross-sectional area loss | 10977902 | Service / 4 |

| Job Number<br>Site A Stand Golf Club, Ashbourne<br>Grove, Whitefield, Manchester M45<br>7NL | Surveyed by (Operator)<br>Aden | Base Unit<br>2JYX7NX9SK | Date<br>19/12/2024 |
|---|---|---|---|
| Settled deposits coarse 30% cross-sectional area loss | | | |

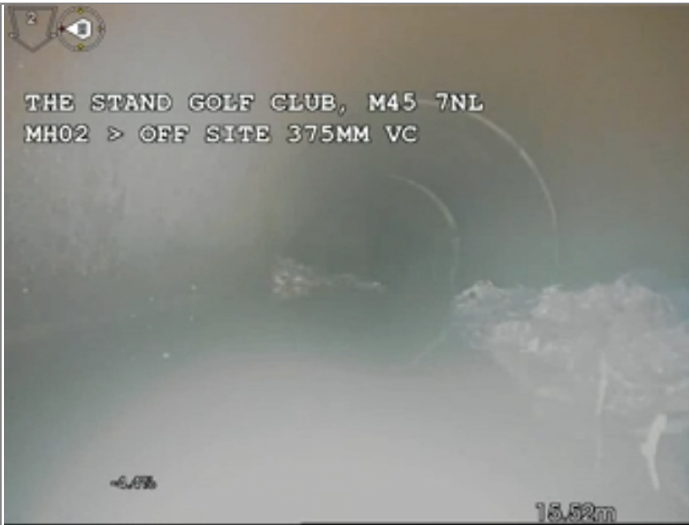
| Position | Code | Description | Photo | Type/Grade |
|---|---|---|---|---|
| 15.52 | DER (F2) | Settled deposits coarse 20% cross-sectional area loss, Finished | 10977909 | Service / 3 |

Settled deposits coarse 20% cross-sectional area loss, Finished

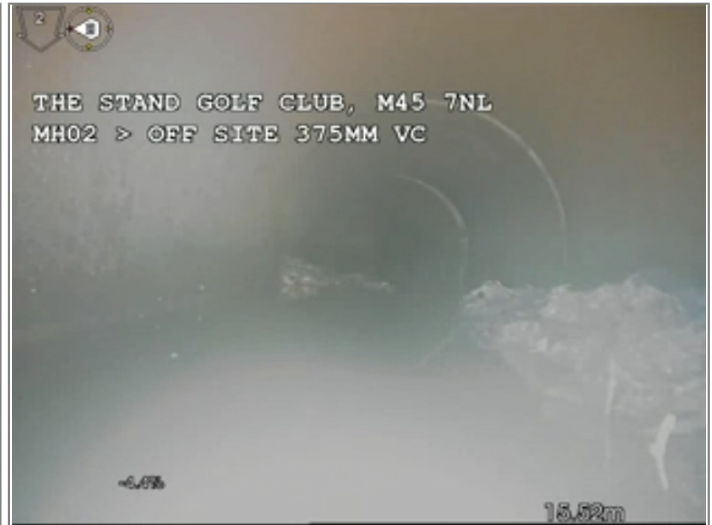
| Position | Code | Description | Photo | Type/Grade |
|---|---|---|---|---|
| 15.52 | SA | Survey abandoned - Remark: SA DUE TO 30% SILT / DEBRIS, UNABLE TO PASS. MH03 IN VIEW APPROX 5M FROM CCTV. | 10977931 | Comment / 0 |

Survey abandoned - Remark: SA DUE TO 30% SILT / DEBRIS, UNABLE TO PASS. MH03 IN VIEW APPROX 5M FROM CCTV.

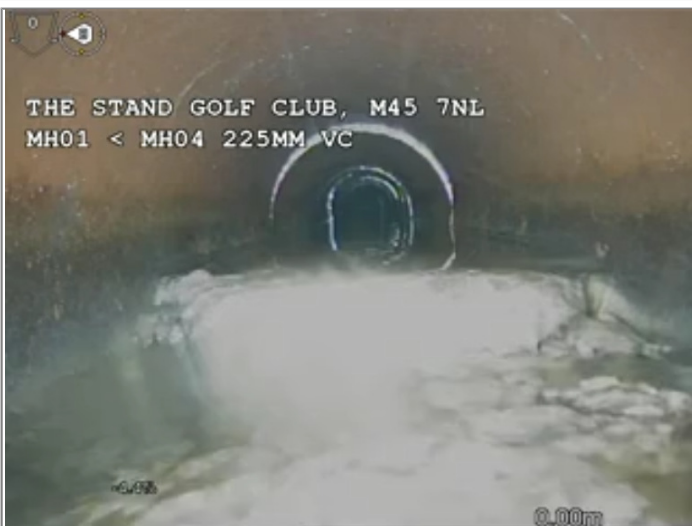
| Position | Code | Description | Photo | Type/Grade |
|---|---|---|---|---|
| 0.00 | DEE (S1) | Attached deposits, encrustation from 04 to 08 o'clock 25% cross-sectional area loss, Start | 10977975 | Service / 4 |

Attached deposits, encrustation from 04 to 08 o'clock 25% cross-sectional area loss, Start

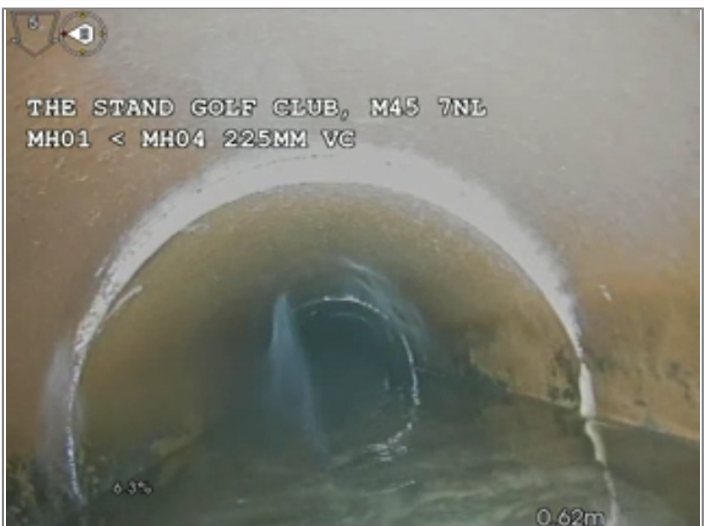
| Position | Code | Description | Photo | Type/Grade |
|---|---|---|---|---|
| 0.62 | JDM | Joint displaced medium | 10977985 | Structural / 1 |

Joint displaced medium

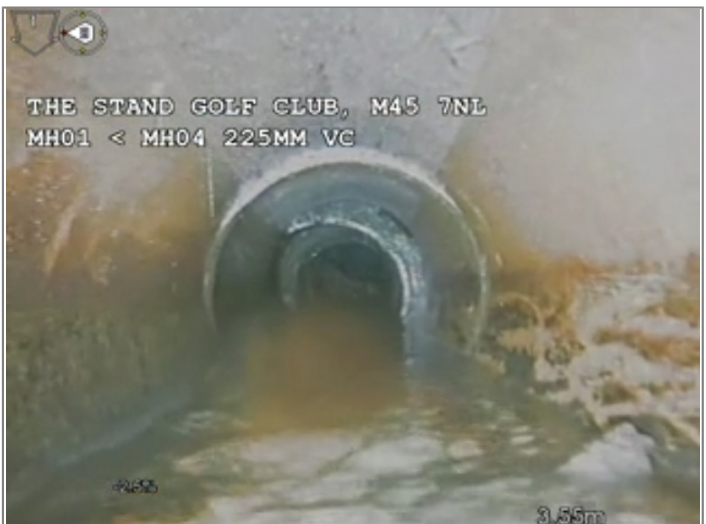
| Position | Code | Description | Photo | Type/Grade |
|---|---|---|---|---|
| 3.55 | DEE (F1) | Attached deposits, encrustation from 04 to 08 o'clock 25% cross-sectional area loss, Finished | 10978090 | Service / 4 |

Attached deposits, encrustation from 04 to 08 o'clock 25% cross-sectional area loss, Finished

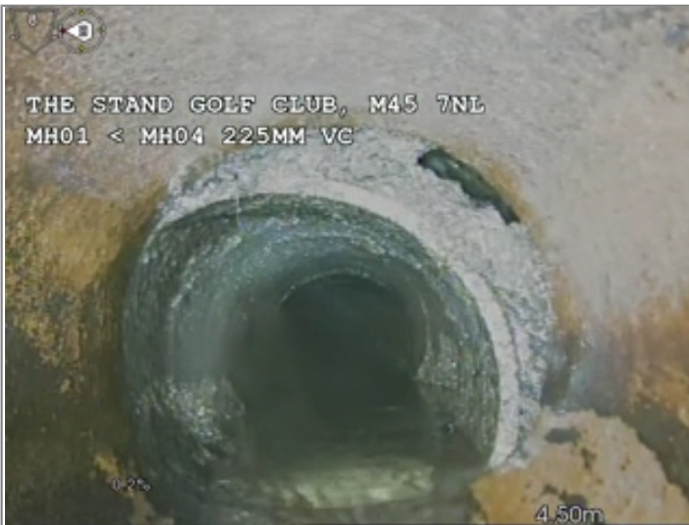
| Position | Code | Description | Photo | Type/Grade |
|---|---|---|---|---|
| 4.50 | OJL | Open joint large | 10978100 | Structural / 1 |

Open joint large

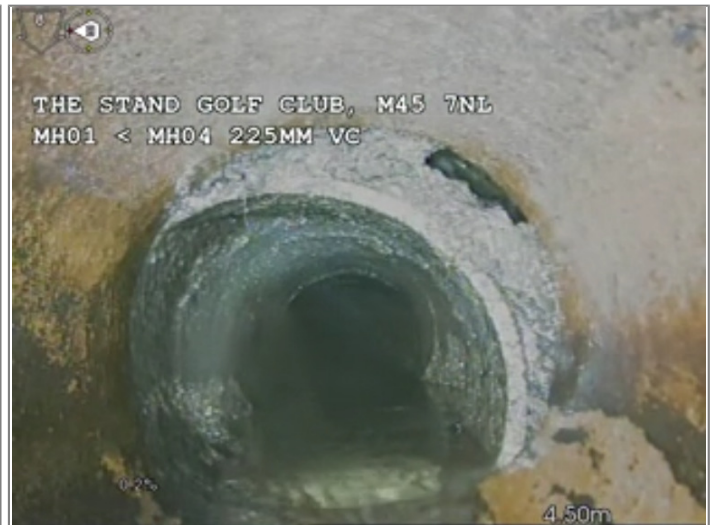
| Position | Code | Description | Photo | Type/Grade |
|---|---|---|---|---|
| 4.50 | JDL | Joint displaced large | 10978105 | Structural / 1 |

Joint displaced large

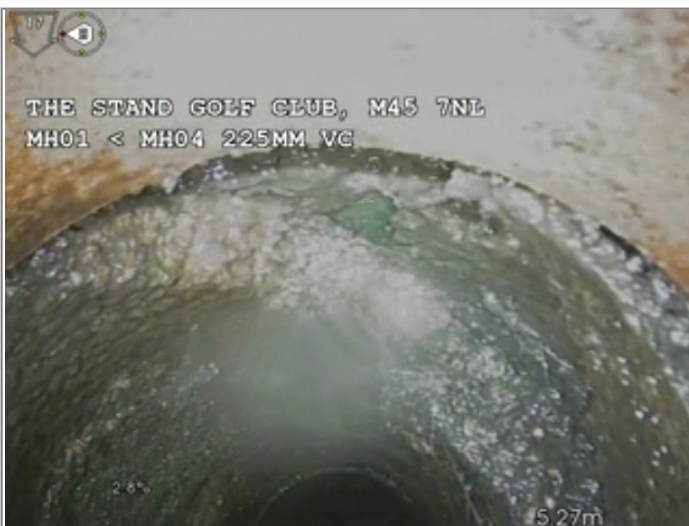
| Position | Code | Description | Photo | Type/Grade |
|---|---|---|---|---|
| 5.27 | IRJ | Infiltration running at 12 o'clock at joint | 10978111 | Service / 4 |

Infiltration running at 12 o'clock at joint

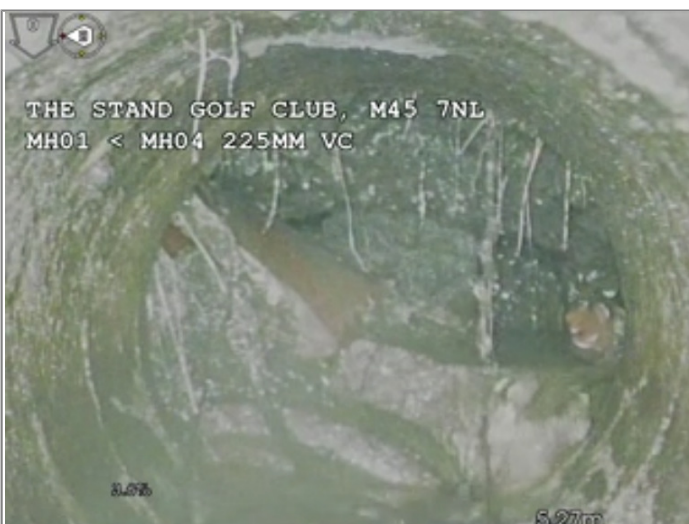
| Position | Code | Description | Photo | Type/Grade |
|---|---|---|---|---|
| 5.27 | XP | Collapsed drain/sewer 95% - Remark: PLEASE NOTE COLLAPSED DRIAN IS APPROX 3-5M FROM CCTV | 10978125 | Structural / 5 |

Collapsed drain/sewer 95% - Remark: PLEASE NOTE COLLAPSED DRAIN IS APPROX 3-5M FROM CCTV

| <p>5: Pipe is already or will shortly be impermeable: Eg. collapsed pipe, deeply rooted pipe or other drainage obstructions. Pipe loses water or danger of backwater in basements etc.</p> <p><b>REHABILITATION IS URGENT AND SHORT-TERM. IN ORDER TO PREVENT FURTHER DAMAGE,<br/>NECESSARY TEMPORARY SPOT REPAIR HAS TO BE CONDUCTED ON EMERGENCY LEVEL.</b></p> | | | |

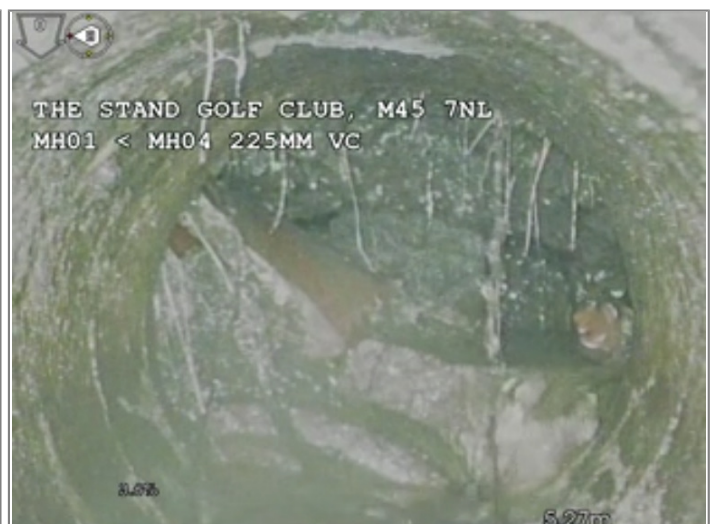
| Position | Code | Description | Photo | Type/Grade |
|---|---|---|---|---|
| 5.27 | SA | Survey abandoned - Remark: SA DUE TO COLLAPSED DRAIN. | 10978126 | Comment / 0 |

Survey abandoned - Remark: SA DUE TO COLLAPSED DRAIN.

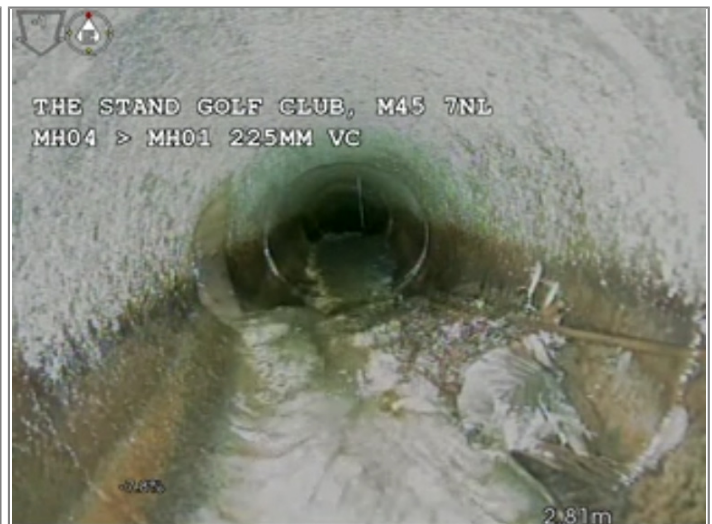
| Position | Code | Description | Photo | Type/Grade |
|---|---|---|---|---|
| 2.81 | RMJ | Roots mass 15% cross-sectional area loss at joint | 10978173 | Service / 3 |

Roots mass 15% cross-sectional area loss at joint

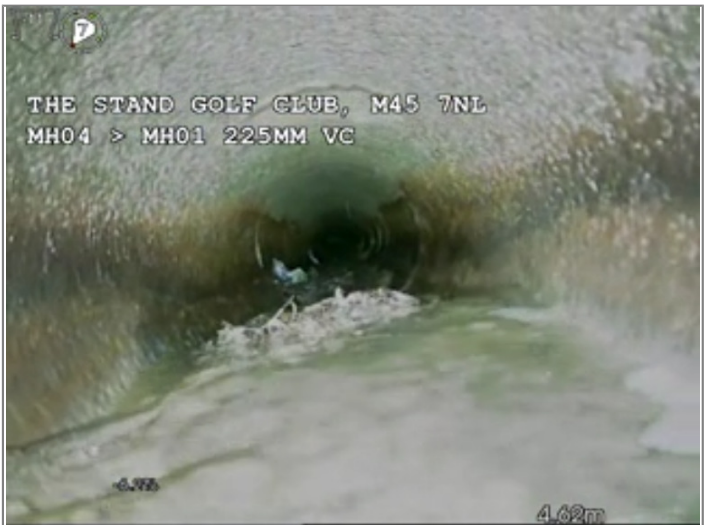
| Position | Code | Description | Photo | Type/Grade |
|---|---|---|---|---|
| 4.62 | RM | Roots mass 20% cross-sectional area loss | 10978195 | Service / 3 |

Roots mass 20% cross-sectional area loss

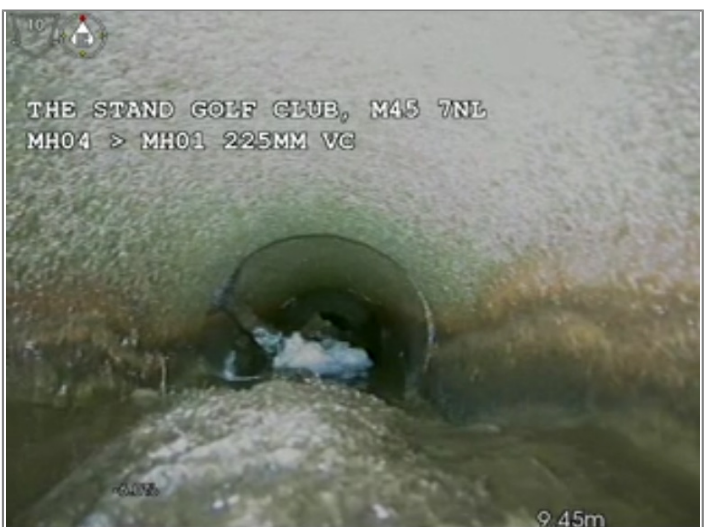
| Position | Code | Description | Photo | Type/Grade |
|---|---|---|---|---|
| 9.45 | RM | Roots mass 50% cross-sectional area loss | 10978219 | Service / 5 |

Roots mass 50% cross-sectional area loss

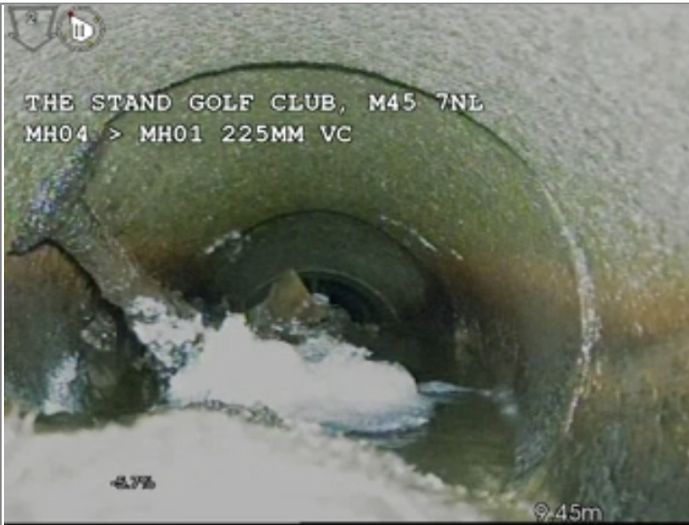
| Position | Code | Description | Photo | Type/Grade |
|---|---|---|---|---|
| 9.45 | RTJ | Roots tap at joint | 10978221 | Service / 4 |

Roots tap at joint

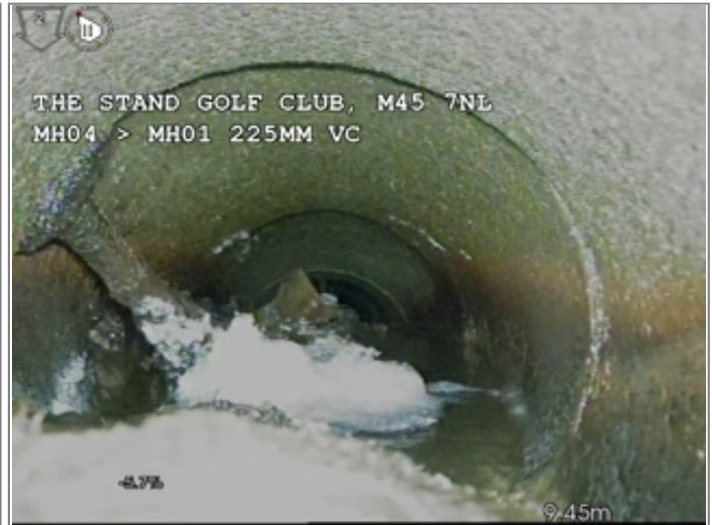
| Position | Code | Description | Photo | Type/Grade |
|---|---|---|---|---|
| 9.45 | SA | Survey abandoned - Remark: SA DUE TO ROOTS MASS 50% UNABLE TO PASS | 10978228 | Comment / 0 |

Survey abandoned - Remark: SA DUE TO ROOTS MASS 50% UNABLE TO PASS
