**Client:** Harry Jackson  
**Site:** Ferngrove House, Bury

## **Overview Report**

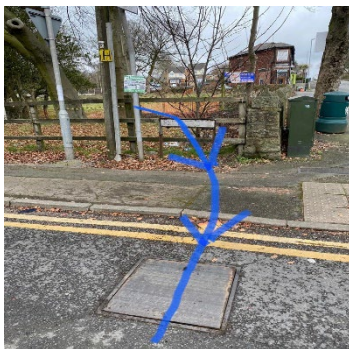
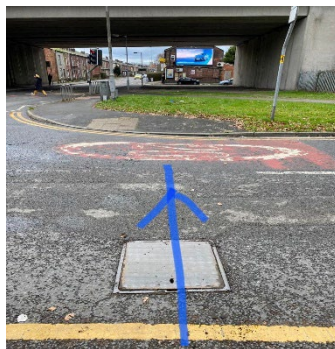
Our engineers attended site in order to carry out and complete a CCTV inspection to the exposed culvert on the site to determine the outfall location. Upon arrival we found the water level of the culvert to be above 50% therefore the camera unit was unable to obtain a clear image of the culvert, this being classed an incomplete survey. However, we can confirm that the culvert was flowing more than adequately despite the water level being above 50% of the diameter. We lifted a chamber cover located on Ferngrove and found this to be the next chamber downstream beyond/outside of the boundary. We were unable to locate the next chamber down for the run but would advise to contact the local authority or United utilities for any further information regarding the culvert as we understand it to not be the client/customer responsibility once the water course / drainage has left the site or crossed over a boundary line. See below the run of the culvert.
