## ASBESTOS DEMOLITION SURVEY

Former Soap Works, Kenyon St Works, Kenyon St, Ramsbottom, BL0 0AB

PROJECT NO. 70064333 -- 70043831

DATE: September 2019

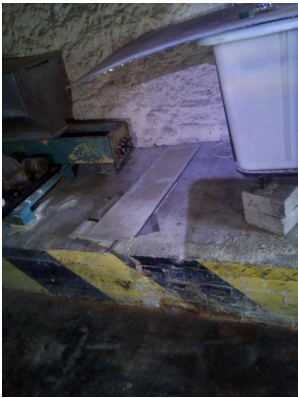
| Location | Item Description | Extent / Quantity | Product Type | Damage Extent | Surface Treatment | Asbestos Type | Material Assessment Total | Material Risk Rating | Accessibility | Sample Reference | Asbestos Identification | Recommendations / Comments | Photographs |
|---|---|---|---|---|---|---|---|---|---|---|---|---|---|
| Administration Building<br>Ground Floor<br>020 Warehouse | Cement debris to left wall | 2 m² | 1 | 2 | 1 | 1 | 5 | Low | High | 70043831/JM018 | Chrysotile | Remove<br><br>Concrete floor, brick walls, mmmf pipe insulation, fibreboard ceiling, metal & wood primary ceiling. | |

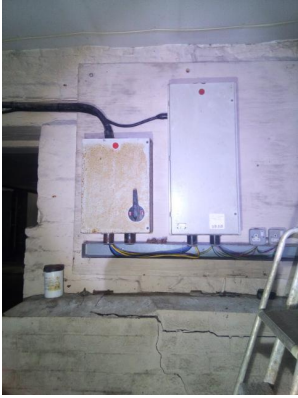
| Location | Item Description | Extent / Quantity | Product Type | Damage Extent | Surface Treatment | Asbestos Type | Material Assessment Total | Material Risk Rating | Accessibility | Sample Reference | Asbestos Identification | Recommendations / Comments | Photographs |
|---|---|---|---|---|---|---|---|---|---|---|---|---|---|
| Administration Building<br>Ground Floor<br>020 Warehouse | Flashguards to electrics | 2 boxes No. | 2 | 1 | 1 | 1 | 5 | Low | High | As70026829/MC007 | Chrysotile | Remove | |

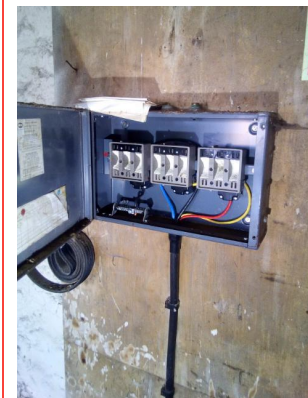
| Location | Item Description | Extent / Quantity | Product Type | Damage Extent | Surface Treatment | Asbestos Type | Material Assessment Total | Material Risk Rating | Accessibility | Sample Reference | Asbestos Identification | Recommendations / Comments | Photographs |
|---|---|---|---|---|---|---|---|---|---|---|---|---|---|
| Administration Building<br>1st Floor<br>014 Store | Flashguards | 9 No. | 2 | 1 | 2 | 1 | 6 | Low | Med | 70043831/JM020 | Chrysotile | Remove | |

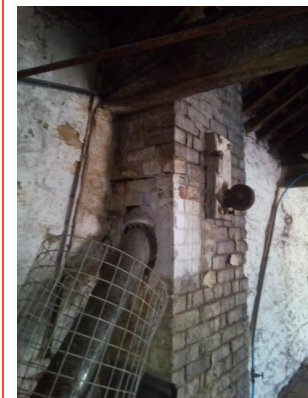
| Location | Item Description | Extent / Quantity | Product Type | Damage Extent | Surface Treatment | Asbestos Type | Material Assessment Total | Material Risk Rating | Accessibility | Sample Reference | Asbestos Identification | Recommendations / Comments | Photographs |
|---|---|---|---|---|---|---|---|---|---|---|---|---|---|
| Administration Building<br>1st Floor<br>014 Store | Cement cowl to top of metal flue from boiler | 4 lm | 1 | 1 | 1 | 1 | 4 | Very Low | High | 70043831/JM021 | Chrysotile | Remove<br>Cowl - Flue goes up into chimney. | |

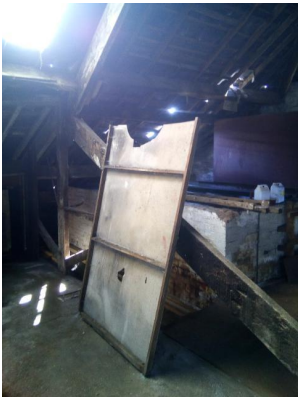
| Location | Item Description | Extent / Quantity | Product Type | Damage Extent | Surface Treatment | Asbestos Type | Material Assessment Total | Material Risk Rating | Accessibility | Sample Reference | Asbestos Identification | Recommendations / Comments | Photographs |
|---|---|---|---|---|---|---|---|---|---|---|---|---|---|
| Administration Building<br>1st Floor<br>014 Warehouse Store | Cement panel | 2 m <sup>2</sup> | 1 | 2 | 1 | 1 | 5 | Low | High | 70026829/MC008 | Chrysotile | <b>Remove</b><br><br>Metal and wooden floor, brick walls, metal tanks, slate underside to roof, metal flue, plastic water tanks, wooden panel to rear of electrics. | |

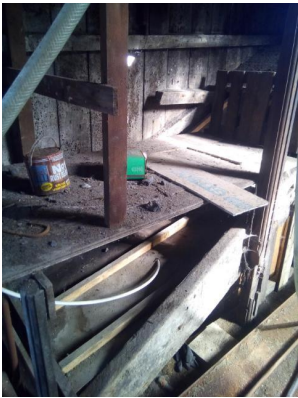
| Location | Item Description | Extent / Quantity | Product Type | Damage Extent | Surface Treatment | Asbestos Type | Material Assessment Total | Material Risk Rating | Accessibility | Sample Reference | Asbestos Identification | Recommendations / Comments | Photographs |
|---|---|---|---|---|---|---|---|---|---|---|---|---|---|
| Administration Building<br>1st Floor<br>014 Warehouse Store | Cement panel to door used as a shelf | 2 m <sup>2</sup> | 1 | 2 | 1 | 1 | 5 | Low | High | As70026829/MC008 | Chrysotile | Remove | |

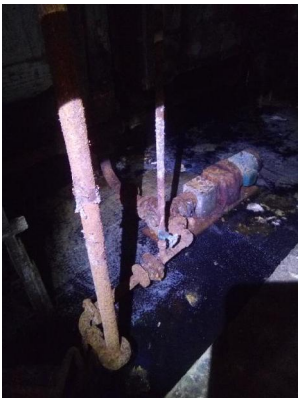
| Location | Item Description | Extent / Quantity | Product Type | Damage Extent | Surface Treatment | Asbestos Type | Material Assessment Total | Material Risk Rating | Accessibility | Sample Reference | Asbestos Identification | Recommendations / Comments | Photographs |
|---|---|---|---|---|---|---|---|---|---|---|---|---|---|
| Main Factory Basement<br>001 Basement | No access | - | - | - | - | - | - | - | - | Presumed 01 | Presumed Asbestos | <p>Further investigation required, presume asbestos present until accessed<br/>No access due to Flood water.<br/>Unknown depth.</p> <p>Care should be taken during demolition and work stopped if suspect material are discovered</p> | |

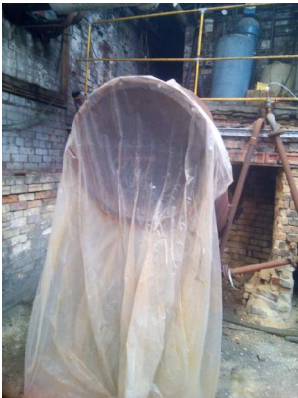
| Location | Item Description | Extent / Quantity | Product Type | Damage Extent | Surface Treatment | Asbestos Type | Material Assessment Total | Material Risk Rating | Accessibility | Sample Reference | Asbestos Identification | Recommendations / Comments | Photographs |
|---|---|---|---|---|---|---|---|---|---|---|---|---|---|
| Main Factory Ground Floor<br>001 Boiler House | Rope gasket to flue and penetration through brick wall | 2 x 2 lm | 2 | 1 | 1 | 1 | 5 | Low | High | 70026829/MC015 | Chrysotile | Remove | |

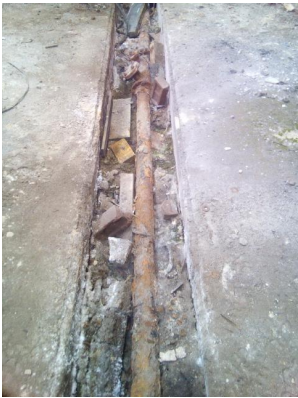
| Location | Item Description | Extent / Quantity | Product Type | Damage Extent | Surface Treatment | Asbestos Type | Material Assessment Total | Material Risk Rating | Accessibility | Sample Reference | Asbestos Identification | Recommendations / Comments | Photographs |
|---|---|---|---|---|---|---|---|---|---|---|---|---|---|
| Main Factory Ground Floor<br>001 Boiler House | Composite sample to pipe in floor duct | 4 m <sup>2</sup> | 3 | 3 | 2 | 1 | 9 | Med | High | 70026829/MC016 | Chrysotile | Remove | |

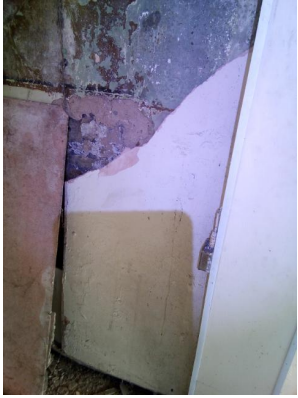
| Location | Item Description | Extent / Quantity | Product Type | Damage Extent | Surface Treatment | Asbestos Type | Material Assessment Total | Material Risk Rating | Accessibility | Sample Reference | Asbestos Identification | Recommendations / Comments | Photographs |
|---|---|---|---|---|---|---|---|---|---|---|---|---|---|
| Main Factory Ground Floor 003 Office | Cement panel to external wall | 5 m <sup>2</sup> | 1 | 2 | 1 | 1 | 5 | Low | High | 70043831/JM001 | Chrysotile | Remove | |

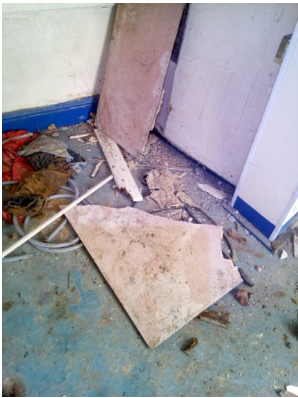
| Location | Item Description | Extent / Quantity | Product Type | Damage Extent | Surface Treatment | Asbestos Type | Material Assessment Total | Material Risk Rating | Accessibility | Sample Reference | Asbestos Identification | Recommendations / Comments | Photographs |
|---|---|---|---|---|---|---|---|---|---|---|---|---|---|
| Main Factory Ground Floor 003 Office | Cement debris to floor | 2 m <sup>2</sup> | 1 | 3 | 1 | 1 | 6 | Low | High | As 70043831/JM001 | Chrysotile | Remove | |

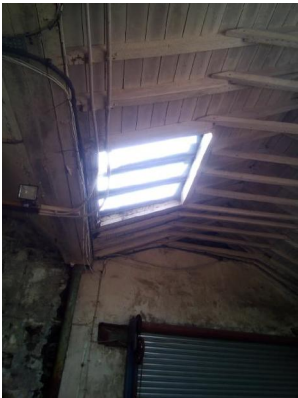
| Location | Item Description | Extent / Quantity | Product Type | Damage Extent | Surface Treatment | Asbestos Type | Material Assessment Total | Material Risk Rating | Accessibility | Sample Reference | Asbestos Identification | Recommendations / Comments | Photographs |
|---|---|---|---|---|---|---|---|---|---|---|---|---|---|
| Main Factory Ground Floor<br>005 Loading Bay | Rope seal to skylights | 6 m <sup>2</sup> | 2 | 1 | 2 | 1 | 6 | Low | High | 70028629/MC006 | Chrysotile | Remove | |

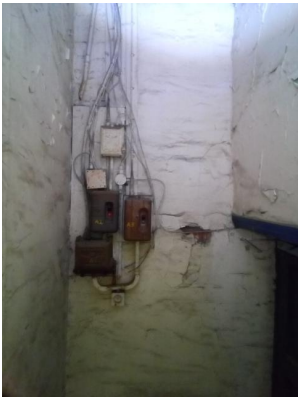
| Location | Item Description | Extent / Quantity | Product Type | Damage Extent | Surface Treatment | Asbestos Type | Material Assessment Total | Material Risk Rating | Accessibility | Sample Reference | Asbestos Identification | Recommendations / Comments | Photographs |
|---|---|---|---|---|---|---|---|---|---|---|---|---|---|
| Main Factory Ground Floor 006 Entrance | Flashguards to electrics | 3 No. | 2 | 1 | 2 | 1 | 6 | Low | High | As70026829/MC007 | Chrysotile | Remove | |

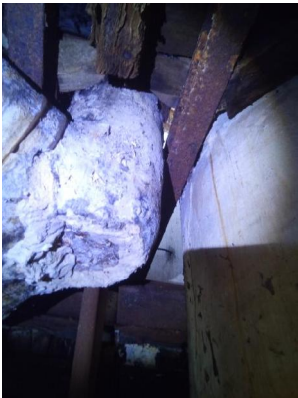
| Location | Item Description | Extent / Quantity | Product Type | Damage Extent | Surface Treatment | Asbestos Type | Material Assessment Total | Material Risk Rating | Accessibility | Sample Reference | Asbestos Identification | Recommendations / Comments | Photographs |
|---|---|---|---|---|---|---|---|---|---|---|---|---|---|
| Main Factory Ground Floor<br>016 Underside of Tanks | Pipe insulation next to vessels | 4 lm | 3 | 3 | 2 | 2 | 10 | High | High | As70026829/MC024 | Amosite, Chrysotile | <b>Remove</b> | |

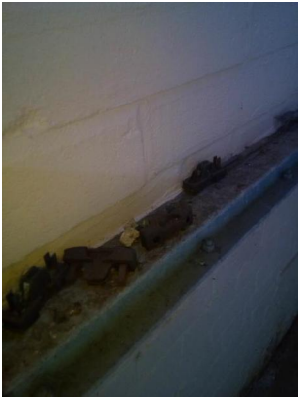
| Location | Description | Extent | Recommendation |
|---|---|---|---|
| Main Factory<br>Ground Floor<br>018 Fragrance Lab | Loose flashguard to steel work | 1 No. | Remove |

| Location | Item Description | Extent / Quantity | Product Type | Damage Extent | Surface Treatment | Asbestos Type | Material Assessment Total | Material Risk Rating | Accessibility | Sample Reference | Asbestos Identification | Recommendations / Comments | Photographs |
|---|---|---|---|---|---|---|---|---|---|---|---|---|---|
| Main Factory Ground Floor<br>018 Fragrance Lab | Loose flashguard to steel work | 1 No. | 2 | 2 | 2 | 1 | 7 | Med | High | As 70026829/MC007 | Chrysotile | <p><b>Remove</b></p> <p>Concrete floor, brick walls, steel wall supports, compressed card ceiling tiles, wooden primary ceiling, modern sink pad.</p> | |

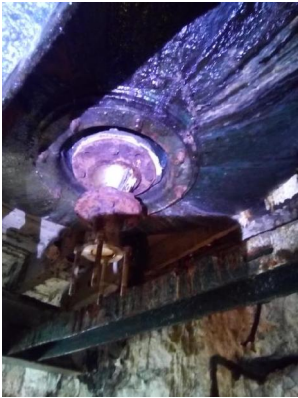
| Location | Item Description | Extent / Quantity | Product Type | Damage Extent | Surface Treatment | Asbestos Type | Material Assessment Total | Material Risk Rating | Accessibility | Sample Reference | Asbestos Identification | Recommendations / Comments | Photographs |
|---|---|---|---|---|---|---|---|---|---|---|---|---|---|
| Main Factory Ground Floor<br>020 Former P16 Soap kettle area | Fibreboard gasket to flange on underside of vessel | 1 No. | 2 | 2 | 2 | 1 | 7 | Med | High | 70043831/JM005 | Chrysotile | <b>Remove</b><br><br>Concrete floor, brick walls, fibreboard and wooden ceiling, exposed metal pipes, | |

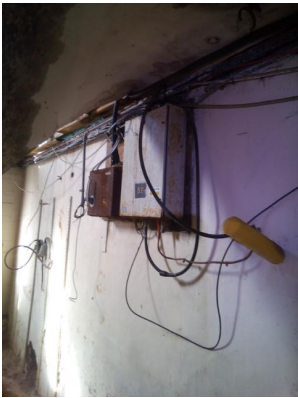
| Location | Item Description | Extent / Quantity | Product Type | Damage Extent | Surface Treatment | Asbestos Type | Material Assessment Total | Material Risk Rating | Accessibility | Sample Reference | Asbestos Identification | Recommendations / Comments | Photographs |
|---|---|---|---|---|---|---|---|---|---|---|---|---|---|
| Main Factory Ground Floor<br>020 Former P16 Soap kettle area | Flashguard to electrcs | 2 boxes No. | 2 | 2 | 2 | 1 | 7 | Med | High | As 70026829/MC007 | Chrysotile | Remove | |

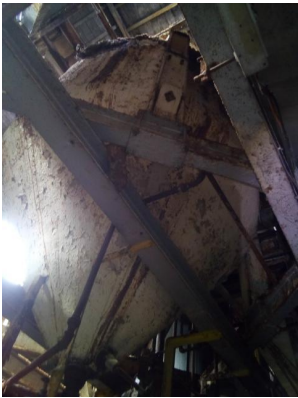
| Location | Item Description | Extent / Quantity | Product Type | Damage Extent | Surface Treatment | Asbestos Type | Material Assessment Total | Material Risk Rating | Accessibility | Sample Reference | Asbestos Identification | Recommendations / Comments | Photographs |
|---|---|---|---|---|---|---|---|---|---|---|---|---|---|
| Main Factory Ground Floor<br>023 Former Tank room 3 | Insulation to large white vessel | 20 m <sup>2</sup> | 3 | 2 | 2 | 2 | 9 | Med | High | 70026829/MC026 | Amosite, Chrysotile | Remove | |

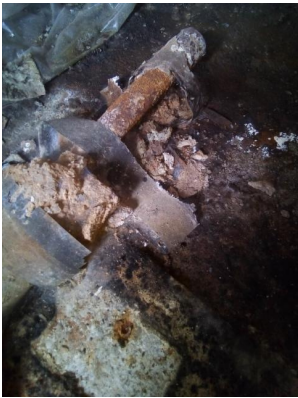
| Location | Item Description | Extent / Quantity | Product Type | Damage Extent | Surface Treatment | Asbestos Type | Material Assessment Total | Material Risk Rating | Accessibility | Sample Reference | Asbestos Identification | Recommendations / Comments | Photographs |
|---|---|---|---|---|---|---|---|---|---|---|---|---|---|
| Main Factory Ground Floor<br>025 Caustic soda & bleachers room | Pipe insulation debris to floor | 6 m² | 3 | 3 | 3 | 3 | 12 | High | High | 70026829/MC029 | Crocidolite, Amosite & Chrysotile | <b>Remove, Restrict access until made safe</b> | |

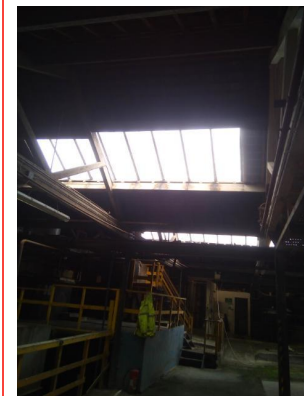
| Location | Item Description | Extent / Quantity | Product Type | Damage Extent | Surface Treatment | Asbestos Type | Material Assessment Total | Material Risk Rating | Accessibility | Sample Reference | Asbestos Identification | Recommendations / Comments | Photographs |
|---|---|---|---|---|---|---|---|---|---|---|---|---|---|
| Main Factory Ground Floor<br>025 Caustic soda & bleachers room | Rope seal to skylights | 60 Windows No. | 2 | 1 | 2 | 1 | 6 | Low | Med | As70026829/MC006 | Chrysotile | Remove | |

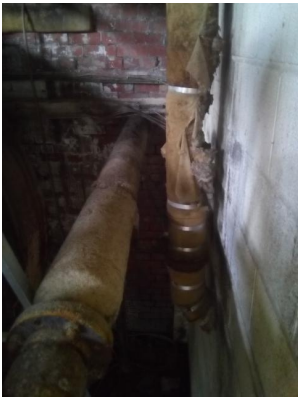
| Location | Item Description | Extent / Quantity | Product Type | Damage Extent | Surface Treatment | Asbestos Type | Material Assessment Total | Material Risk Rating | Accessibility | Sample Reference | Asbestos Identification | Recommendations / Comments | Photographs |
|---|---|---|---|---|---|---|---|---|---|---|---|---|---|
| Main Factory Ground Floor<br>025 Caustic soda & bleachers room | Pipe insulation | 5 lm | 3 | 2 | 2 | 2 | 9 | Med | | As70026829/MC025 | Amosite, Chrysotile | <b>Remove</b><br>Next to where tank 15 - Continues with lagged mmmf. | |

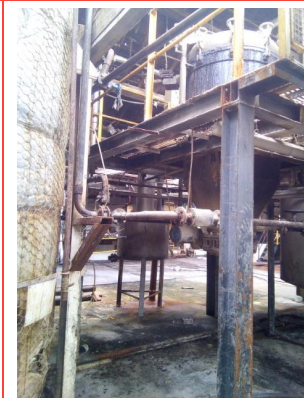
| Location | Item Description | Extent / Quantity | Product Type | Damage Extent | Surface Treatment | Asbestos Type | Material Assessment Total | Material Risk Rating | Accessibility | Sample Reference | Asbestos Identification | Recommendations / Comments | Photographs |
|---|---|---|---|---|---|---|---|---|---|---|---|---|---|
| Main Factory Ground Floor<br>027 Pipework throughout | Gaskets | Throug<br>hout<br>No. | 2 | 1 | 1 | 1 | 5 | Low | High | As70026829/MC014 | Chrysotile | Remove | |

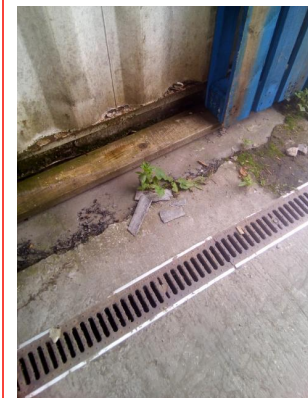
| Location | Item Description | Extent / Quantity | Product Type | Damage Extent | Surface Treatment | Asbestos Type | Material Assessment Total | Material Risk Rating | Accessibility | Sample Reference | Asbestos Identification | Recommendations / Comments | Photographs |
|---|---|---|---|---|---|---|---|---|---|---|---|---|---|
| Old Forklift Shed<br>Ground Floor<br>001 Shed | Cement debris to floor | 1 m <sup>2</sup> | 1 | 2 | 1 | 1 | 5 | Low | High | As70026829/MC028 | Chrysotile | Remove | |
