| <b>BAY 23. EXISTING CONDITION AND REMEDIAL WORKS.</b> | | | |

### **3.2 Condition of the External Fabric and Methodology of Survey**

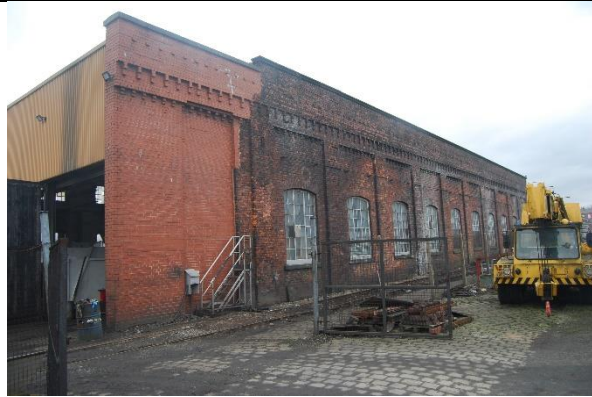
SE.05 (Bays 29a to 20a)

- i. There are a number of perished bricks requiring replacement, estimate circa 30m<sup>2</sup>.
- ii. The elevation is in need of re-pointing as follows:
  - The upper section of the brickwork requires repointing from the lower corbel level to coping level.
  - A number of pilasters require partial repointing circa 35m<sup>2</sup>.
  - Repoint all copings.
- iii. Overhaul all timber windows
- iv. Allow for removing a number of corroding iron brackets across the elevation and making good.

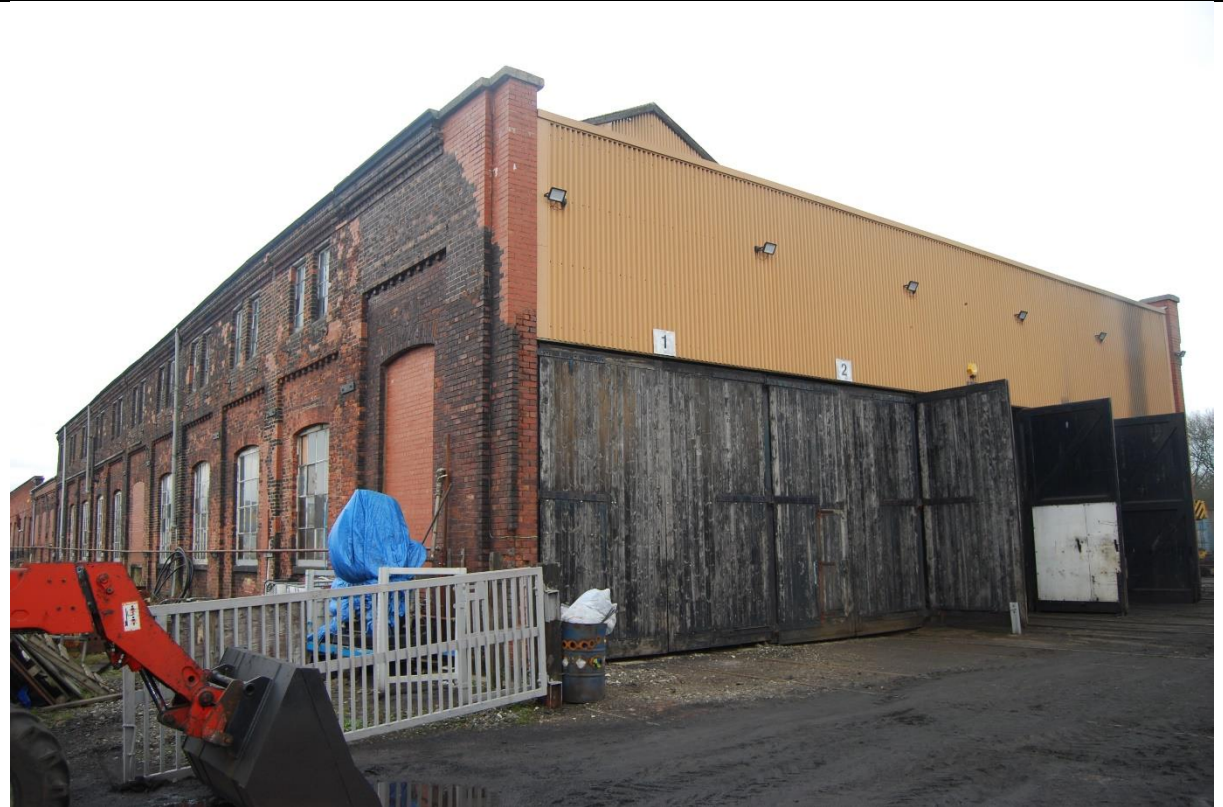
SE.01

The profiled metal cladding is in a serviceable condition. The timber access doors are aged and perished and require renewal.

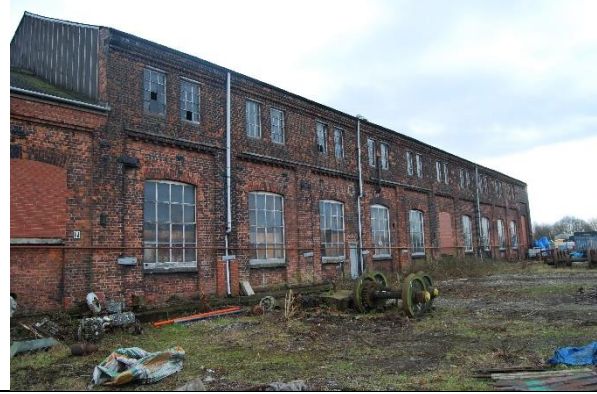
W.01 (Bays 19 to 29)

- i. There are a number of perished bricks requiring replacement, estimate circa 30m<sup>2</sup>.
- ii. The elevation is in need of 50% re-pointing and the following:
  - The upper section of the brickwork requires repointing from the lower corbel level to coping level.
- iii. Overhaul all timber windows
- iv. Allow for removing a number of corroding iron brackets across the elevation and making good.
- v. Replace up to 20m<sup>2</sup> perished bricks.
- vi. Replace existing rainwater goods with powder coated aluminium.

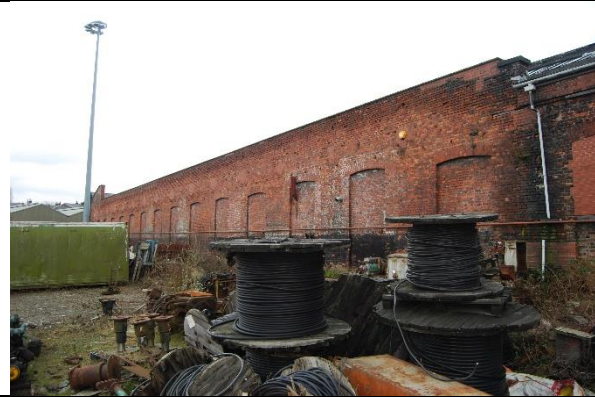
W.03 (Bays 1 - 15)

- i. There are a number of perished bricks requiring replacement, estimate 30-40m<sup>2</sup>.
- ii. The elevation is in need of re-pointing as follows:
  - Re-point the upper 33 courses of brickwork, elsewhere 50% repoint
- iii. Rainwater goods comprise of PVC to Bays 16, 17 & 18, replace with aluminium ogee and new downpipes. Include for new timber fascia.
- iv. Take off a re-bed all existing copings to Bays 3 to 15.
- v. Allow for removing a number of corroding iron brackets across the elevation and making good.
