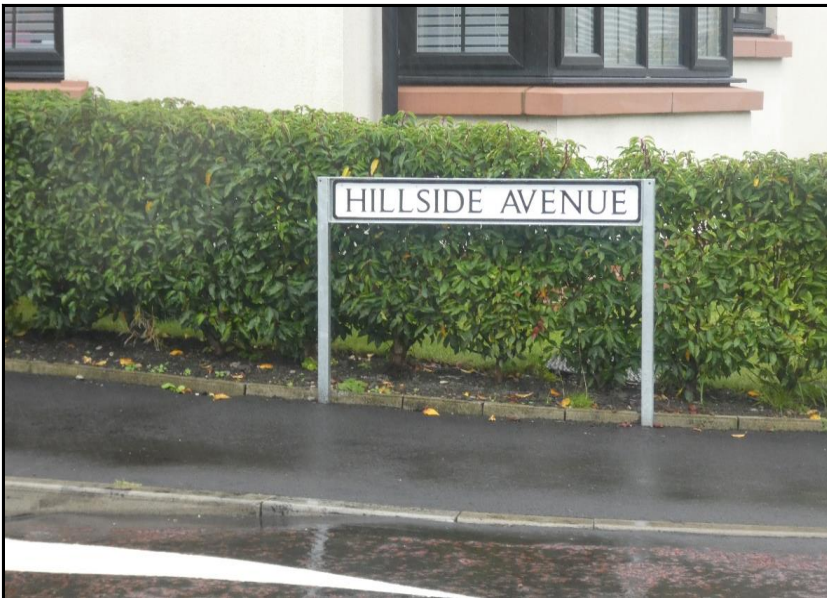
Photograph 1. Hillside Avenue adjoining George Street

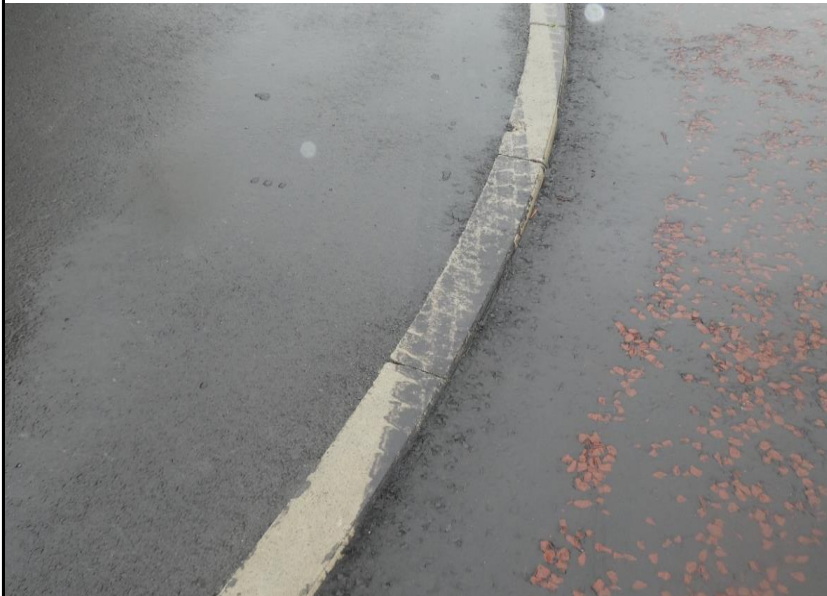
Photograph 3. Kerbing is stained and marked on both sides of the roadway

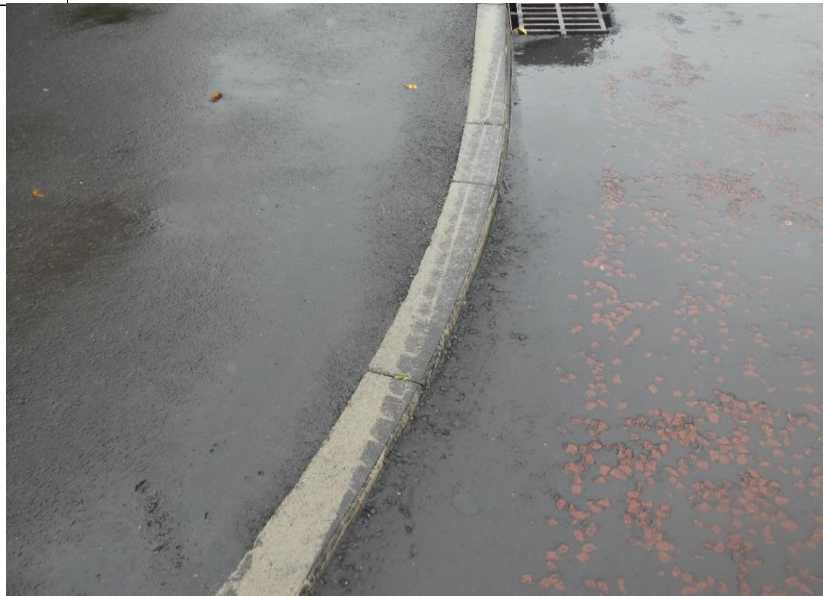
Photograph 4. Kerbing is stained and marked on both sides of the roadway

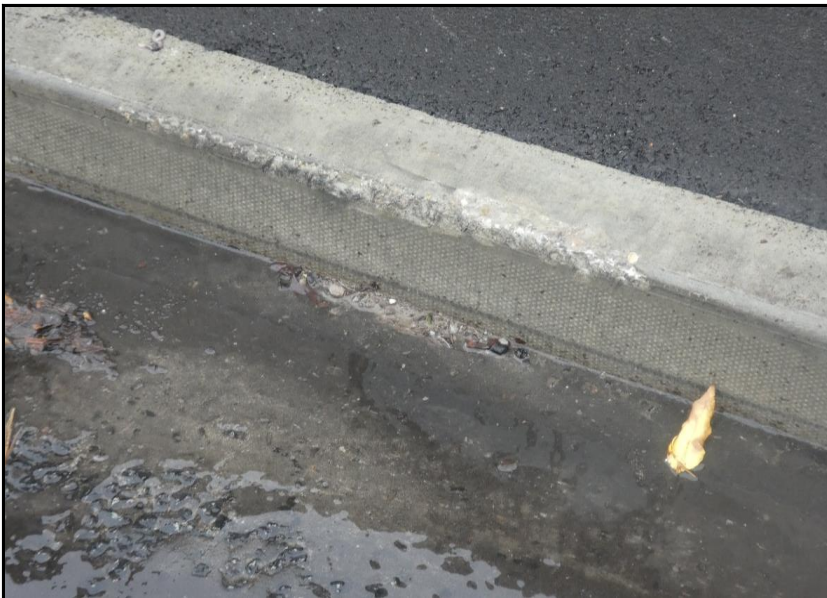
Photograph 5. Localised impact damage to the kerbs

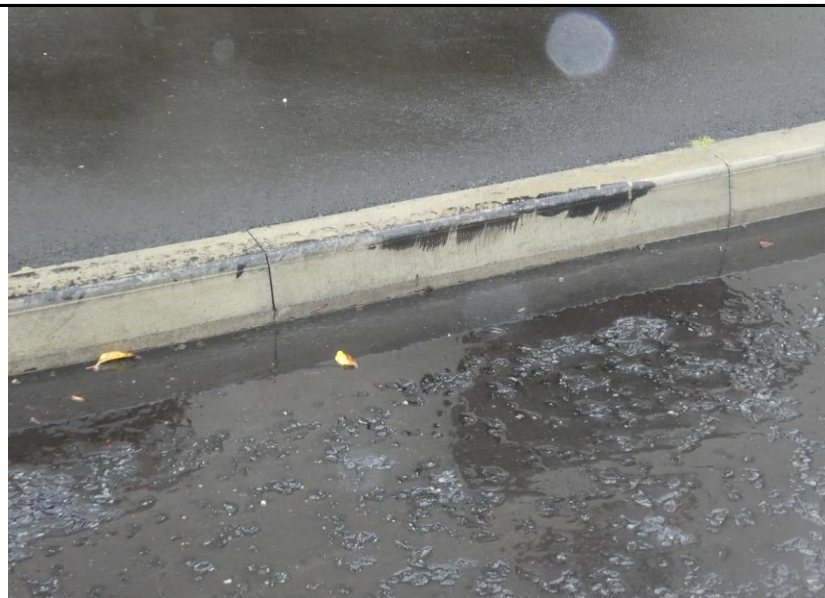
Photograph 6. Staining the kerbing

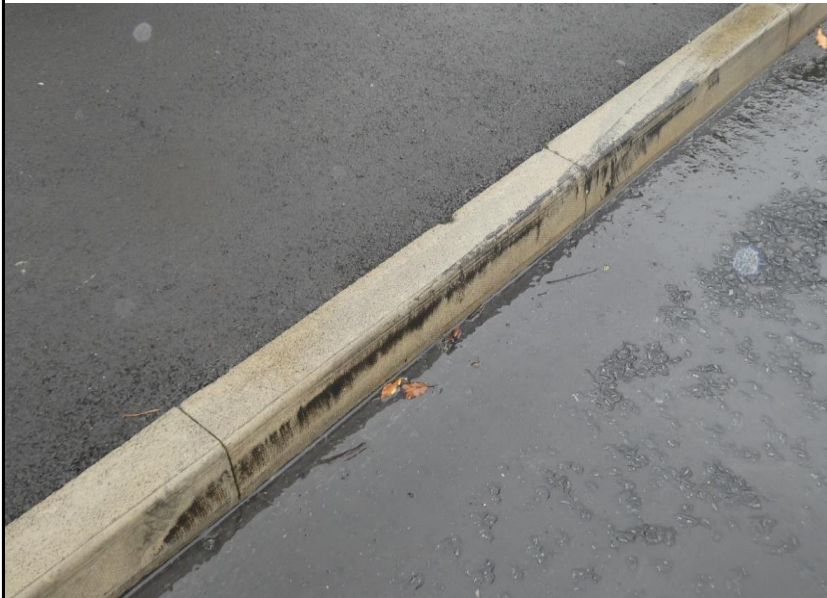
Photograph 7. Staining to the kerbing

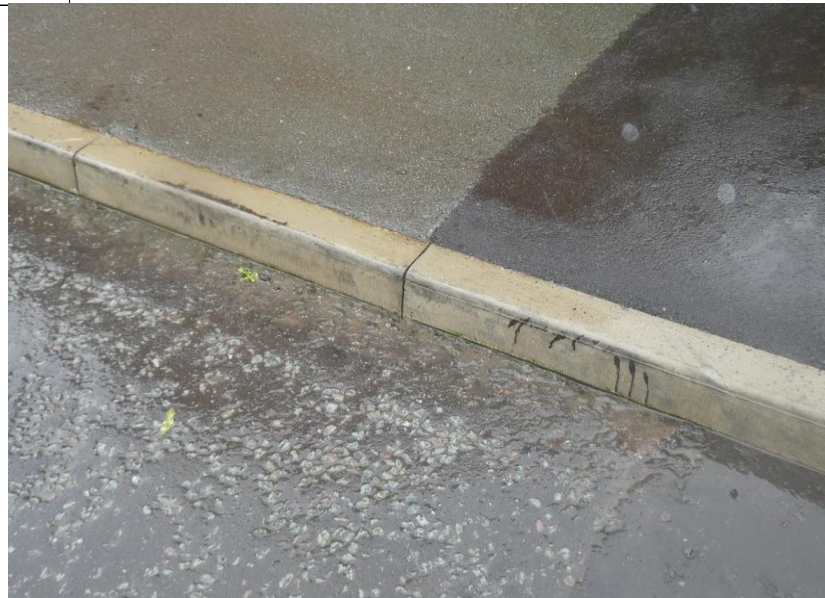
Photograph 8. Staining to the kerbing

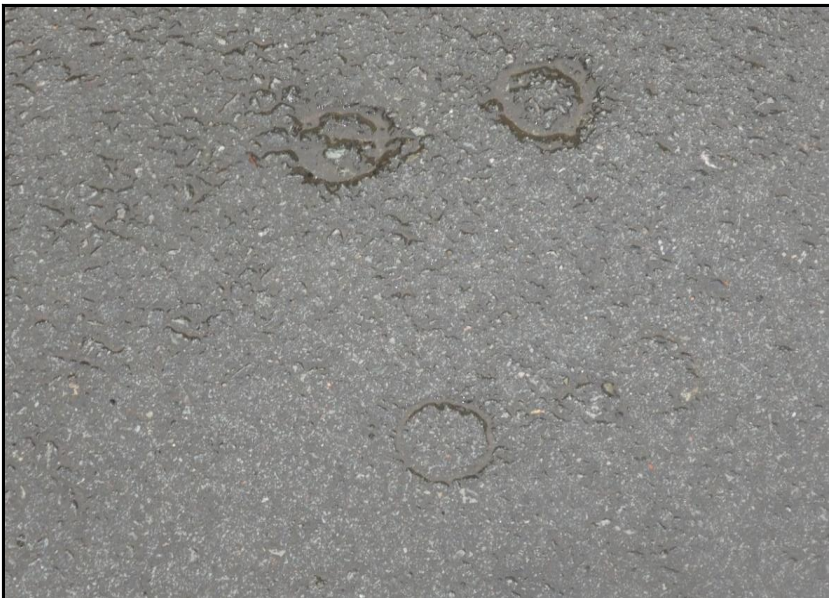
Photograph 9. Localised indentations to footpath areas

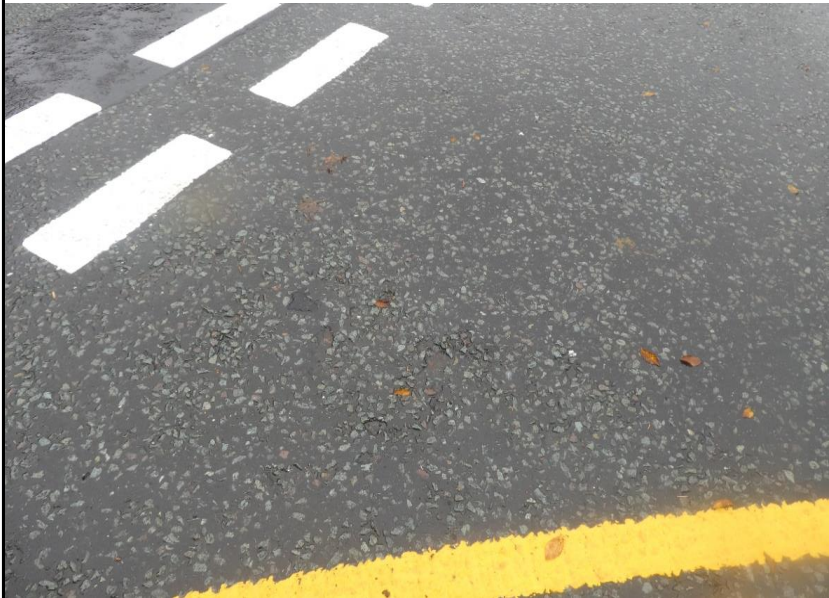
Photograph 11. Minor erosion to the surfacing at the junction with George Street.

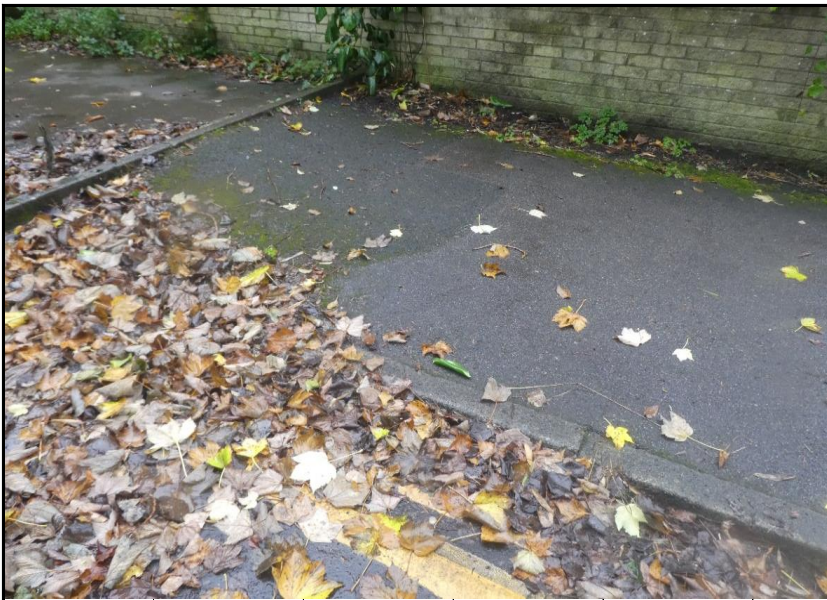
Photograph 13. Tarmacadam surfacing to the footpath

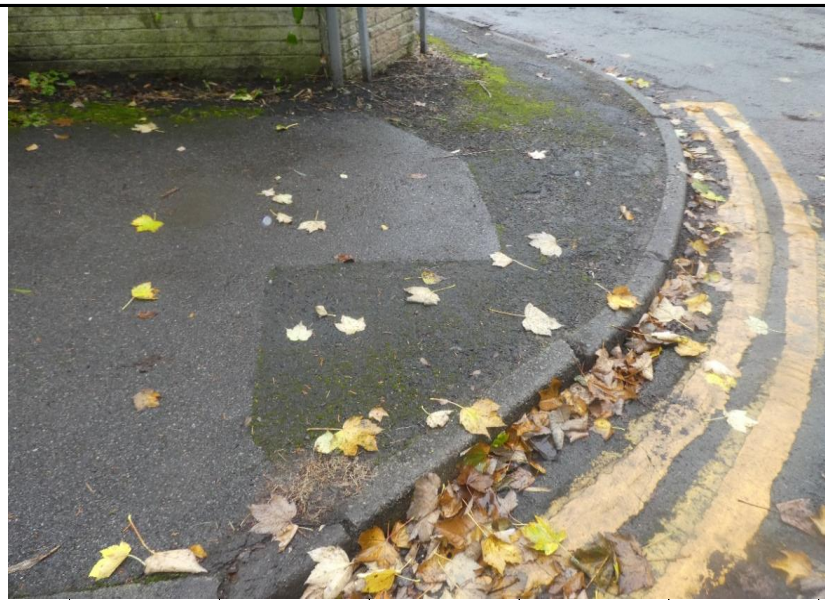
Photograph 14. Localised damage and settlement to the concrete kerbs

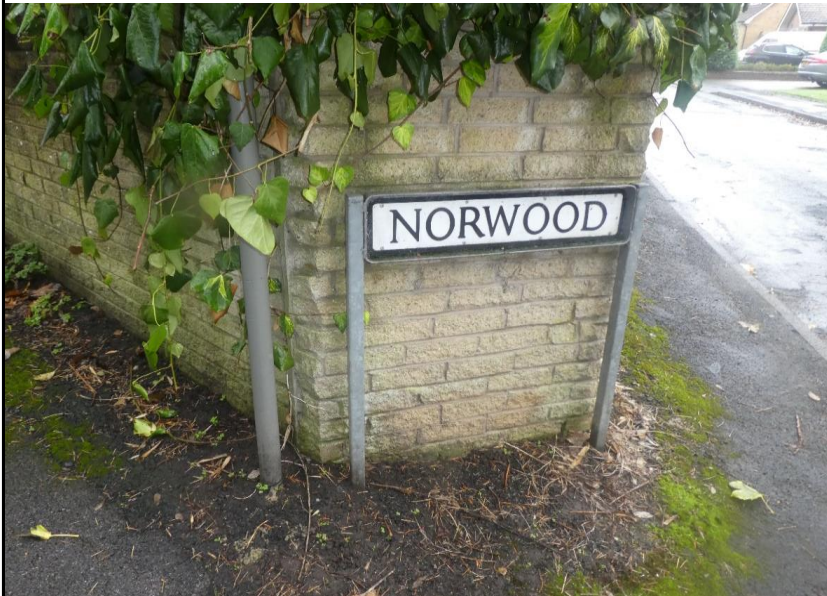
Photograph 15. Norwood located directly to the north of the site entrance

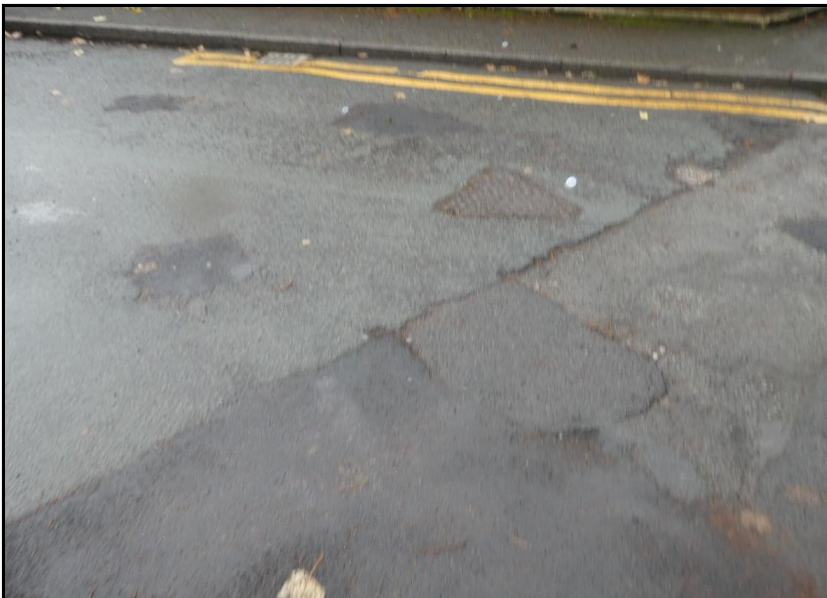
Photograph 17. Localised reinstatement of road surfacing to Norwood junction slightly eroded

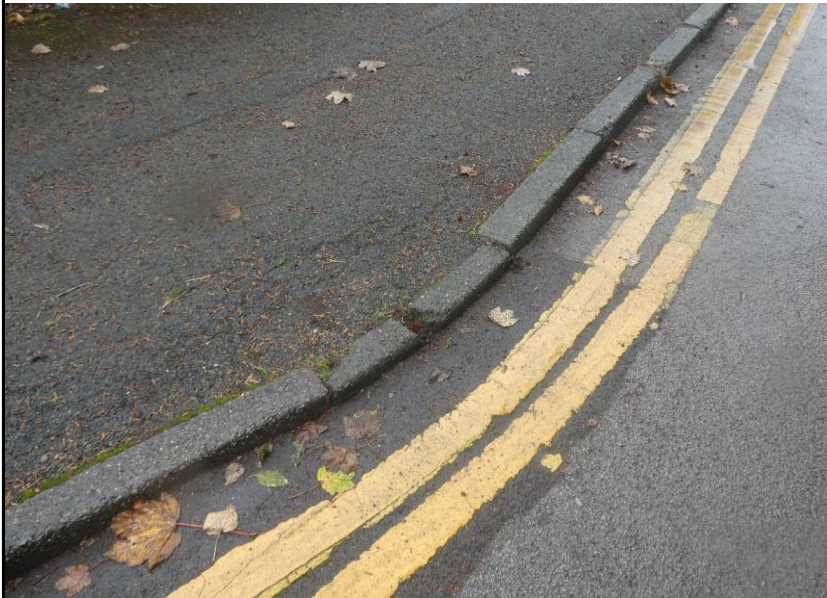
Photograph 19. Damaged and uneven kerbs to Norwood junction

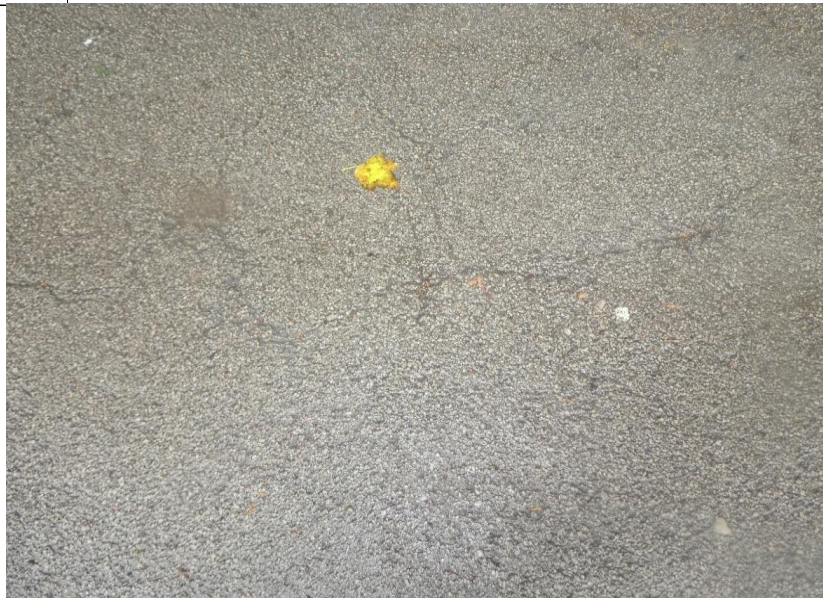
Photograph 20. Localised cracking to road surface

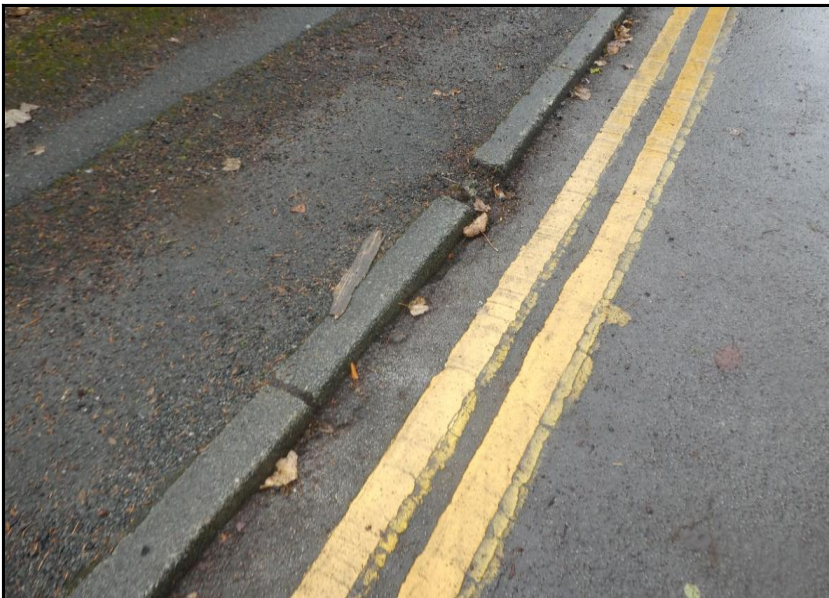
Photograph 21. Uneven and damaged kerb to George Street

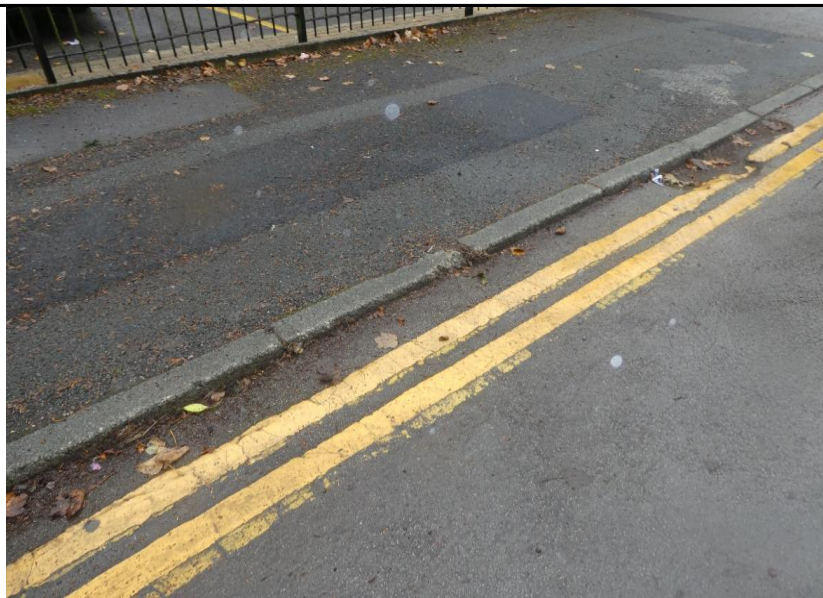
Photograph 22. Uneven and damaged kerb to George Street

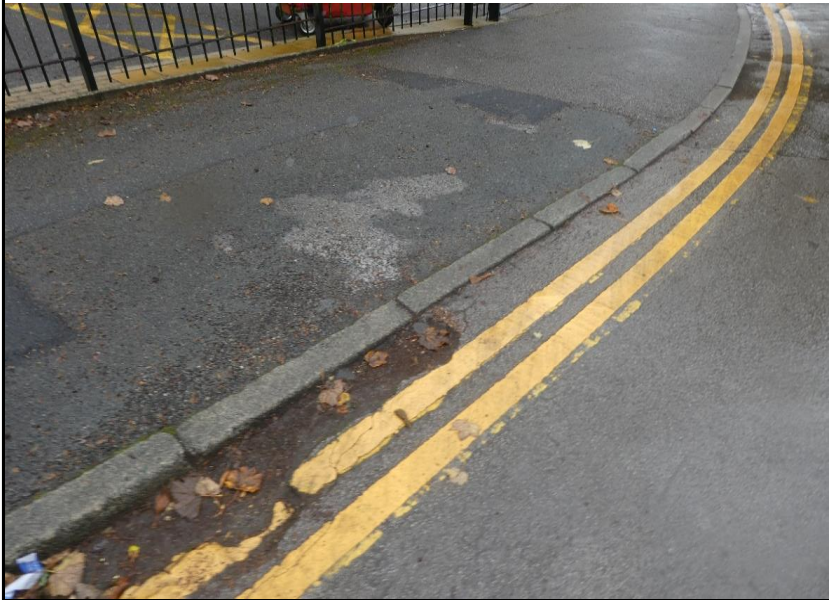
Photograph 23. Uneven and damaged kerb to George Street

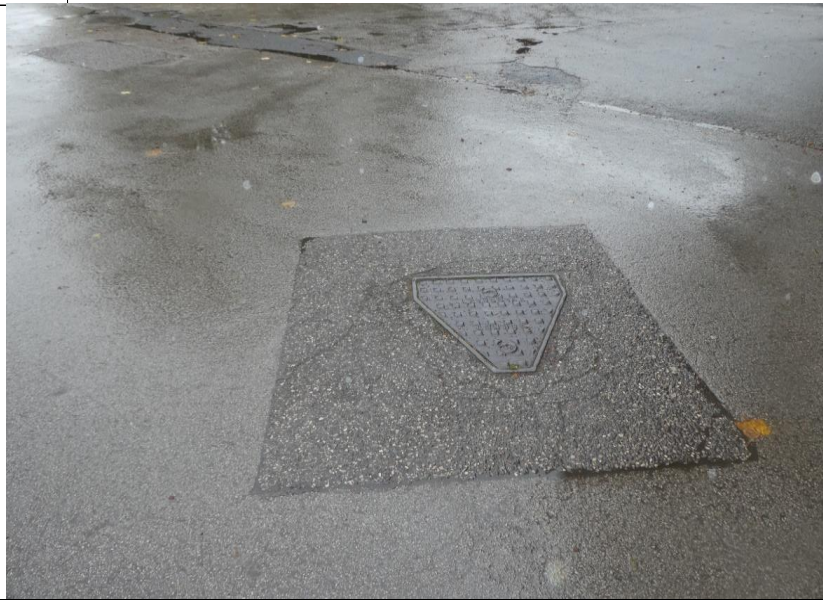
Photograph 24. Reinstatement to inspection chamber cracked and eroding

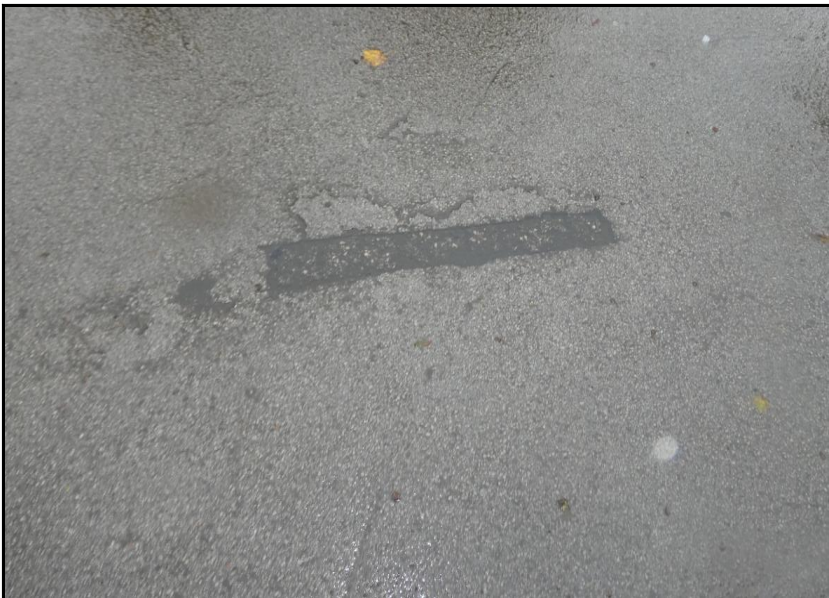
Photograph 25. Localised erosion to surfacing

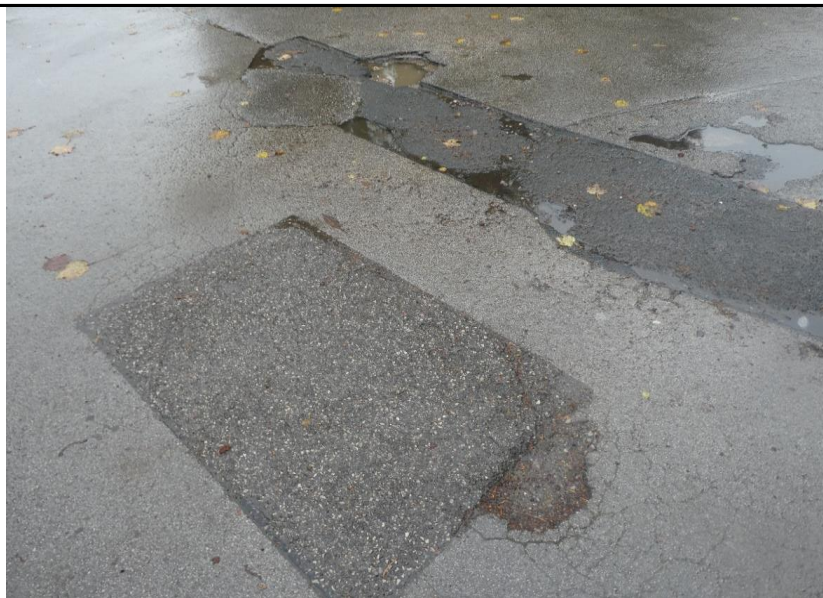
Photograph 26. Reinstated area of surfacing damaged and eroded

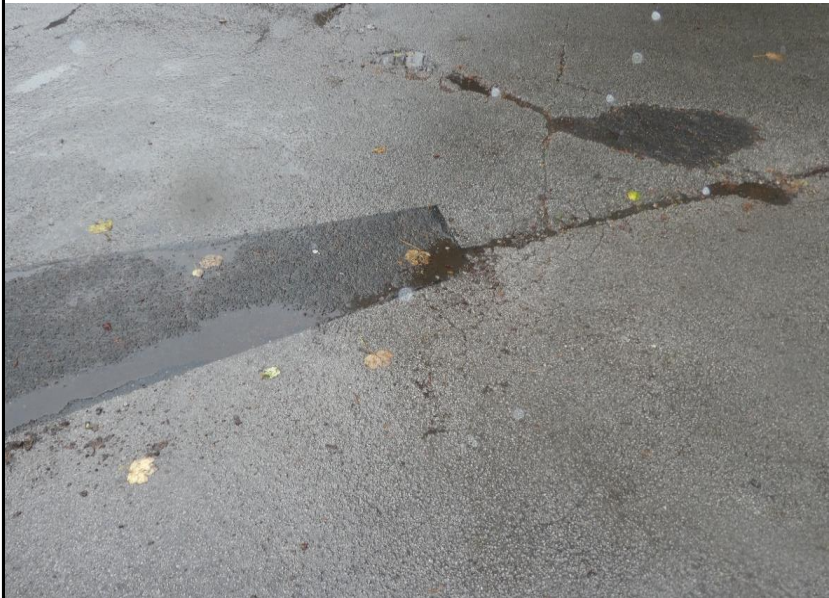
Photograph 27. Reinstated area of surfacing damaged and eroded

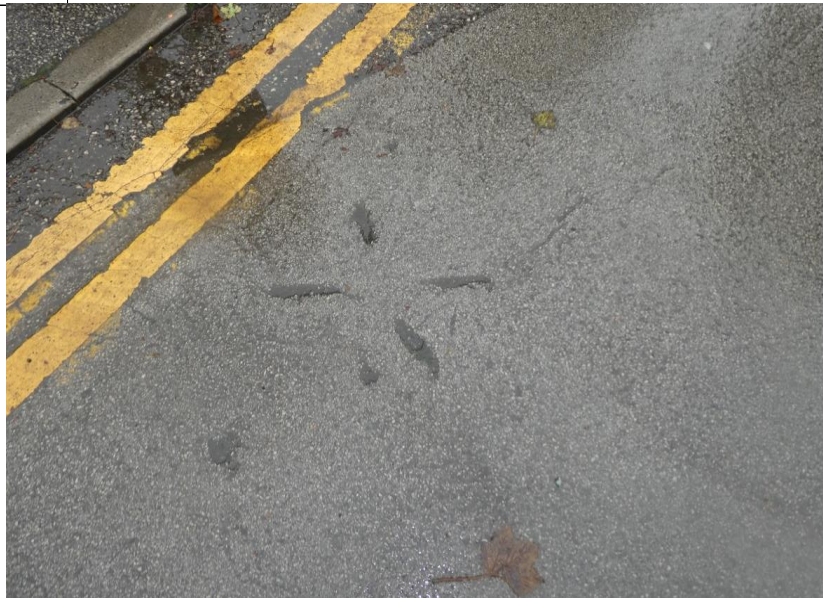
Photograph 28. Localised indentations to road surfacing

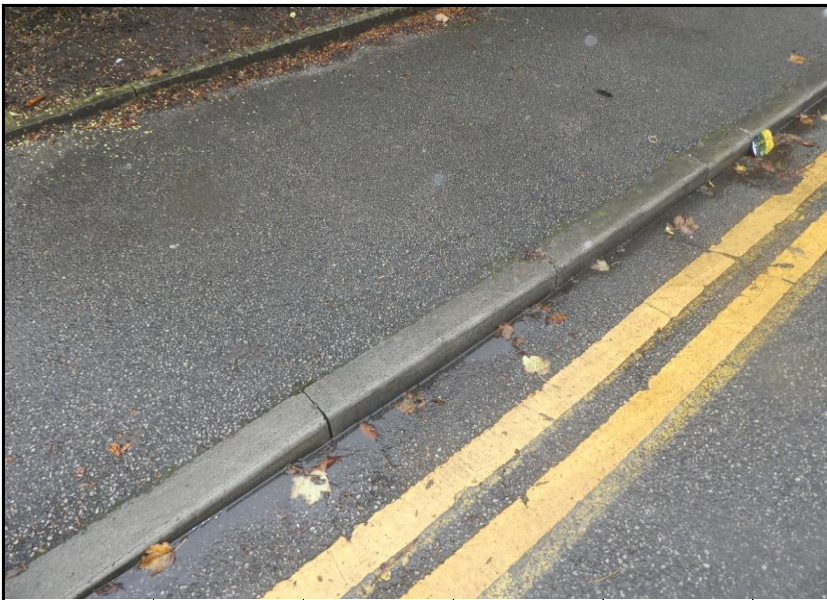
Photograph 29. Adjoining footpath in reasonable condition

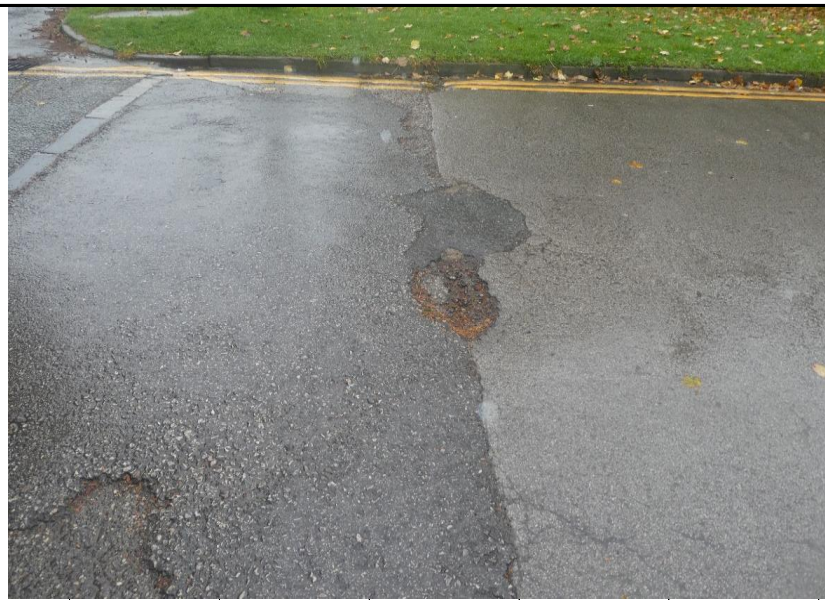
Photograph 30. Localised erosion to surfacing

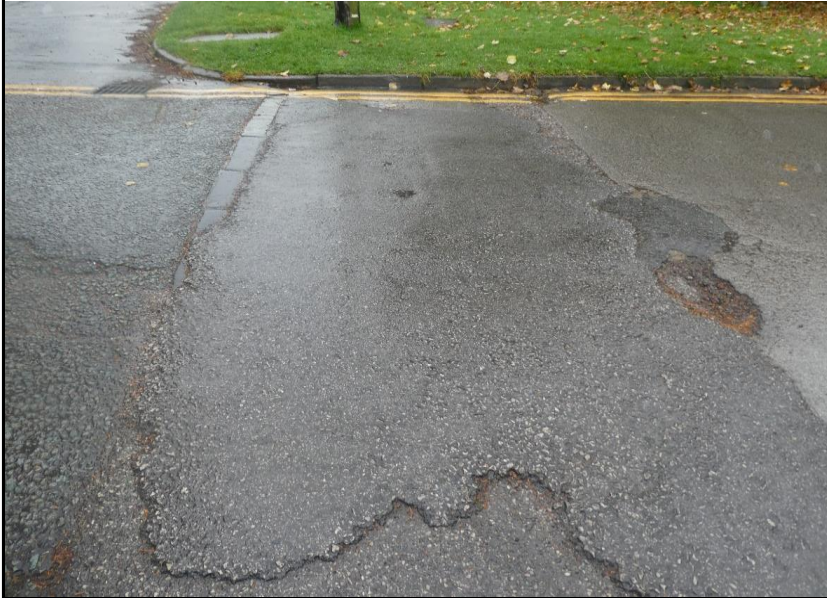
Photograph 31. Localised erosion to surfacing

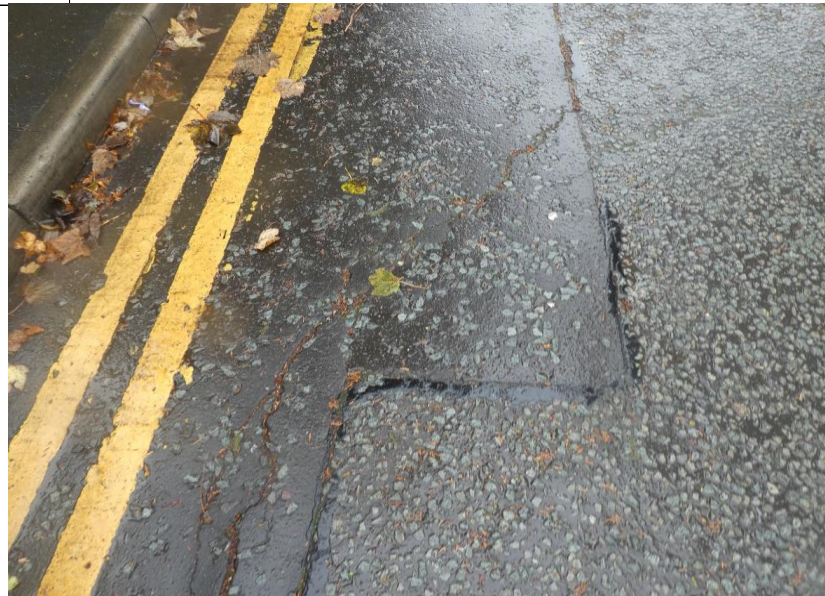
Photograph 36. Cracking to surfacing

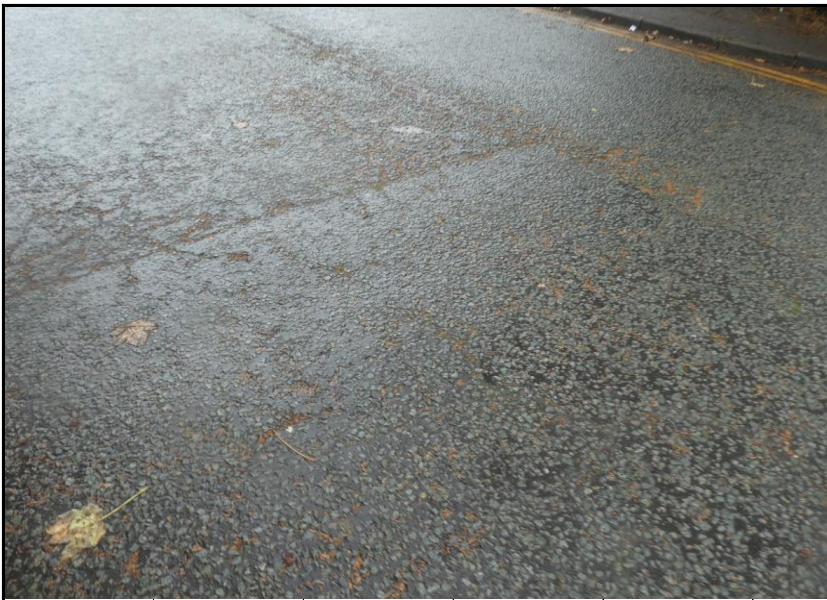
Photograph 37. Erosion of wearing coat of surfacing

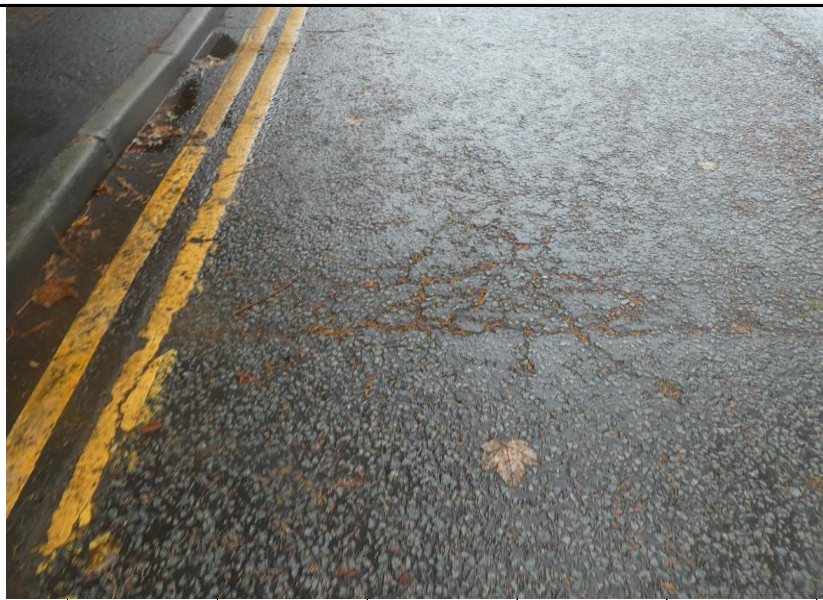
Photograph 38. Badly eroded and cracked surfacing

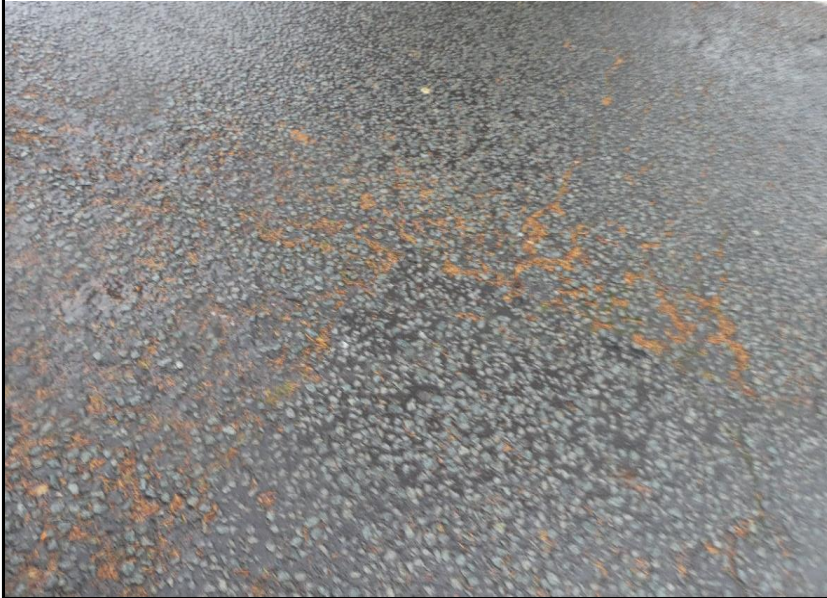
Photograph 39. Badly eroded and cracked surfacing.

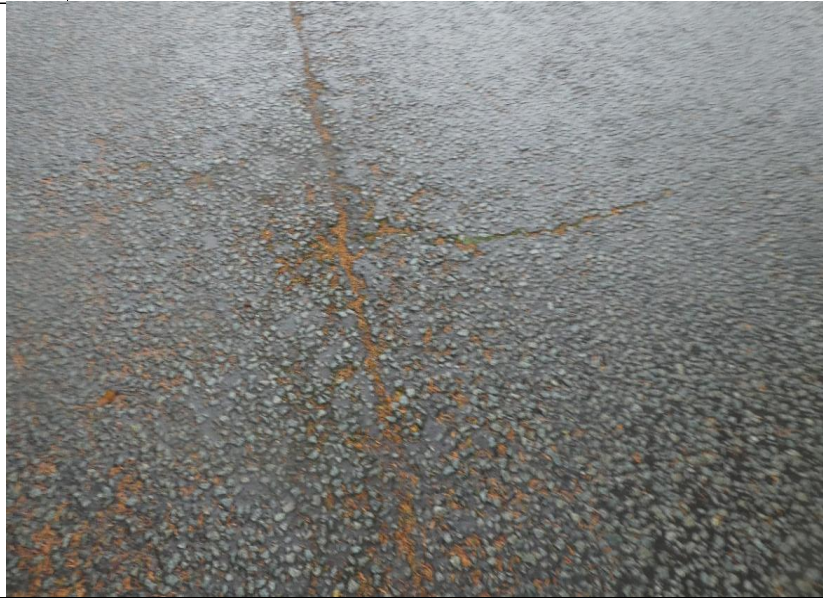
Photograph 40. Badly eroded and cracked surfacing.

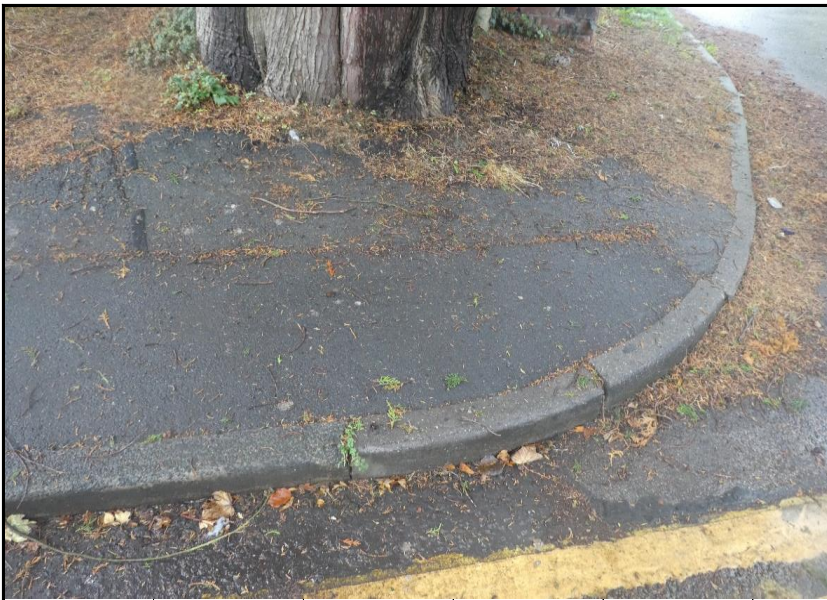
Photograph 41. Damaged and uneven kerbing.

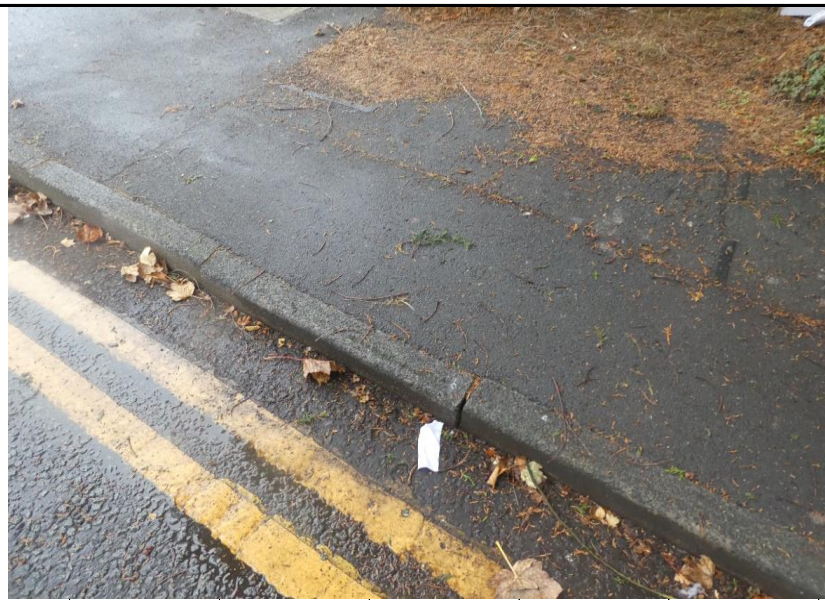
Photograph 42. Uneven kerbing.

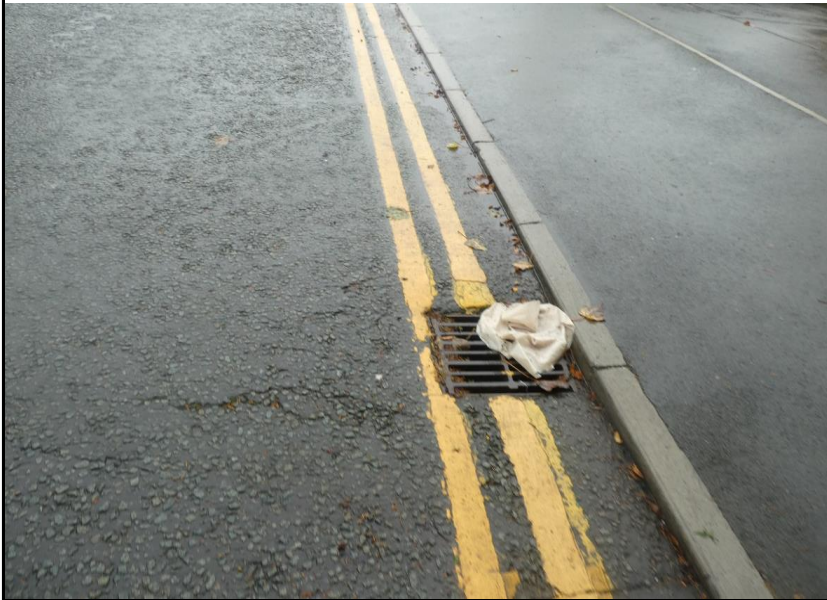
Photograph 43. Localised erosion to surfacing.

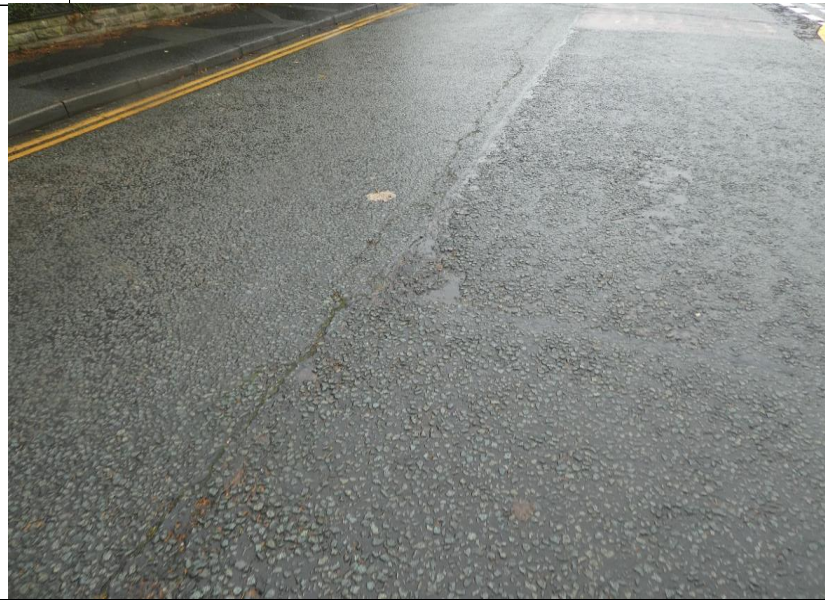
Photograph 44. Cracking to surfacing to centre of roadway.

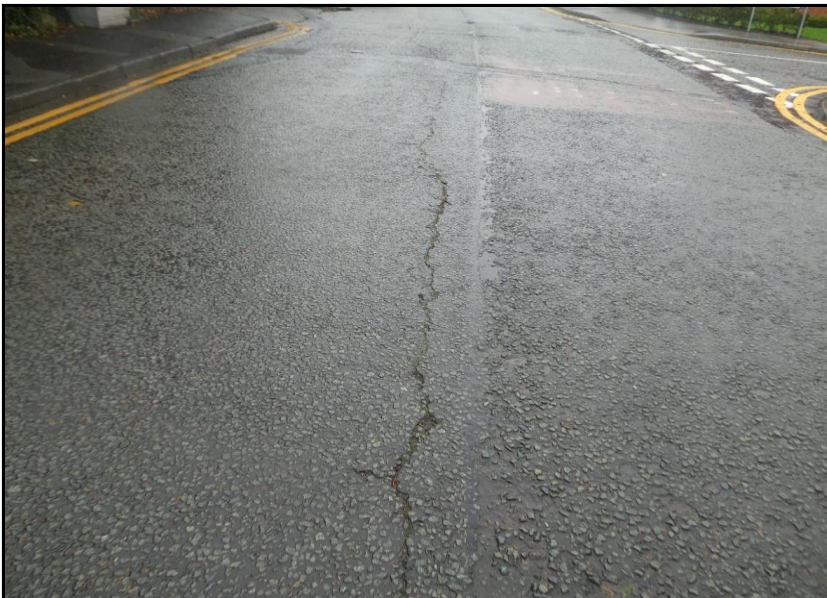
Photograph 45. Cracking to surfacing to centre of roadway.

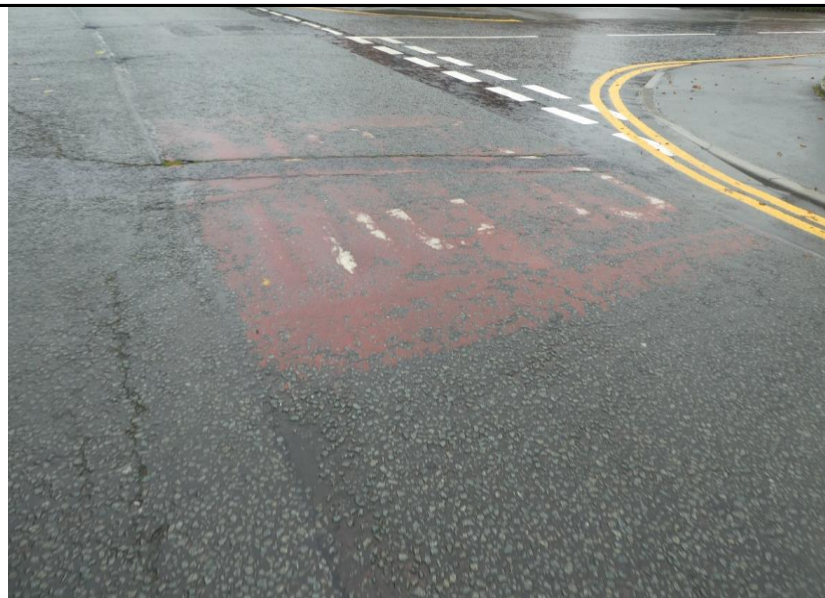
Photograph 46. Cracking to surfacing to centre of roadway.

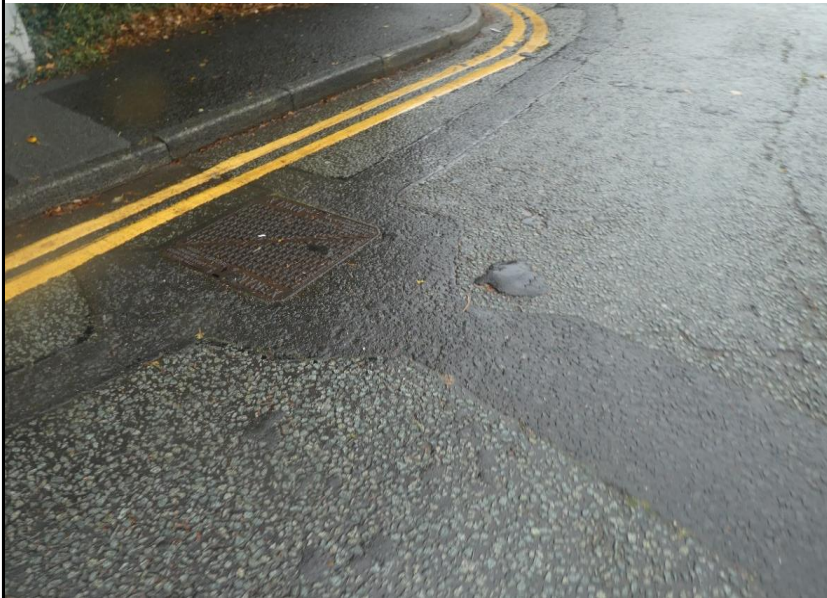
Photograph 47. Localised erosion to surfacing.

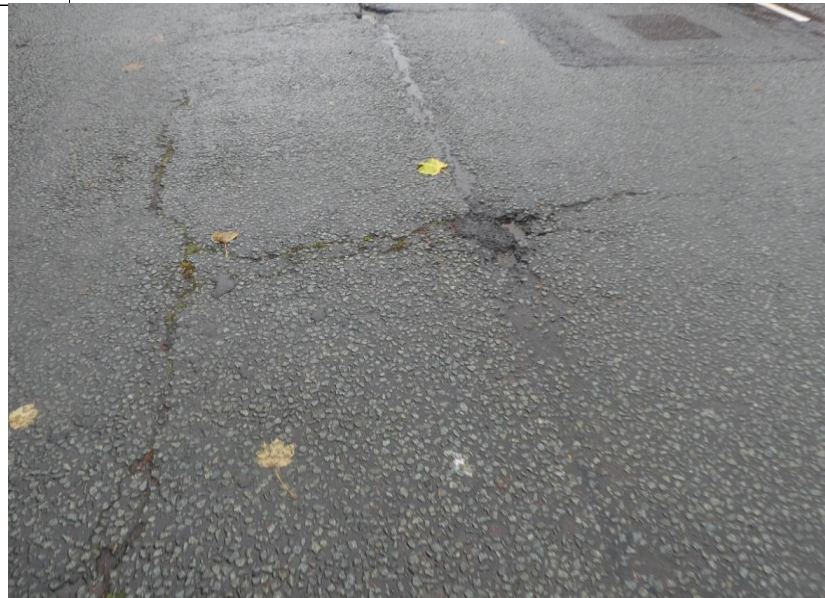
Photograph 48. Cracking and erosion to surfacing.

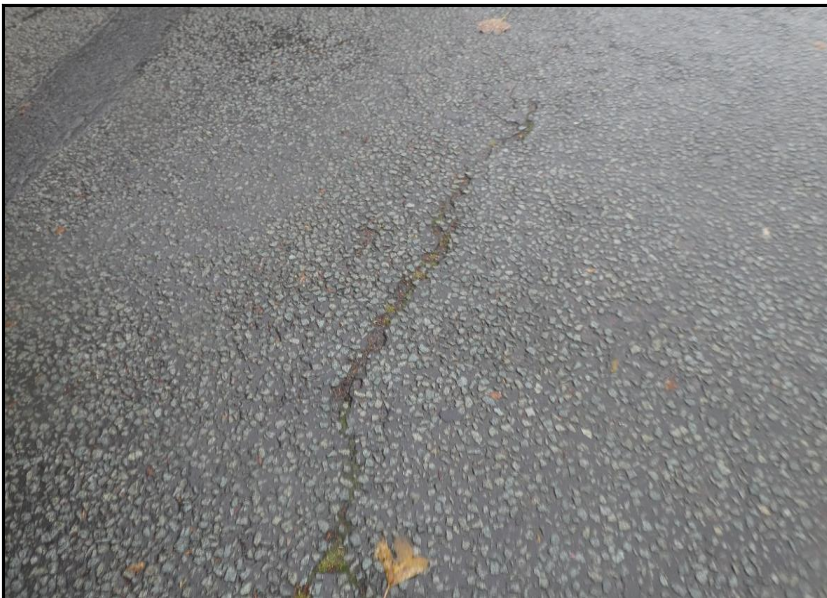
Photograph 49. Cracking and erosion to surfacing.

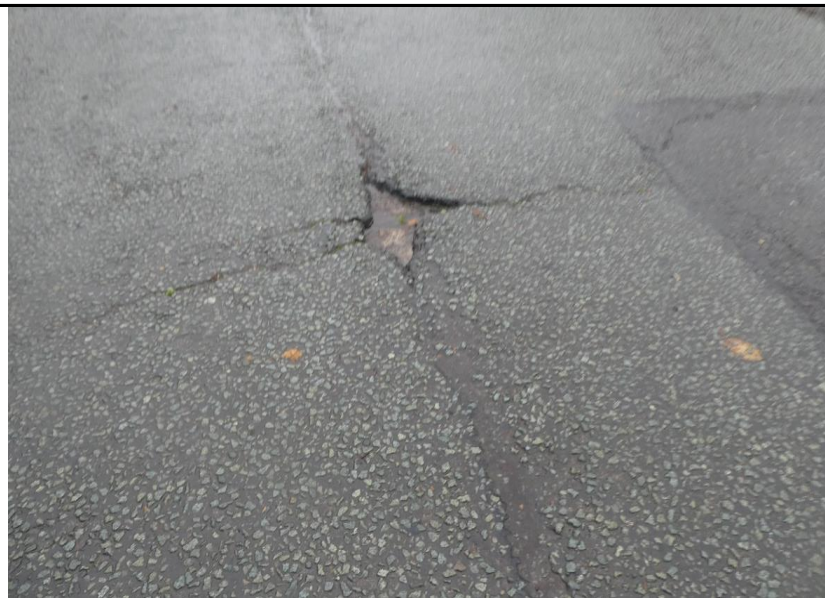
Photograph 50. Cracking and erosion to surfacing.

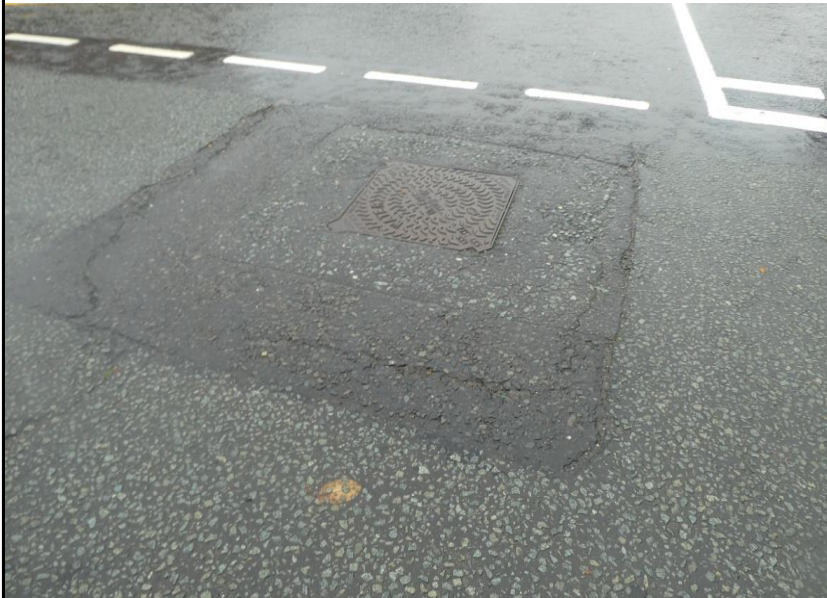
Photograph 51. Cracking and erosion to surfacing.

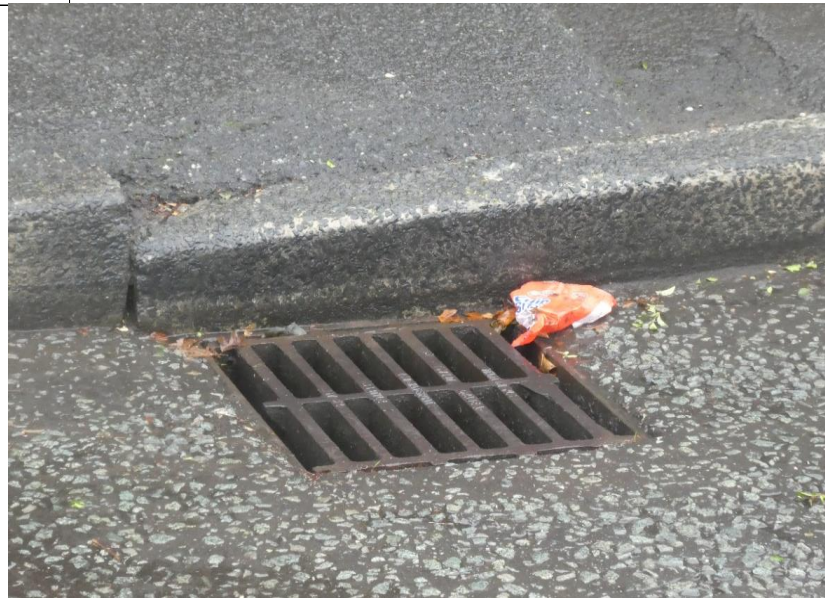
Photograph 52. Uneven kerbs

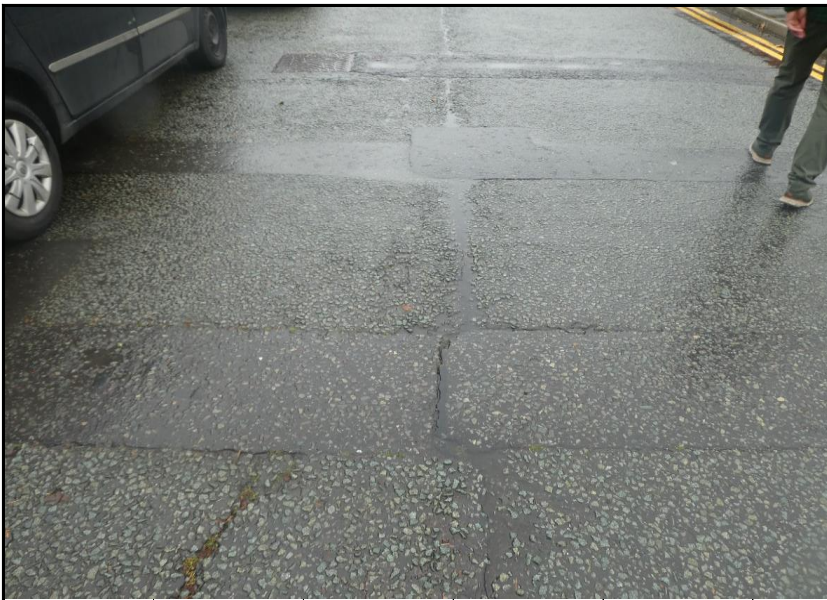
Photograph 53. Cracking to surfacing

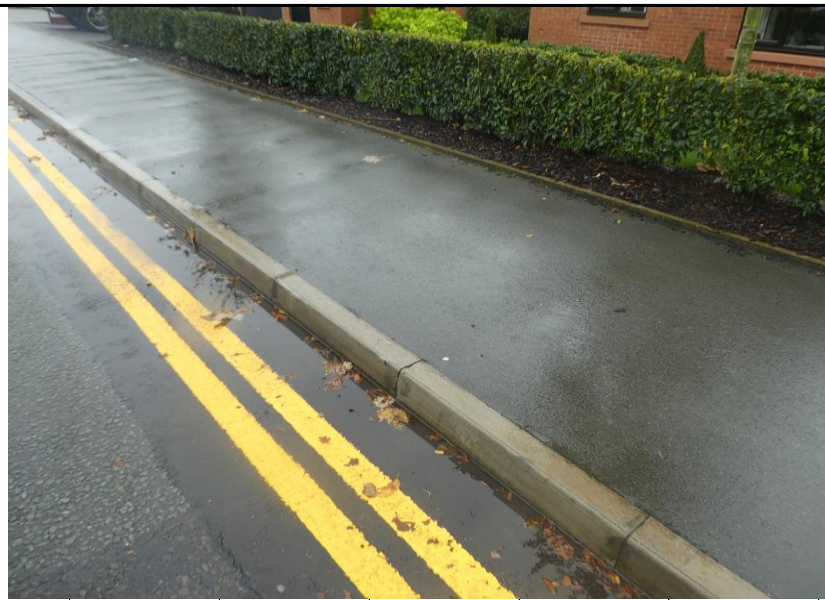
Photograph 54. Footpath in reasonable condition
