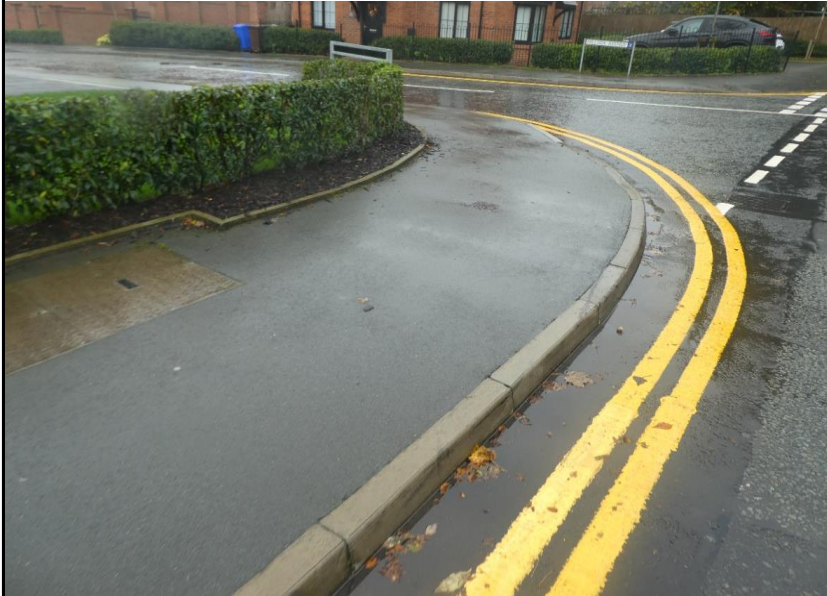
Photograph 55. Footpath in reasonable condition

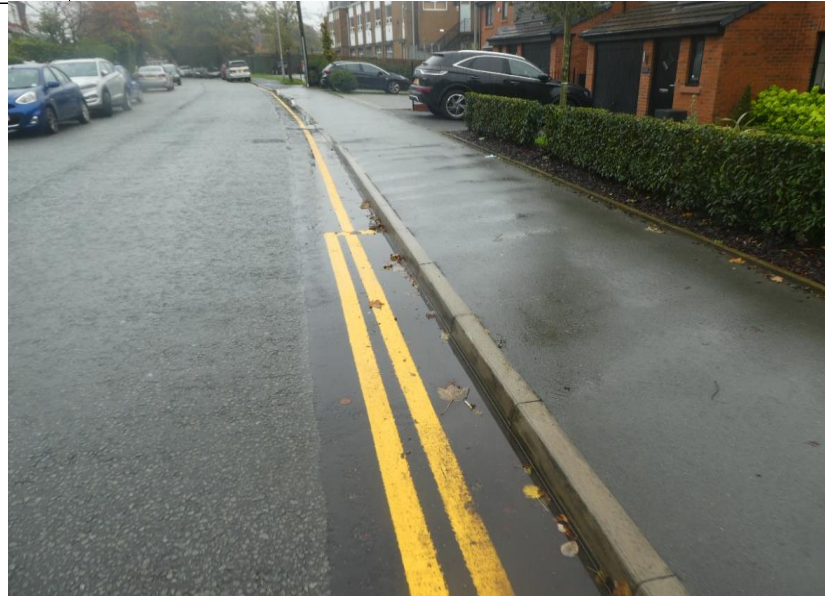
Photograph 56. Footpath in reasonable condition

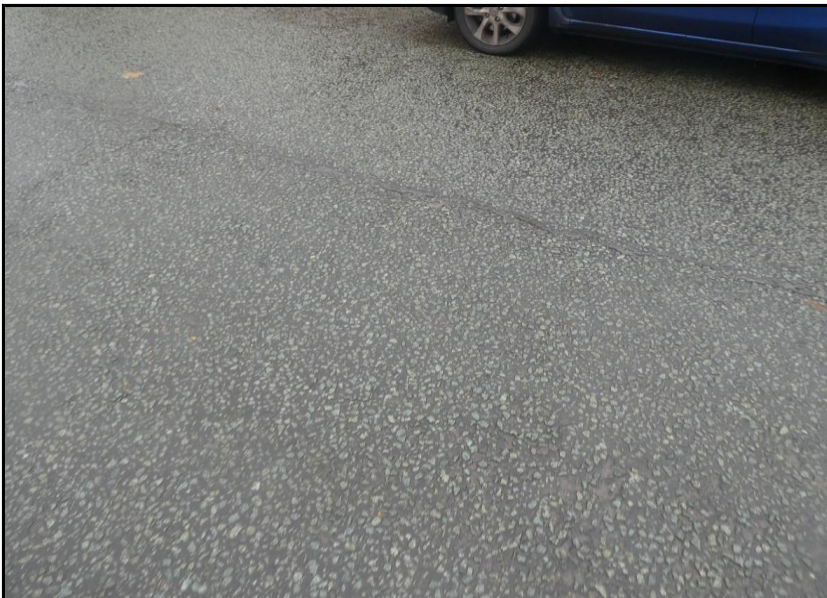
Photograph 57 Surfacing in reasonable condition.

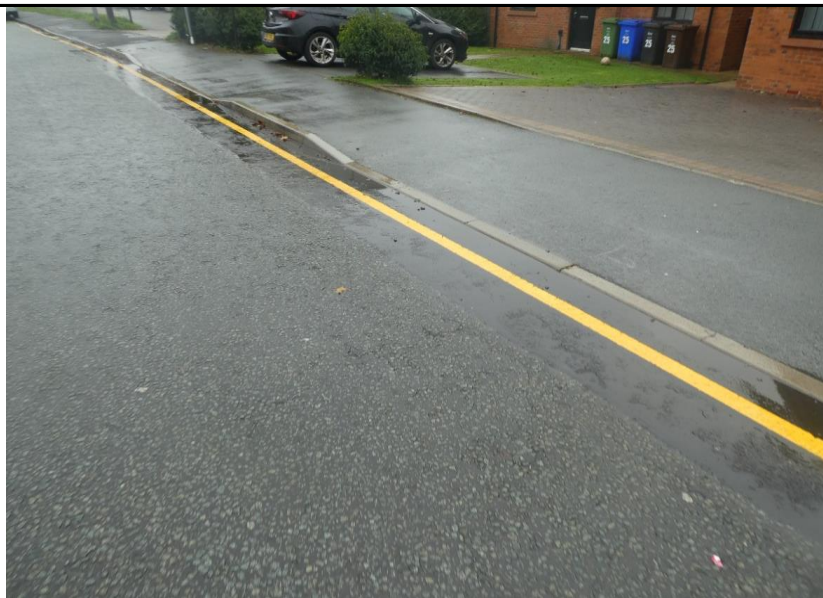
Photograph 58. Surfacing in reasonable condition.

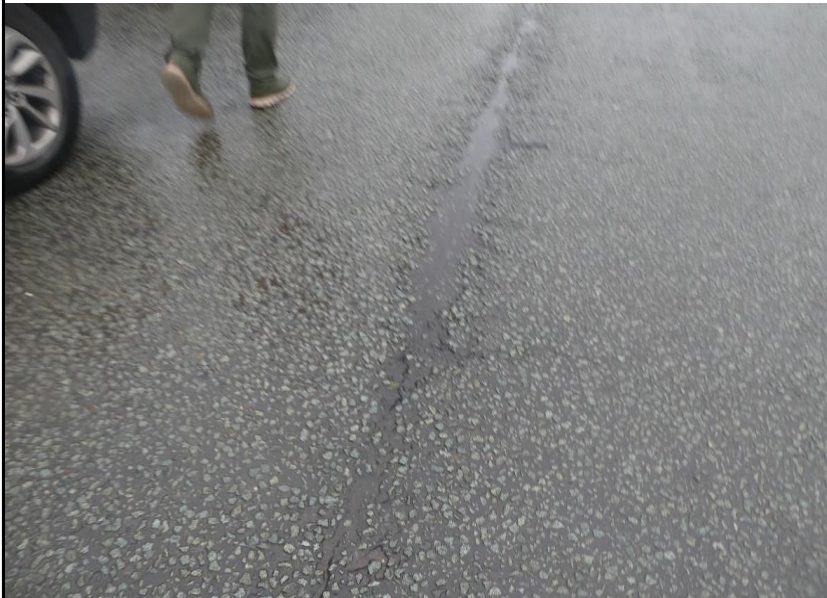
Photograph 59. Erosion to central section of roadway

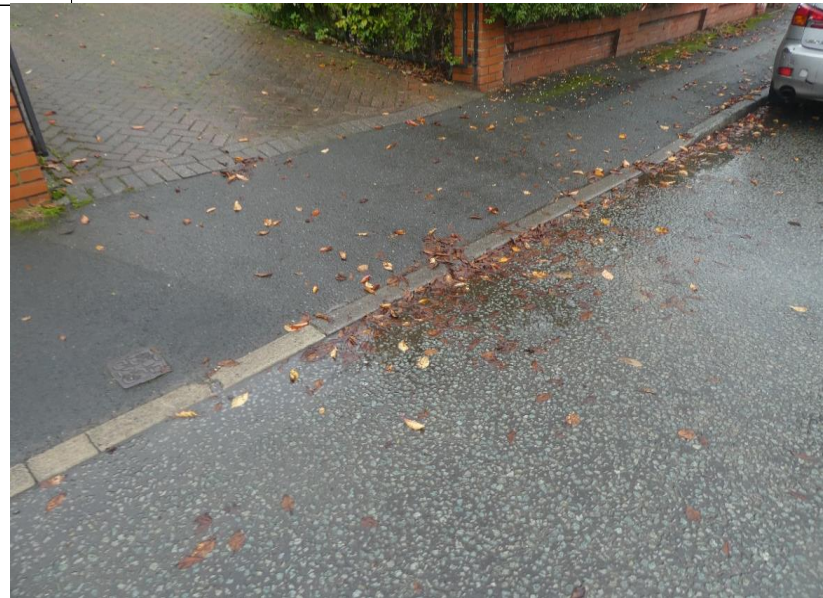
Photograph 60. Localised damage to kerbing

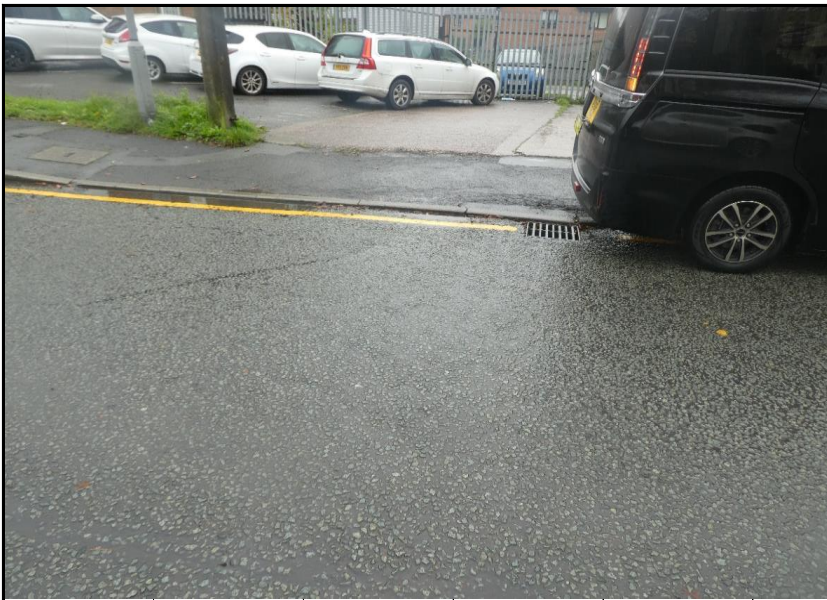
Photograph 61. Minor erosion to surfacing

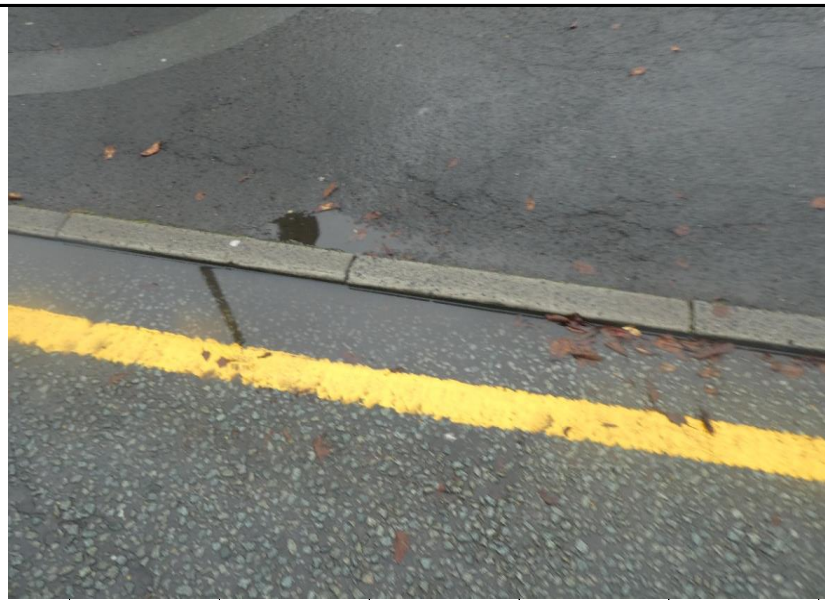
Photograph 62. Erosion to footpath surfacing of junction to business premises

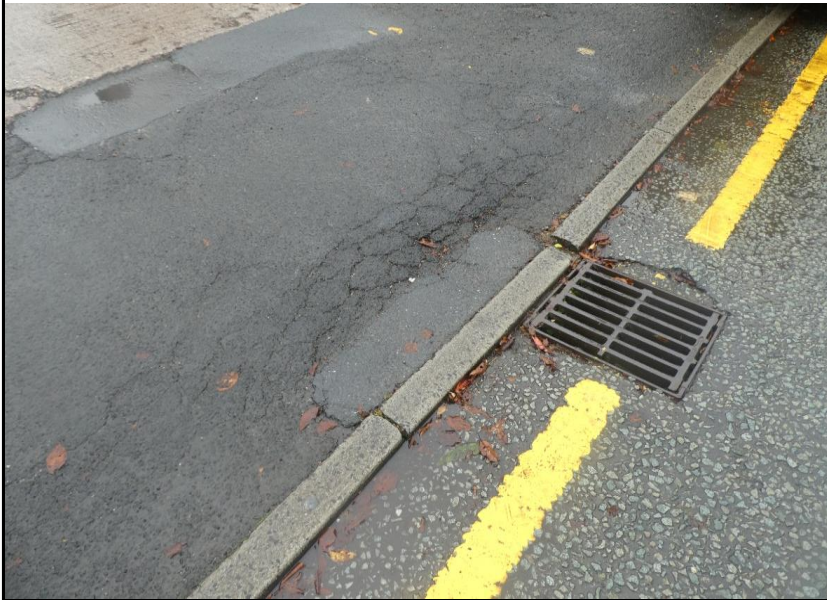
Photograph 63. Erosion to footpath surfacing of junction to business premises

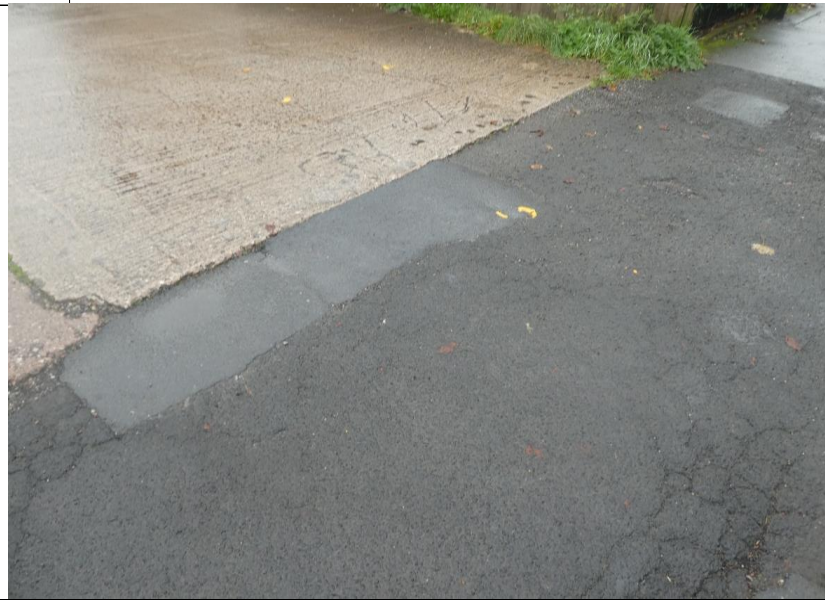
Photograph 64. Erosion to footpath surfacing of junction to business premises

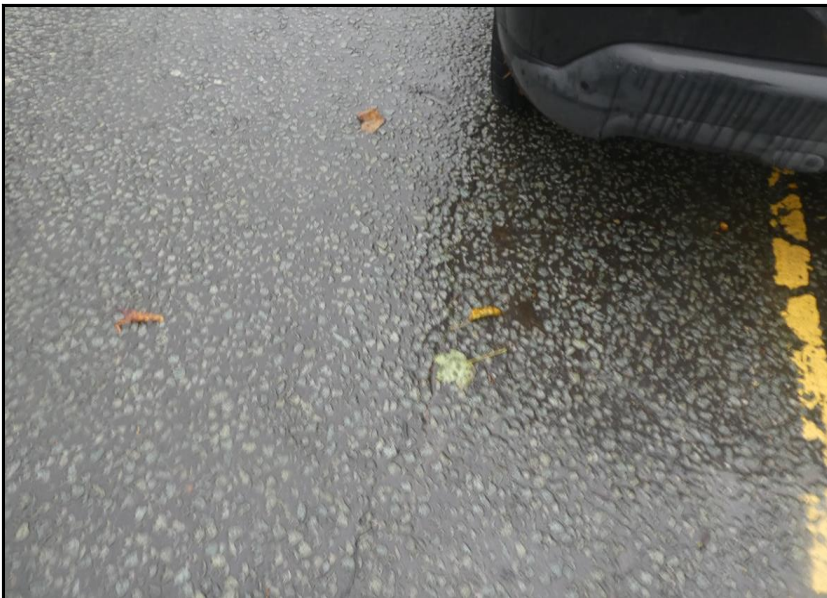
Photograph 69. Cracking to surfacing

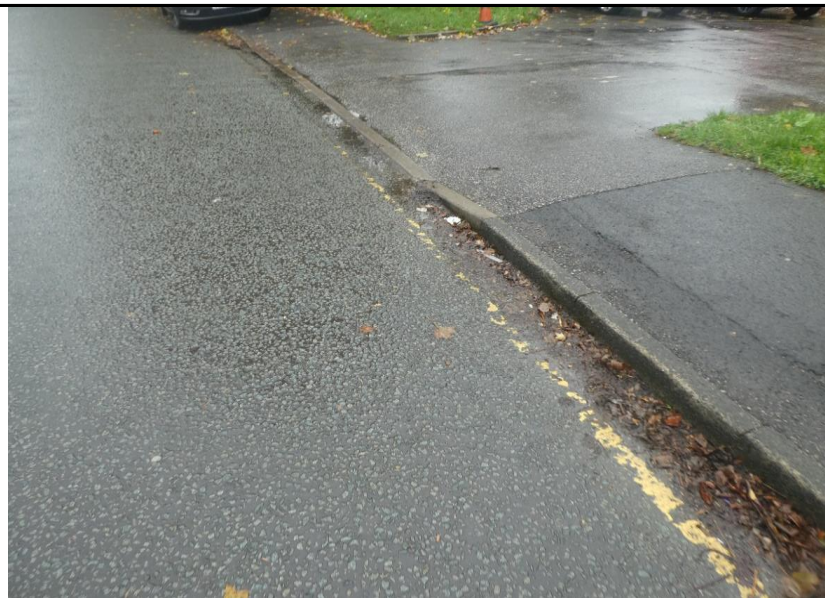
Photograph 70. Erosion to footpath

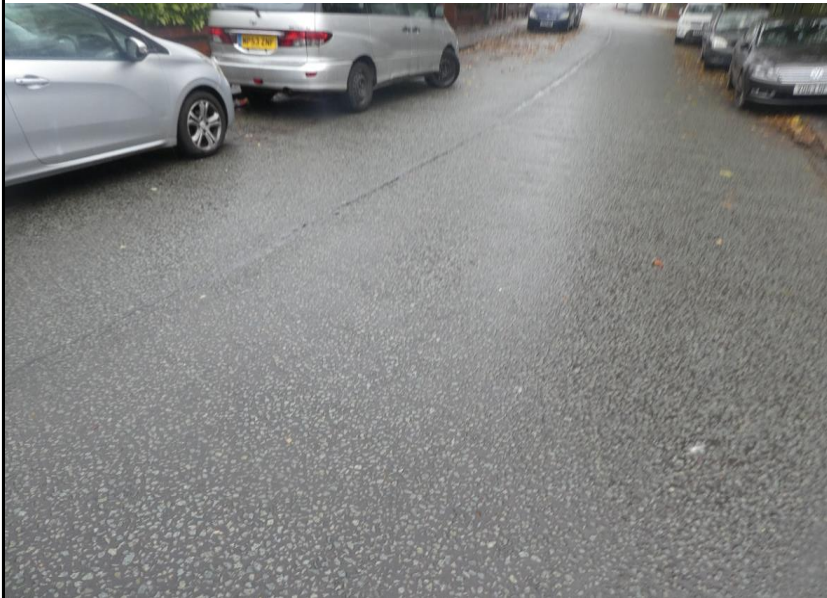
Photograph 71. Road surfacing in reasonable condition

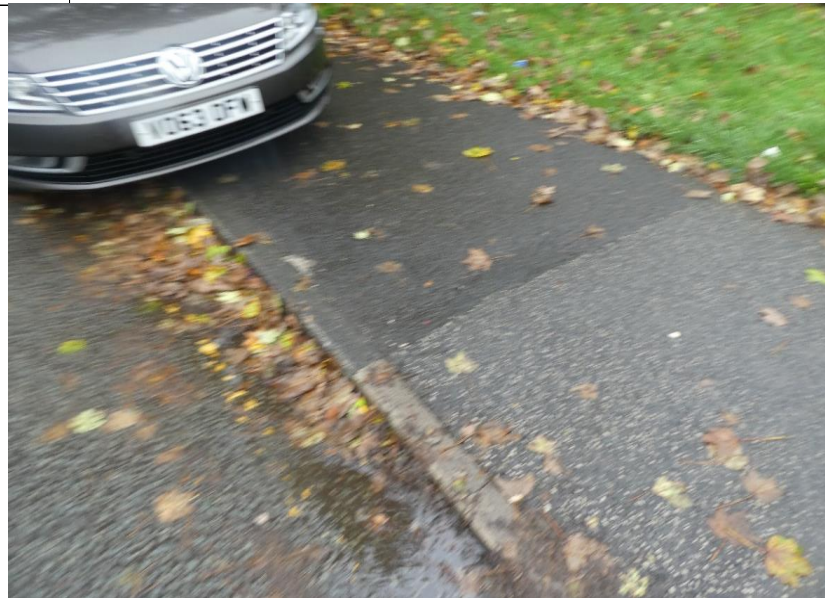
Photograph 72. Footpath in reasonable condition

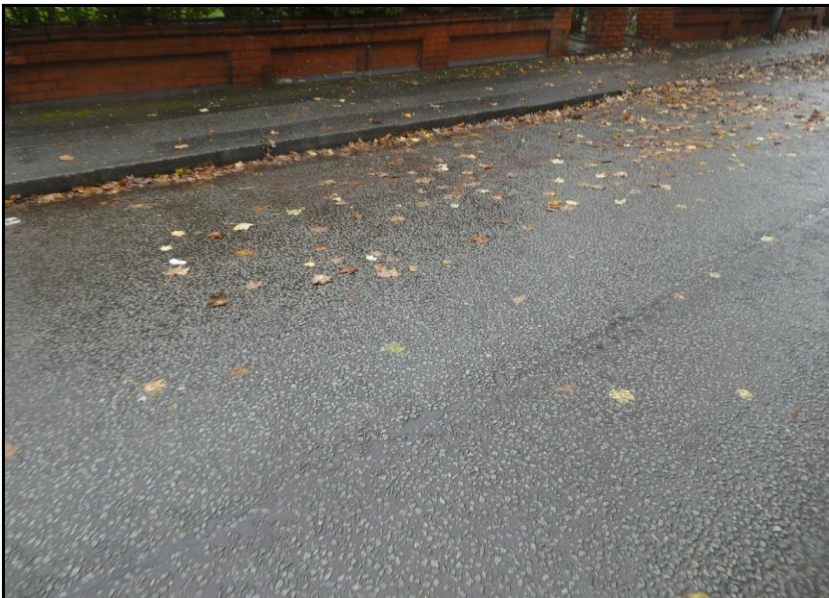
Photograph 73. Road surfacing in reasonable condition

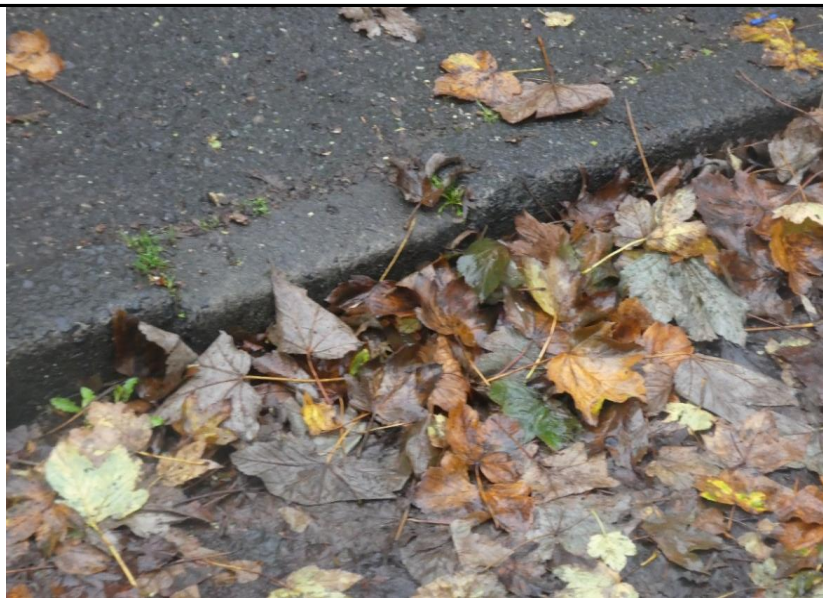
Photograph 74. Uneven kerbs to footpath

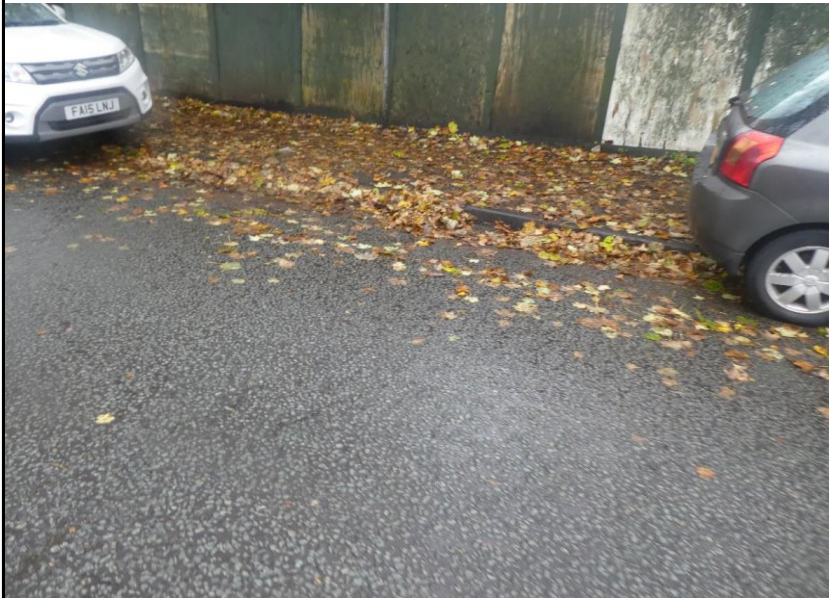
Photograph 75. Road surfacing in reasonable condition

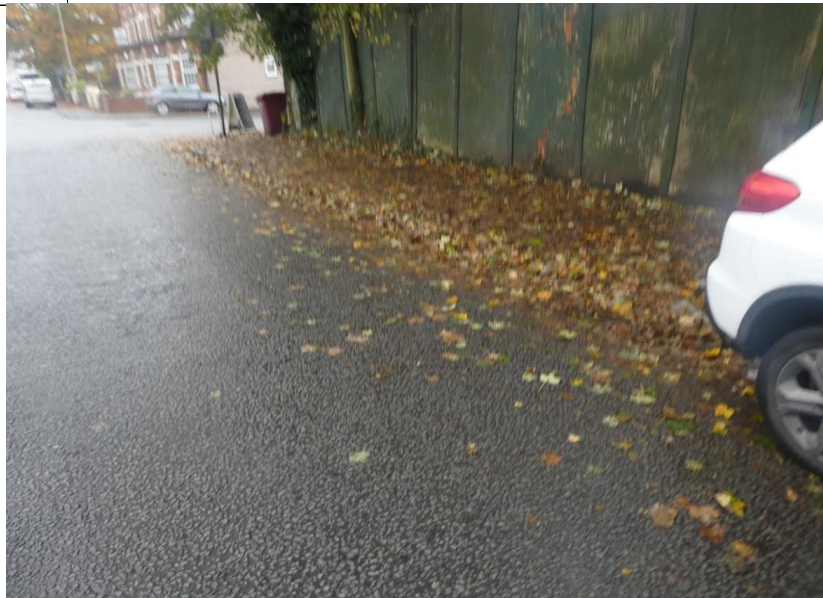
Photograph 76. Road surfacing in reasonable condition

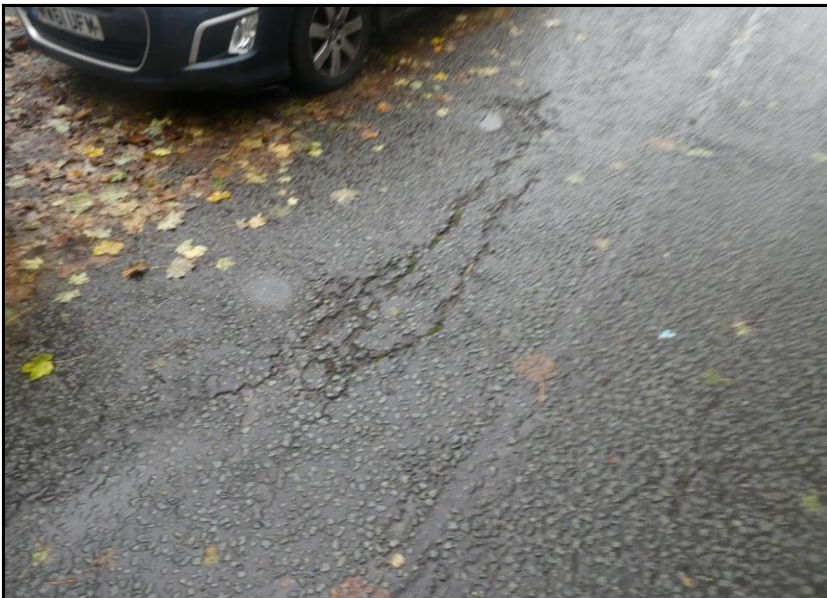
Photograph 77. Localised cracking to surfacing.

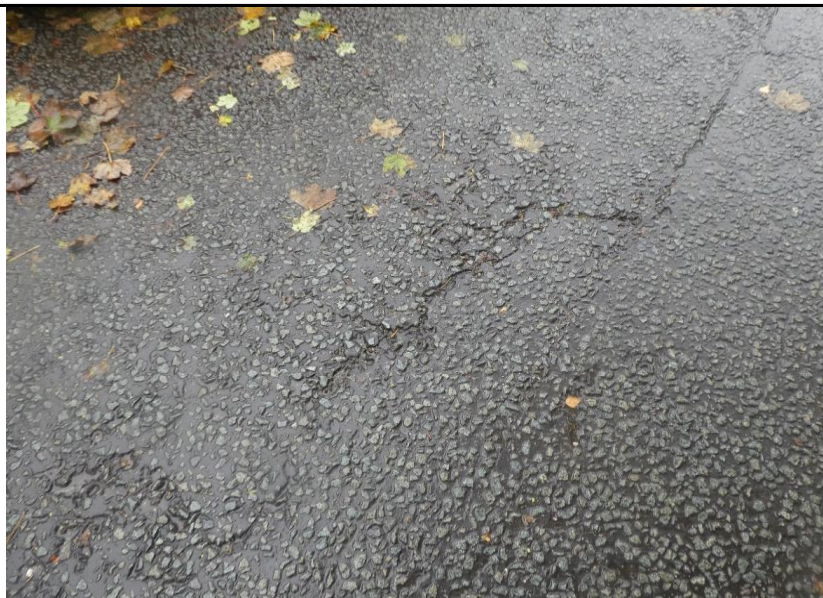
Photograph 78. Localised cracking to surfacing.

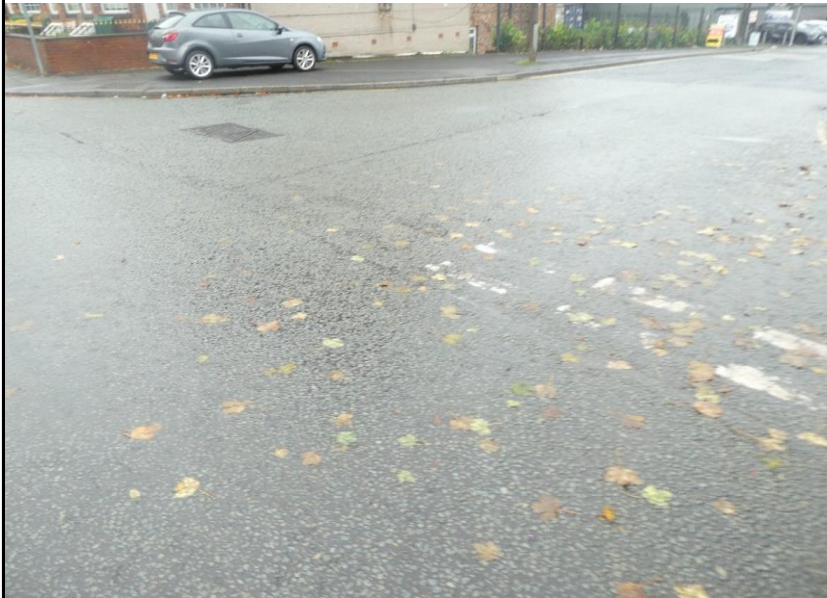
Photograph 79. Junction to industrial estate.

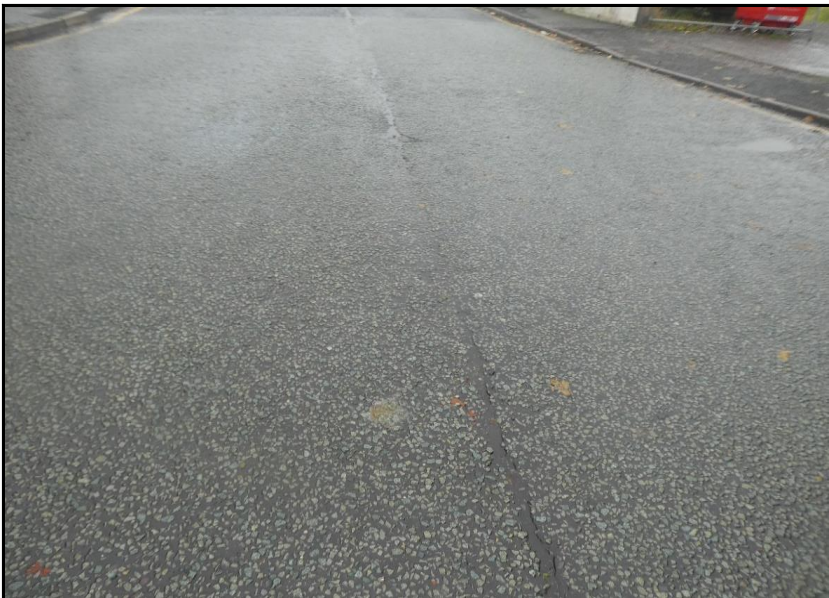
Photograph 81.Exposed joint to centre of roadway

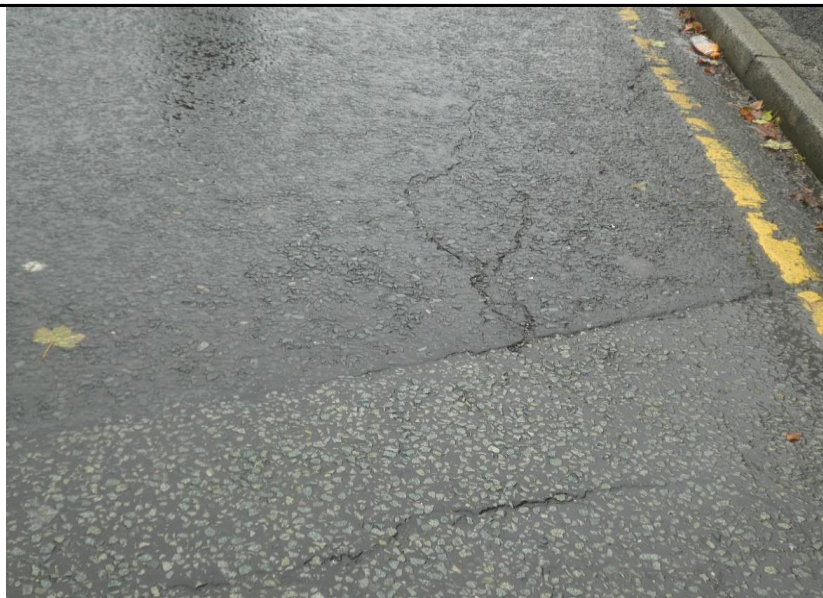
Photograph 82. Localised cracking to road surfacing.

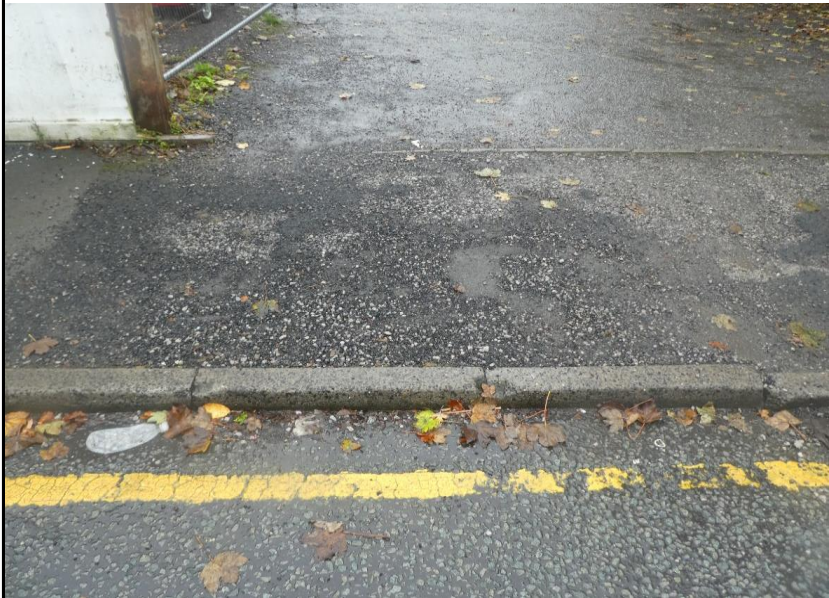
Photograph 83. Localised erosion to footpath

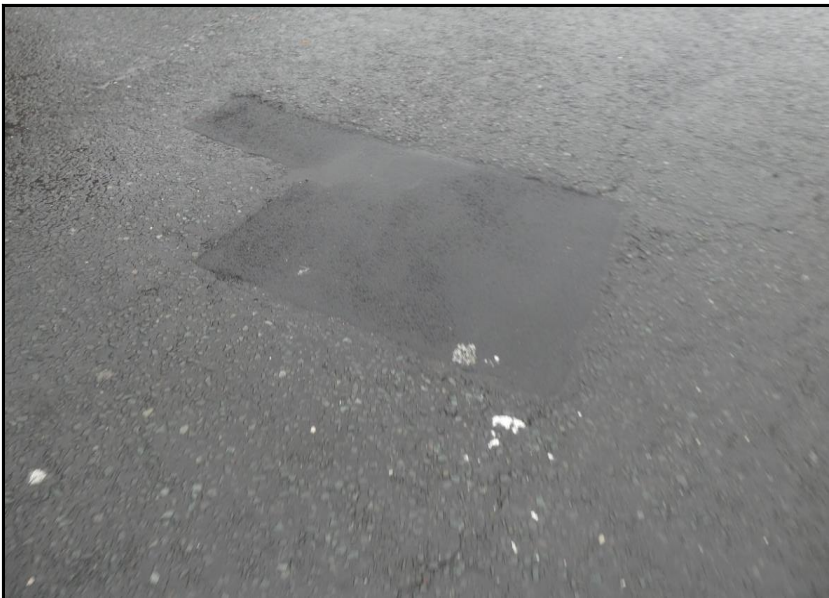
Photograph 85. Localised reinstatement of road surfacing.
