# Asbestos Refurbishment & Demolition survey

Knowsley House

Ainsworth Nursing Home

| Type of survey: | Refurbishment & Demolition survey (MA only) | | |

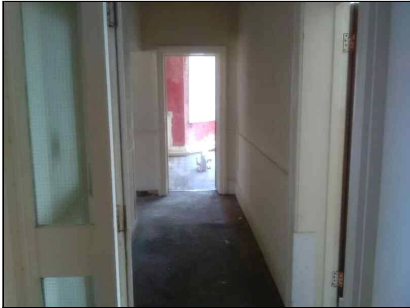
| | Survey Date: | Lead Surveyor | Survey Type | Floor | Analysis |
|---|---|---|---|---|---|
| | Knowsley House, Ainsworth Nursing Home | hall G01 | No suspect material found | N/A | |

| | Survey Date: | Lead Surveyor | Survey Type | Floor | Analysis |
|---|---|---|---|---|---|
| Recommended action | No further action required | | | | |

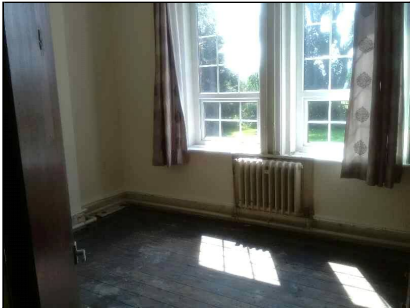
| | Survey Date: | Lead Surveyor | Survey Type | Floor | Analysis |
|---|---|---|---|---|---|
| | Knowsley House, Ainsworth Nursing Home | all rooms throughout floor G02 | No suspect material found | N/A | |

| | Survey Date: | Lead Surveyor | Survey Type | Floor | Analysis |
|---|---|---|---|---|---|
| Recommended action | No further action required | | | | |

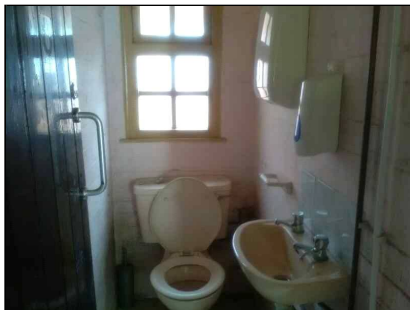
| | Survey Date: | Lead Surveyor | Survey Type | Floor | Analysis |
|---|---|---|---|---|---|
| | Knowsley House, Ainsworth Nursing Home | wc G04 | No suspect material found | N/A | |

| | Survey Date: | Lead Surveyor | Survey Type | Floor | Analysis |
|---|---|---|---|---|---|
| Recommended action | | No further action required | | | |

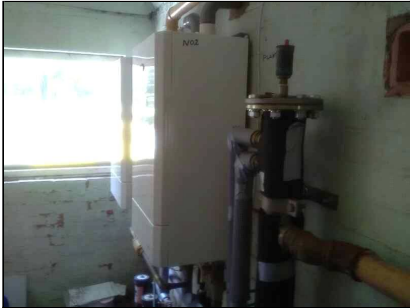
| | Survey Date: | Lead Surveyor | Survey Type | Floor | Analysis |
|---|---|---|---|---|---|
| | Knowsley House, Ainsworth Nursing Home | plant room G05 | No suspect material found | N/A | |

| | Survey Date: | Lead Surveyor | Survey Type | Floor | Analysis |
|---|---|---|---|---|---|
| Recommended action | | No further action required | | | |

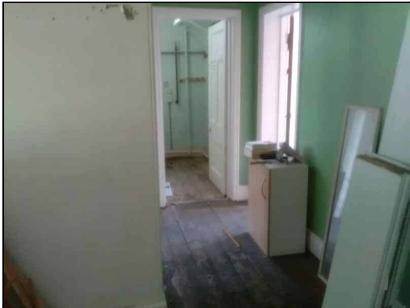
| | Survey Date: | Lead Surveyor | Survey Type | Floor | Analysis |
|---|---|---|---|---|---|
| | Knowsley House, Ainsworth Nursing Home | landing/stairs 101 | No suspect material found | N/A | |

| | Survey Date: | Lead Surveyor | Survey Type | Floor | Analysis |
|---|---|---|---|---|---|
| Recommended action | | No further action required | | | |

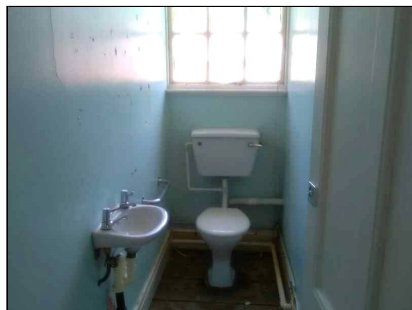
| Survey Date: | Lead Surveyor | Survey Type | Floor | Analysis |
|---|---|---|---|---|
| Knowsley House, Ainsworth Nursing Home | wc 102 | No suspect material found | N/A | |

| Survey Date: | Lead Surveyor | Survey Type | Floor | Analysis |
|---|---|---|---|---|
| Recommended action | No further action required | | | |

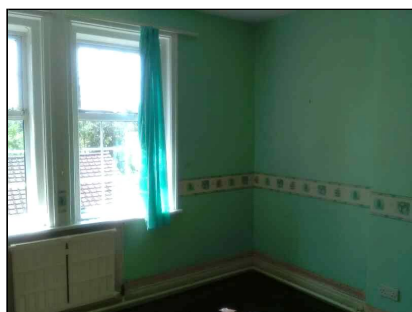
| Survey Date: | Lead Surveyor | Survey Type | Floor | Analysis |
|---|---|---|---|---|
| Knowsley House, Ainsworth Nursing Home | all rooms throughout floor 103 | No suspect material found | N/A | |

| Survey Date: | Lead Surveyor | Survey Type | Floor | Analysis |
|---|---|---|---|---|
| Recommended action | No further action required | | | |

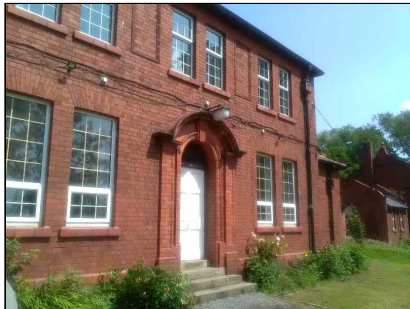
| | Survey Date: | Lead Surveyor | Survey Type | Floor | Analysis |
|---|---|---|---|---|---|
| | Knowsley House, Ainsworth Nursing Home | external E01 | No suspect material found | N/A | |

| | Survey Date: | Lead Surveyor | Survey Type | Floor | Analysis |
|---|---|---|---|---|---|
| Recommended action | No further action required | | | | |
