# Mondi Mill Chimney Inspection Report

Mondi Mill  
Chimney Inspection  
Ramsbottom,  
BL0 0BS

B23519/R001

08 August 2019

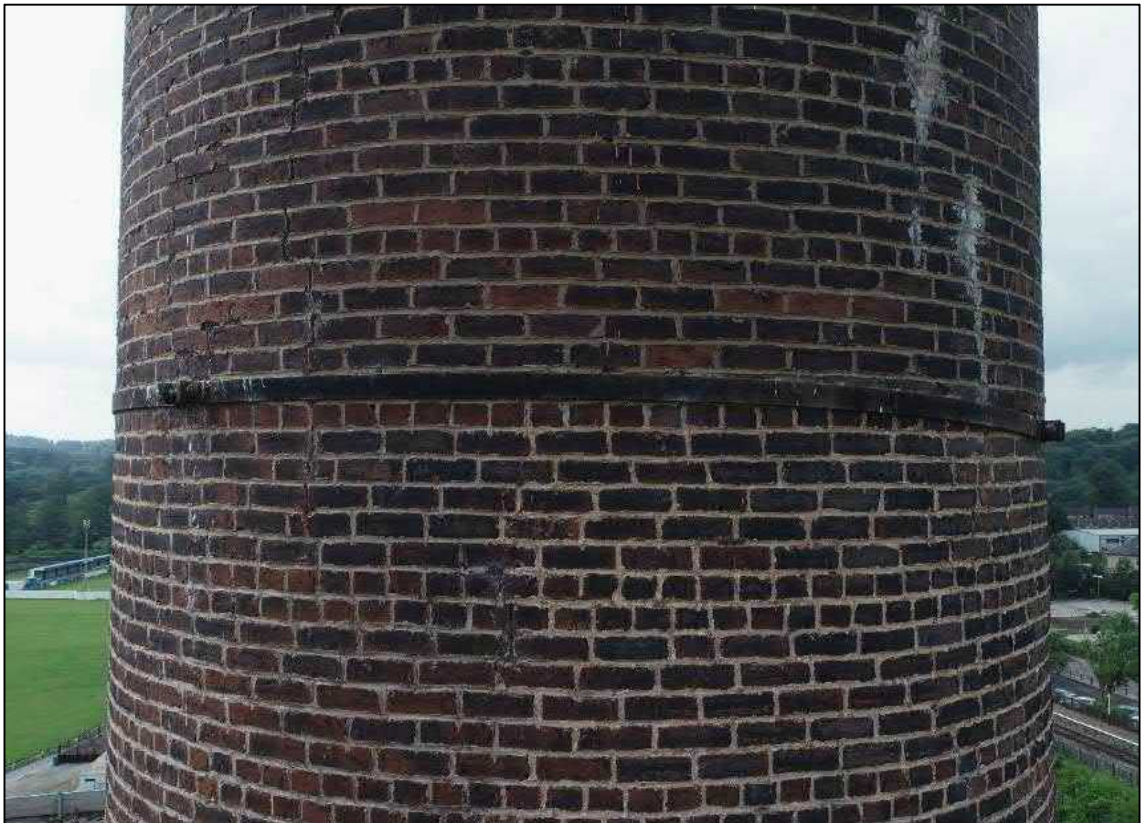
Photograph 2

- 3.2.5 A long, almost vertical, crack was evident from approx. five courses below band Nr.13 up to approx. 5 courses below band Nr.14. This occurred typically through the joints, however, some fractured masonry is present (Photograph 2).

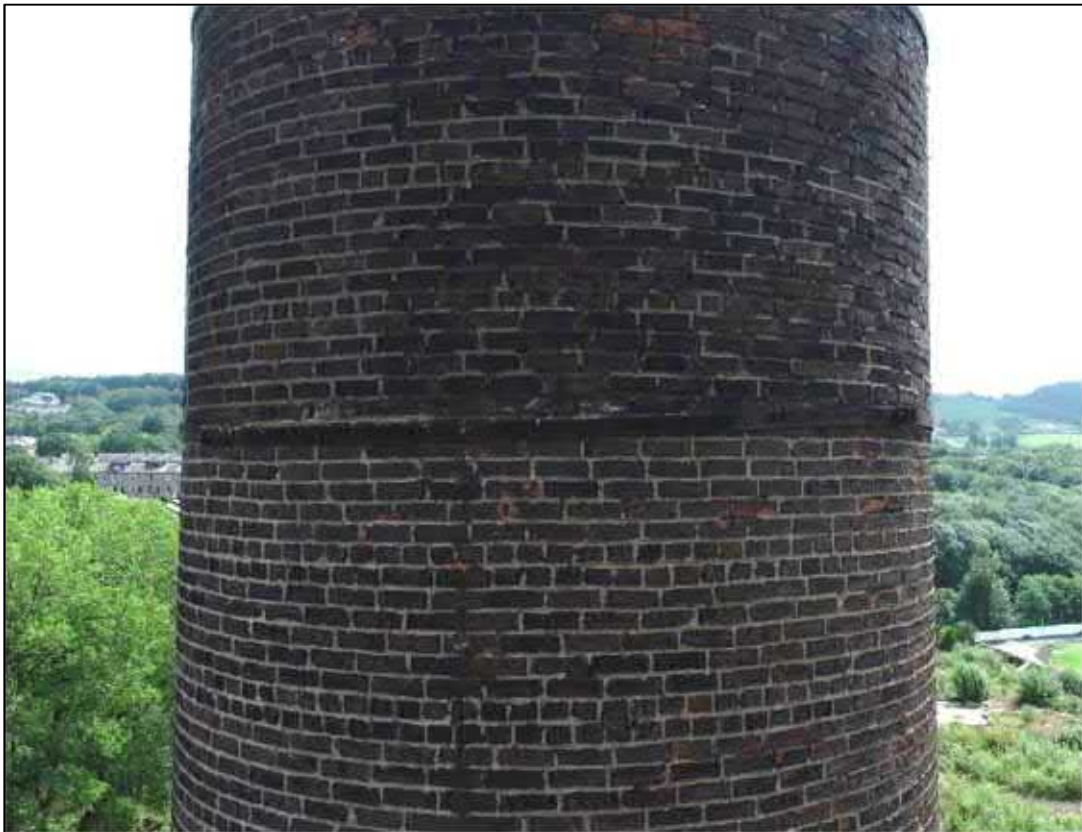
Photograph 4

- 3.3.1 The west elevation appears typically in a reasonable condition throughout. Recent repointing is present with minimal loss observed. One continuous line of missing/lost mortar was noted from bottom to top, however, this appears to have been on a potential lightning conductor rod route, as small clips (now redundant) were present affixed to the wall through the full height.
- 3.3.2 A vertical fracture in the masonry was noted between bands Nr.4 & 5, approximately seven courses in height (Photograph 4).

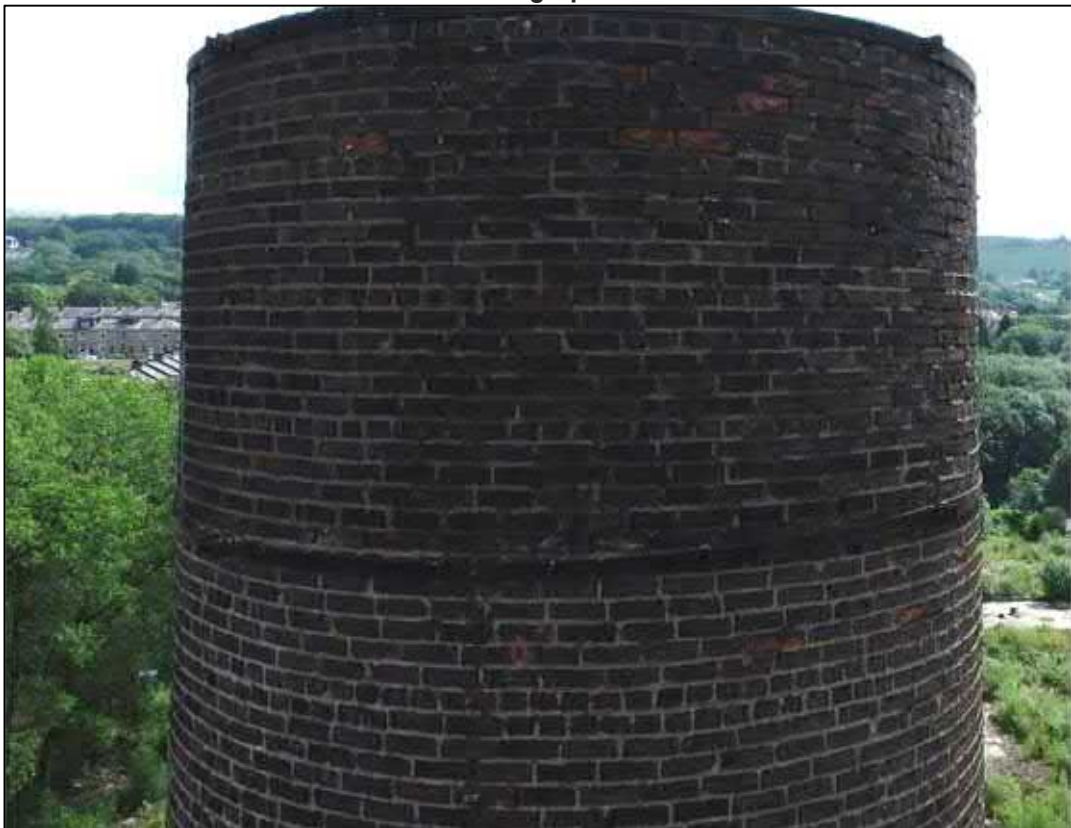
Photograph 5

- 3.3.3 Vegetation was evident to a discrete area between bands Nr.8 & 9 on the southwest elevation.
- 3.3.4 As noted in section 3.2, restraint band Nr.13 appears to have dropped at the northwest face (Photograph 5). This is local to the band connections and appears in the order of 90mm maximum from inspection on this elevation.
- 3.3.5 Between bands Nr.13 & 14, a large area of missing/lost recent pointing was noted, in the region of 30-40% (Photograph 6).

- 4.1.3 The restraint bands appear in a reasonable condition, however, a number have slipped to one face. It is not clear whether this is due to a loosening of the bands or the masonry has contracted. It is also uncertain whether the pointing around the edges of the bands were from recent (within the last 3 years) or whether this precedes the decommissioning of the chimney. It is recommended that the bands are re-tensioned and monitored for future movement.

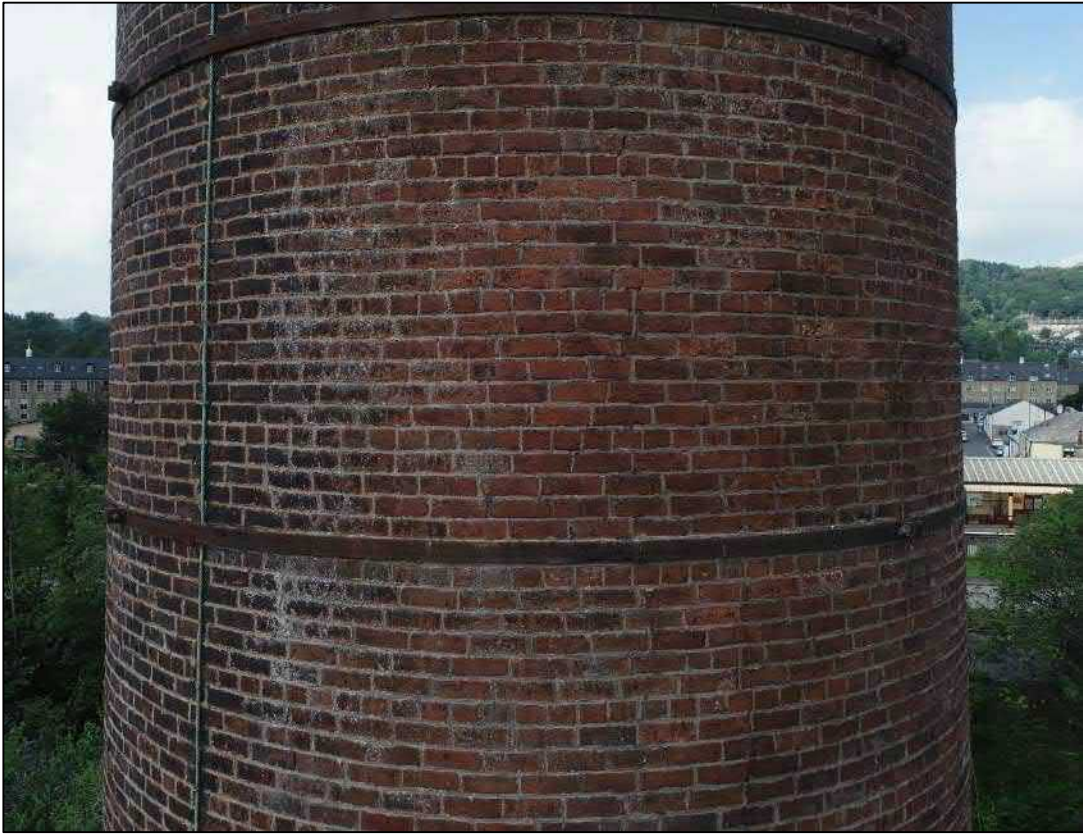
Photograph 8

- 3.4.5 A previously repointed crack was noted between bands Nr.13 & 14. This appears to have deteriorated with loss of mortar observed across the full height of the crack (Photograph 8).

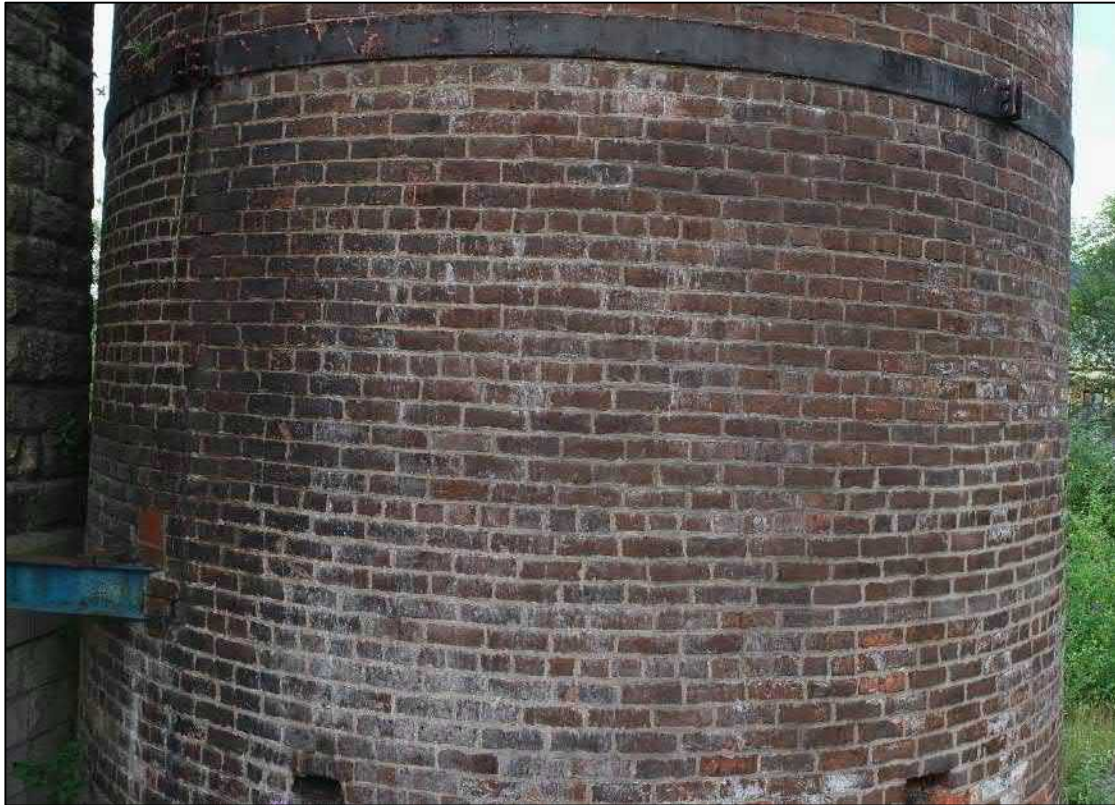
Photograph 9

- 3.5.1 The east elevation appears in fair condition. Much of the relatively recent pointing appears intact, however, the finish to the pointing appears different in areas to that on other faces. No deterioration was observed in these areas, therefore, it is assumed that this is purely a workmanship issue (Photograph 9).

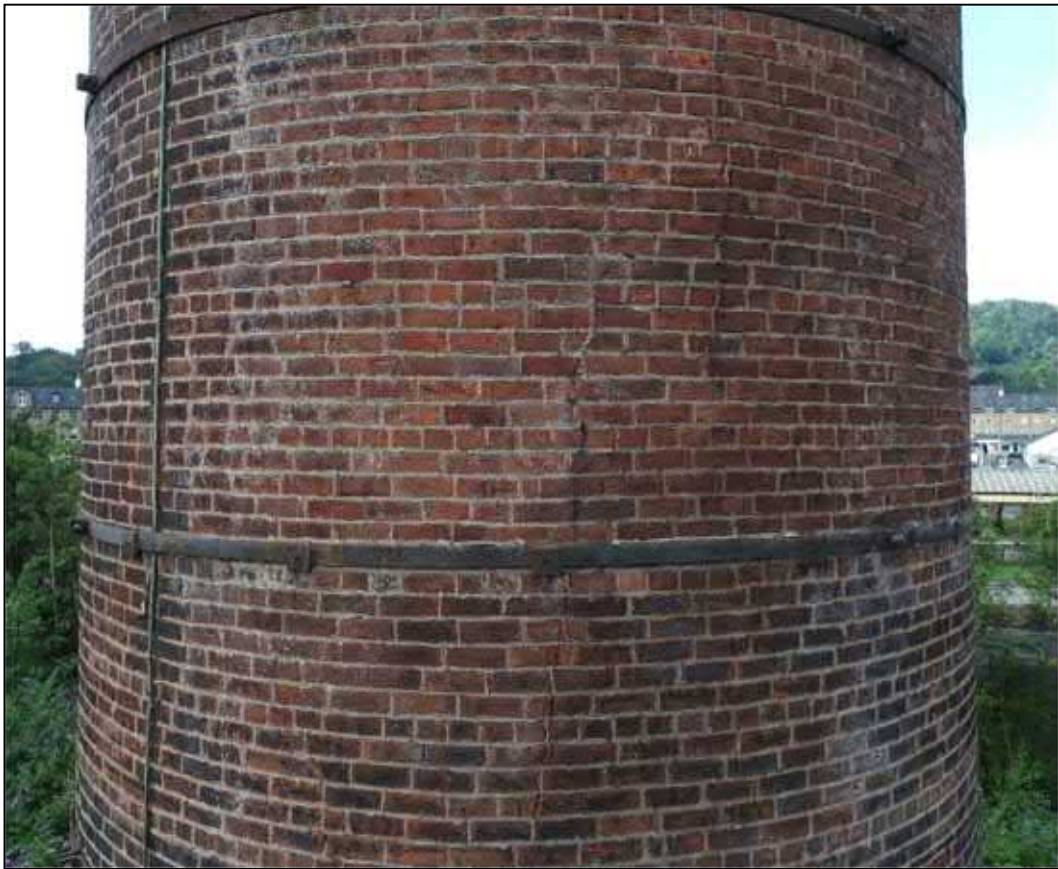
Photograph 10

- 3.5.2 A large area of efflorescence was evident from ground level to band Nr.1 (Photograph 10).
- 3.5.3 Vegetation was noted growing at the southeast face directly above band Nr.1.

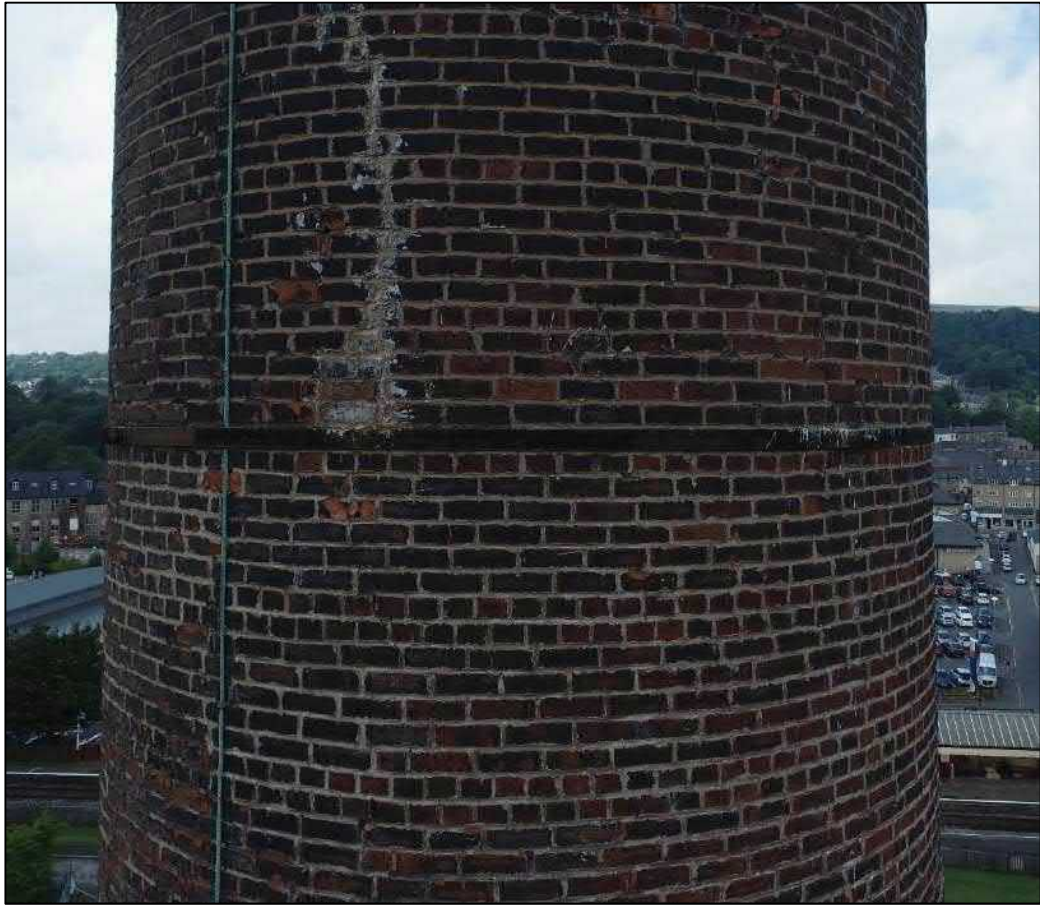
Photograph 12

- 3.5.6 A long vertical crack was observed between bands Nr.9 & 11. This has been noted on previous inspection in 2016 and appears to have deteriorated (Photograph 12).

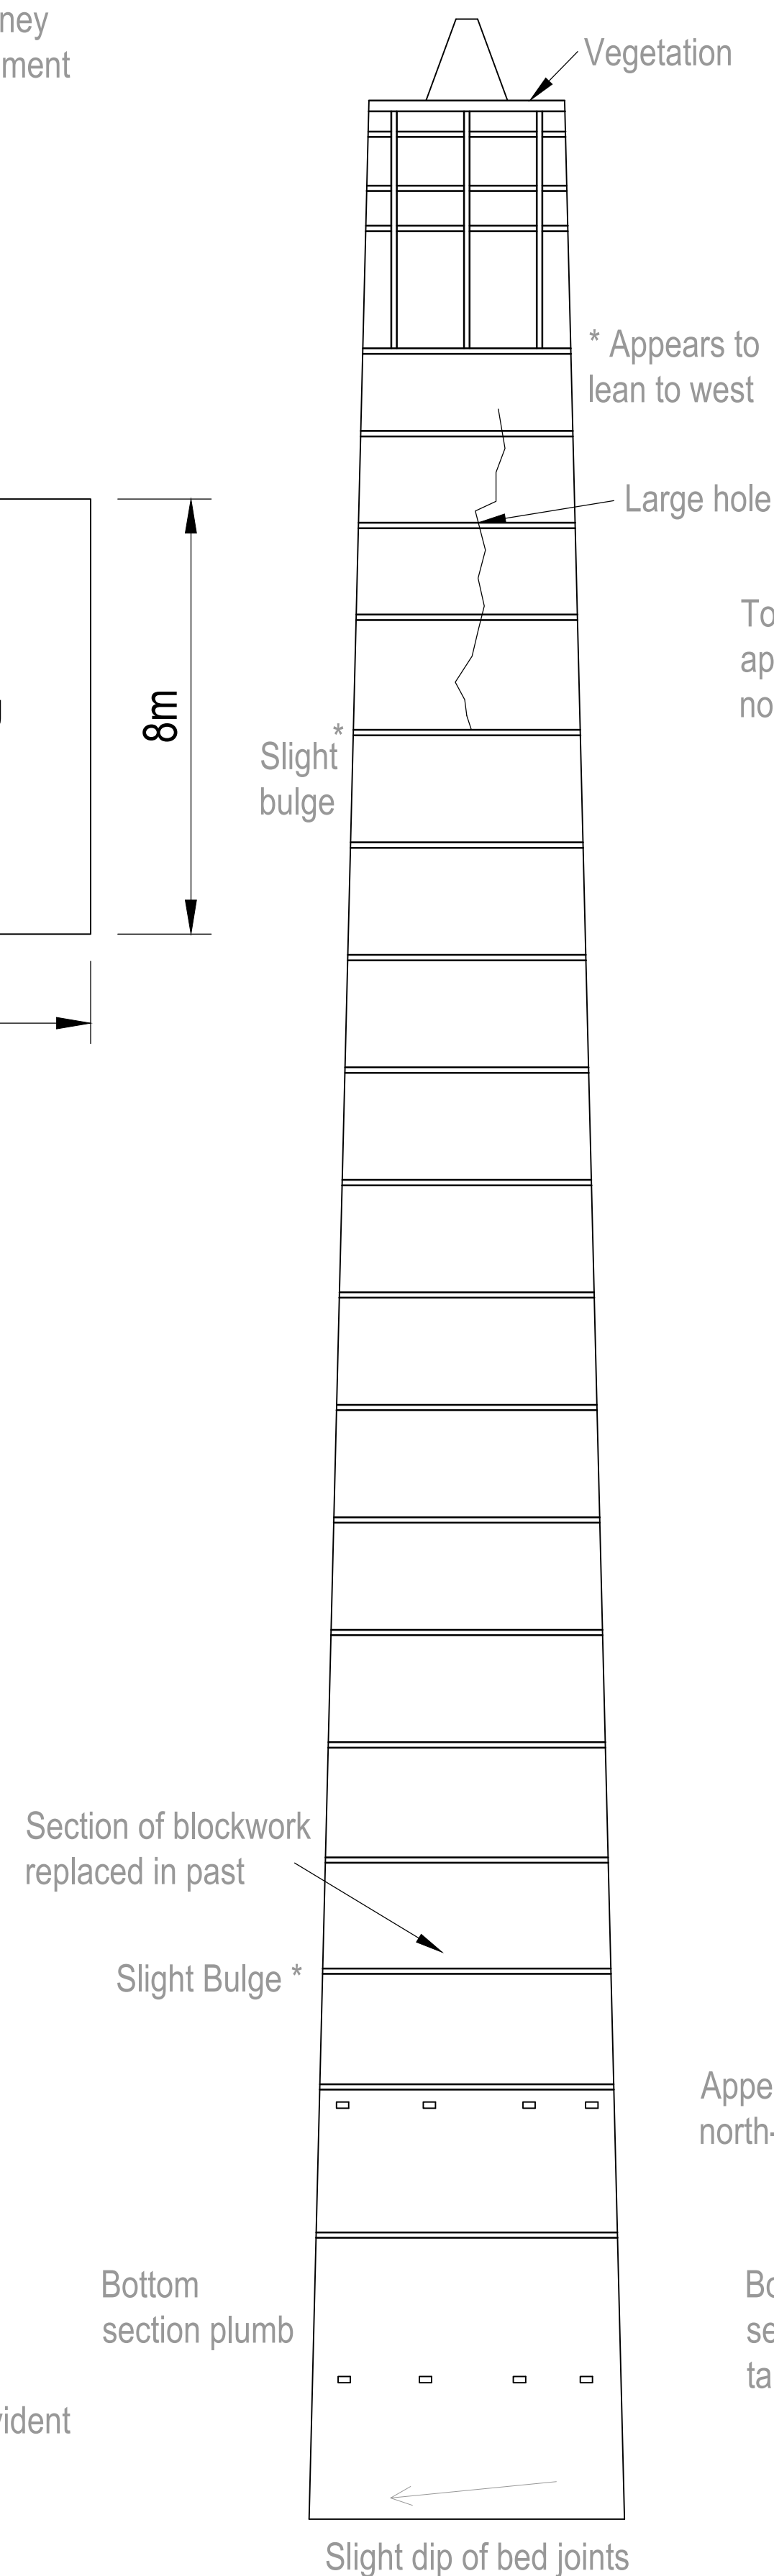
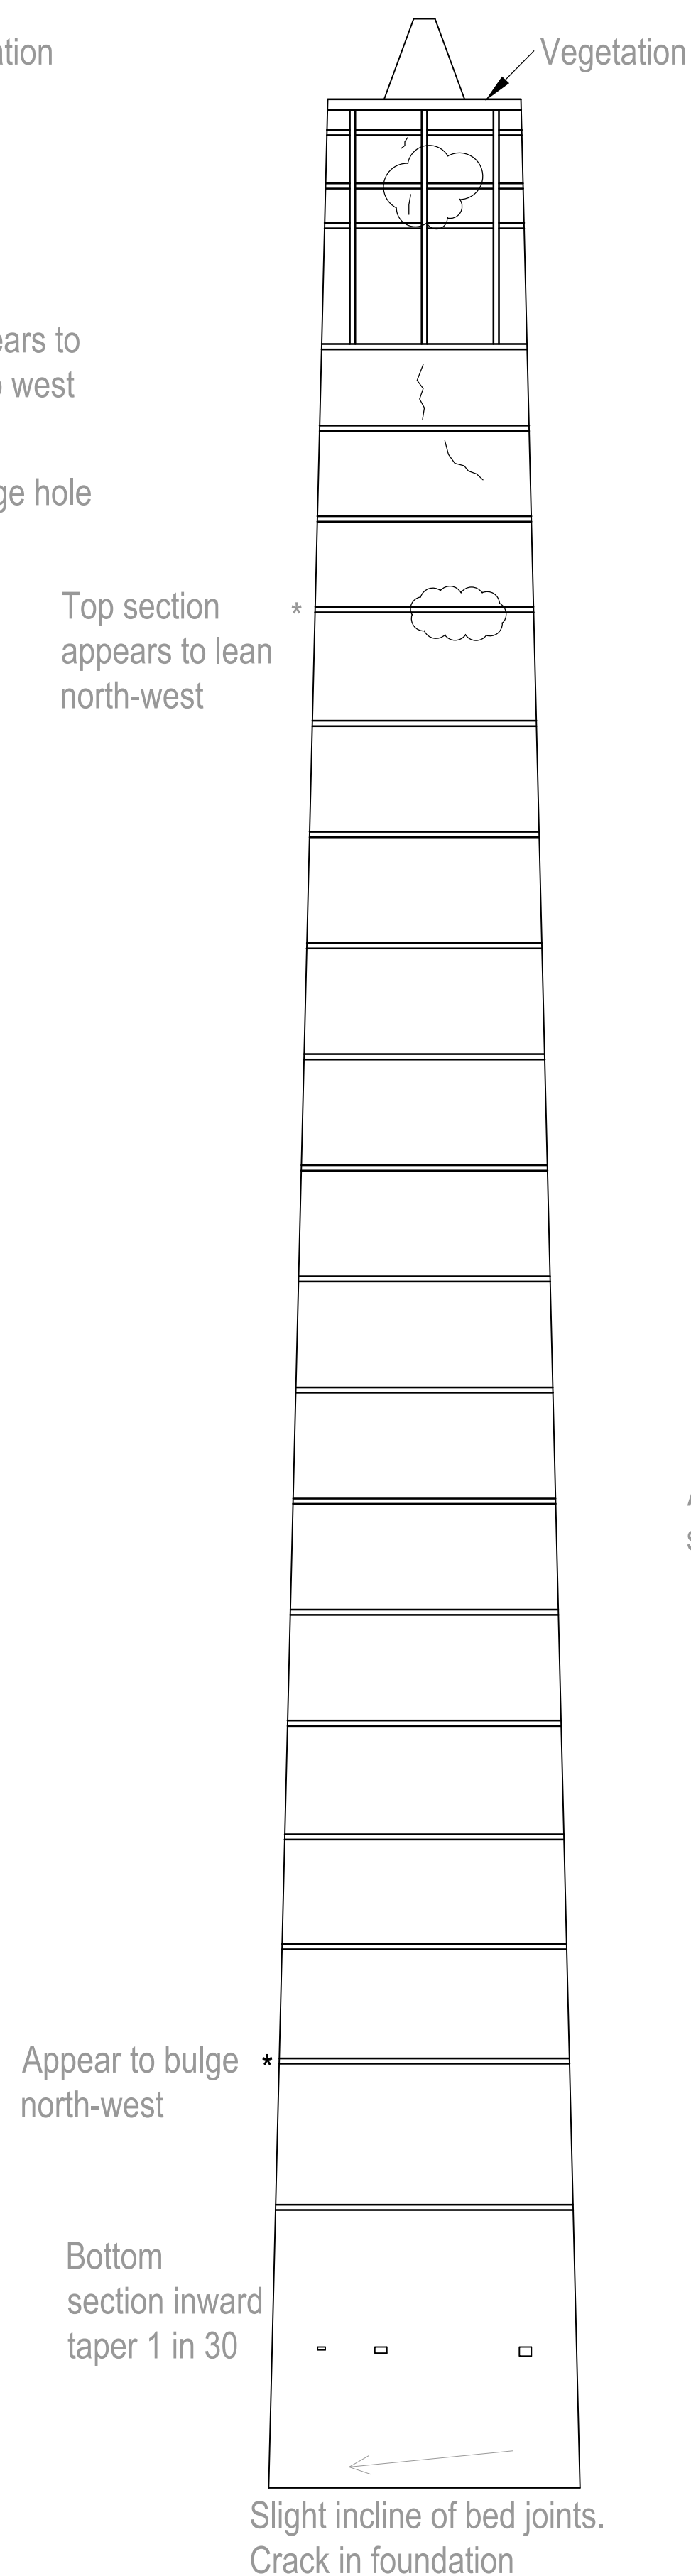
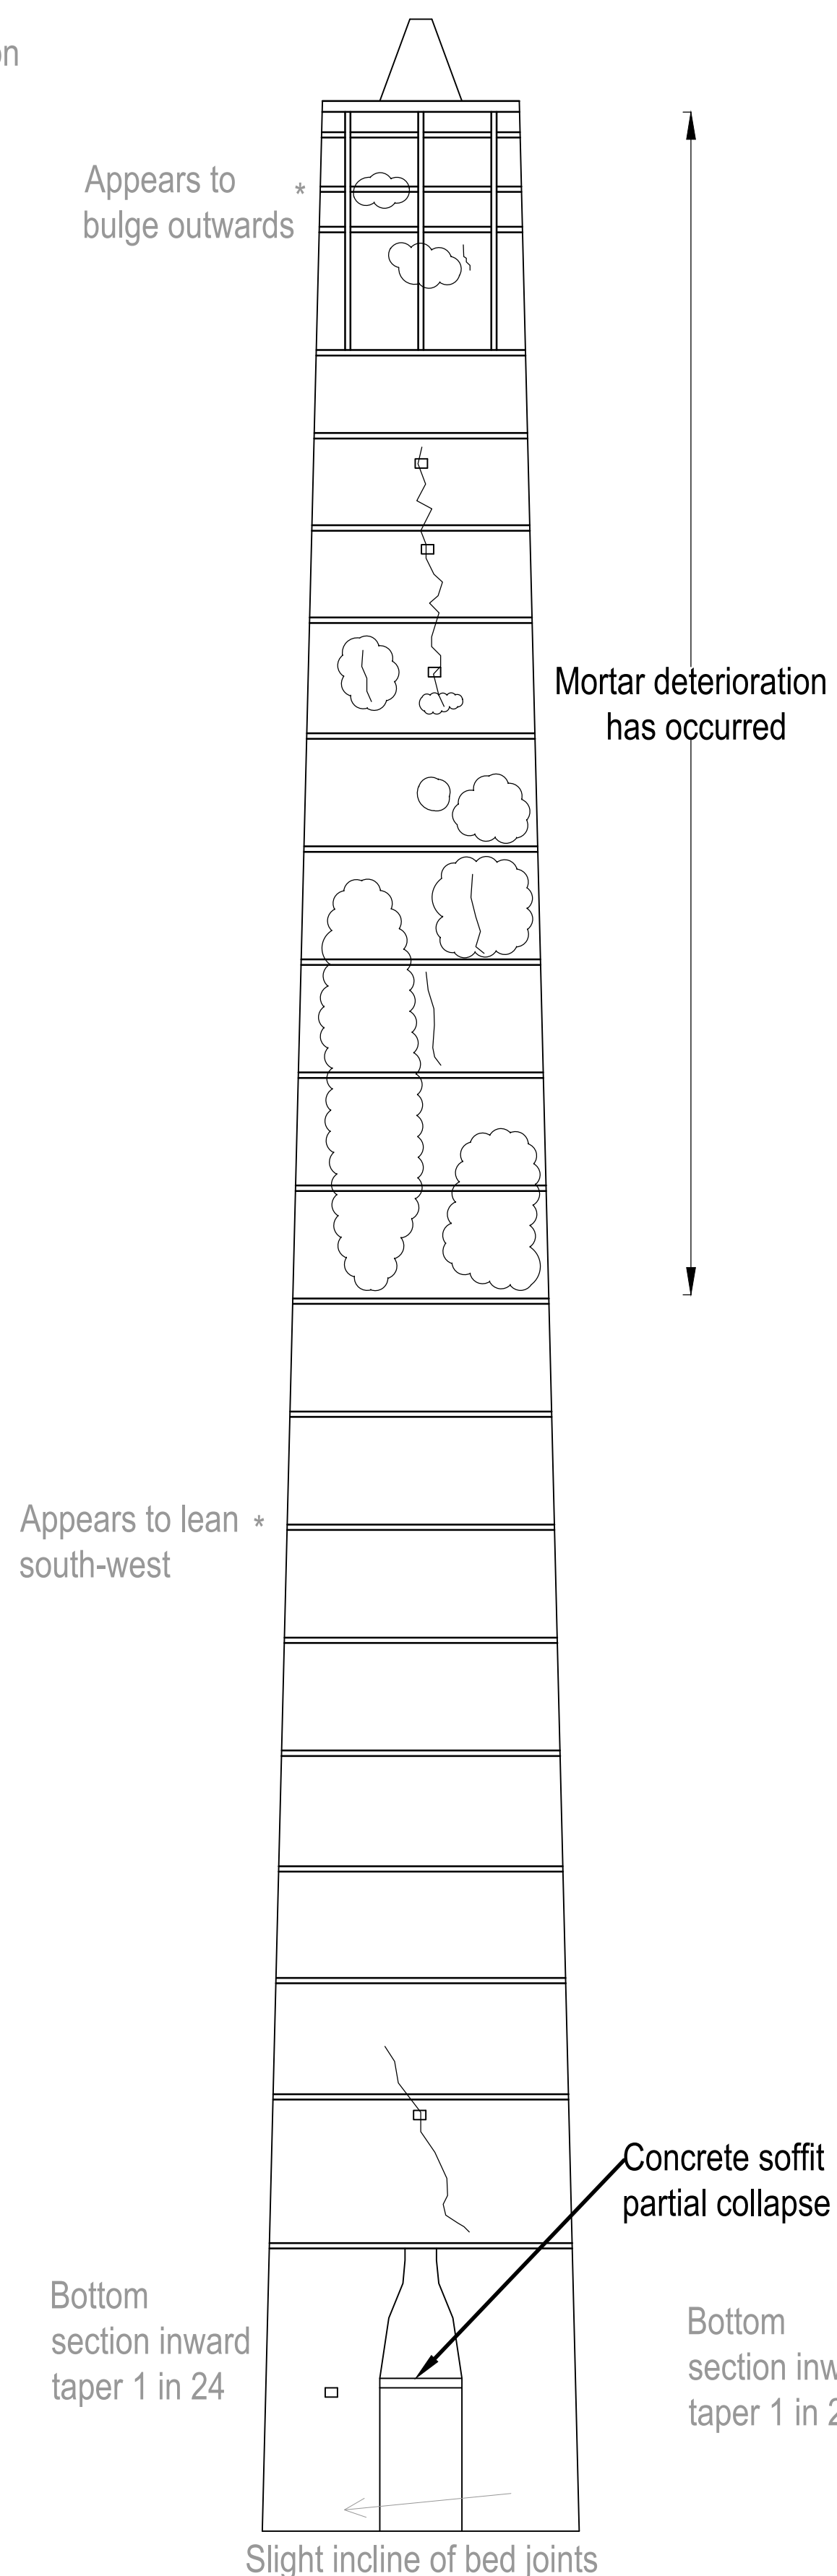
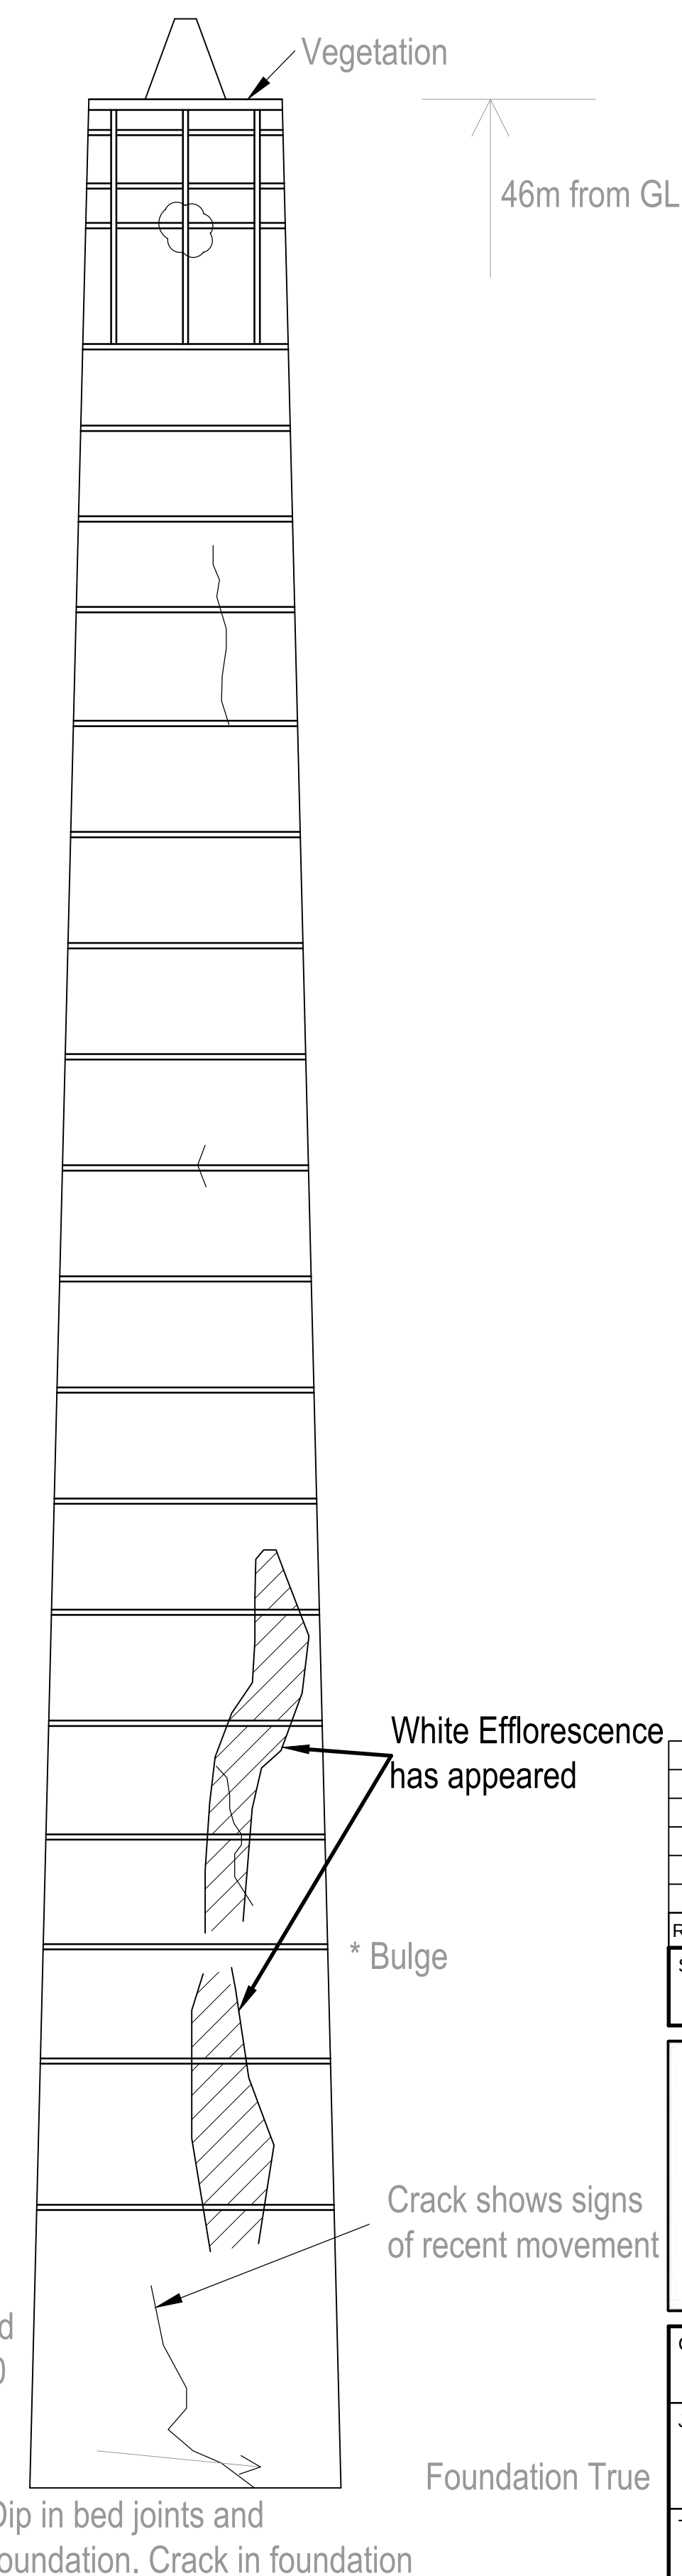
| Title | ELEVATIONS INDICATING DEFECTS<br>AND CHANGES SINCE LAST<br>INSPECTION |

Reference should be made to the previous defects identified in the report prepared by JNP Group in 2012. These defects are still evident from observations made in the recent inspection. Any deterioration has been recorded on the drawing attached to this report (NG8034 – 02).

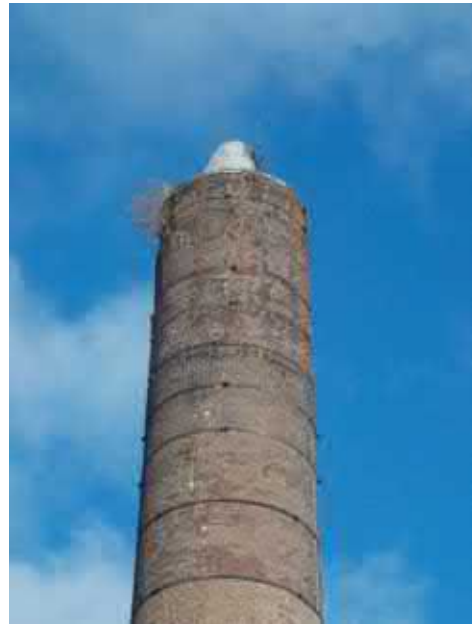
There are large areas of efflorescence staining to the mid and lower sections of the east elevation.

**Efflorescence to East Elevation**

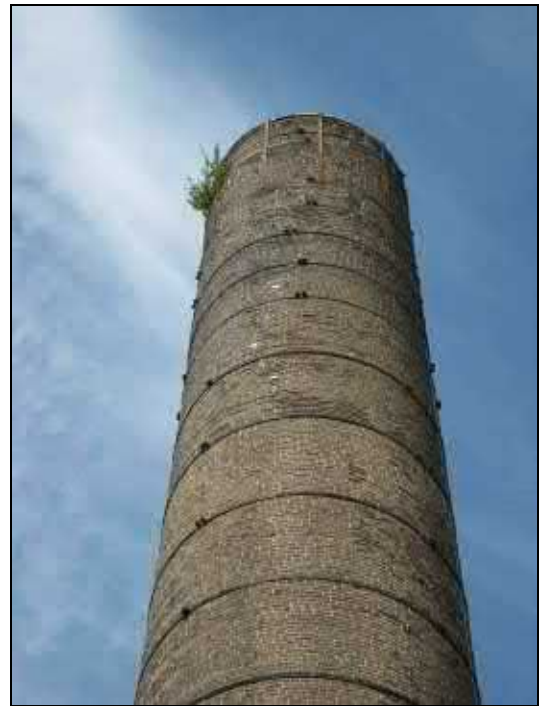
Elevation from NW showing lean to South West

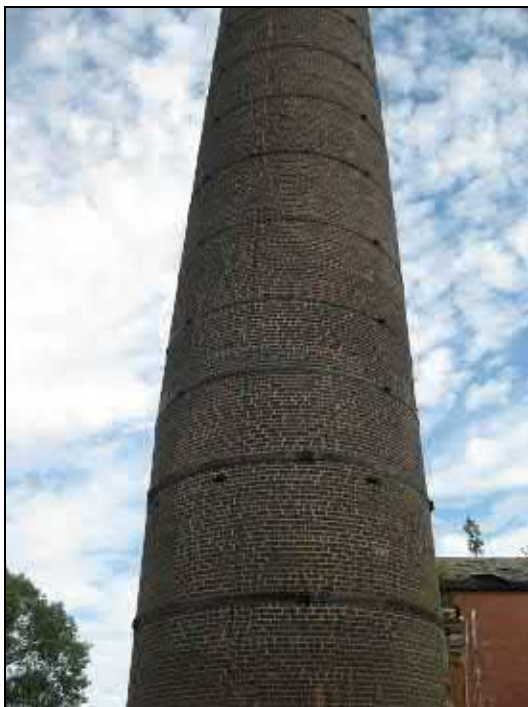
South elevation showing masonry re-pointing  
erosion and cracking

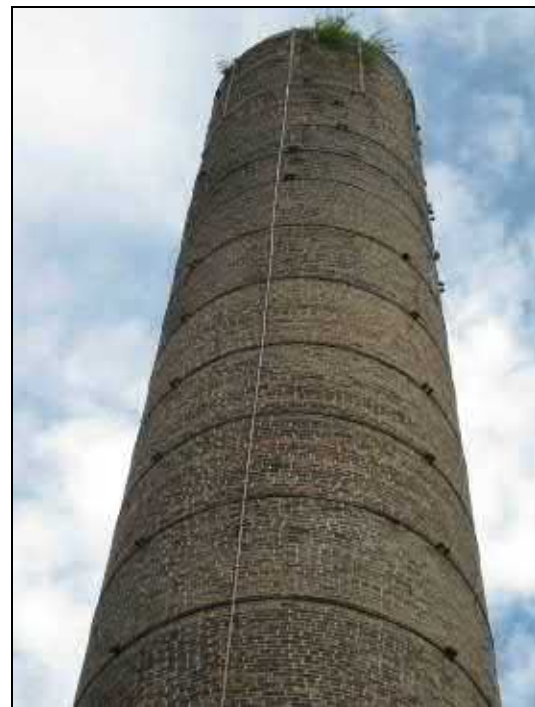
West elevation showing previous repair at  
approximately 10m.

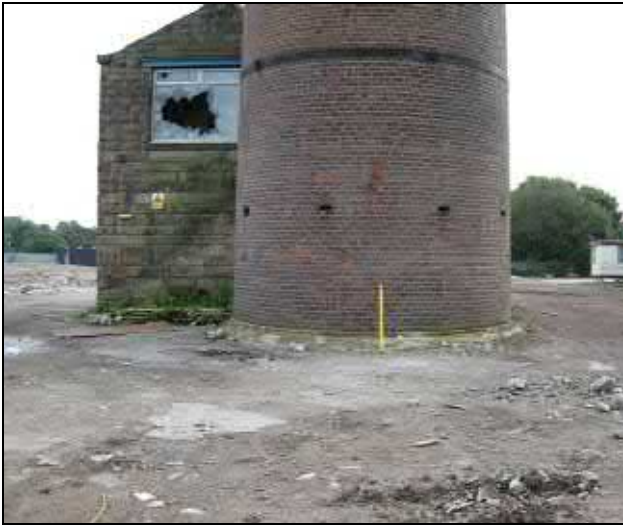
West elevation showing outwards movement of walls

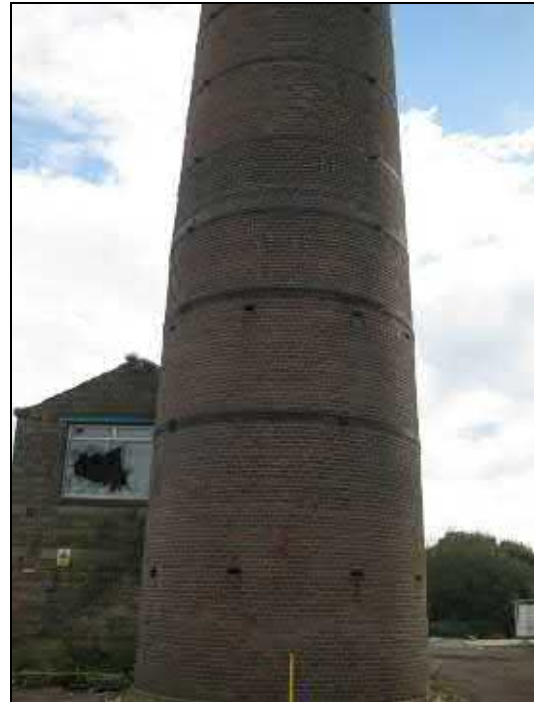
North elevation showing recent impact damage and evidence of base movement in past

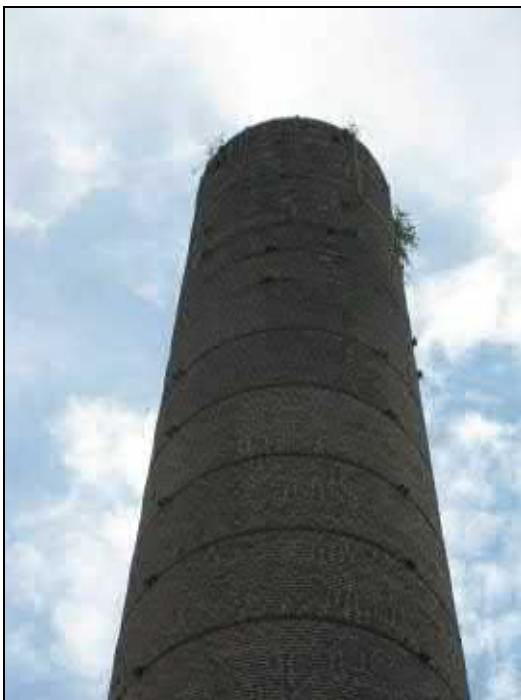
North elevation showing previous repair at approximately 10m

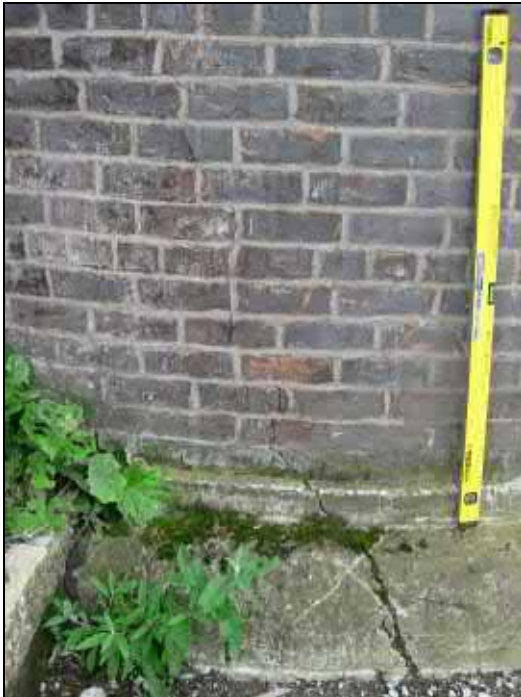
Indication of previous repointing

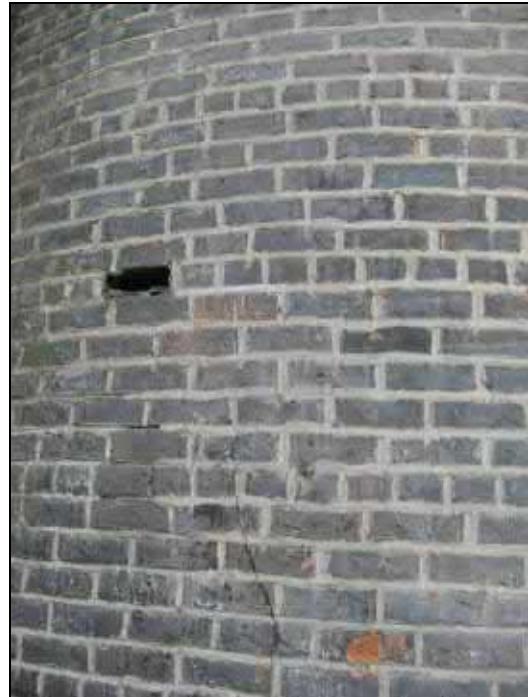
Historic crack of foundation to east elevation  
with recent movement apparent

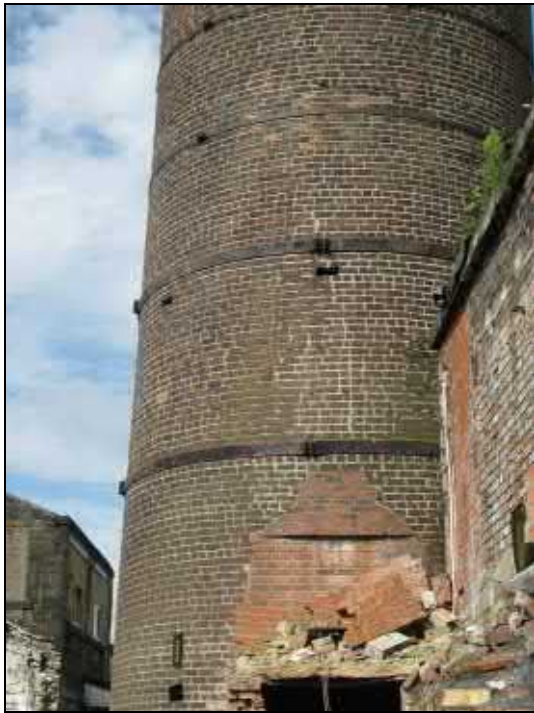
South elevation showing extremely unstable building  
connected to bottom of chimney

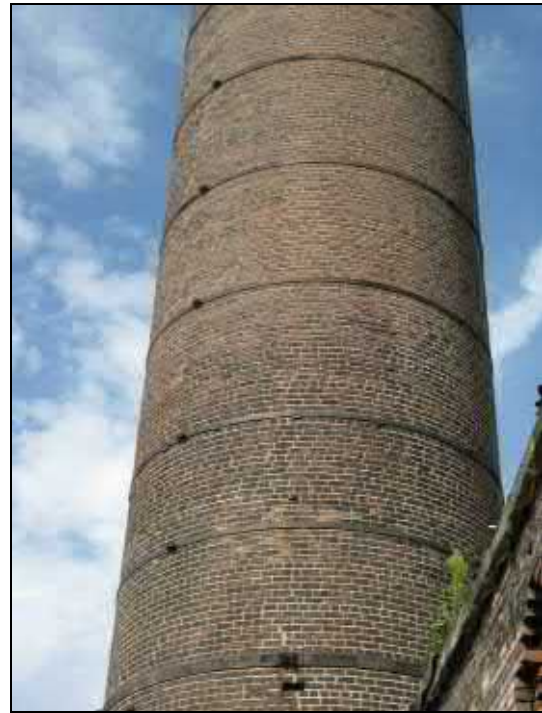
South elevation showing previous repairs near bottom

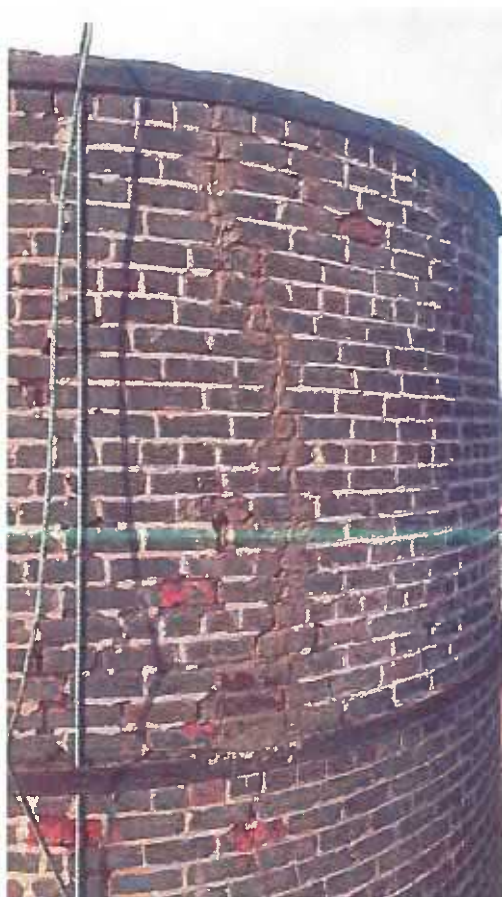
**Picture 3 – Crack repairs to southern elevation**
