S1/ECH/10/CB/HO/7.0/R1

### **FORMER MONDI SITE BRIDGE STREET RAMSBOTTOM**

Further to your instruction Betts Associates visited the above site in July 2019 to review the condition of existing buildings as shown on the aerial photograph.

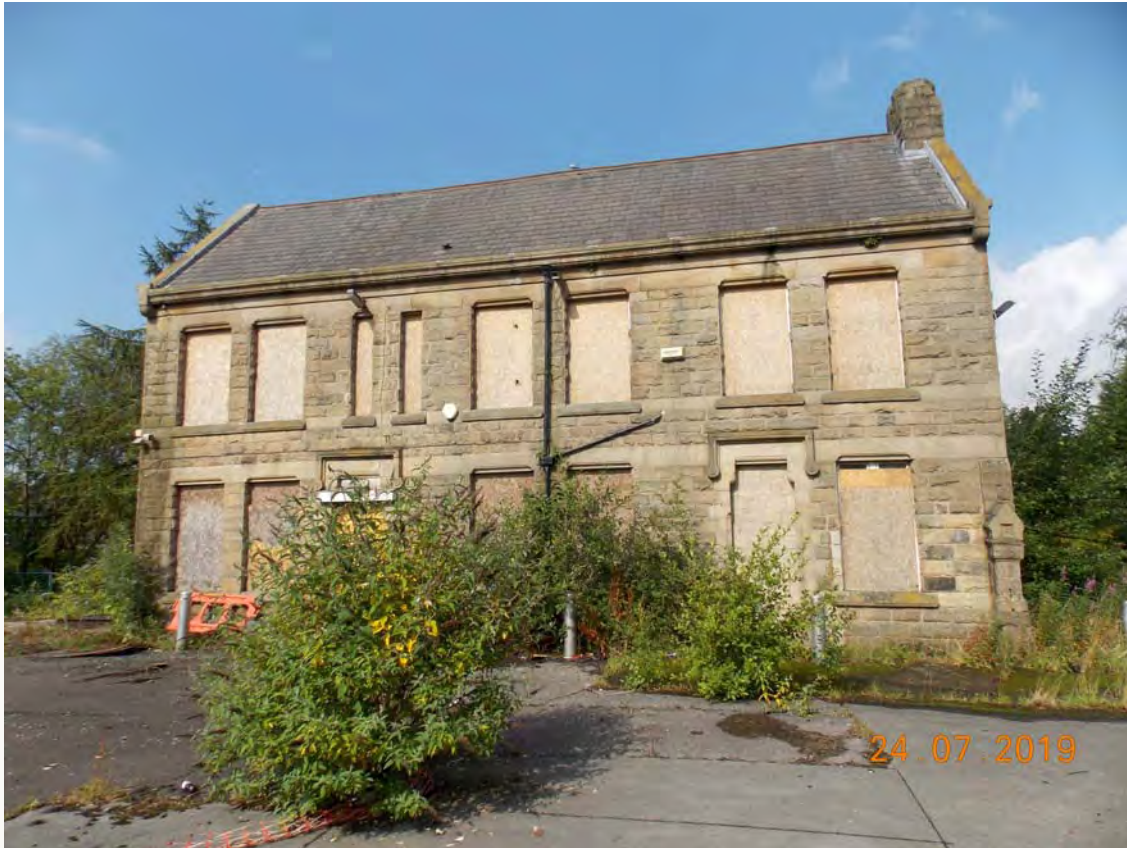
Of the three buildings assessed this structure was in the best condition.

Dense vegetation has grown all around the building which restricts the access.

The roof condition appears reasonable with flashings in place. The line of the ridge appears to have dropped at the front left hand.

The external wall is dressed stonework with stone lintels generally in reasonable condition, however there is a noticeable bulge in the left hand front elevation (east side) at roof level. See photograph below. This position coincides with the dropped ridge line. It is possible that the roof movement had pushed the external wall outwards. An inspection of the internal structure is necessary to confirm this.

**Building A** - Has a reasonable building envelope but would need further investigation into the bulging of masonry, possibly due to potential roof distortion. Roof, floor joists and ground floor would require further investigation.

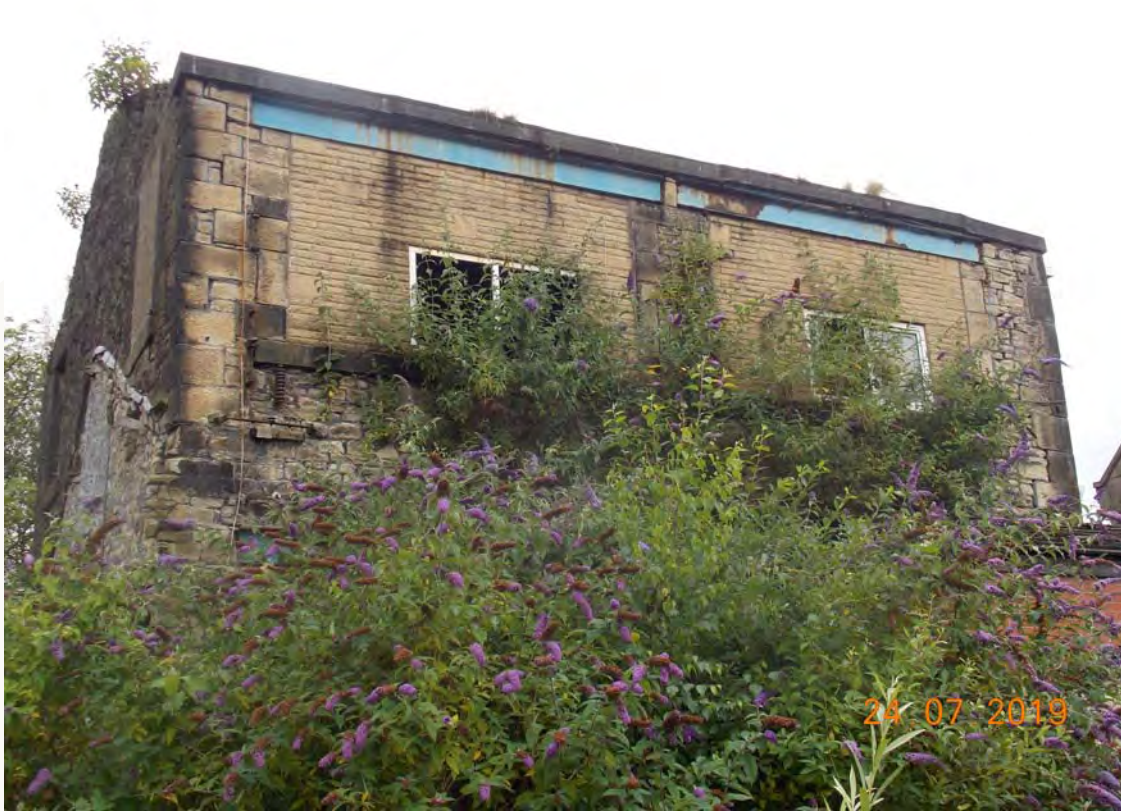
The front elevation (shown above) could not be accessed but from photographs it can be seen to be random stonework in the main which has been modified with steelwork and infill stonework. Corrosion of the steelwork is occurring at the supports and distorting the masonry. A single storey extension has been added to the frontage.

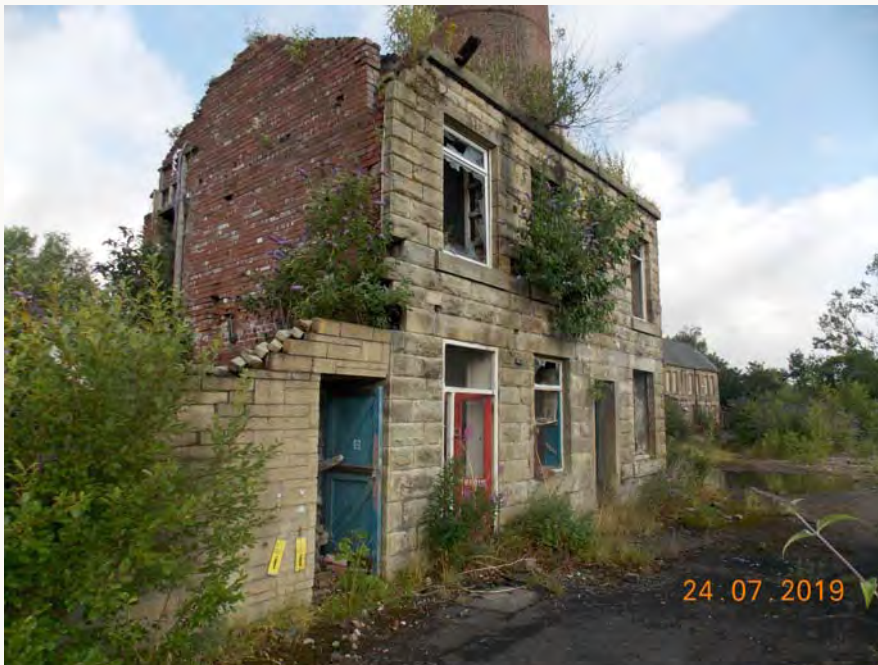
This building is a two storey structure with stone facing masonry. The building is derelict and not safe to enter.

The photograph above shows the front (east facing) elevation.

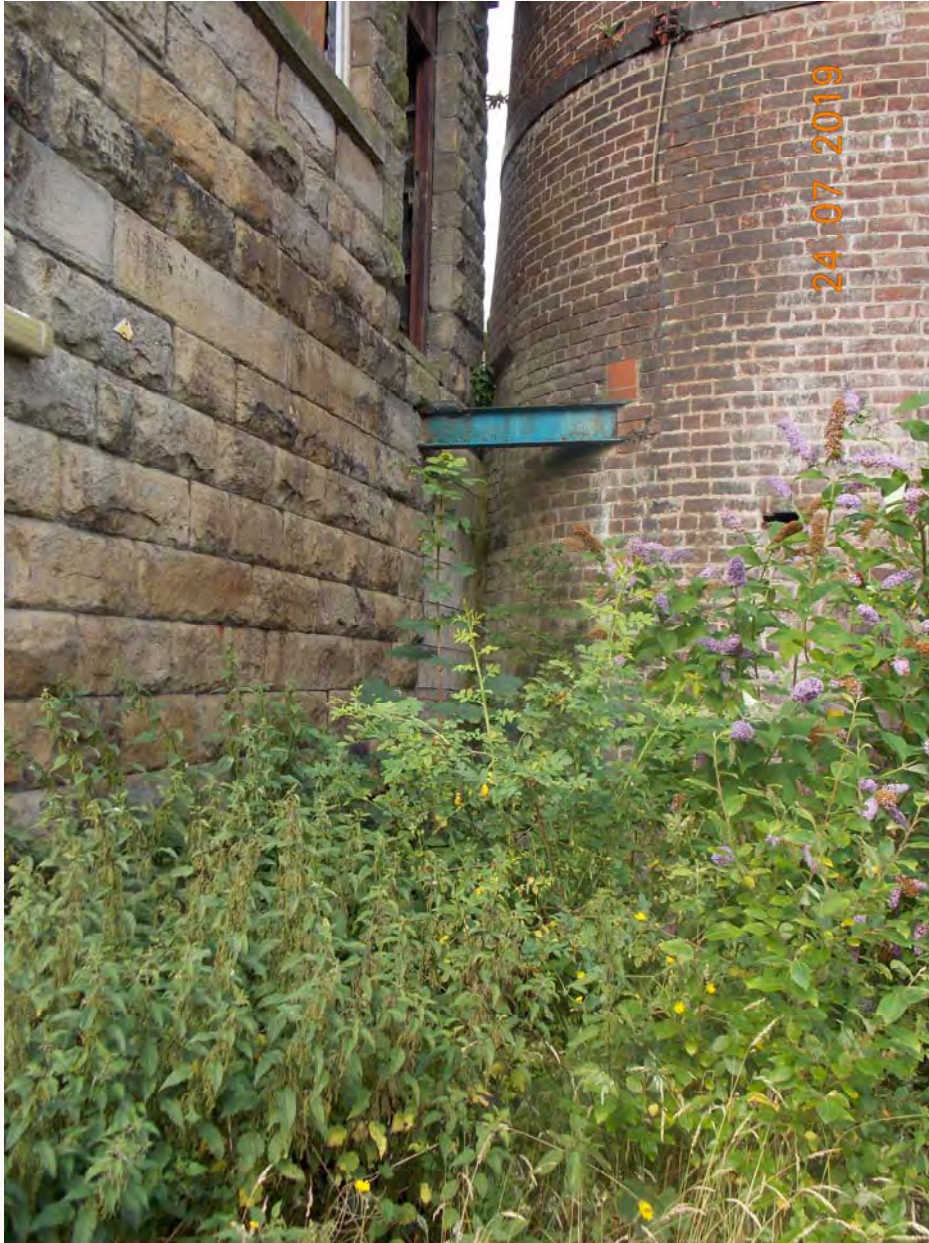
The north end of the building is also stonework however the tall brick chimney is in close proximity. A steel section connects this elevation and the chimney at first floor level and below this, in the northwest corner, Building C merges with the chimney.

The rear of Building C is brick construction. At the base of the chimney access to the main shaft is formed where the two buildings meet. Due to limited access it is not clear which is the original structure of the chimney and this requires further investigation, particularly due to the potential instability of Building C.

**Building C** – In a dangerous condition with large holes in masonry and unbonded brickwork, particularly on the rear and south side elevation. It is not clear how this building is connected to the chimney at ground level. Further investigation is required in this area before any remedial works are undertaken.

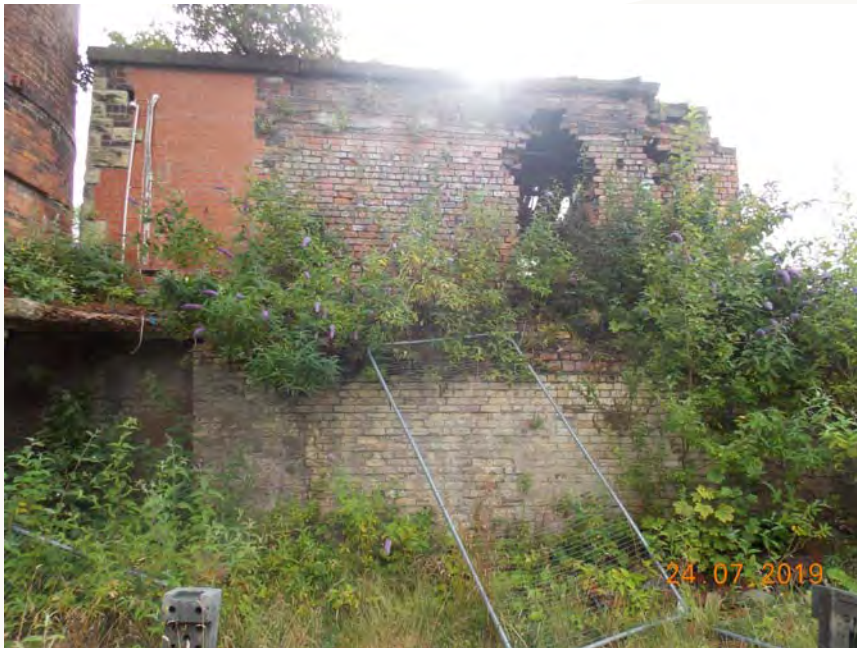
The south end of Building C is in a dangerous condition with brickwork being unbonded.

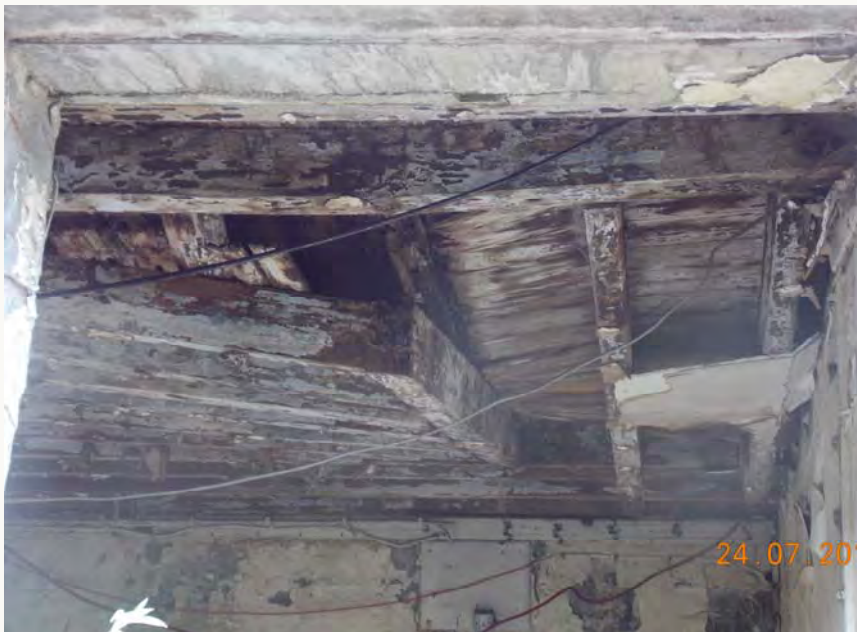
An inspection of the first floor construction could be made from outside the building which showed rotten floor joists in danger of collapse
