# Structural Report

7, Taylors Lane, Ainsworth.

Job No: 21268

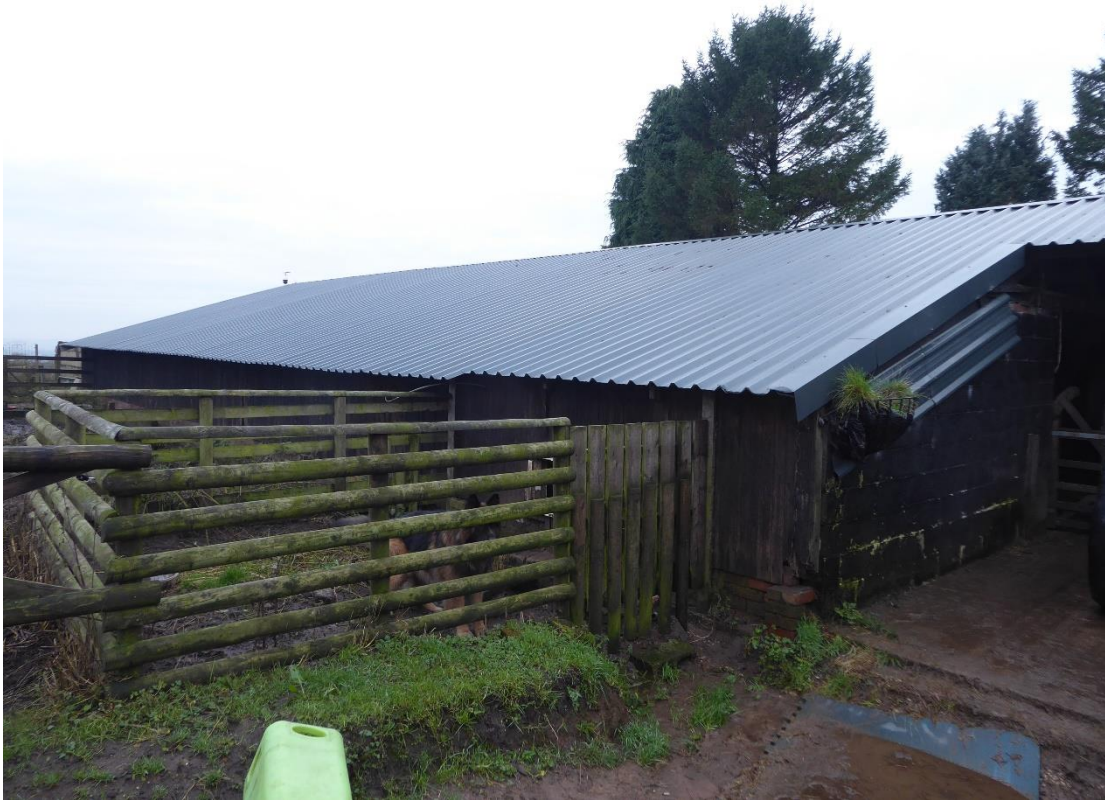
Photograph 1 - General external view of the eastern elevation.

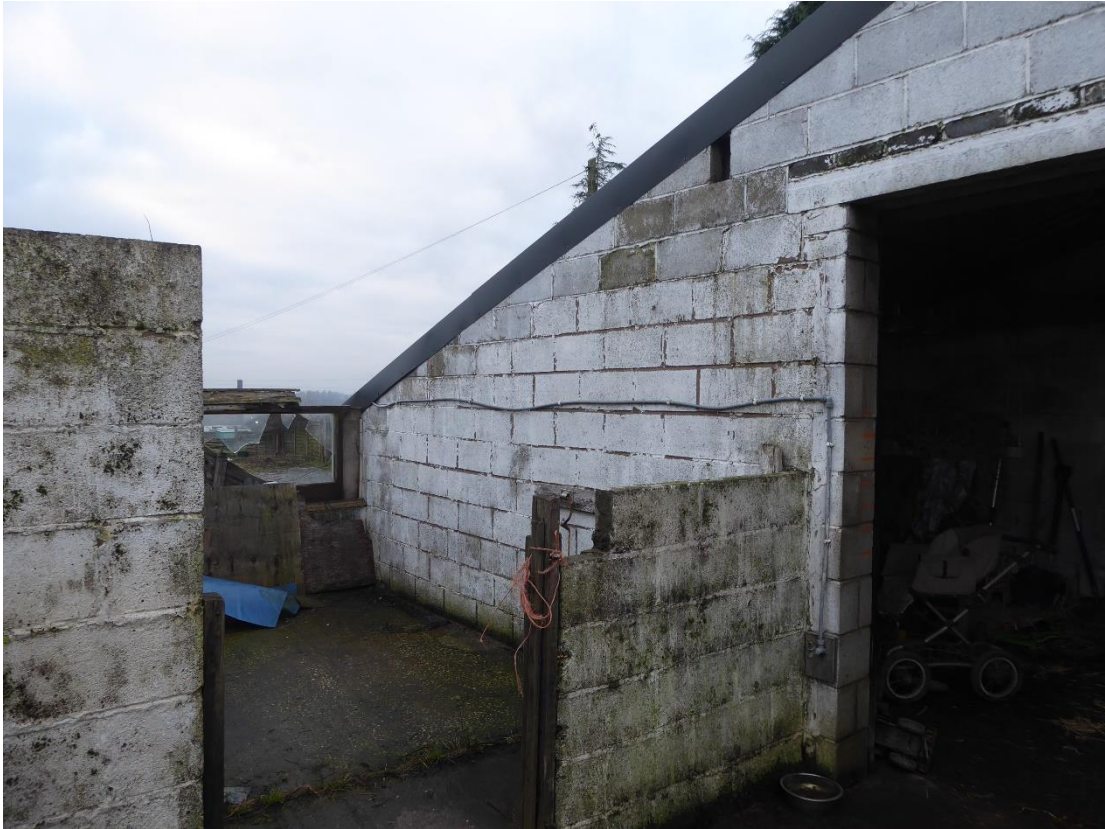
Photograph 2 – Partial view of the southern elevation.

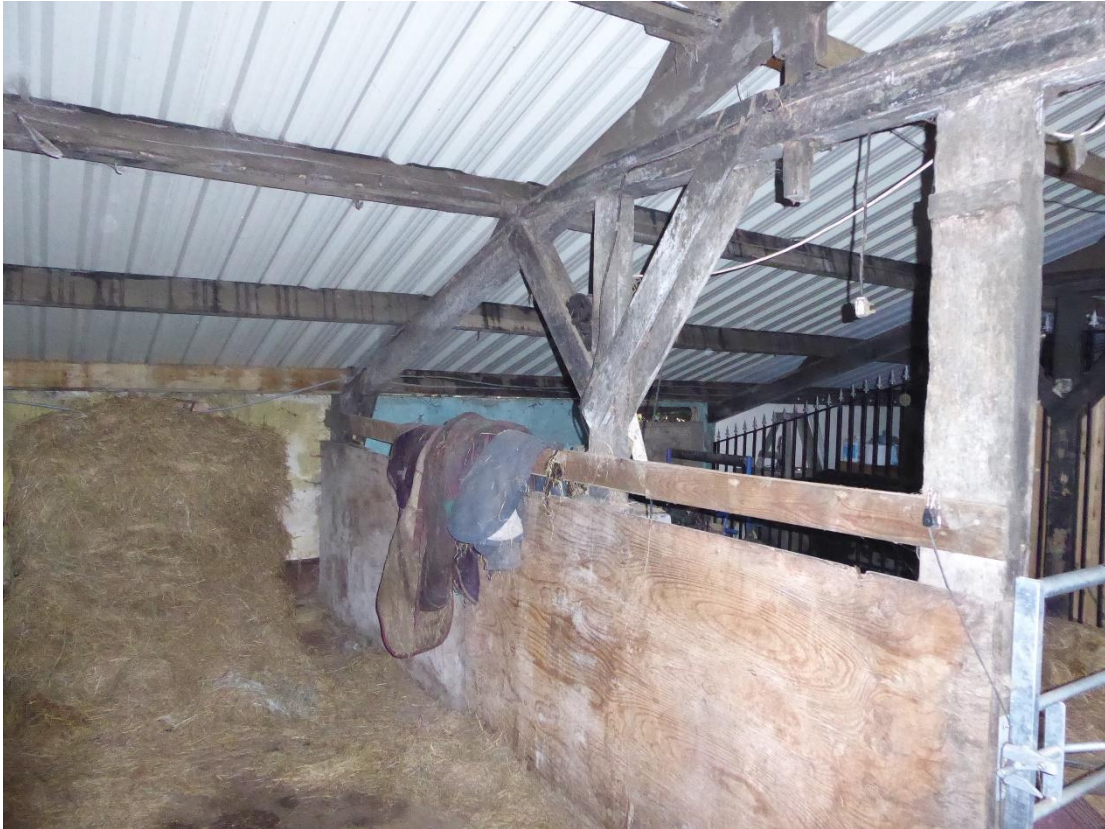
3.4 We've completed some preliminary calculations which indicate that the timber roof structure will need to be completely replaced or strengthened to support a new domestic light weight roof without slates or tiles.

Photograph 3 – Partial view of the supporting timber frame.

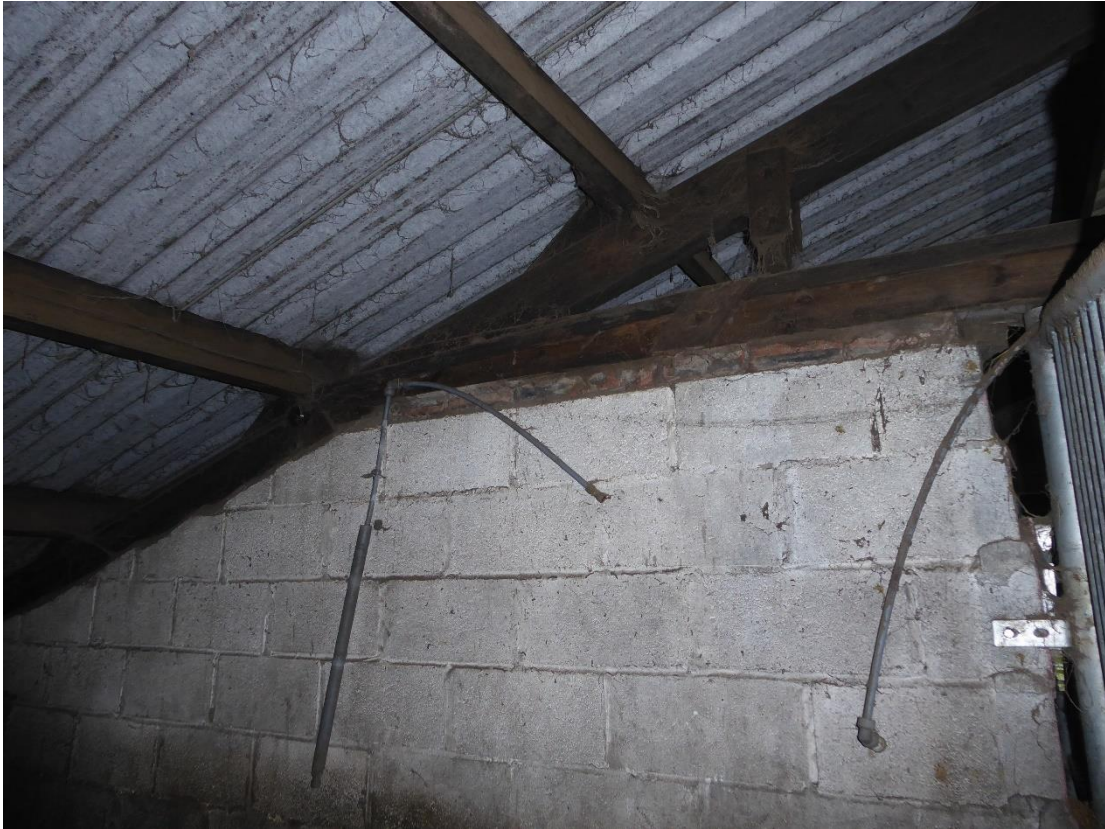
3.1 The supporting concrete block walls are supported directly off the existing concrete slab.

Photograph 4 – Partial view of the internal supporting masonry walls.
