**STRUCTURAL REPORT**  
**Carriage Shed, Buckley Wells Locomotive Works**  
**Baron Street**  
**Bury**  
**for**  
**East Lancashire Railway**  
**Job No. 12889**

## Executive Summary

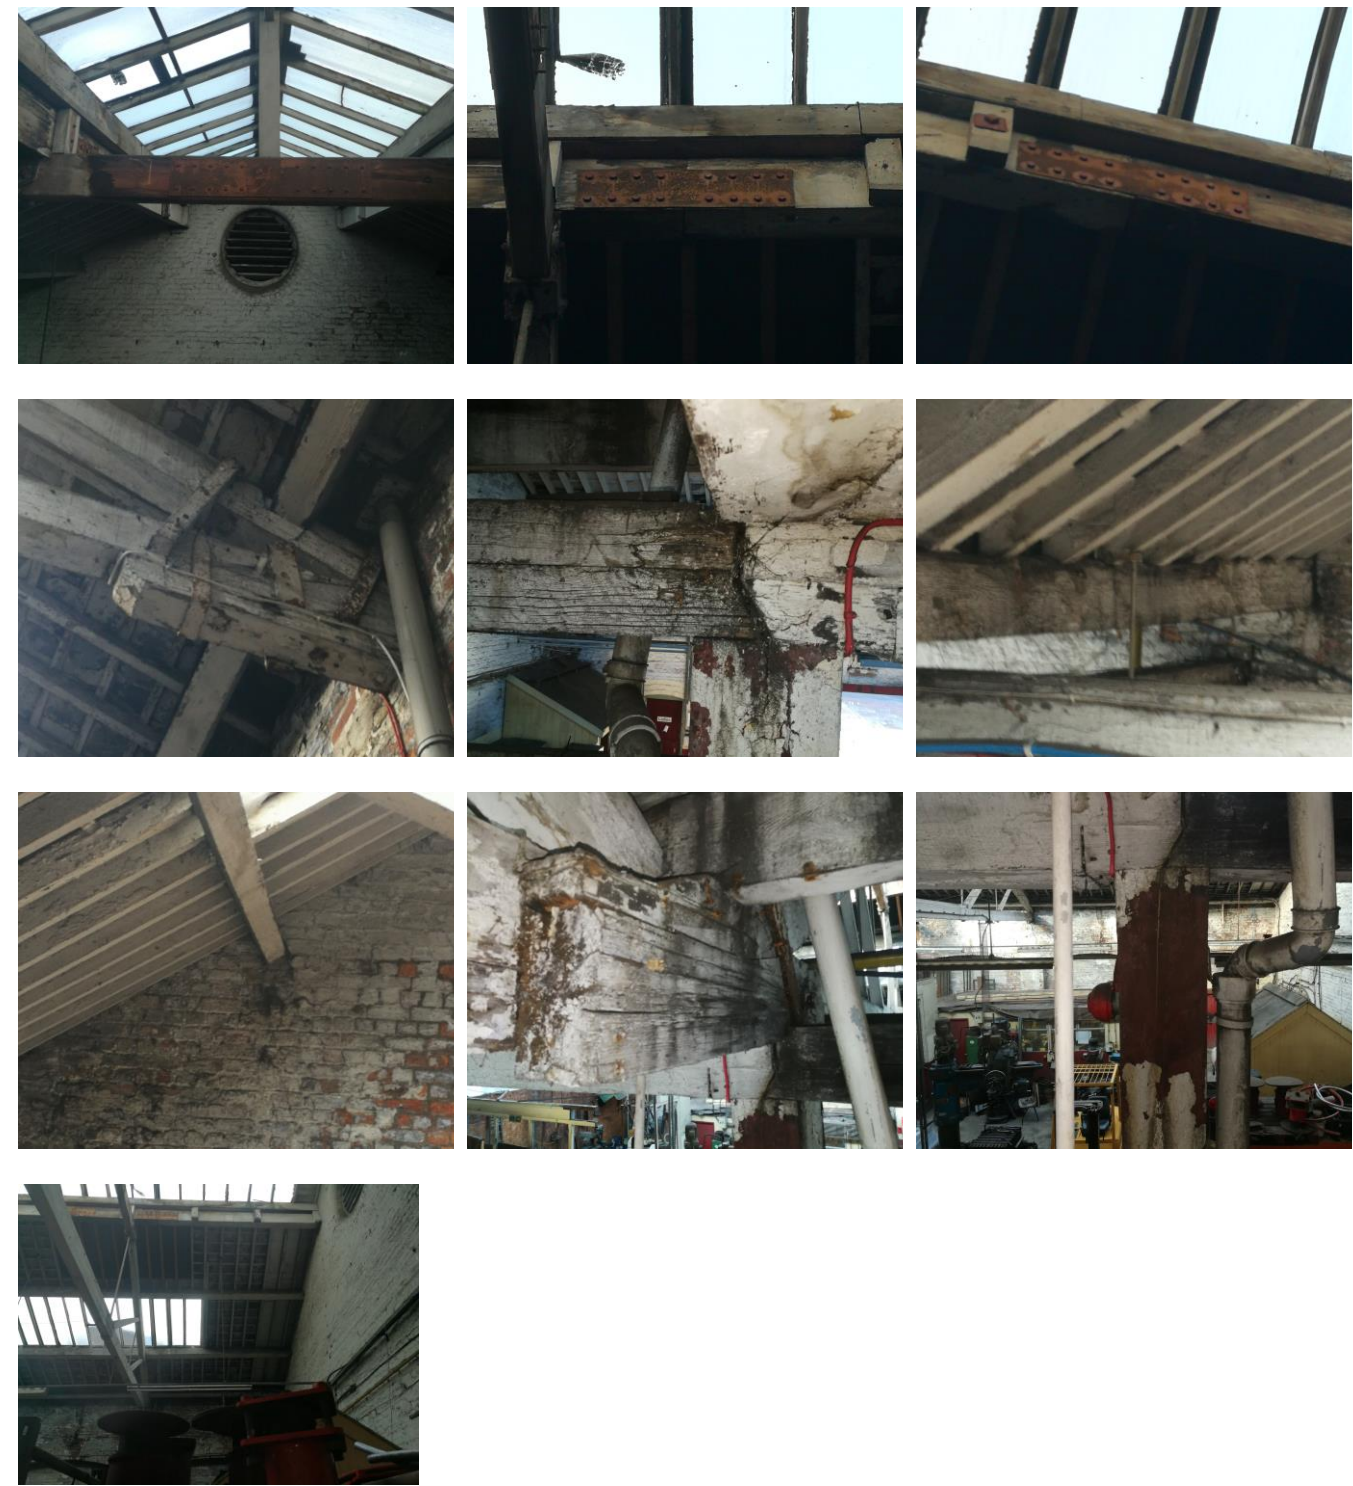
Truss 1

This truss has an existing repair detail at its bearing in the West external wall, we presume the repair was required due to historic water ingress issues. The truss eaves connection detail East at the central valley (B3) has failed in shear due to decay. This defect is a result of a defective valley gutter resulting in extensive decay of the bottom chord. Refer to Timber Specialist report for remedial details.

The top surface of the bottom chord at mid span is showing signs of decay.

The central timber member which ties the heads of all the columns and provides the bearing for the trusses is showing signs of decay at either end. The lap joint at the head of the column has been constructed incorrectly originally as the member is too short, it is also showing signs of decay.

Two purlins in bay 1 (P5 and P6) are showing signs of decay at the bearing in the gable wall due to water ingress issues. Refer to Timber Specialists report for remedial details.

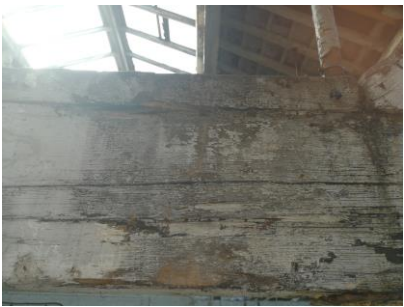
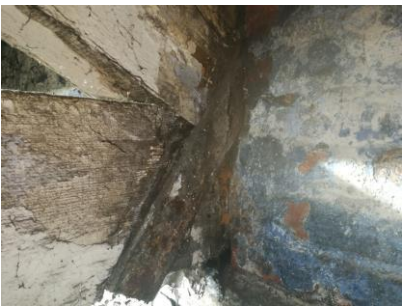
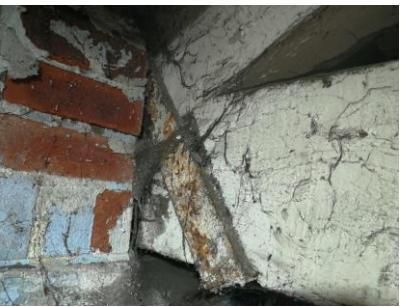
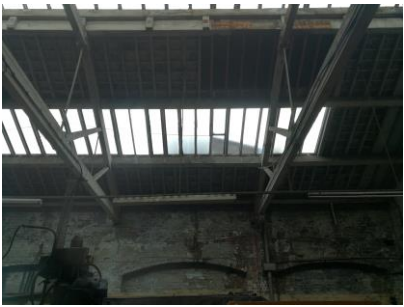
Truss 2

At the time of the visual inspection no signs of decay were apparent to any of the structural members.

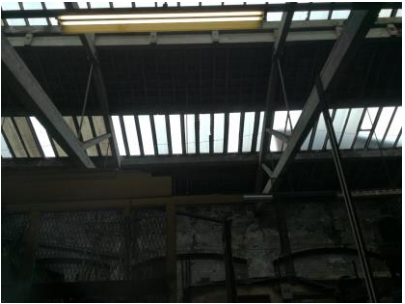
Truss 3

At the time of the visual inspection no signs of decay were apparent to any of the structural members, however the existing bearing repair detail is inadequate, a full timber repair is required before the temporary scaffold support can be removed

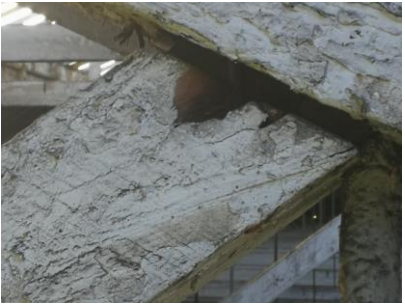
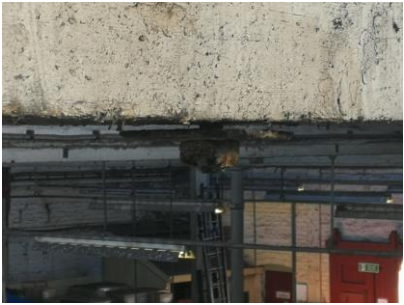
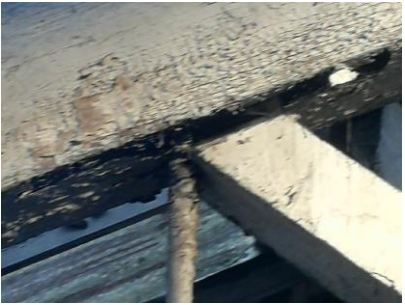
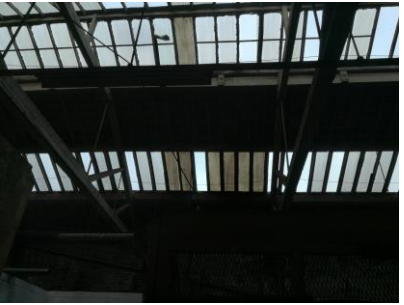
Truss 4

At the time of the visual inspection no signs of decay were apparent to any of the structural members, however the internal members and vertical tie rods of the truss are loose and not working as intended.

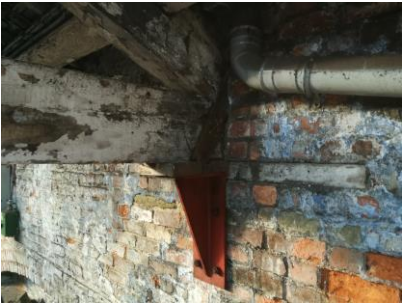
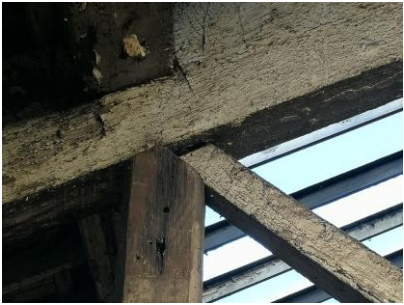
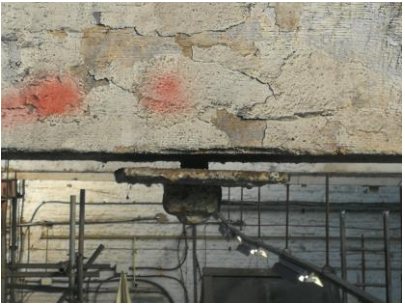
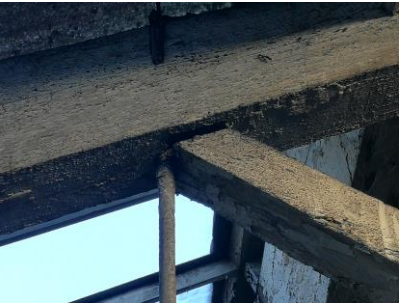
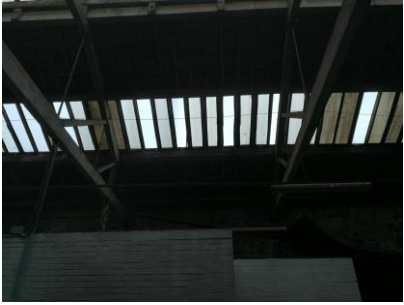
Truss 5

This truss has an existing repair detail at the bearing in the West wall, we presume the repair was required due to historic water ingress issues. The existing bearing repair detail is inadequate a full timber repair will be required before the bracket detail and existing timber prop can be removed.

Due to this existing repair the truss is also showing signs of movement, lozengeing as the internal timber members along with the vertical tie bars are loose and not working as intended.

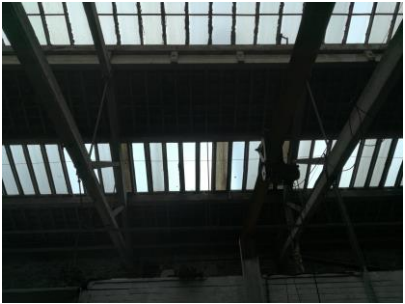
Truss 6

At the time of the visual inspection no signs of decay were apparent to any of the structural members, however the truss is showing signs of movement, lozengeing as the internal members and vertical tie rods of the truss are loose and not working as intended.

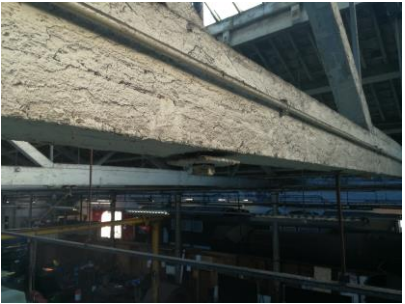
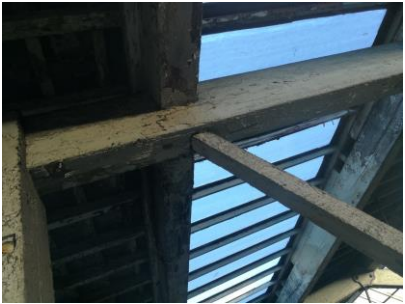
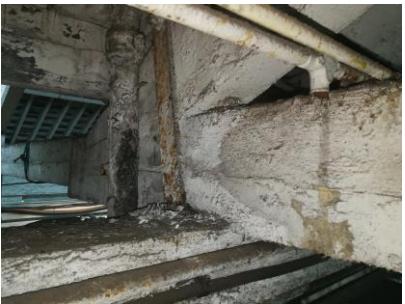
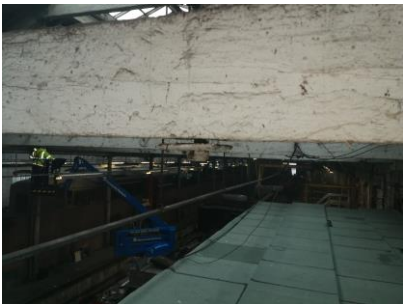
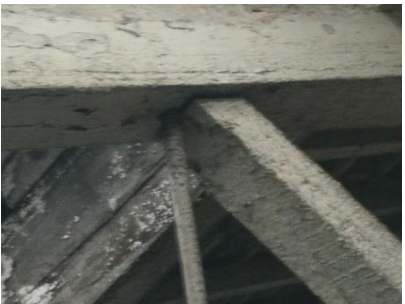
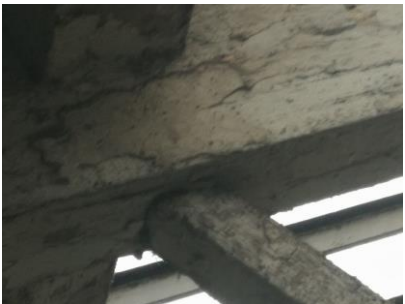
Truss 7

At the time of the visual inspection no signs of decay were apparent to any of the structural members, however the truss bearing in the West wall has an existing scarf joint repair, we presume the repair was required due to historic water ingress issues. Due to this existing repair, the truss is also showing signs of movement, lozengeing as the internal timber members along with the vertical tie bars are loose and not working as intended.

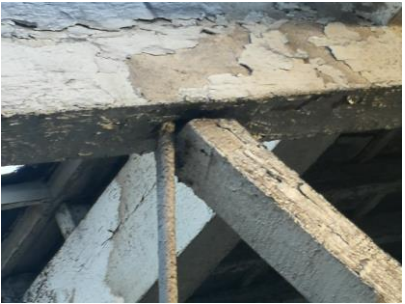
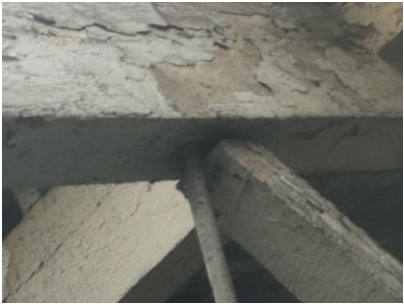
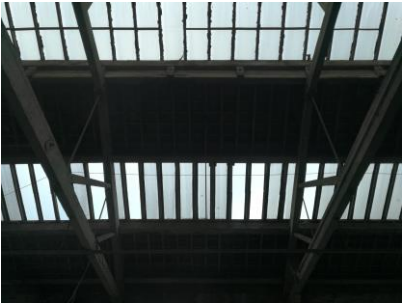
Truss 8

At the time of the visual inspection no signs of decay were apparent to any of the structural members, however the truss is showing signs of movement, lozengeing as the internal members and vertical tie rods of the truss are loose and not working as intended.

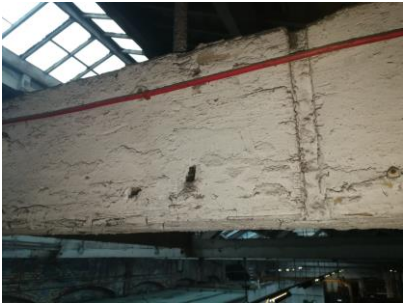
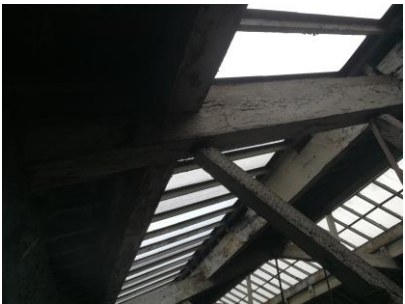
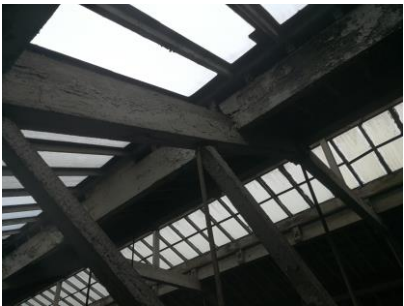
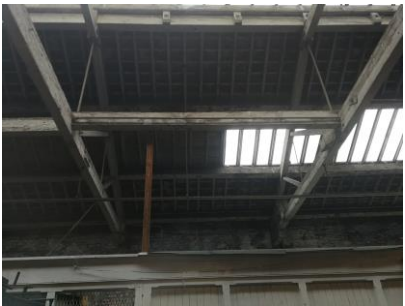
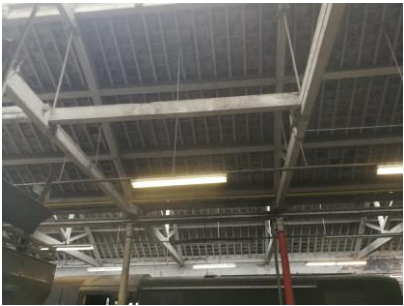
Truss 9

The truss bearing in the West wall has an existing scarf joint repair which is showing signs of decay due to prolonged water ingress issues at the rainwater pipe location. Due to this defect the bearing of the purlin (P1) is also showing signs of decay. Refer to Timber Specialist report for remedial details.

As a result of this existing repair, the truss is also showing signs of movement, lozengeing as the internal timber members along with the vertical tie bars are loose and not working as intended. In one instance a strut is completely missing.
