## Refurbishment & Demolition Survey To Land Off Hilton Lane/Butterstile Close, Prestwich, Manchester, M25 9RS

| Date of Survey: | 01&02/11/22 |
| Report Reference No: | RDS1440 |

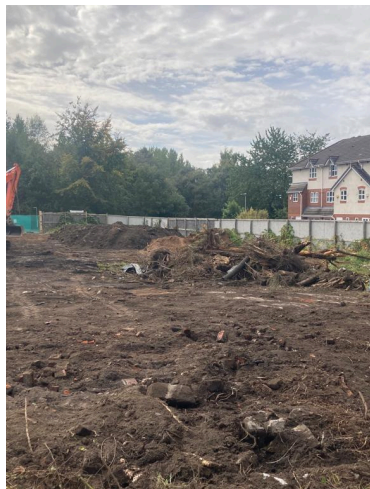
| | <b>Location:</b> Area A | <b>Inspection Number:</b> 001 |

| | <b>Material Description:</b> N/A | <b>Asbestos Type:</b> NAD |
| | <b>Quantity/Extent:</b> N/A | <b>Condition:</b> N/A |

| | <b>Risk Rating:</b> N/A | <b>Surveyors Recommendation:</b> No Further Action Required |

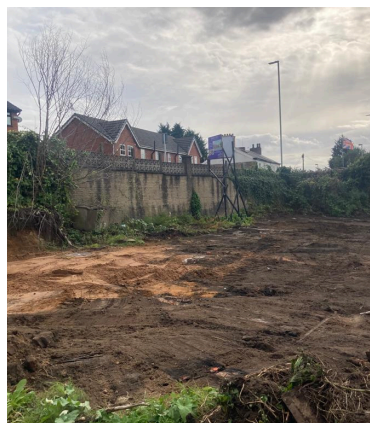
| | <b>Location:</b> Area B | <b>Inspection Number:</b> 002 |

| | <b>Material Description:</b> N/A | <b>Asbestos Type:</b> NAD |
| | <b>Quantity/Extent:</b> N/A | <b>Condition:</b> N/A |

| | <b>Risk Rating:</b> N/A | <b>Surveyors Recommendation:</b> No Further Action Required |

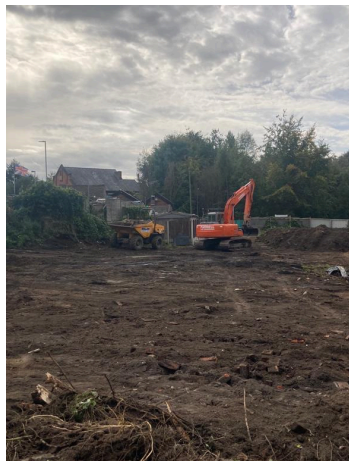
| | <b>Location:</b> Area C | <b>Inspection Number:</b> 003 |

| | <b>Material Description:</b> N/A | <b>Asbestos Type:</b> NAD |
| | <b>Quantity/Extent:</b> N/A | <b>Condition:</b> N/A |

| | <b>Risk Rating:</b> N/A | <b>Surveyors Recommendation:</b> No Further Action Required |

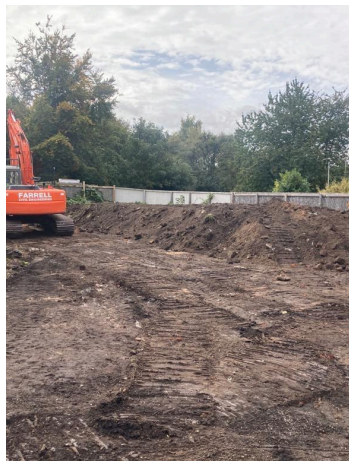
| | <b>Location:</b> Area D | <b>Inspection Number:</b> 004 |

| | <b>Material Description:</b> N/A | <b>Asbestos Type:</b> NAD |
| | <b>Quantity/Extent:</b> N/A | <b>Condition:</b> N/A |

| | <b>Risk Rating:</b> N/A | <b>Surveyors Recommendation:</b> No Further Action Required |

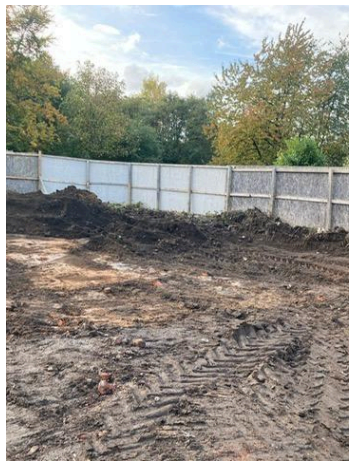
| | <b>Location:</b> Area E | <b>Inspection Number:</b> 004 |

| | <b>Material Description:</b> N/A | <b>Asbestos Type:</b> NAD |
| | <b>Quantity/Extent:</b> N/A | <b>Condition:</b> N/A |

| | <b>Risk Rating:</b> N/A | <b>Surveyors Recommendation:</b> No Further Action Required |
