# Haslam Brow, Bury, Manchester

## Visual Highway Condition Survey Report

784-A113188

Shaheen Developments

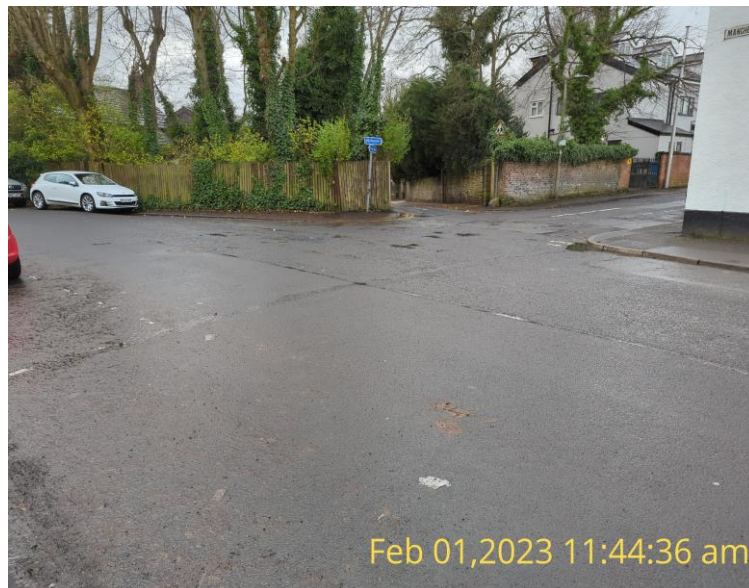
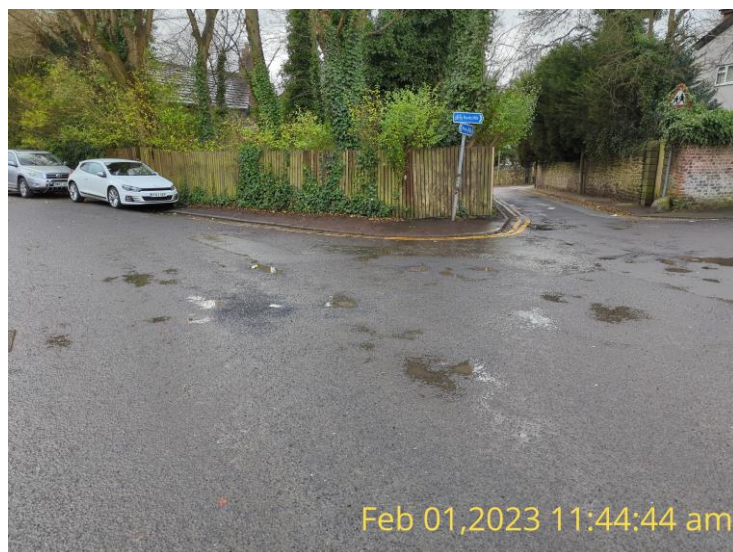
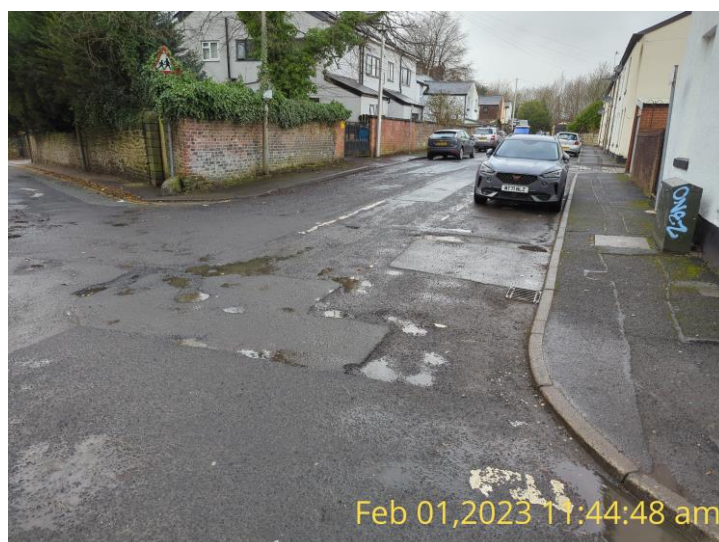
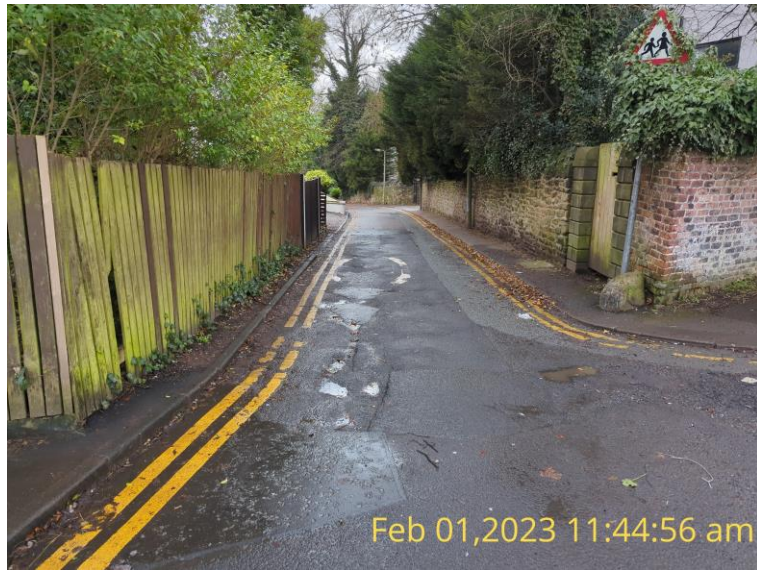
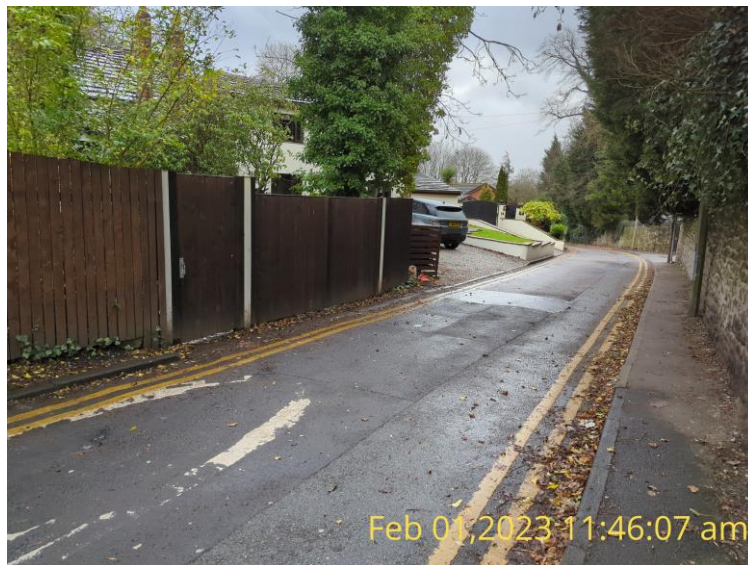
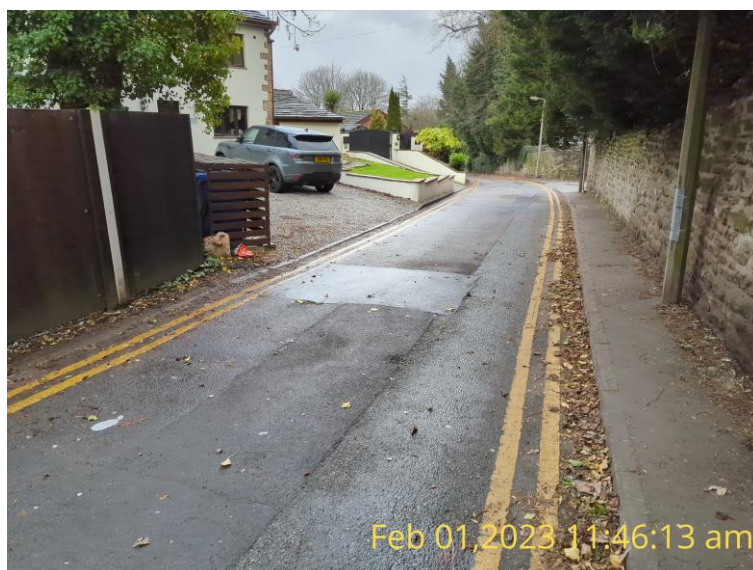
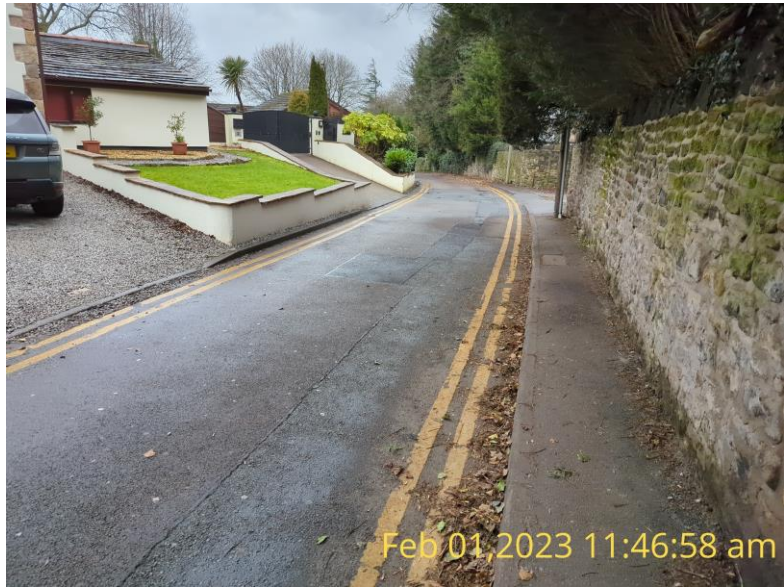
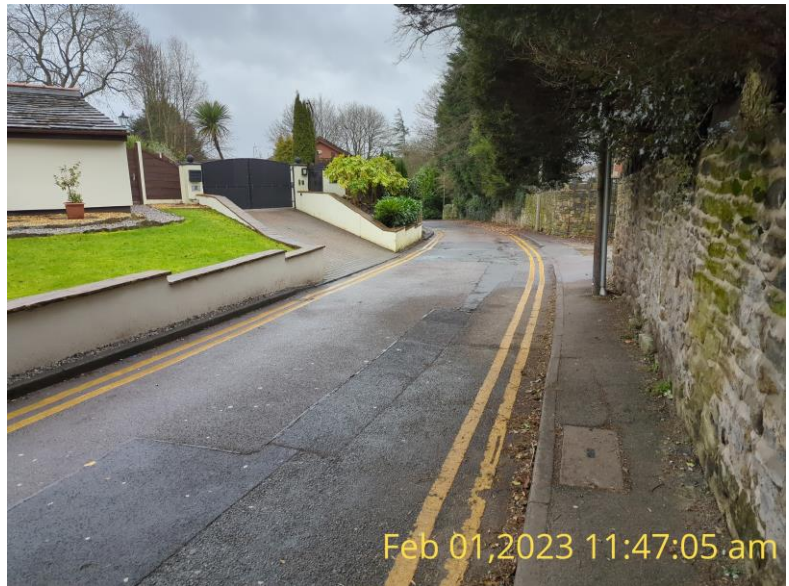
| | <b>Texture of Road Surface</b> | Significant variation in texture of road surface at the junction with the main roads | |
| | <b>Difference in Level:<br/>Longitudinal/Transverse<br/>Uneven road surface</b> | Consistent potholes and failed patches present at the junction interface and the mouth of Haslam brow. The degradation continues down the lane at the start of the survey. | |
| | <b>Cracking</b> | Cracking along the road surface with sporadic potholes | |

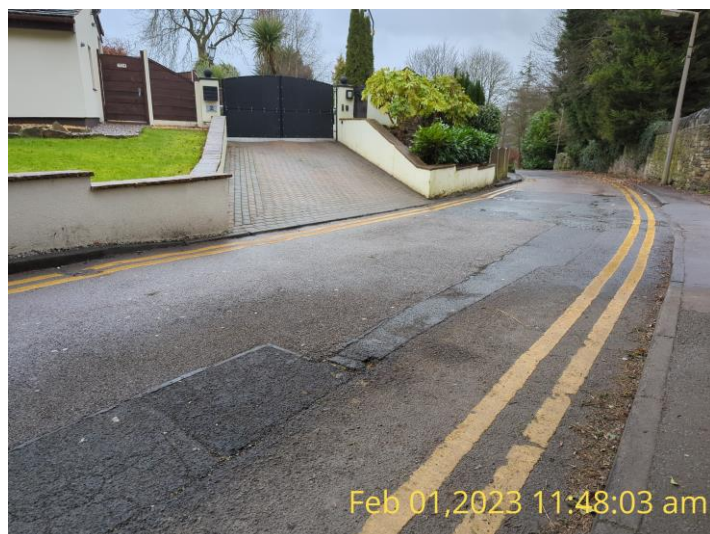
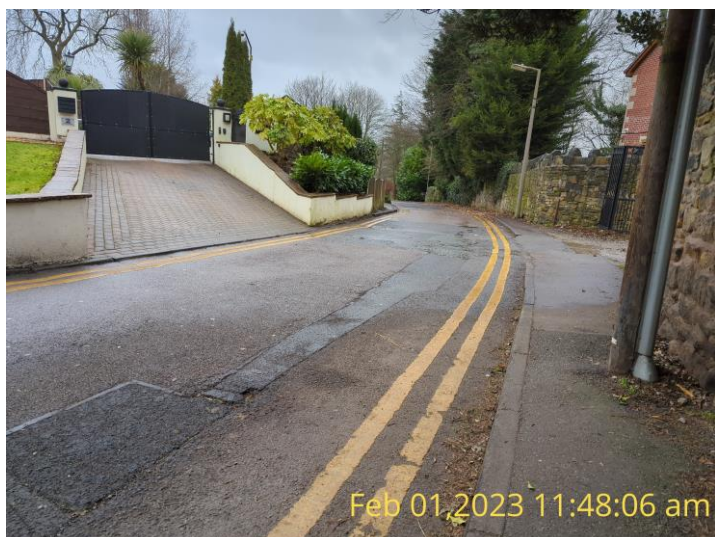
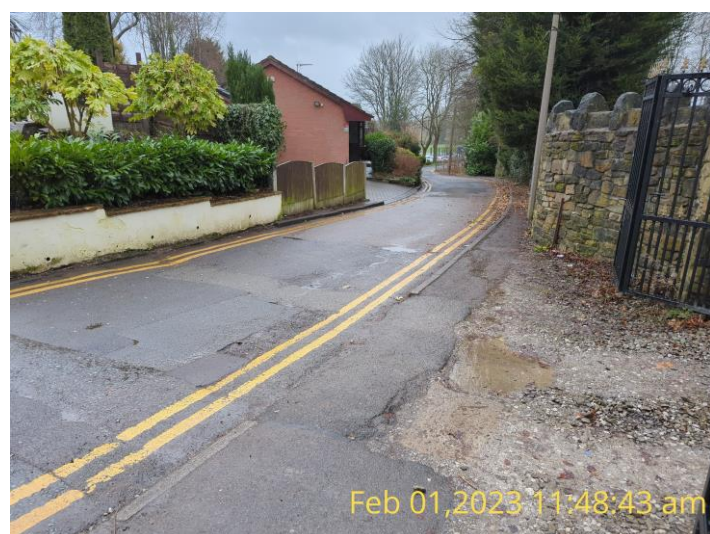
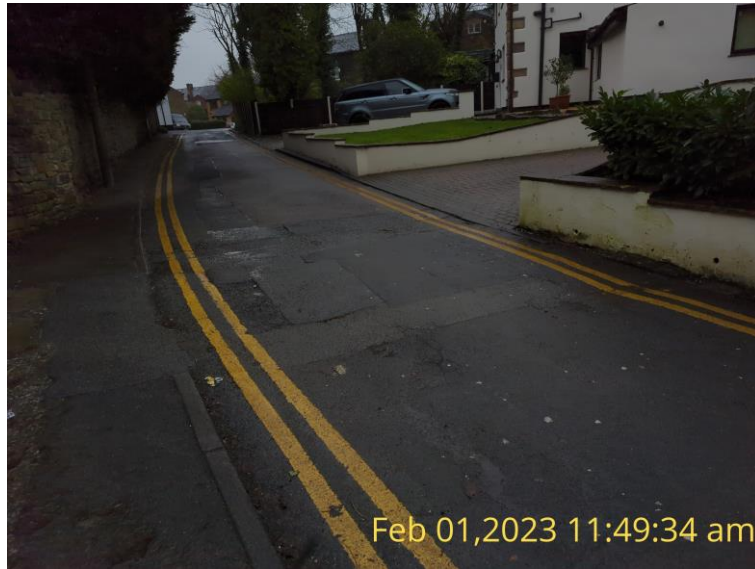
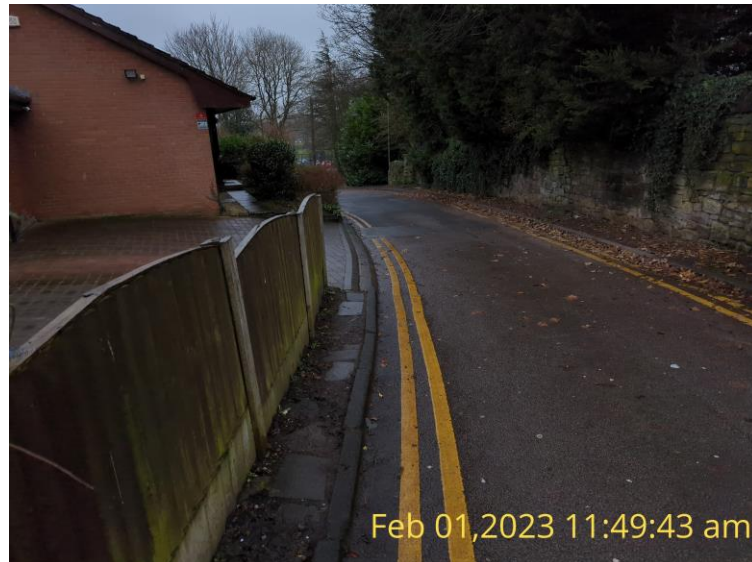
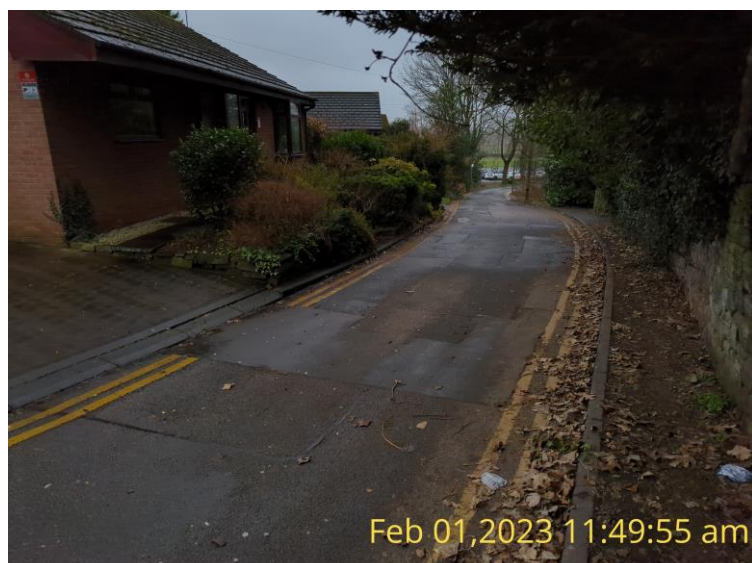
| | <b>Texture of Road Surface</b> | Significant variation in texture of road surface |
| | <b>Difference in Level:<br/>Longitudinal/Transverse<br/>Uneven road surface</b> | The footway and Northbound lane has suffered major deterioration potentially due to the heavy school traffic at peak times. Longitudinal failed patch on the right hand side of the carriageway |
| | <b>Cracking</b> | Cracking present on the carriageway |
| | <b>Edge Deterioration</b> | Major potholes on the footway at the entrance to the driveway. Major subsidence and degradation at the gateway entrance |

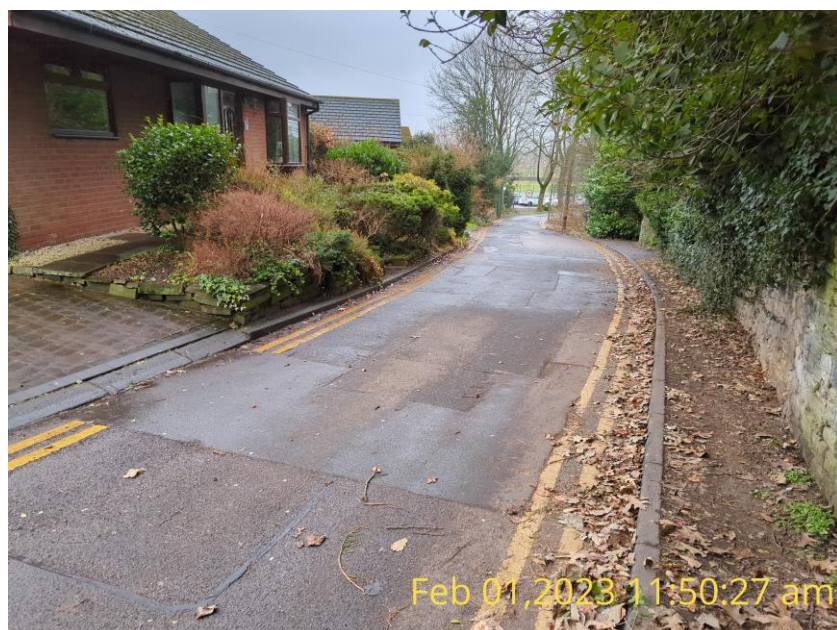
| <b>Chainage (m):</b> | <b>From: Haslam Brow (Ch.50m)</b> | <b>To: (Ch.75m)</b> |

| | <b>Texture of Road Surface</b> | Significant variation in texture of road surface |
| | <b>Difference in Level:<br/>Longitudinal/Transverse<br/>Uneven road surface</b> | Uneven footway due to the major deformation and potholes on left hand side. Failed patches at the mouth of driveways. |
| | <b>Cracking</b> | Minimal cracking on the carriageway |
| | <b>Edge Deterioration</b> | Left channel showing major degradation |
| | <b>Others</b> | Leaves and debris on the footway and carriageway on the approach to the school |

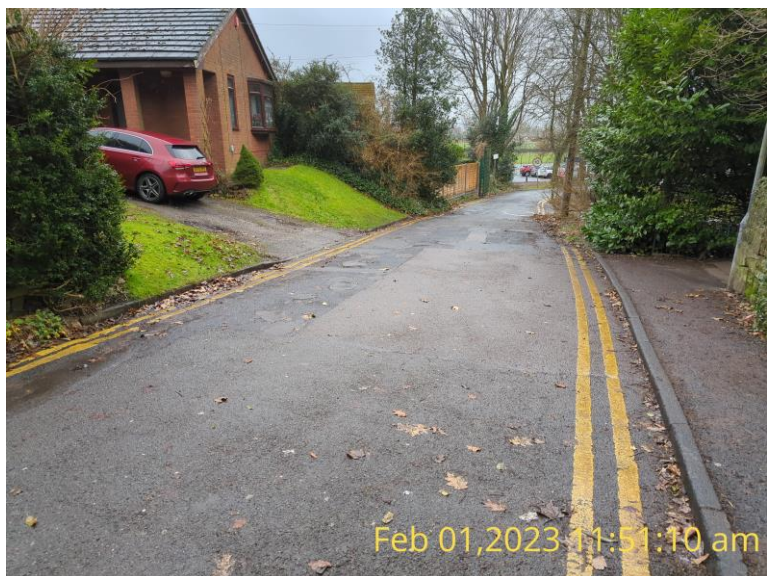
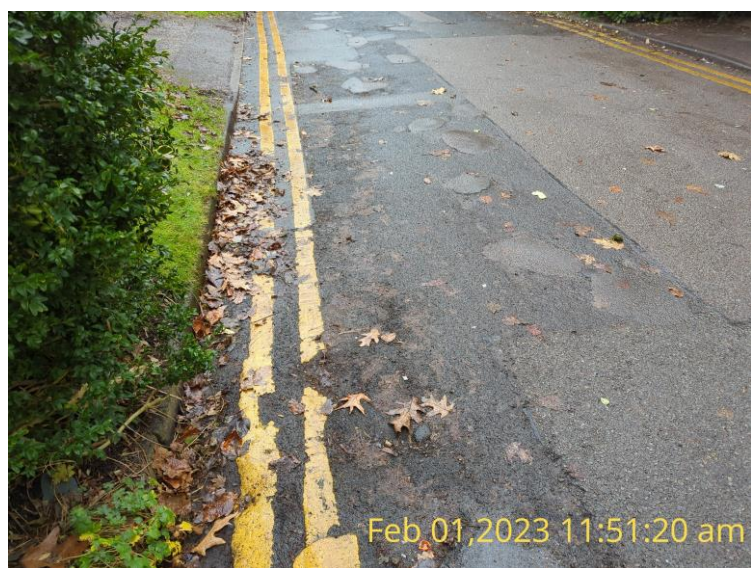
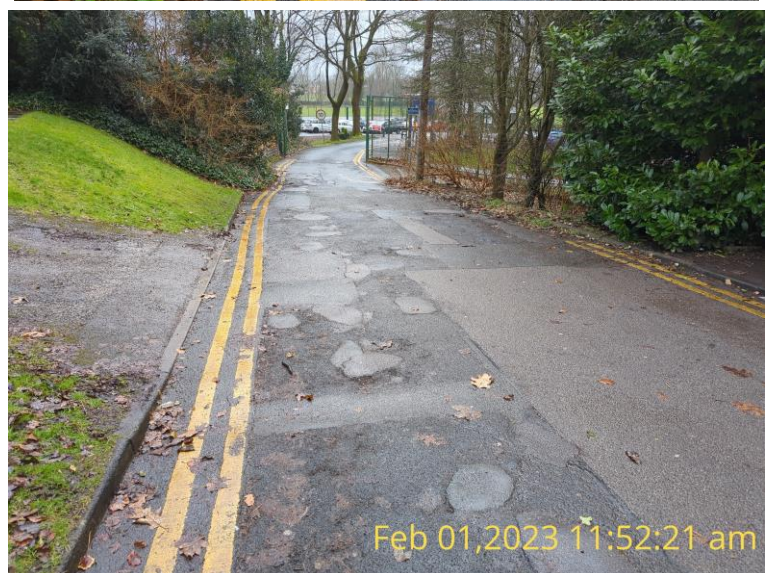
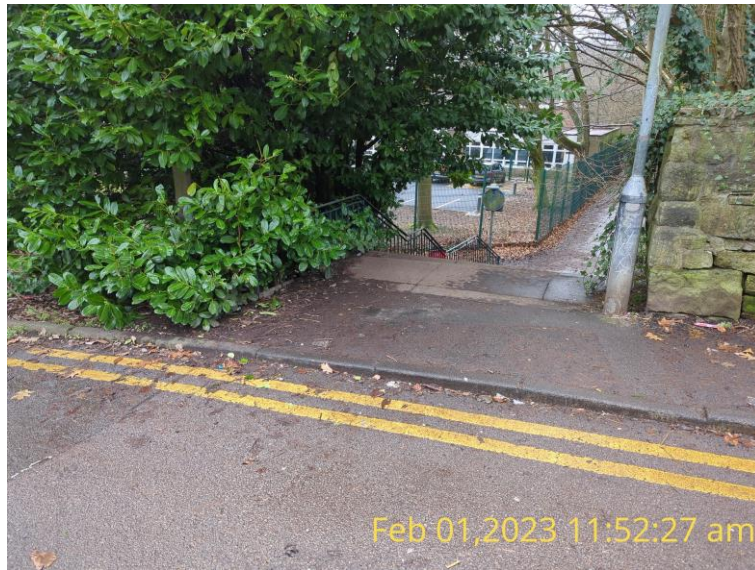
| <b>Chainage (m):</b> | <b>From: Haslam Brow (Ch.75m)</b> | <b>To: (Ch.104m)</b> |

| | <b>Texture of Road Surface</b> | Left hand side of the lane showing major deformation with failed patches along the carriageway |
| | <b>Difference in Level:<br/>Longitudinal/Transverse<br/>Uneven road surface</b> | Uneven road surface on the carriageway with potholes forming on the approach to the school. |
| | <b>Cracking</b> | Transverse Cracking and crazing along the road surface indicating the patches need some attention. |
| | <b>Edge Deterioration</b> | Major surface deterioration and subsidence at the side road with potholes forming. Leaves and soil encroaching onto the carriageway |

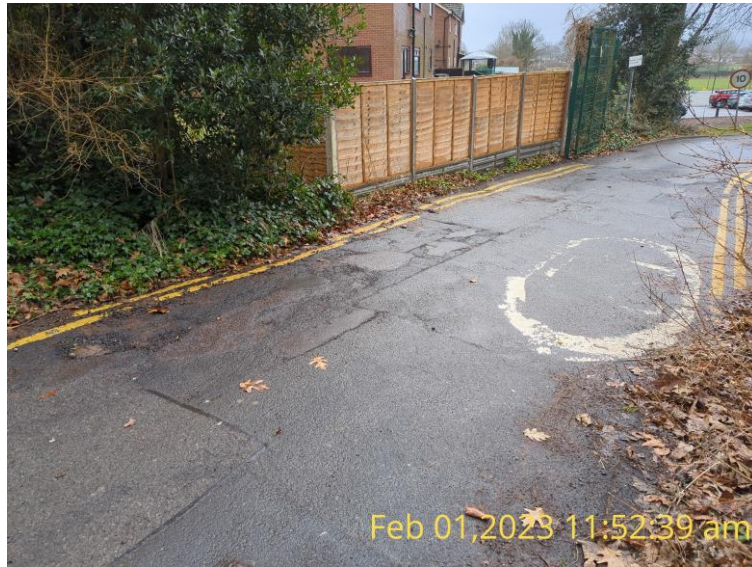
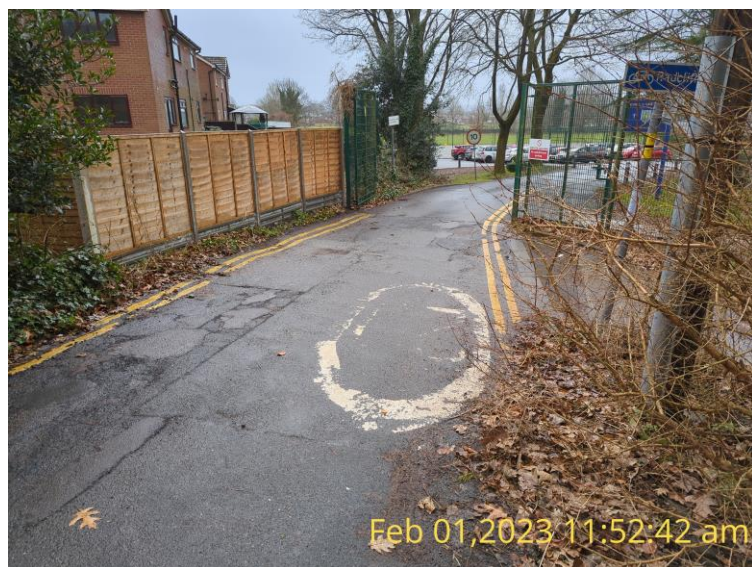
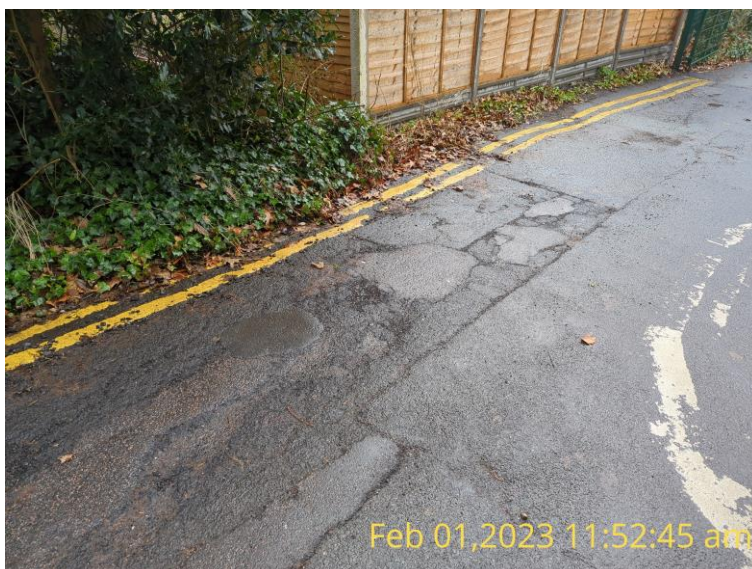
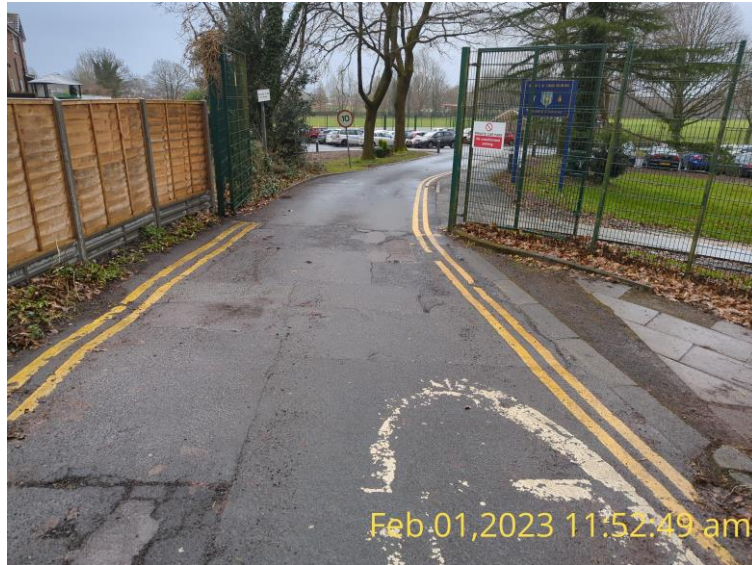
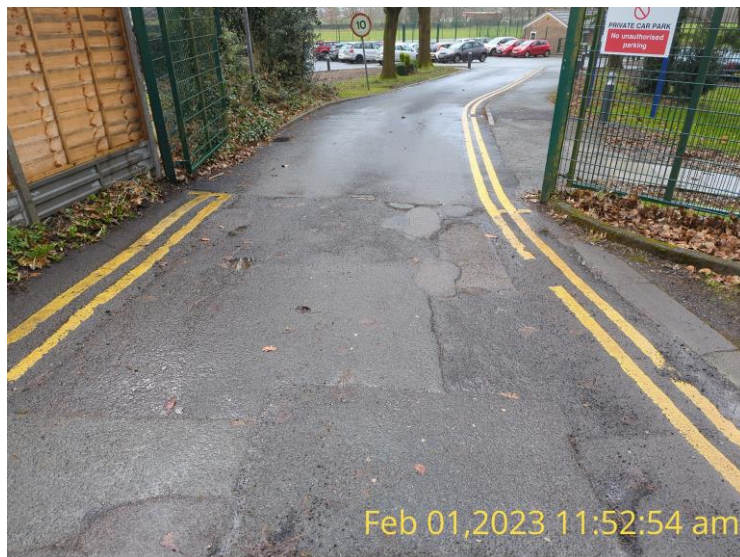
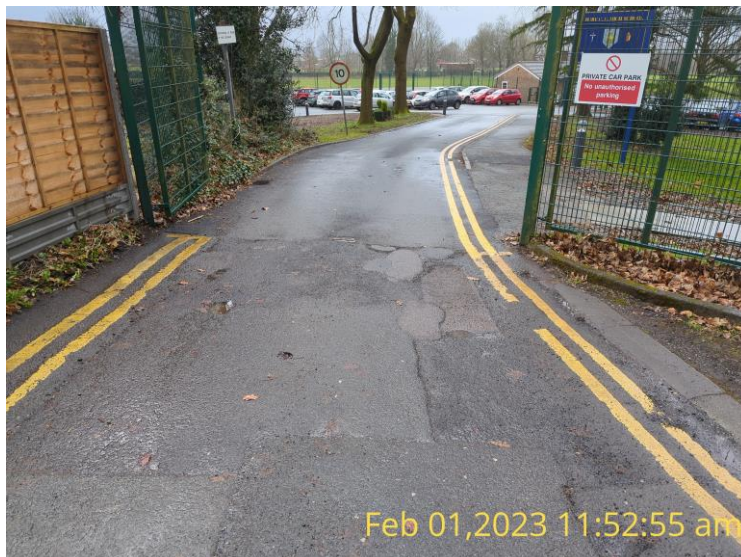
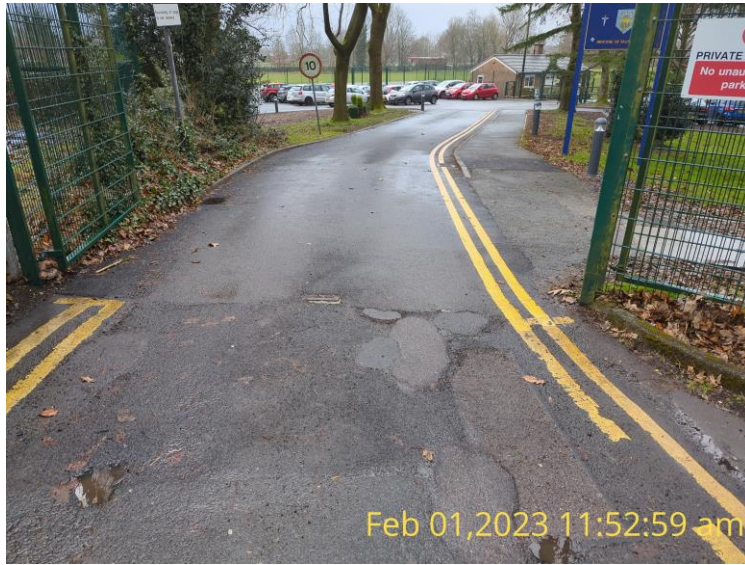
| | <b>Chainage (m):</b> | <b>From: Haslam Brow (Ch.75m)</b> | <b>To: (Ch.104m)</b> |

| | <b>Texture of Road Surface</b> | Uneven carriageway surface | |
| | <b>Difference in Level:<br/>Longitudinal/Transverse<br/>Uneven road surface</b> | Uneven road surface on the carriageway with potholes forming on the approach to the school. | |
| | <b>Cracking</b> | Transverse Cracking and crazing along the road surface indicating the patches need some attention. | |
| | <b>Edge Deterioration</b> | Major surface deterioration and subsidence at the side road with potholes forming. Leaves and soil encroaching onto the carriageway | |
