# **The Lee, Walmersley Road, Bury, BL9 5JA**

## **Condition Survey**

(For refurbishment / repair of the existing roof covering, including leadwork)

**Dated: 20<sup>th</sup> June 2024**

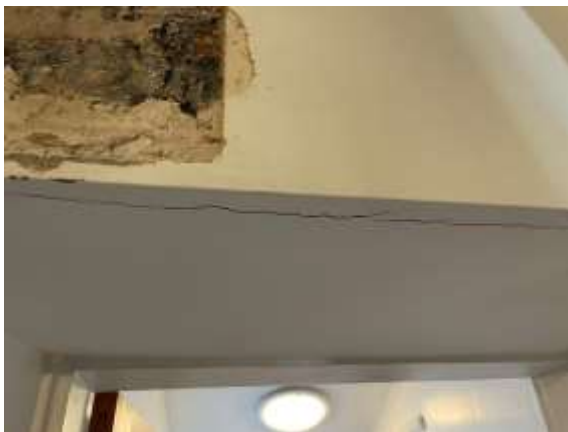
B5.01 Water ingress damage is evidenced within one bedroom, with some localised areas of plaster finish having been removed, to allow the masonry walls behind to dry out. Repairs to plaster finishes using renovating plaster will be required to reinstate the internal wall surfaces, with painted finish.

Evidence of water ingress from leaking roof above – with loose plaster removed to allow the masonry wall behind to dry out prior to making good plasterwork.

D1.02 Repair any damaged plasterwork to wall faces to rooms below using renovating plaster and repaint.

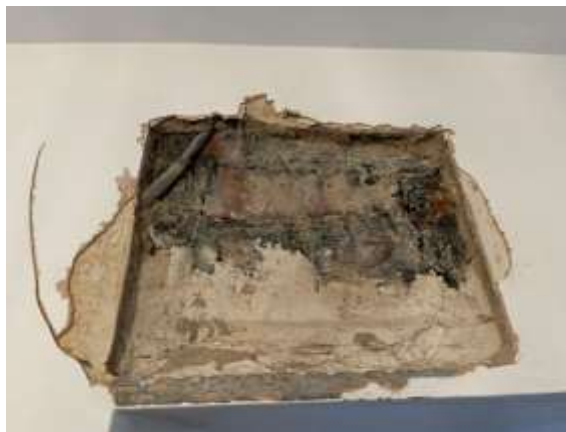
Evidence of water ingress from leaking roof above – with loose plaster removed to allow the masonry wall behind to dry out prior to making good plasterwork.

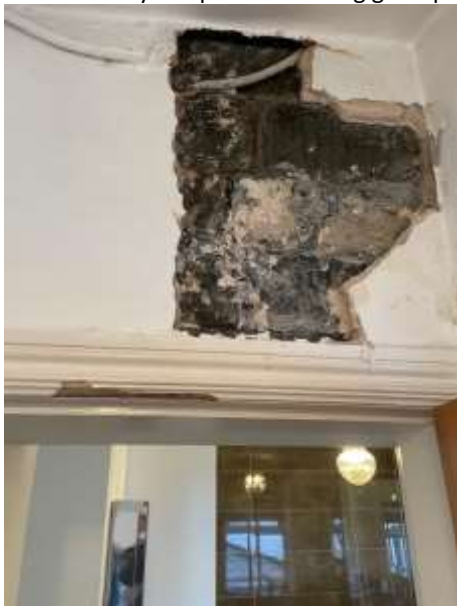
Evidence of water ingress from leaking roof above – with loose plaster removed to allow the masonry wall behind to dry. Water damage to timber architrave around opening.

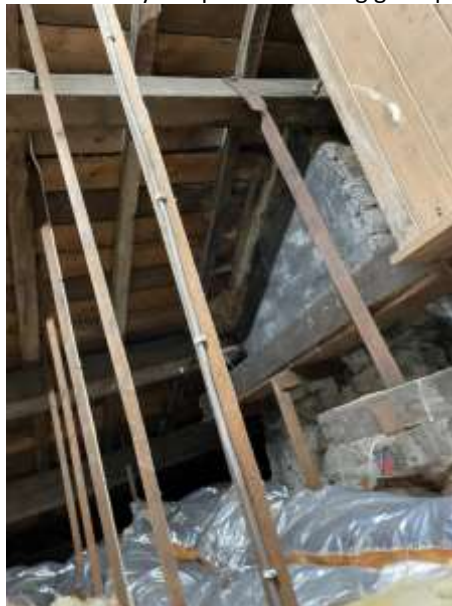
Roof structure includes traditional timber purlins and rafters, supported locally timber truss framing.

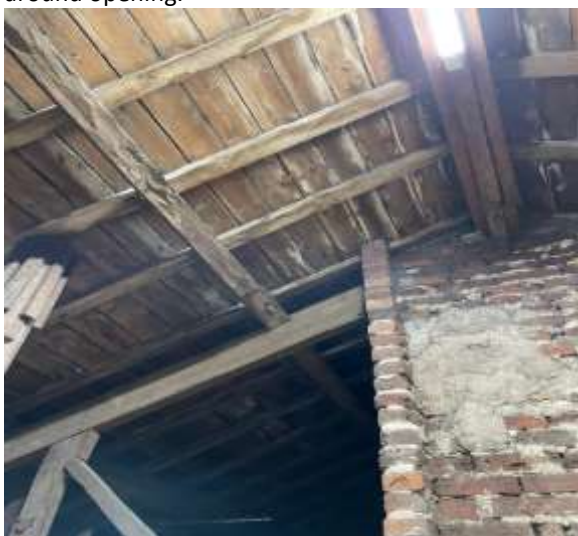
Evidence of water damage to timber boarding through water ingress and / or condensation.

D1.01 Insert breathable sarking felt beneath slate covering and over the timber sarking boards, including new treated timber battens and counter battens – to prevent any further water ingress into roof space below and to protect the existing historic timber roof structure. Use copper clout nails fixed into rafters and avoid fixing into boarding, to avoid risk of condensation and further degradation of the timberwork.

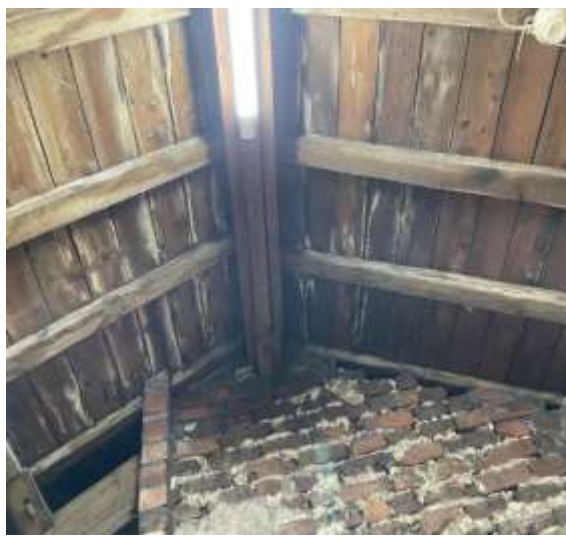
Evidence of water damage to timber boarding through water ingress and condensation forming on exposed galvanised clout nails.

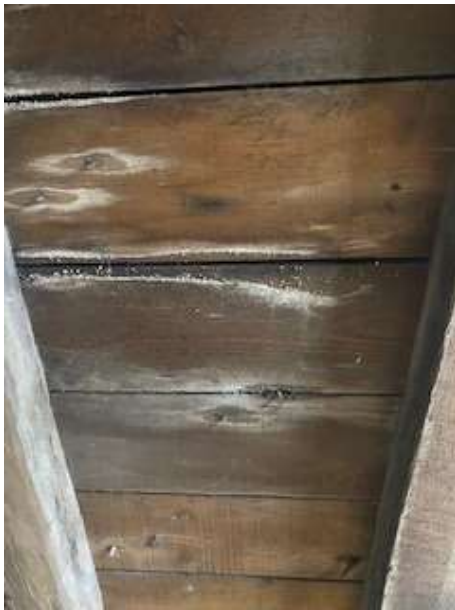
Evidence of water damage to timber boarding through water ingress and condensation forming on exposed galvanised clout nails.

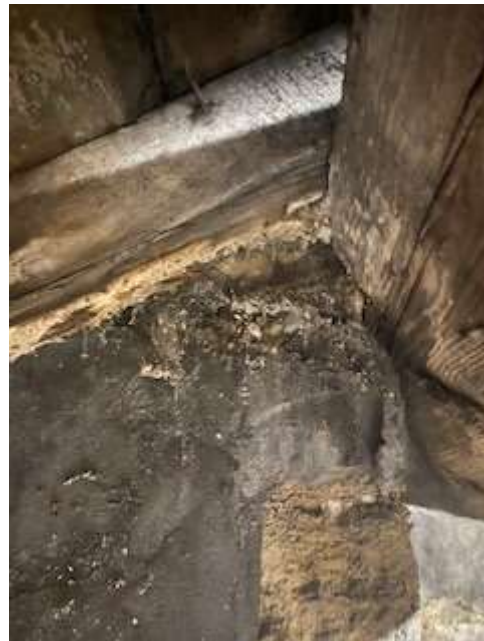
Evidence of some localised timber decay which requires further investigation and treatment by specialist timber treatment company.

C1.01 Timberwork to roof structure needs to be inspected by a timber treatment specialist.

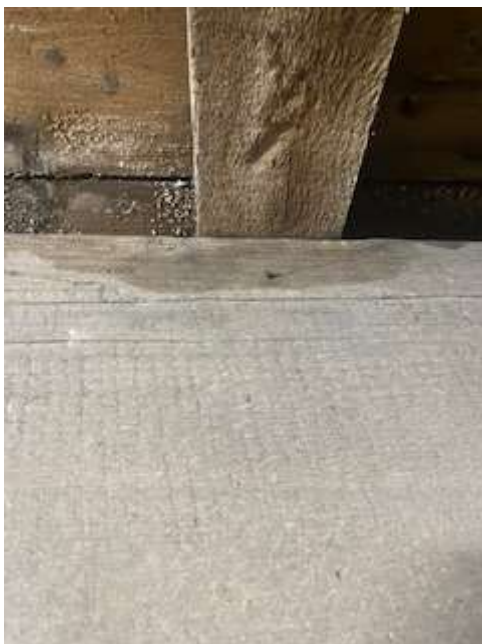
Evidence of localised mould growth following water ingress through roofing slates.

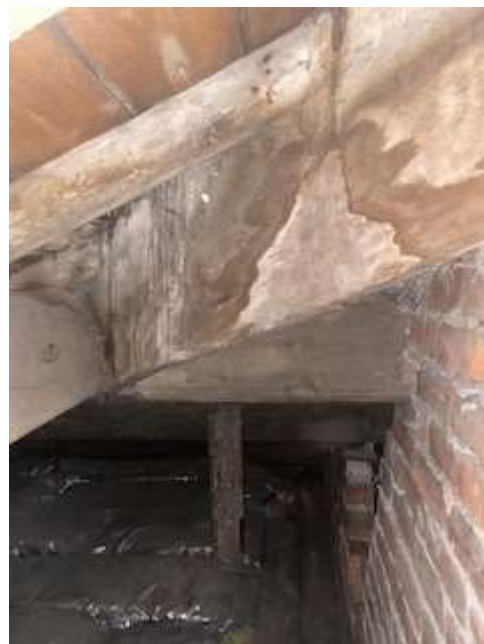
Evidence of water ingress onto timber purlins through roofing slates.

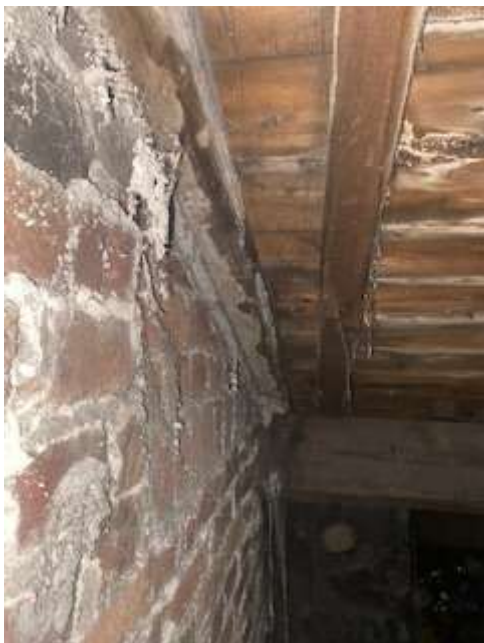
Evidence of water damage to timber boarding through water ingress and condensation forming on exposed galvanised clout nails.
