## Phase 1 GeoEnvironmental Desk Study

Land Adjacent to 11 Walter Street  
Prestwich

May 2023

**Report No. A5417-23**

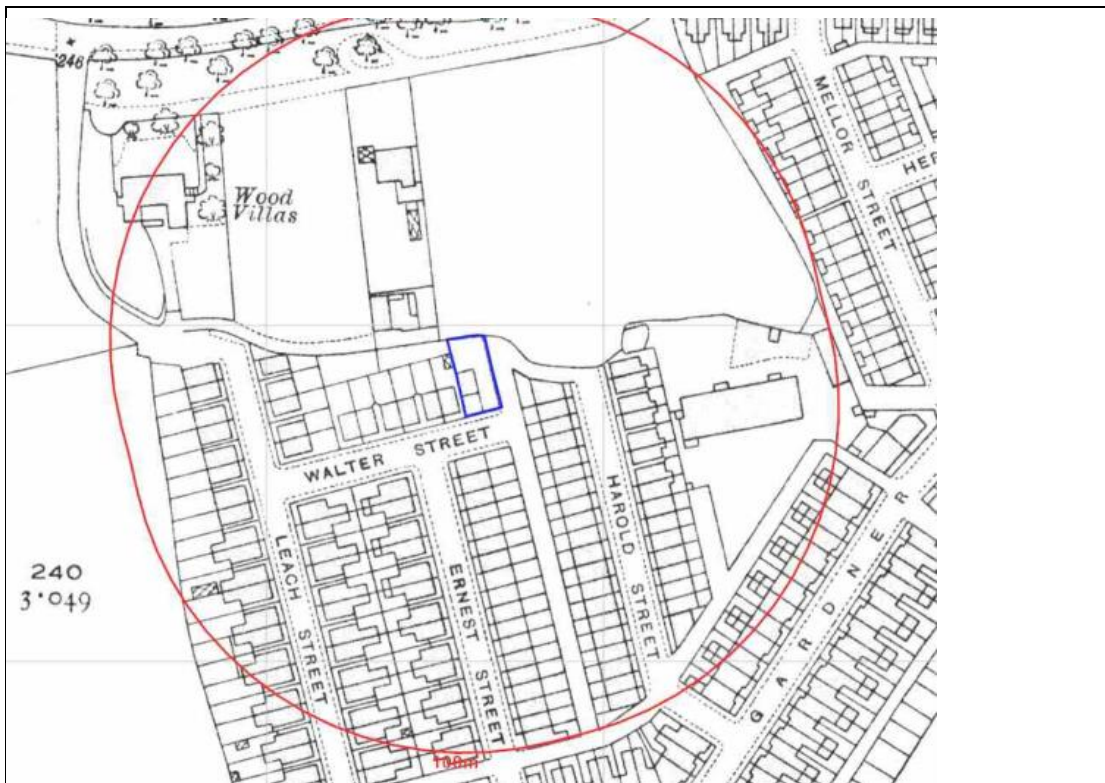
**Extract from 1922 Map: Two buildings on site**

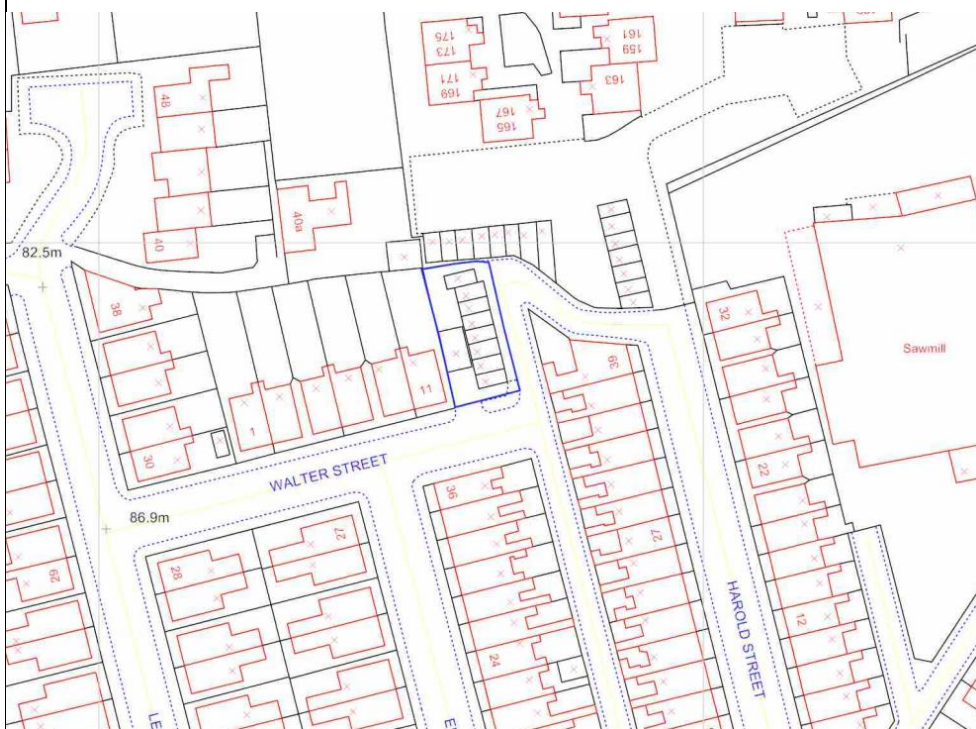
**Extract from 2003 Map showing garages on the site and a building in the west. The building in the west is present on site from at least 1922 and the northernmost garage is present since 1951.**

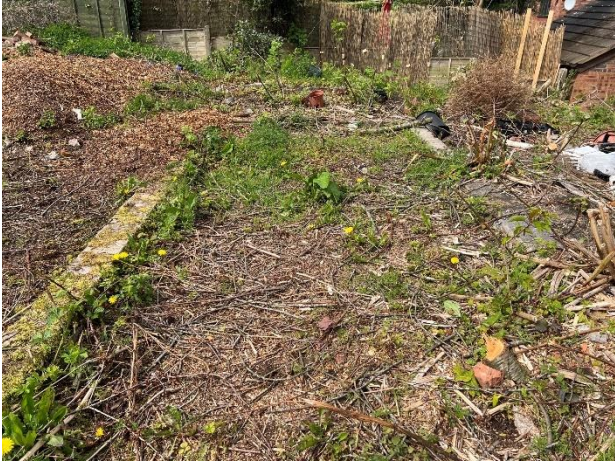
| <p style="text-align: center;"><b>Plate 5 : Old garage walls</b></p> | <p style="text-align: center;"><b>Plate 6 : Recently removed trees and Japanese Knotweed</b></p> |

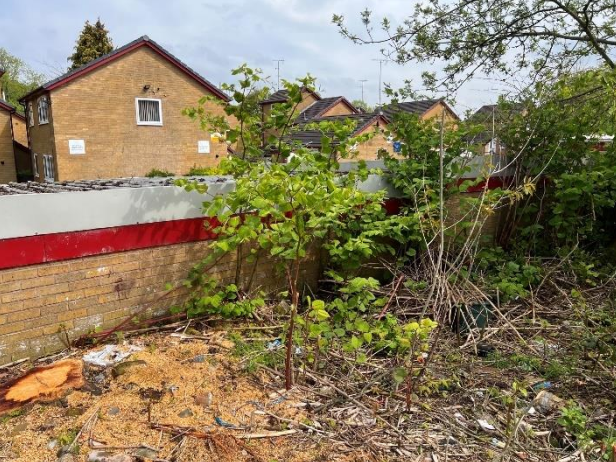
- 7.3 The site was partially covered by hardstanding associated with former garages and fly tipped materials including plastic crates and garden waste. There was no obvious evidence of contamination such as oil stains or odorous materials. The northern end of the site was overgrown with evidence of recently removed trees. Japanese Knotweed was noted in this area.

- 10.6 An intrusive investigation should be undertaken to establish geotechnical parameters for the design of foundations, floor slabs and any proposed drainage soakaways.
- 10.7 As part of the geotechnical investigation, it is recommended that samples of soil are recovered for contamination testing to confirm whether there are any potential risks. A water supply pipe risk assessment could also be carried out as part of these works.
- 10.8 Prior to site clearance, specialist advice should be sought for the treatment of Japanese Knotweed.

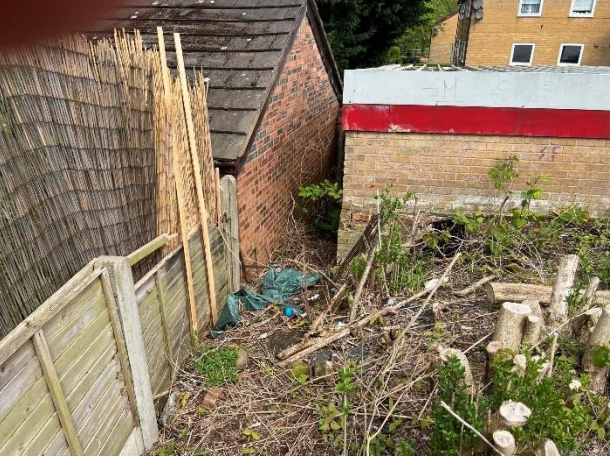
| <p style="text-align: center;"><b>Plate 7: Looking east to “crescent” area</b></p> | <p style="text-align: center;"><b>Plate 8 Evidence of drop to adjacent properties</b></p> |

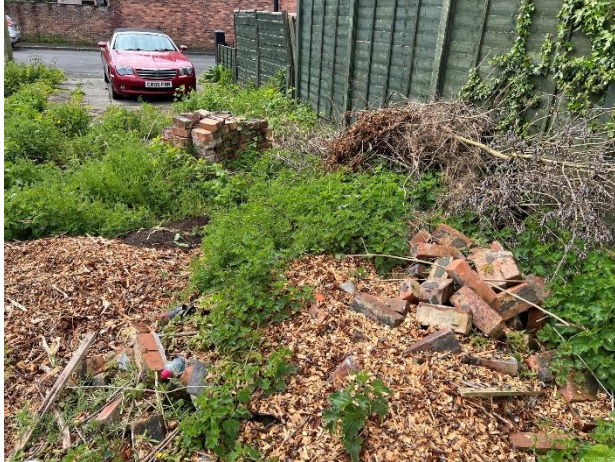
| <p style="text-align: center;"><b>Plate 9 General rubbish and tree chippings</b></p> | <p style="text-align: center;"><b>Plate 10 Looking north to “crescent” area</b></p> |

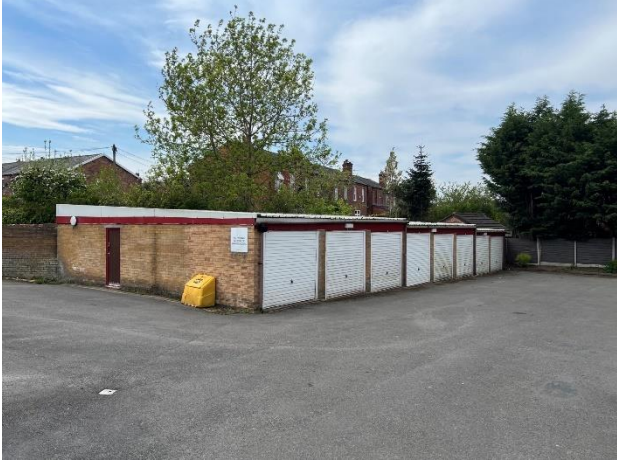
| <p><b>Plate 11 Garages on adjacent property showing drop in height</b></p> | |
