**Longden & Cook Real Estate Limited**  
**Chartered Surveyors**  
Victoria Buildings  
9-13 Silver Street  
Bury  
BL9 0EU

## **Report on Value**

**49 Bury Road  
Radcliffe  
M26 2UG**

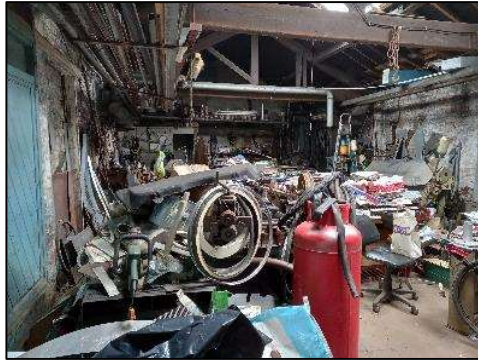
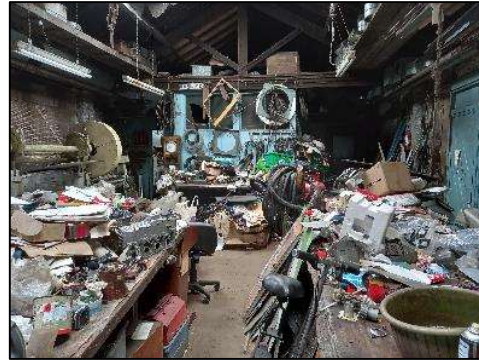
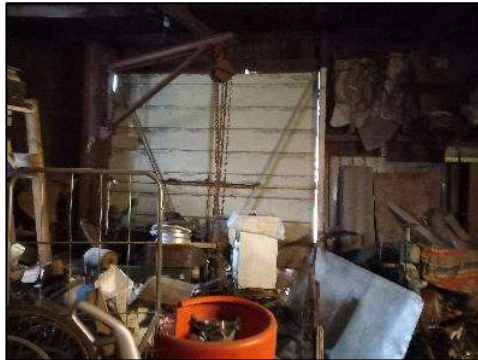
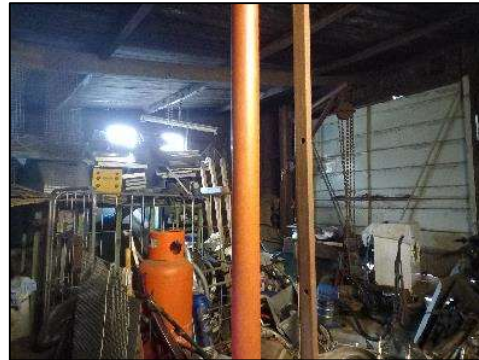
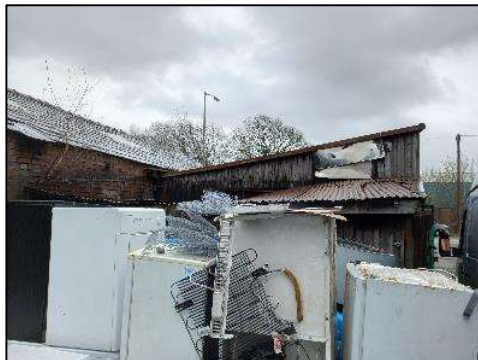
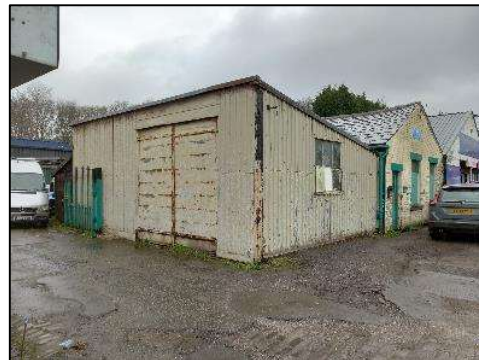
All of the buildings appear to be structurally unsound.

The main building needs a full programme of renovation and redecoration. We are unable to comment on whether damp or water ingress is present in the walls. There were also visible roof leaks during our inspection, which could be as a result of broken/failing gutters as well as slipped or broken slates. The roof appears to be in need of complete overhaul.

The other two timber-built buildings appear structurally unsound and are being used purely for storage. We were only able to inspect one of them internally. The building we did inspect was suffering from water ingress and the roof is being supported by internal 'Acro' props. Both units appear to have suffered significant roof damage and seem to be structurally unsound.
