## Asbestos Demolition Survey

**Blocks 54, 55, 56 & 57  
Fairfield General Hospital  
Rochdale Old Road  
Bury  
BL9 7TD**

**Northern Care Alliance NHS Group**

| Project Number: | Survey Date: | Issue Date: |
|---|---|---|
| B-38673s3 | 12 May 2023 | 16 May 2023 |

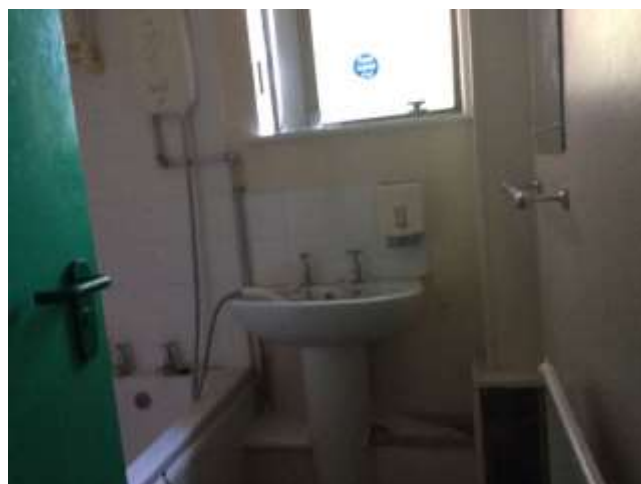
| Quantity | 5 m <sup>2</sup> |

| Analysis Result | No Asbestos Detected | 0 |
| Condition | Good Condition | 0 |

### Recommendations

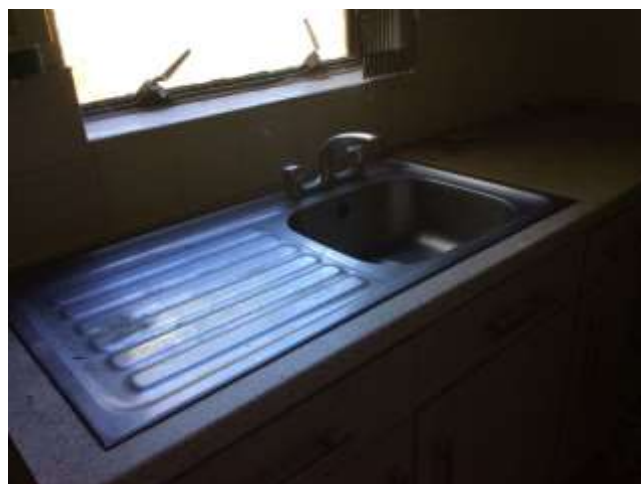
| Quantity | 1 m <sup>2</sup> |

| Analysis Result | No Asbestos Detected | 0 |
| Condition | Good Condition | 0 |

| Recommendations |

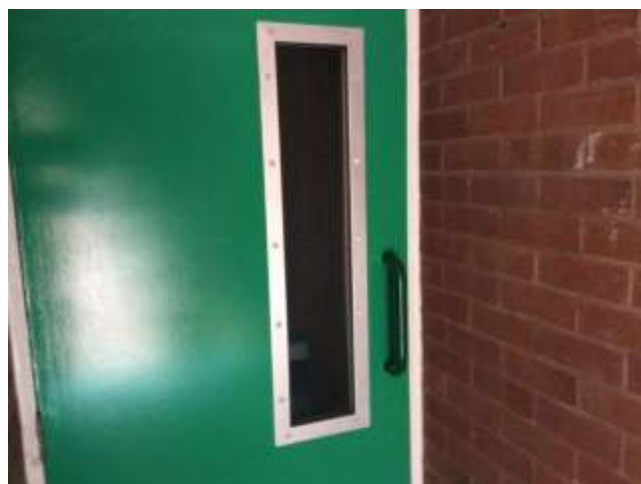
| Quantity | 1 Units |

| Analysis Result | No Asbestos Detected | 0 |
| Condition | Good Condition | 0 |

### Recommendations

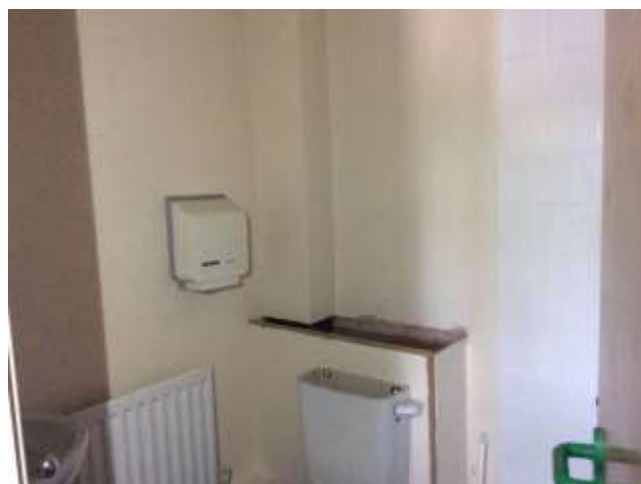
| Quantity | 5 m <sup>2</sup> |

| Analysis Result | No Asbestos Detected | 0 |
| Condition | Good Condition | 0 |

### Recommendations

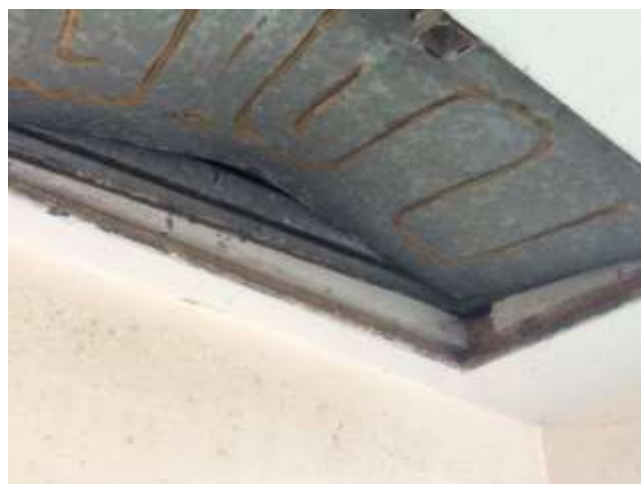
| Quantity | 4 Units |

| Analysis Result | No Asbestos Detected | 0 |
| Condition | Low Damage | 1 |

### Recommendations

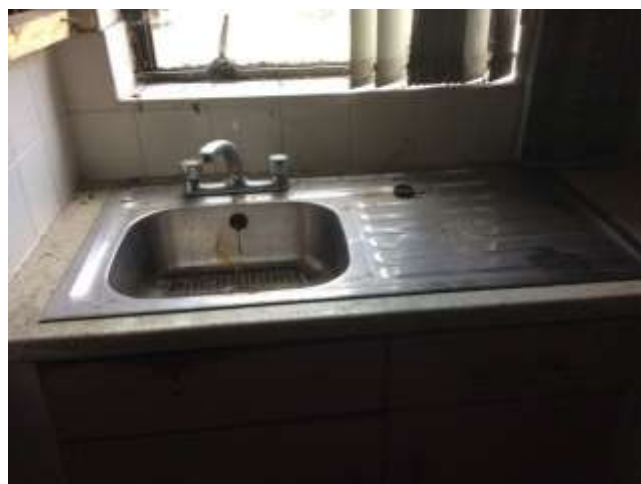
| Quantity | 1 m <sup>2</sup> |

| Analysis Result | No Asbestos Detected | 0 |
| Condition | Good Condition | 0 |

| Recommendations |

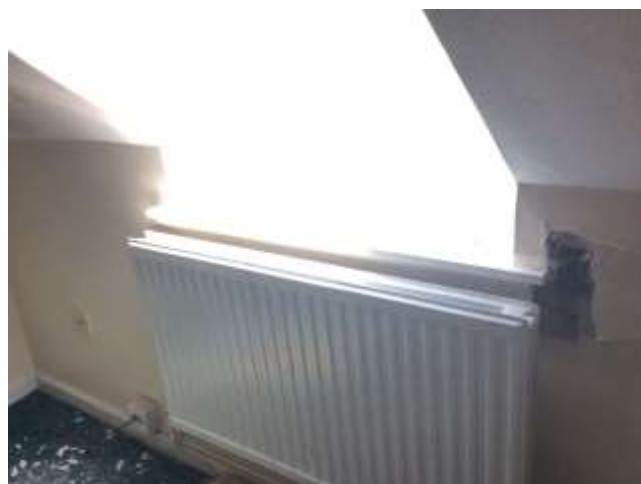
| Quantity | 1 m <sup>2</sup> |

| Analysis Result | No Asbestos Detected | 0 |
| Condition | Low Damage | 1 |

### Recommendations

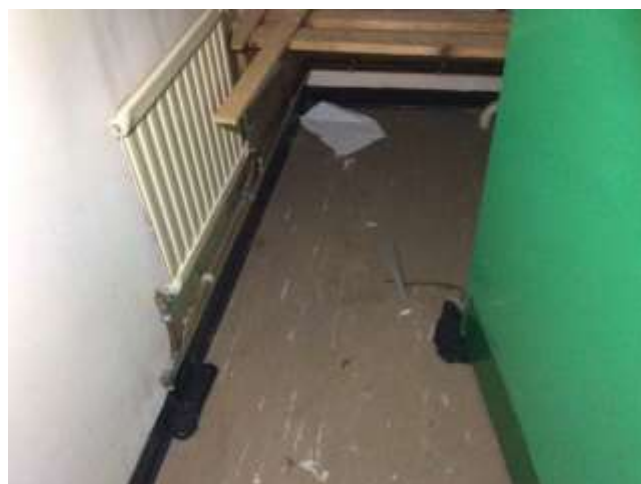
| Quantity | 2 m <sup>2</sup> |

| Analysis Result | No Asbestos Detected | 0 |
| Condition | Good Condition | 0 |

### Recommendations

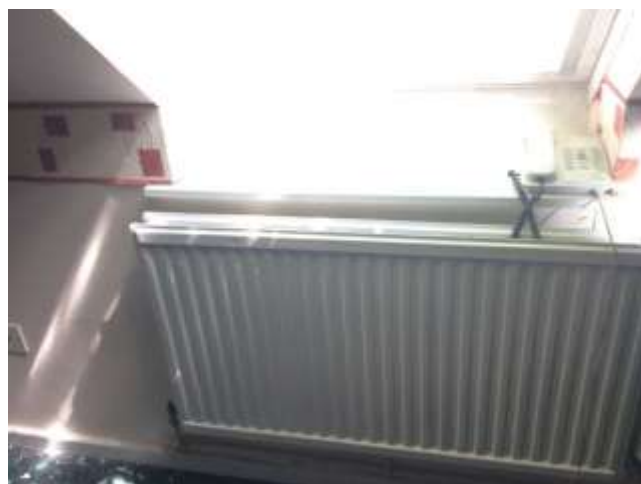
| Quantity | 1 m <sup>2</sup> |

| Analysis Result | No Asbestos Detected | 0 |
| Condition | Good Condition | 0 |

### Recommendations

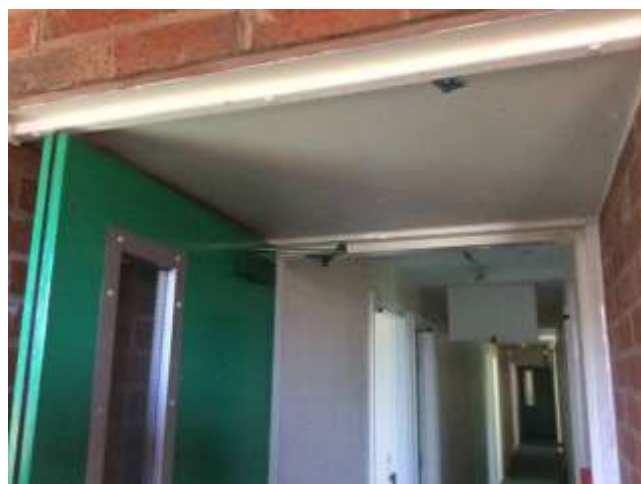
| Quantity | 1 m <sup>2</sup> |

| Analysis Result | No Asbestos Detected | 0 |
| Condition | Medium Damage | 2 |

### Recommendations

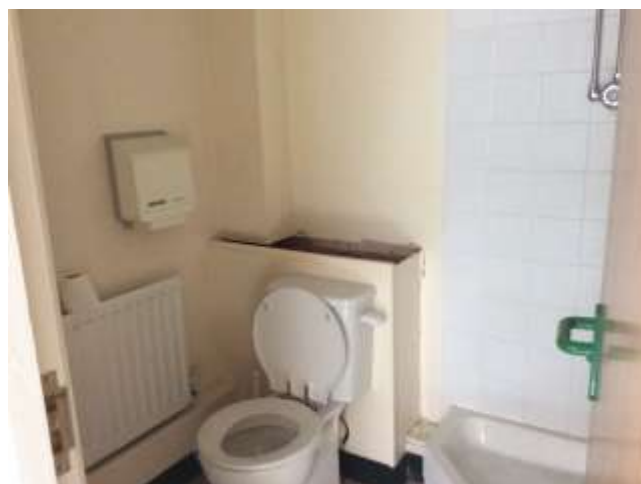
| Quantity | 5 m <sup>2</sup> |

| Analysis Result | No Asbestos Detected | 0 |
| Condition | Good Condition | 0 |

### Recommendations

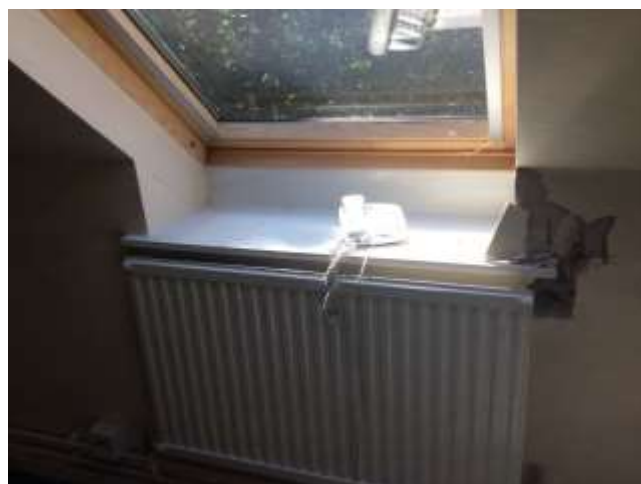
| Quantity | 1 m <sup>2</sup> |

| Analysis Result | No Asbestos Detected | 0 |
| Condition | Good Condition | 0 |

### Recommendations

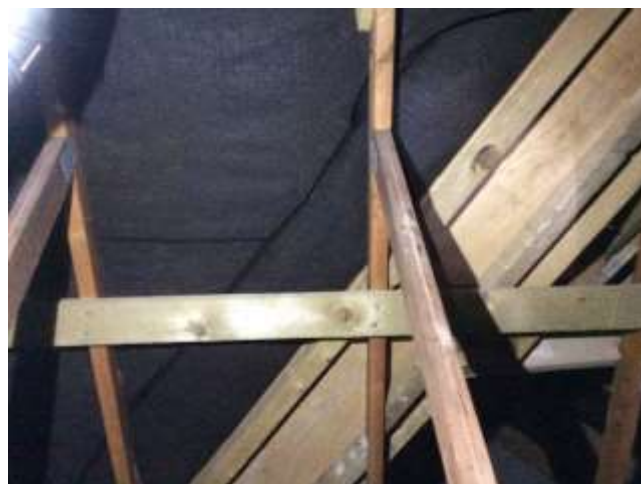
| Quantity | >50 m <sup>2</sup> |

| Analysis Result | No Asbestos Detected | 0 |
| Condition | Good Condition | 0 |

### Recommendations

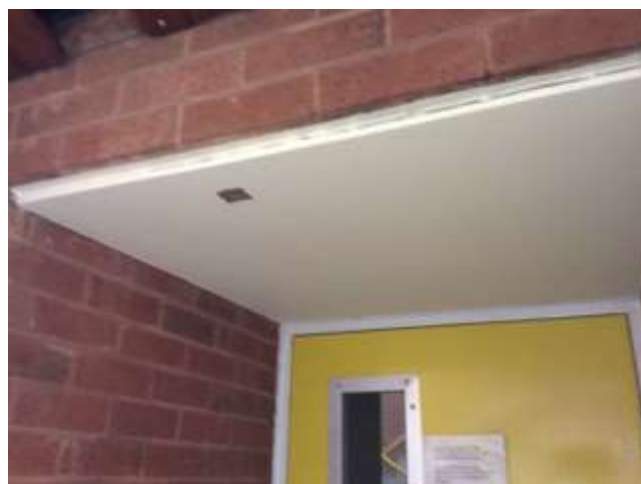
| Quantity | 2 m <sup>2</sup> |

| Analysis Result | No Asbestos Detected | 0 |
| Condition | Good Condition | 0 |

### Recommendations

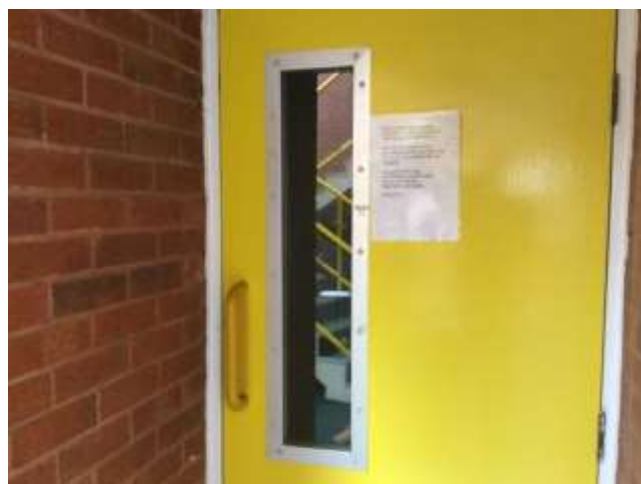
| Quantity | 2 Units |

| Analysis Result | No Asbestos Detected | 0 |
| Condition | Good Condition | 0 |

### Recommendations

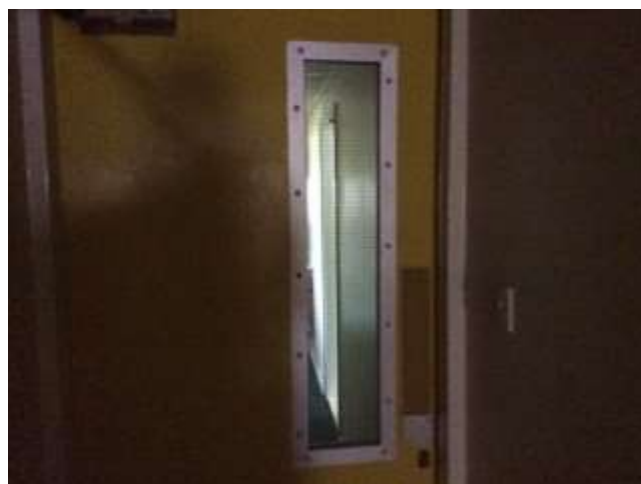
| Quantity | 2 Units |

| Analysis Result | No Asbestos Detected | 0 |
| Condition | Good Condition | 0 |

### Recommendations
