# Architectural Services

## Asbestos Management

### Radcliffe Market Hall – Asbestos Management Plan Review

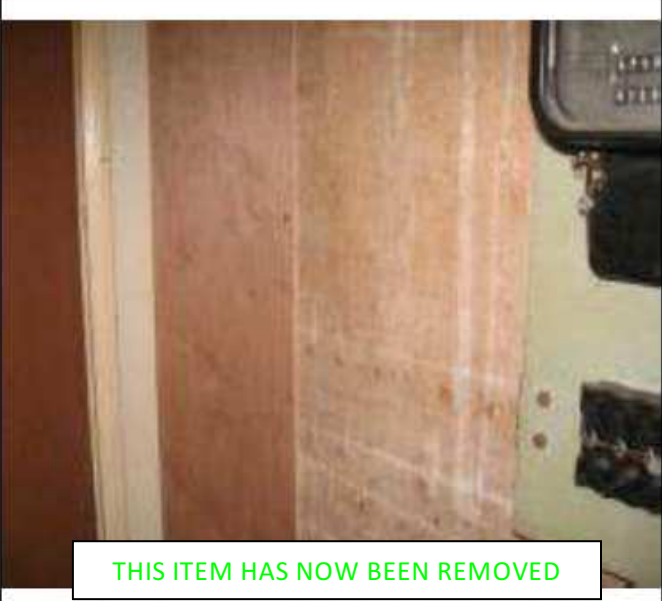
| <b>Asb Item ID:</b> | 91-AI-001 | | |

| <b>Item Description:</b> | Cement wall cladding behind the door | | |
| <b>Location:</b> | 69/Electrics | | |
| <b>Asbestos Fibres:</b> | Chrysotile | | |
| <b>Damage:</b> | Low Damage | | |

| <b>Recommendation</b> | Item removed | | |

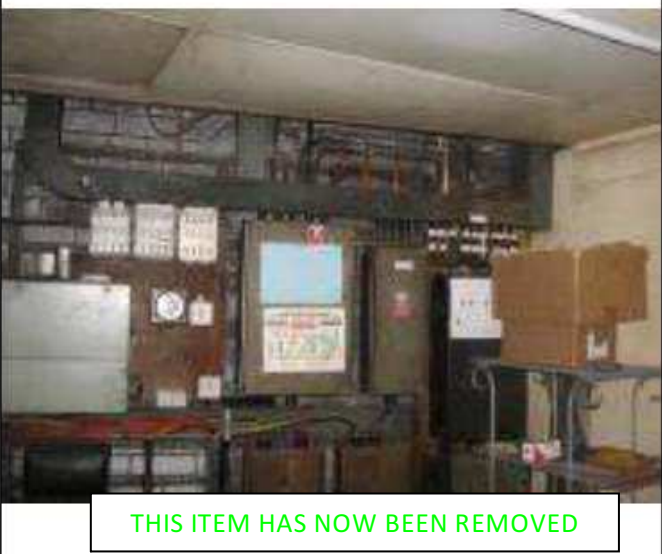
| <b>Asb Item ID:</b> | 91-AI-002 | | |

| <b>Item Description:</b> | Internal seals and/ or components within the fuse boxes | | |
| <b>Location:</b> | 69/Electrics | | |
| <b>Asbestos Fibres:</b> | Crocidolite | | |
| <b>Damage:</b> | Undeterminable | | |

| <b>Recommendation</b> | Item removed | | |

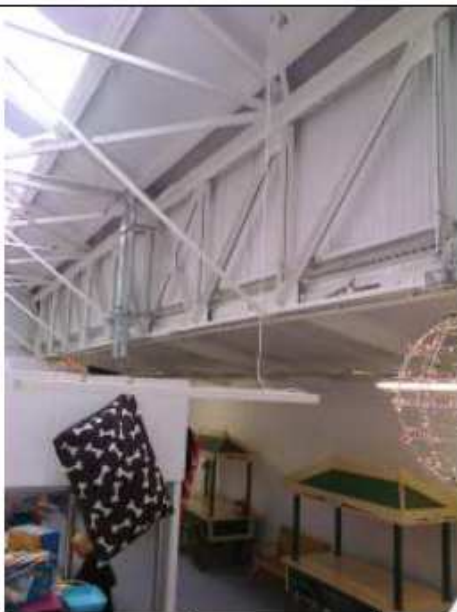
| <b>Asb Item ID:</b> | 91-AI-003 | |

| <b>Item Description:</b> | Cement cladding to walls | |
| <b>Location:</b> | 72/Main Stall Area North East Elevation | |
| <b>Asbestos Fibres:</b> | Chrysotile | |
| <b>Damage:</b> | Low Damage | |

| <b>Recommendation</b> | Monitor condition & manage in-situ | |

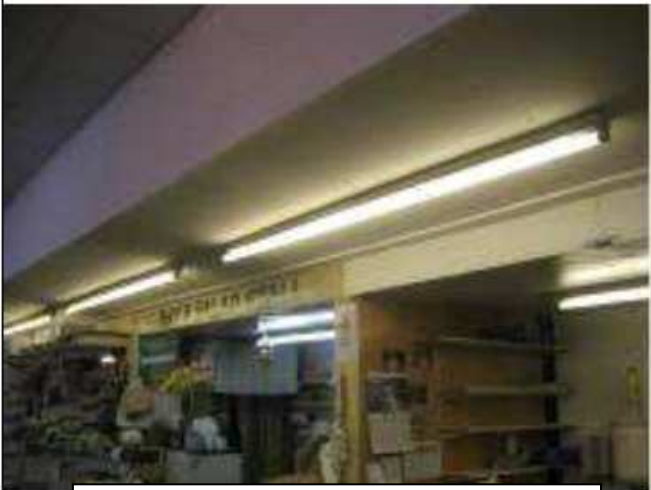
| <b>Asb Item ID:</b> | 91-AI-004 | |

| <b>Item Description:</b> | High level vertical cement panelling to stalls 8 - 16 | |
| <b>Location:</b> | Stalls 8-16 | |
| <b>Asbestos Fibres:</b> | Chrysotile | |
| <b>Damage:</b> | Low Damage | |

| <b>Recommendation</b> | Item removed | |

THIS ITEM HAS NOW BEEN REMOVED

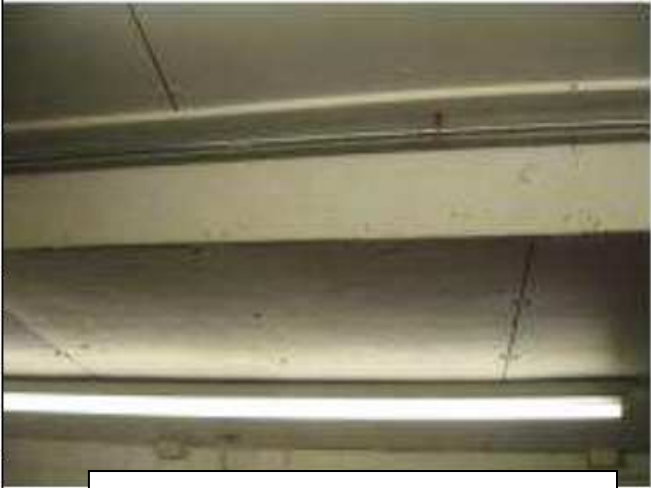
| <b>Asb Item ID:</b> | 91-AI-005 | |

| <b>Item Description:</b> | Cement panelling including boxwork to ceiling | |
| <b>Location:</b> | Stalls 8-16 | |
| <b>Asbestos Fibres:</b> | Chrysotile | |
| <b>Damage:</b> | Low Damage | |

| <b>Recommendation</b> | Item removed | |

THIS ITEM HAS NOW BEEN REMOVED

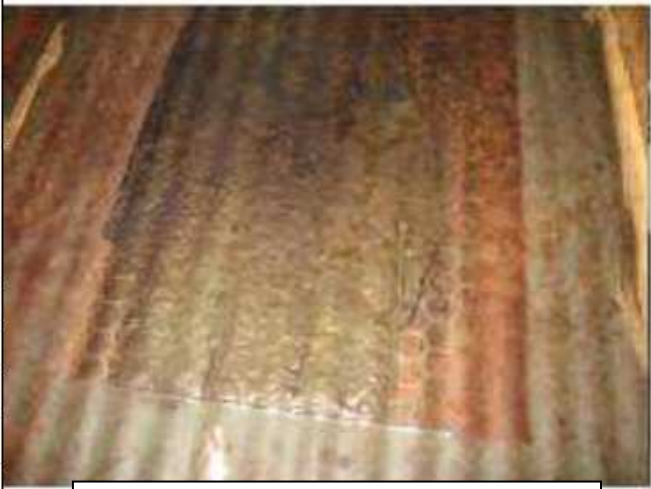
| <b>Asb Item ID:</b> | 91-AI-006 | |

| <b>Item Description:</b> | Bitumen pads to underside of sink unit | |
| <b>Location:</b> | Unit 67 Café | |
| <b>Asbestos Fibres:</b> | Chrysotile | |
| <b>Damage:</b> | Low Damage | |

| <b>Recommendation</b> | Item removed | |

THIS ITEM HAS NOW BEEN REMOVED

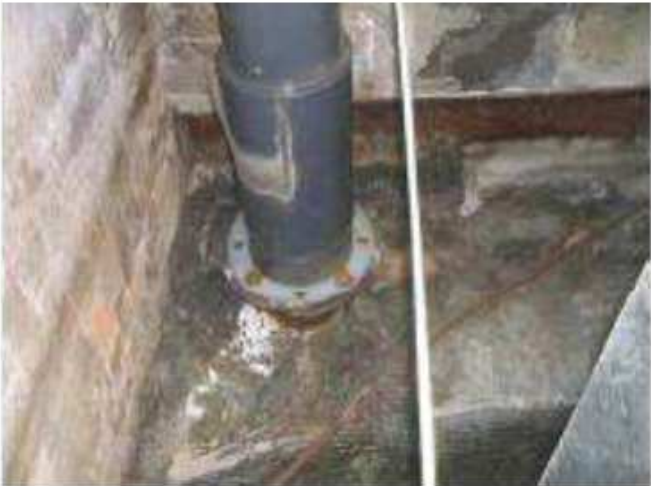
| <b>Asb Item ID:</b> | 91-AI-007 | |

| <b>Item Description:</b> | Gaskets to pipework | |
| <b>Location:</b> | Boiler Area | |
| <b>Asbestos Fibres:</b> | Chrysotile | |
| <b>Damage:</b> | Low Damage | |

| <b>Recommendation</b> | Monitor condition & manage in-situ | |

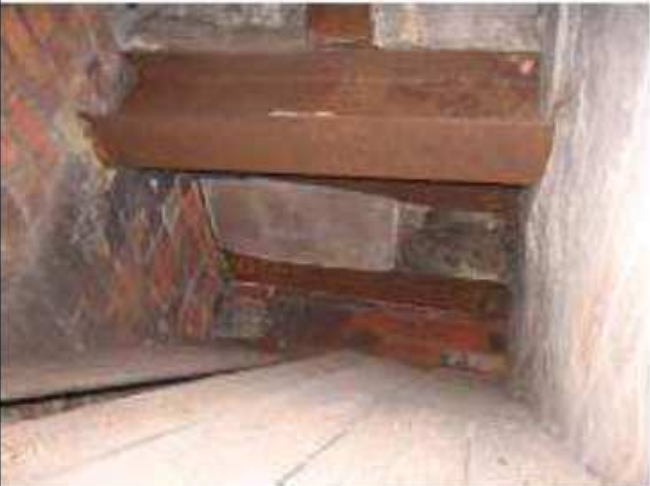
| <b>Asb Item ID:</b> | 91-AI-008 | |

| <b>Item Description:</b> | Cement infill panel to ceiling | |
| <b>Location:</b> | Boiler Area | |
| <b>Asbestos Fibres:</b> | Crocidolite Presumed | |
| <b>Damage:</b> | Low Damage | |

| <b>Recommendation</b> | A sample should be taken by a competent person once safe access can be obtained. Until this occurs the item should be manage in situ. | |

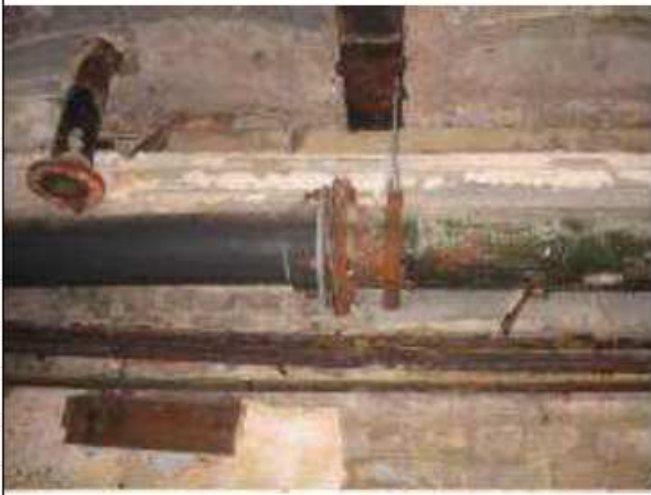
| <b>Asb Item ID:</b> | 91-AI-009 | |

| <b>Item Description:</b> | Gaskets to pipework | |
| <b>Location:</b> | Boiler Area | |
| <b>Asbestos Fibres:</b> | Chrysotile | |
| <b>Damage:</b> | Low Damage | |

| <b>Recommendation</b> | Monitor condition & manage in-situ | |

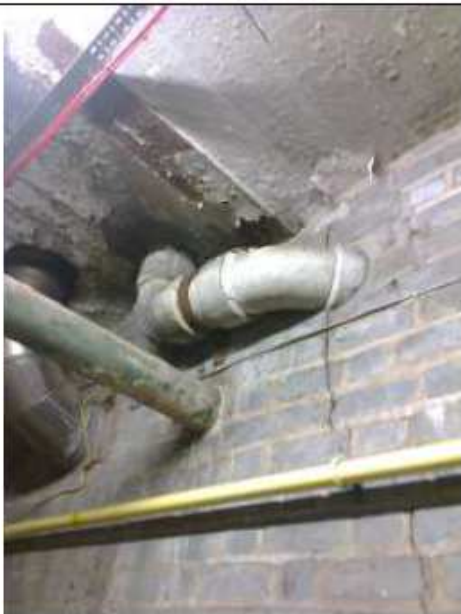
| <b>Asb Item ID:</b> | 91-AI-010 | |

| <b>Item Description:</b> | Cement flue pipe emerging from wall at high level | |
| <b>Location:</b> | Boiler Area | |
| <b>Asbestos Fibres:</b> | Chrysotile | |
| <b>Damage:</b> | Low Damage | |

| <b>Recommendation</b> | Monitor condition & manage in-situ | |

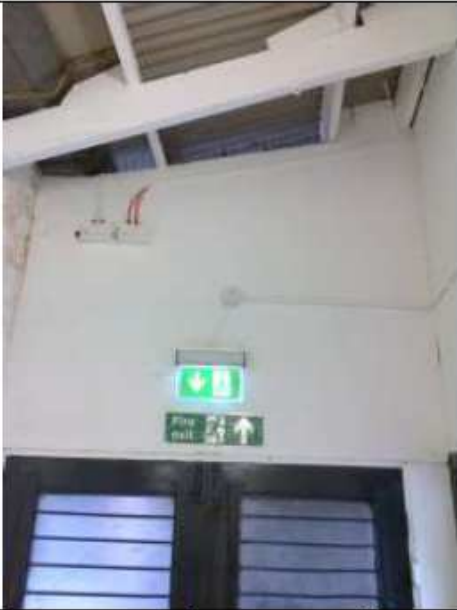
| <b>Asb Item ID:</b> | 91-AI-011 | | |

| <b>Item Description:</b> | Vertical cement panelling above the doorway leading to the external | | |
| <b>Location:</b> | Traders toilets corridor | | |
| <b>Asbestos Fibres:</b> | Crocidolite Presumed | | |
| <b>Damage:</b> | Low Damage | | |

| <b>Recommendation</b> | A sample should be taken by a suitably trained competent person once the area is unoccupied until then monitor and manage in situ | | |
