# CONDITION REPORT

## PERIMETER FENCING

### Peel Brow Primary School

**Date of Issue:** July 2026

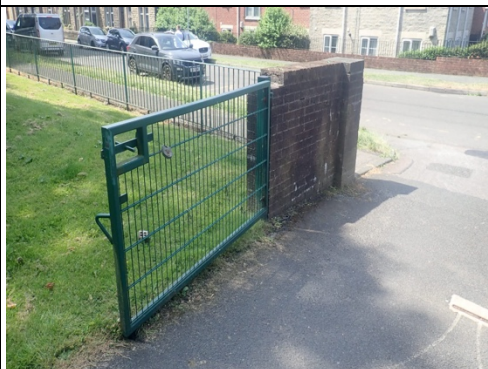
**Photo 1**

Remarks: Low level gates and adamaged brickwork to entrance.

Condition/Priority rating: **D1**

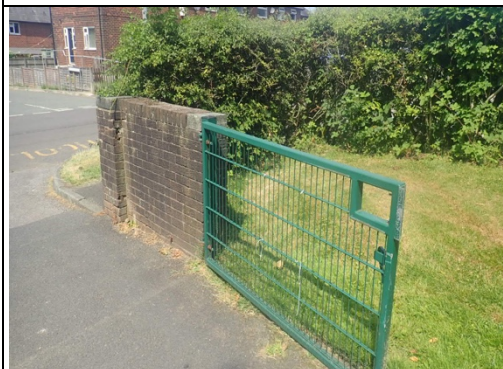
**Photo 6**

Remarks: Low level gates and adamaged brickwork to entrance.

Condition/Priority rating: **D1**

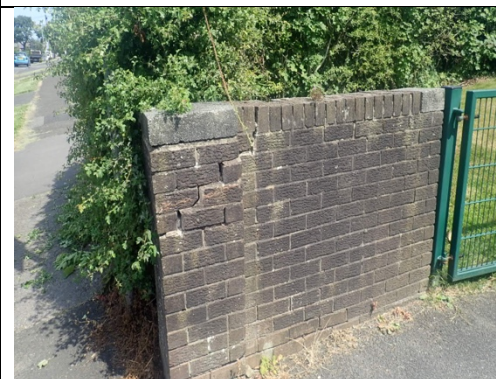
**Photo 3**

Remarks: Low level gates and adamaged brickwork to entrance.

Condition/Priority rating: **D1**

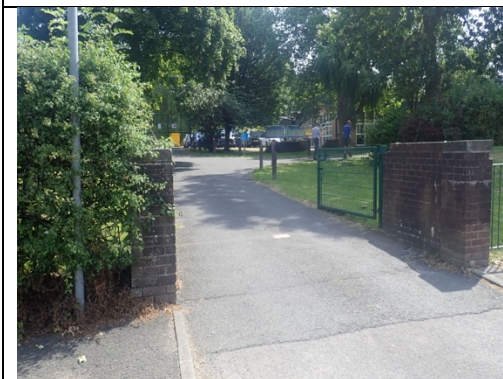
**Photo 4**

Remarks: Low level gates and adamaged brickwork to entrance.

Condition/Priority rating: **D1**

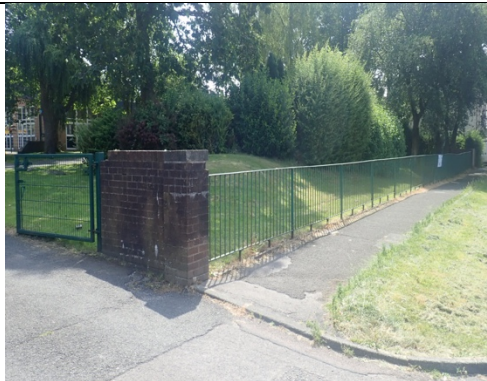
**Photo 5**

Remarks: Low level fencing adjacent to footpath easily scaled by miscreants – open site boundary.

Condition/Priority rating: **D1**

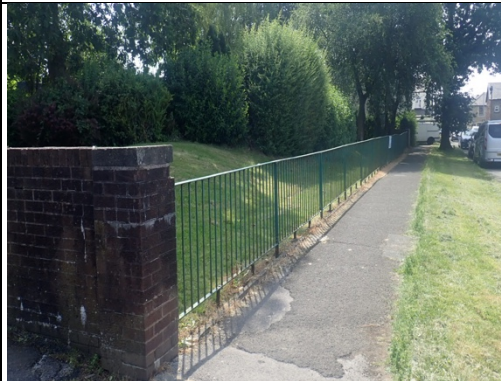
**Photo 6**

Remarks: Low level fencing adjacent to footpath easily scaled by miscreants – open site boundary.

Condition/Priority rating: **D1**

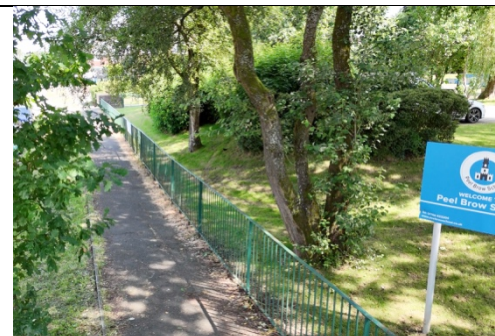
**Photo 7**

Remarks: Low level fencing adjacent to footpath easily scaled by miscreants – open site boundary.

Vegetation along boundary

Condition/Priority rating: **D1**

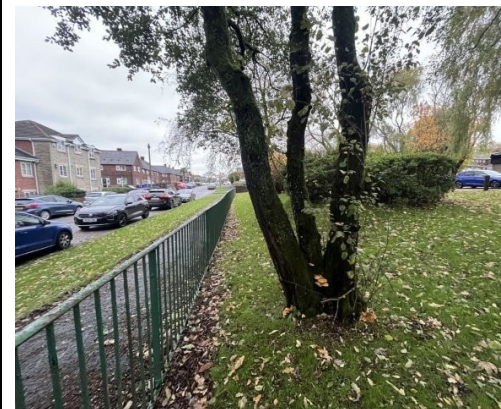
**Photo 8**

Remarks: Low level fencing adjacent to footpath easily scaled by miscreants – open site boundary.

Vegetation along boundary

Condition/Priority rating: **D1**
