# CCTV Survey Report

110 whatley street  
bolton

## 110 whatley street - CCTV Survey Report : 17/01/24

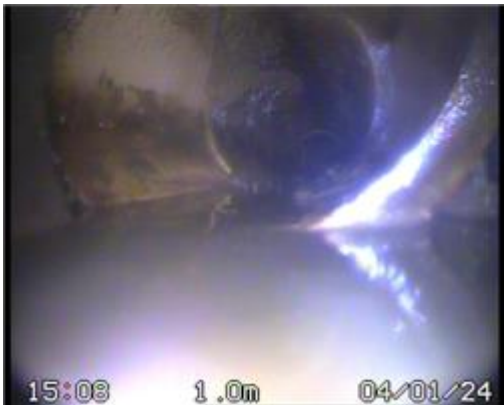
| <b>Section: 1</b><br><b>From: MH1</b><br><b>To: outside MH</b> | | Purpose of Inspection: Routine inspection of condition<br><br>pipe is brocken at 1m and has a hole in at 2.4m line needs digging and repairing to resolve the issues | <b>DRB Grade: C</b><br><b>Pipe Size: 150</b><br><b>Material: Vitrified Clay (i.e. all clayware)</b><br><b>Use: Combined</b> |

| Pos | Video Ref | Code | Description | Image |
|---|---|---|---|---|
| 01.00m | 0:00:00 | BJ | Broken pipe from 12 o'clock to 12 o'clock at joint - Severity 4 | <p>Image Provided - Ref: 0_1</p> |

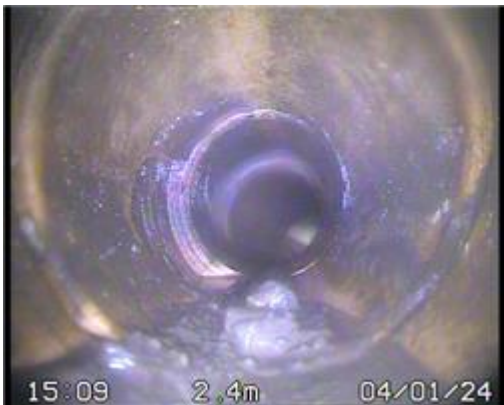
| Pos | Video Ref | Code | Description | Image |
|---|---|---|---|---|
| 02.40m | 0:00:00 | H | Hole in drain/sewer from 06 o'clock to 06 o'clock - Severity 4 | <p>Image Provided - Ref: 0_2</p> |

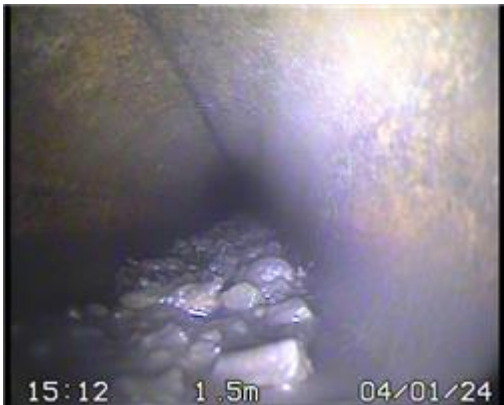
| <b>Section: 2</b><br><b>From: MH1</b><br><b>To: old road gulley</b> | | Purpose of Inspection: Routine inspection of condition<br><br>line is no longer in use | <b>DRB Grade: B</b><br><b>Pipe Size: 150</b><br><b>Material: Vitrified Clay (i.e. all clayware)</b><br><b>Use: Combined</b> |

| Pos | Video Ref | Code | Description | Image |
|---|---|---|---|---|
| 01.50m | 0:00:00 | DERJ | Settled deposits coarse: 40%<br>Cross sectional area loss at joint - Severity 3 | <p>Image Provided - Ref: 1_1</p> |

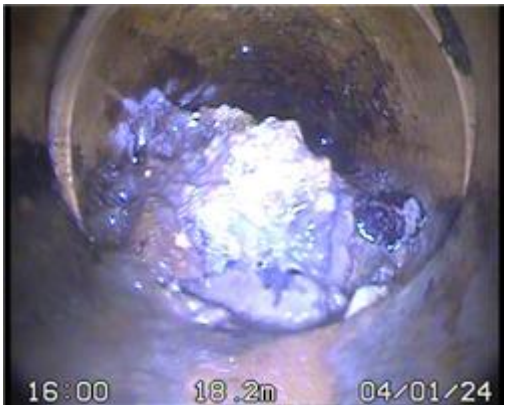
| <b>Section: 3</b><br><b>From: MH2</b><br><b>To: house</b> | | Purpose of Inspection: Routine inspection of condition<br><br>line has a medium displaced joint that is causing the line to hold foul waste and water line needs digging and repairing to sort the issues | <b>DRB Grade: B</b><br><b>Pipe Size: 150</b><br><b>Material: Vitrified Clay (i.e. all clayware)</b><br><b>Use: Combined</b> |

| Pos | Video Ref | Code | Description | Image |
|---|---|---|---|---|
| 18.20m | 0:00:00 | JDM | Joint displaced medium - Severity 3 | <p>Image Provided - Ref: 2_1</p> |

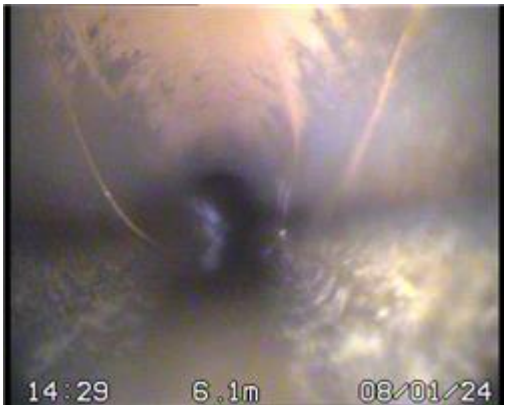
| <b>Section: 4</b><br><b>From: MH2</b><br><b>To: MH3</b> | | Purpose of Inspection: Routine inspection of condition<br><br>line has a large crack in line needs patch liner or digging and repairing | <b>DRB Grade: A</b><br><b>Pipe Size: 150</b><br><b>Material: Vitrified Clay (i.e. all clayware)</b><br><b>Use: Combined</b> |

| Pos | Video Ref | Code | Description | Image |
|---|---|---|---|---|
| 06.10m | 0:00:00 | CLJ | Crack, longitudinal at 12 o'clock at joint - Severity 1 | <p>Image Provided - Ref: 3_1</p> |
