# Drainage Report

**Bury Council  
1 - 5 The Elms, Elms Close  
Whitefield  
Greater Manchester  
M45 8XS**

## The Elms - CCTV Survey Report : 31/08/22

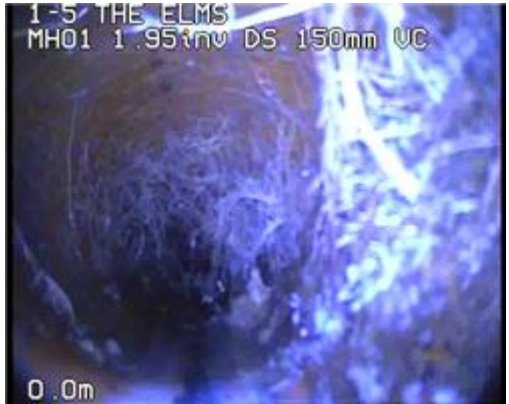
| Pos | Video Ref | Code | Description | Image |
|---|---|---|---|---|
| 00.00m | 0:00:00 | S1 R | Roots 0m - 1.7m - Severity 3 Fine roots | <p>Image Provided - Ref: 0_2</p> |
| 01.70m | 0:00:00 | F1 R | Roots Defect End - Severity 3 Fine roots | |

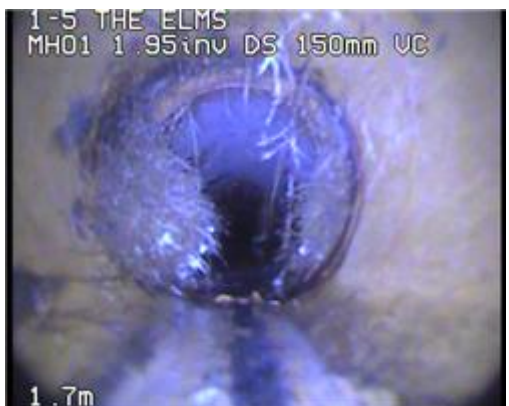
| Pos | Video Ref | Code | Description | Image |
|---|---|---|---|---|
| 01.90m | 0:00:08 | RJ | Roots at joint - Severity 3 | <p>Image Provided - Ref: 0_3</p> |

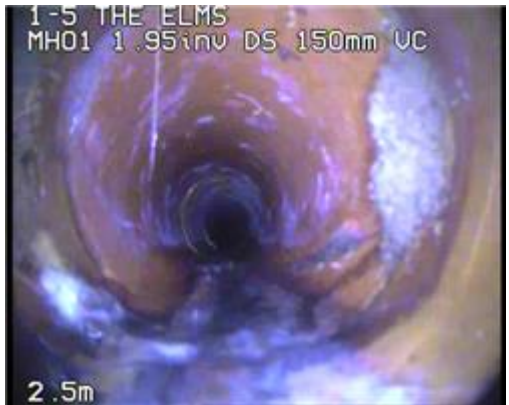
| Pos | Video Ref | Code | Description | Image |
|---|---|---|---|---|
| 02.60m | 0:00:12 | RJ | Roots at joint - Severity 3 | Image Provided - Ref: 0_4<br> |

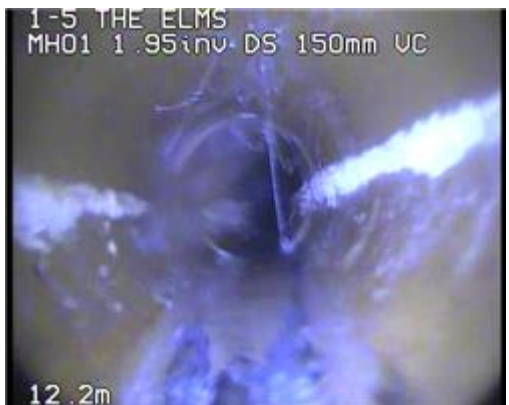
| Pos | Video Ref | Code | Description | Image |
|---|---|---|---|---|
| 12.20m | 0:00:48 | S2 DEG | Attached deposits, grease 12.2m - 13.3m from 03 o'clock to 09 o'clock: 5% Cross sectional area loss - Severity 3 Fine attached grease deposits | Image Provided - Ref: 0_9<br> |
| 13.30m | 0:00:48 | F2 DEG | Attached deposits, grease Defect End from 03 o'clock to 09 o'clock: 5% Cross sectional area loss - Severity 3 Fine attached grease deposits | |

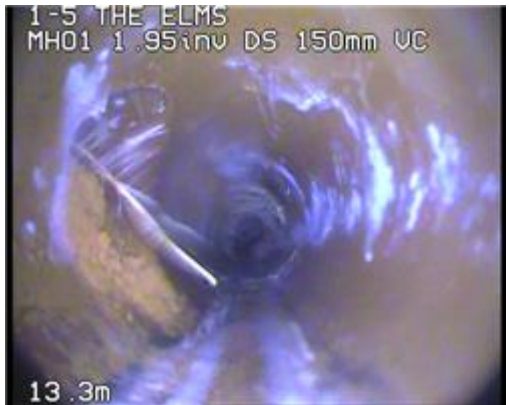
| Pos | Video Ref | Code | Description | Image |
|---|---|---|---|---|
| 13.30m | 0:00:56 | DEE | Attached deposits, encrustation at 09 o'clock: 5% Cross sectional area loss - Severity 3<br>Ochre encrustations from junction | Image Provided - Ref: 0_7<br> |

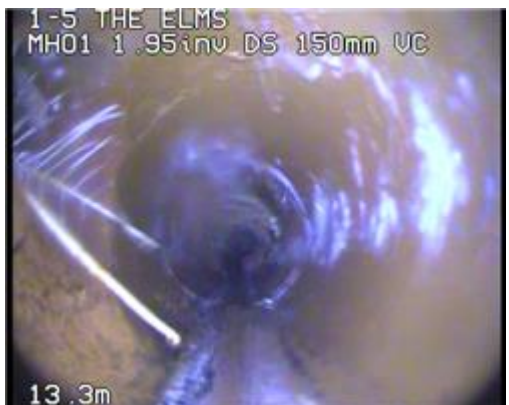
| Pos | Video Ref | Code | Description | Image |
|---|---|---|---|---|
| 13.30m | 0:00:56 | R | Roots - Severity 3<br>Fine roots tap down junction | Image Provided - Ref: 0_8<br> |

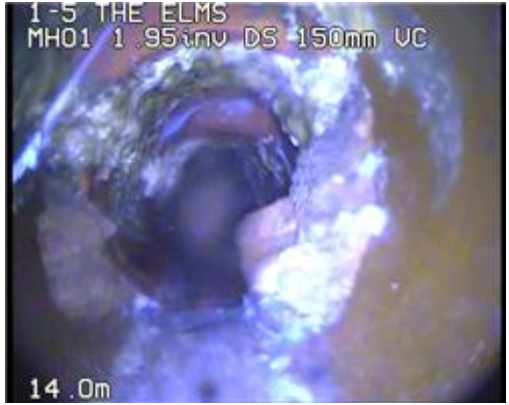
| Pos | Video Ref | Code | Description | Image |
|---|---|---|---|---|
| 14.00m | 0:01:04 | S3 DEG | Attached deposits, grease 14m - 15m from 12 o'clock to 12 o'clock: 10% Cross sectional area loss - Severity 3 | <p>Image Provided - Ref: 0_12</p> |
| 15.00m | 0:01:04 | F3 DEG | Attached deposits, grease Defect End from 12 o'clock to 12 o'clock: 10% Cross sectional area loss - Severity 3 | |

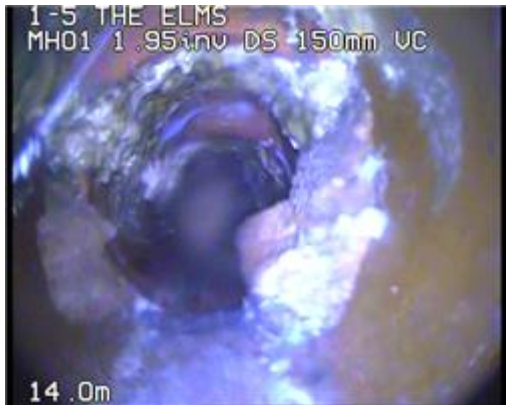
| Pos | Video Ref | Code | Description | Image |
|---|---|---|---|---|
| 14.10m | 0:01:04 | DEEJ | Attached deposits, encrustation from 12 o'clock to 12 o'clock: 20% Cross sectional area loss at joint - Severity 3 | <p>Image Provided - Ref: 0_10</p> |

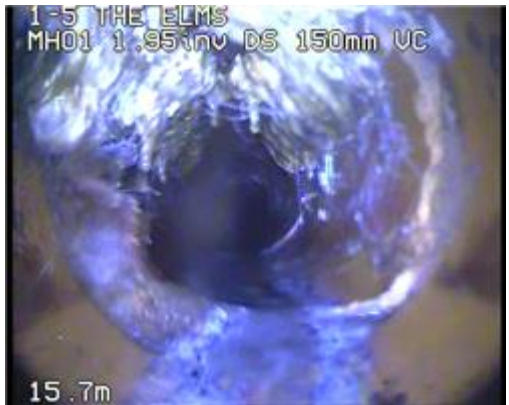
| Pos | Video Ref | Code | Description | Image |
|---|---|---|---|---|
| 15.70m | 0:01:35 | DEG | Attached deposits, grease from 09 o'clock to 03 o'clock: 20% Cross sectional area loss - Severity 3 | <p>Image Provided - Ref: 0_14</p> |

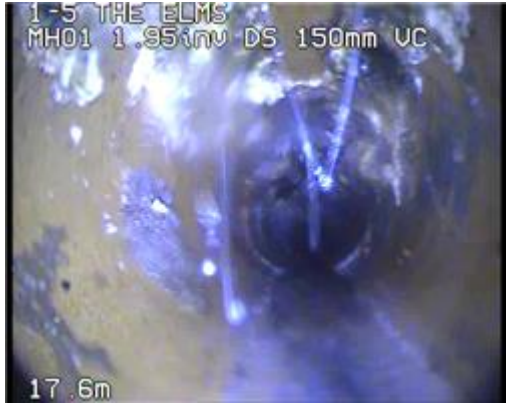
| Pos | Video Ref | Code | Description | Image |
|---|---|---|---|---|
| 17.60m | 0:01:44 | DEG | Attached deposits, grease from 10 o'clock to 02 o'clock: 10% Cross sectional area loss - Severity 3 | <p>Image Provided - Ref: 0_17</p> |

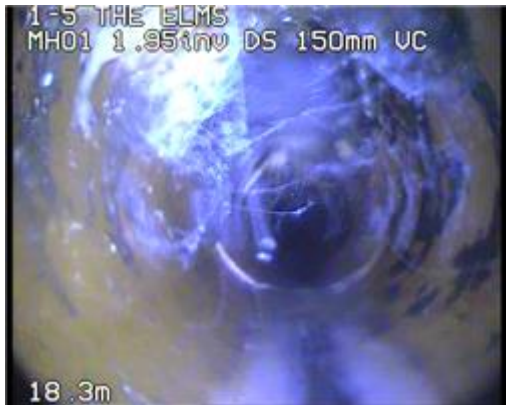
| Pos | Video Ref | Code | Description | Image |
|---|---|---|---|---|
| 18.30m | 0:01:47 | DEG | Attached deposits, grease from 10 o'clock to 02 o'clock: 10% Cross sectional area loss - Severity 3 | <p>Image Provided - Ref: 0_18</p> |

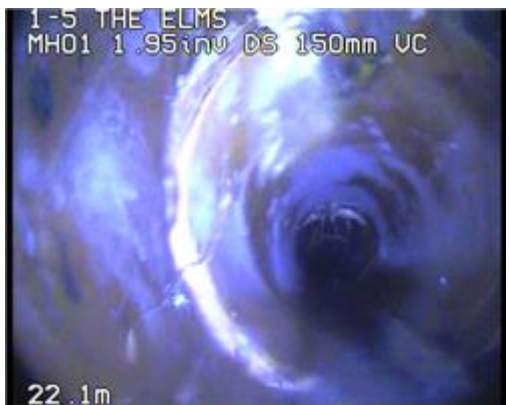
| Pos | Video Ref | Code | Description | Image |
|---|---|---|---|---|
| 22.10m | 0:02:02 | RJ | Roots at joint - Severity 3 | <p>Image Provided - Ref: 0_16</p> |

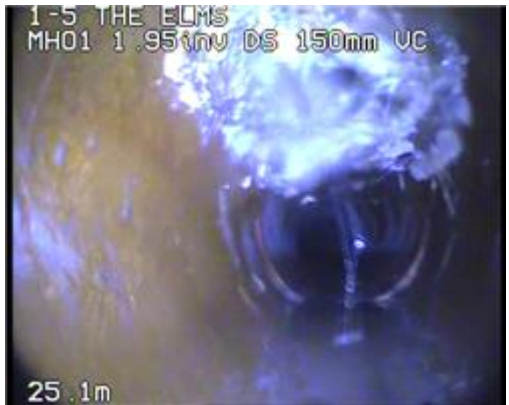
| Pos | Video Ref | Code | Description | Image |
|---|---|---|---|---|
| 25.20m | 0:02:17 | DEG | Attached deposits, grease from 11 o'clock to 01 o'clock: 20% Cross sectional area loss - Severity 3 | <p>Image Provided - Ref: 0_20</p> |

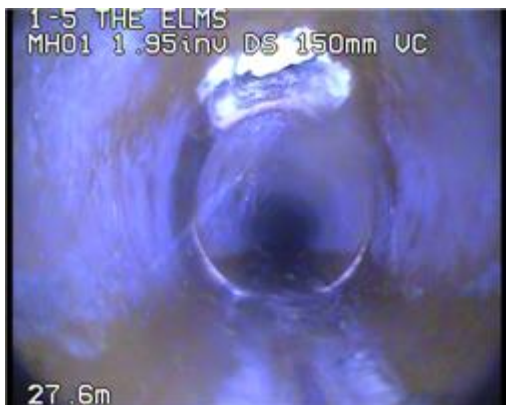
| Pos | Video Ref | Code | Description | Image |
|---|---|---|---|---|
| 27.80m | 0:02:28 | DEG | Attached deposits, grease at 12 o'clock: 10% Cross sectional area loss - Severity 3 | <p>Image Provided - Ref: 0_21</p> |

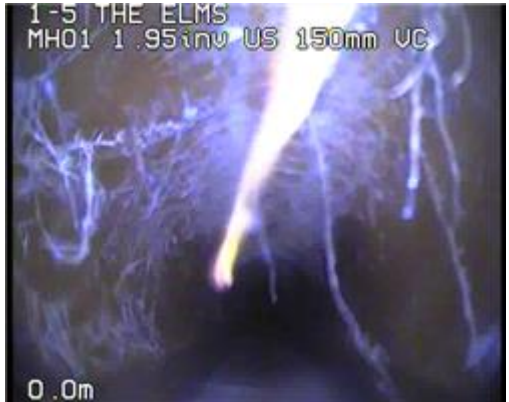
| Pos | Video Ref | Code | Description | Image |
|---|---|---|---|---|
| 00.00m | 0:00:00 | R | Roots - Severity 3 Fine roots | <p>Image Provided - Ref: 1_2</p> |

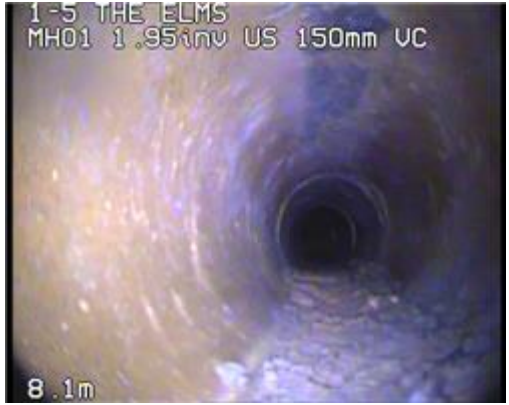
| Pos | Video Ref | Code | Description | Image |
|---|---|---|---|---|
| 08.00m | 0:01:01 | DES | Settled deposits fine: 10%<br>Cross sectional area loss -<br>Severity 3 | Image Provided - Ref: 1_10<br> |

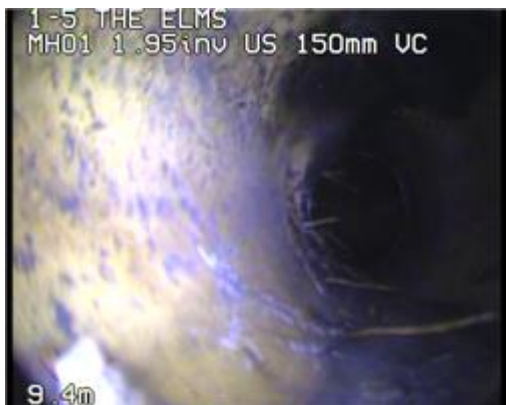
| Pos | Video Ref | Code | Description | Image |
|---|---|---|---|---|
| 09.50m | 0:01:12 | R | Roots - Severity 3<br>Fine roots tap down junction | Image Provided - Ref: 1_12<br> |

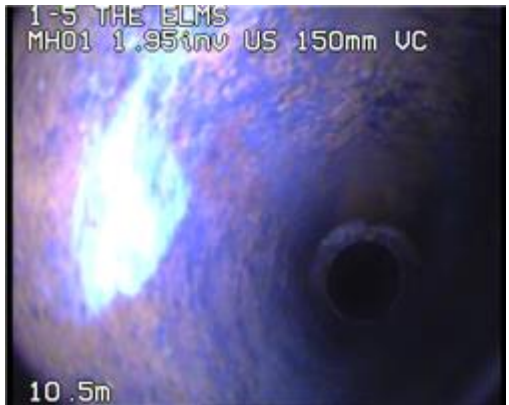
| Pos | Video Ref | Code | Description | Image |
|---|---|---|---|---|
| 11.00m | 0:01:44 | SC | Dimension of drain/sewer changes: 100mm Diameter | <p>Image Provided - Ref: 1_14</p> |
| 11.00m | | SA | Survey abandoned<br>SA - Unable to pass | |

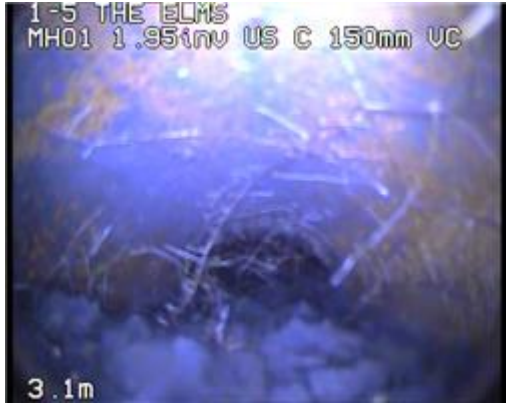
| Pos | Video Ref | Code | Description | Image |
|---|---|---|---|---|
| 03.00m | 0:00:25 | F2 DER | Settled deposits coarse Defect End: 40% Cross sectional area loss - Severity 3<br>Dry coarse debris - Appears redundant | |

| Pos | Video Ref | Code | Description | Image |
|---|---|---|---|---|
| 03.00m | | SA | Survey abandoned<br>SA - Silt | <p>Image Provided - Ref: 2_9999</p> |

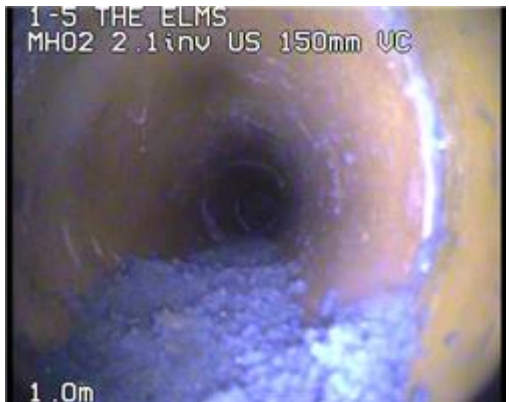
| Pos | Video Ref | Code | Description | Image |
|---|---|---|---|---|
| 00.50m | 0:00:08 | S1 DES | Settled deposits fine 0.5m - 3.2m: 10% Cross sectional area loss - Severity 3 | <p>Image Provided - Ref: 4_3</p> |

| Pos | Video Ref | Code | Description | Image |
|---|---|---|---|---|
| 03.20m | 0:00:08 | F1 DES | Settled deposits fine Defect End: 10% Cross sectional area loss - Severity 3 | |

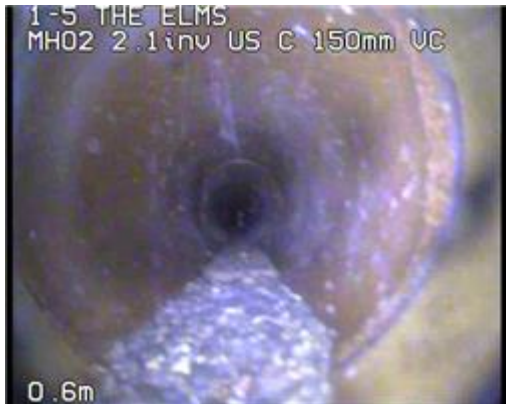
| Pos | Video Ref | Code | Description | Image |
|---|---|---|---|---|
| 00.50m | 0:00:10 | S1 DES | Settled deposits fine 0.5m - 5m: 5% Cross sectional area loss - Severity 3 | <p>Image Provided - Ref: 5_2</p> |
| 05.00m | 0:00:10 | F1 DES | Settled deposits fine Defect End: 5% Cross sectional area loss - Severity 3 | |

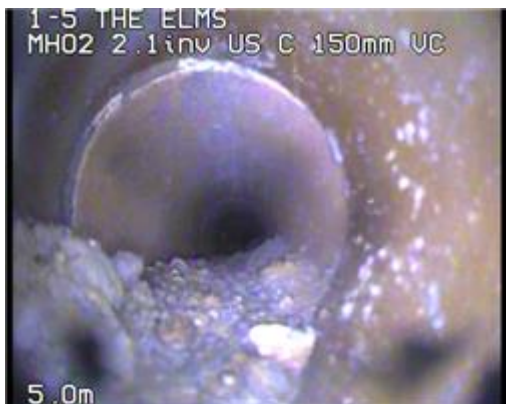
| Pos | Video Ref | Code | Description | Image |
|---|---|---|---|---|
| 00.50m | 0:00:29 | DES | Settled deposits fine: 20% Cross sectional area loss - Severity 3 | <p>Image Provided - Ref: 5_3</p> |
