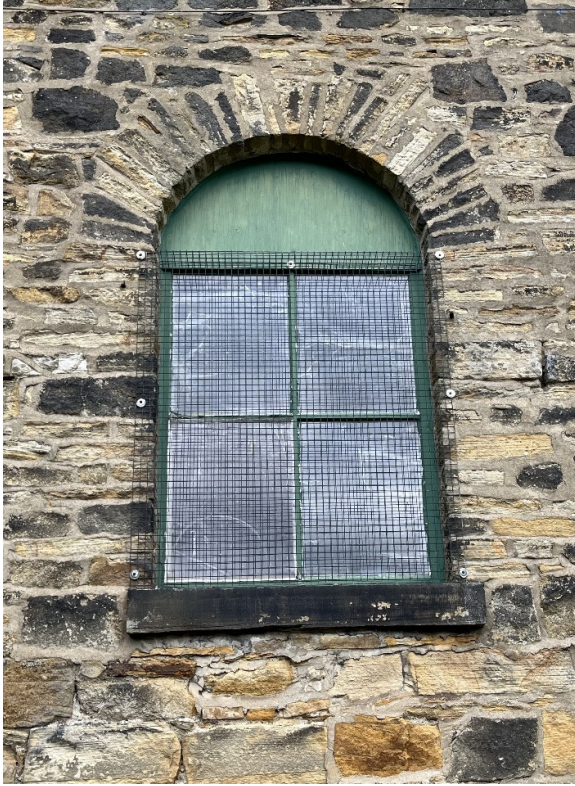
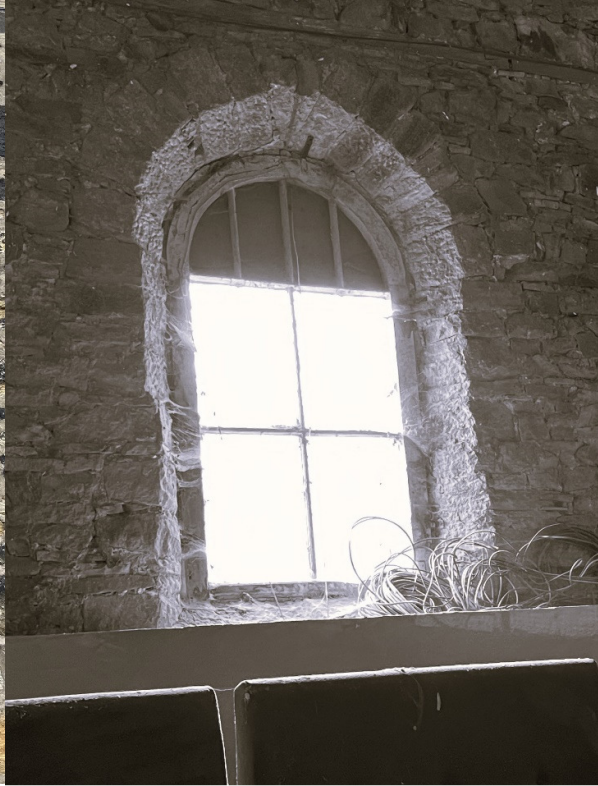
**Window W3 facing west :**

| Outer frame | Remove weldmesh and securing bolts.<br>Robust frame, requires sanding and painting. |
| Glazing bars | Beading missing.<br>Add/replace beading where required, sand and paint. |
| Glazing | Glazing satisfactory on lower 4 panes.<br>Upper semi-circular light is boarded using plywood – sand and paint. |

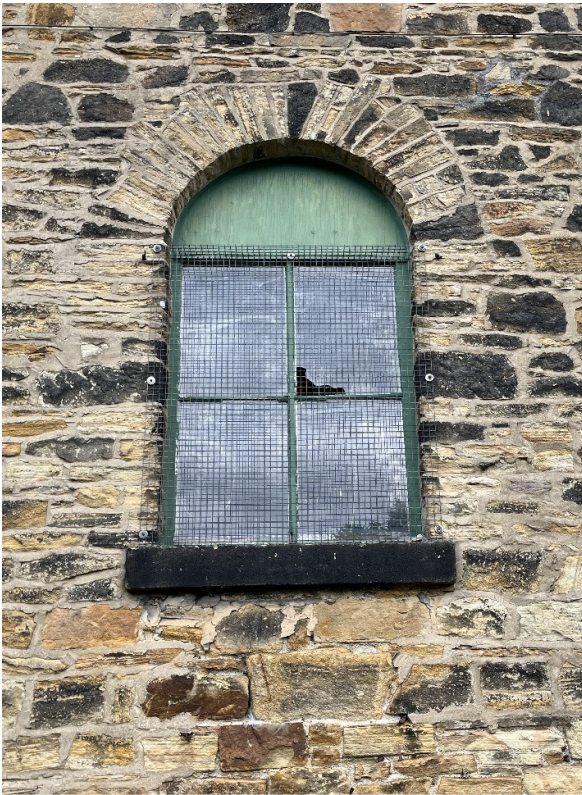
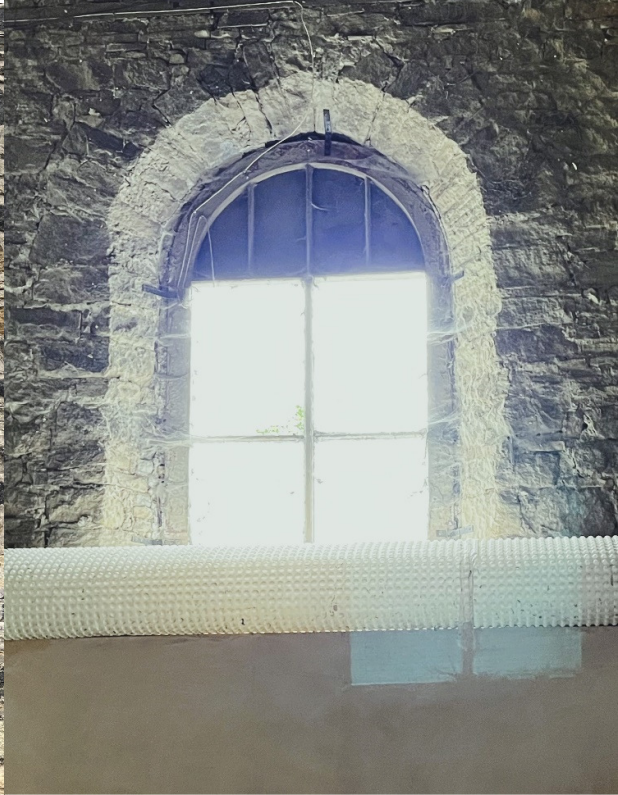
**Window W4 facing west :**

| Outer frame | Remove weldmesh and securing bolts.<br>Robust frame, requires sanding and painting. |
| Glazing bars | Beading missing.<br>Add/replace beading where required, sand and paint. |
| Glazing | Glazing satisfactory on lower 3 panes.<br>1 pane to be replaced.<br>Upper semi-circular light is boarded using plywood – sand and paint. |

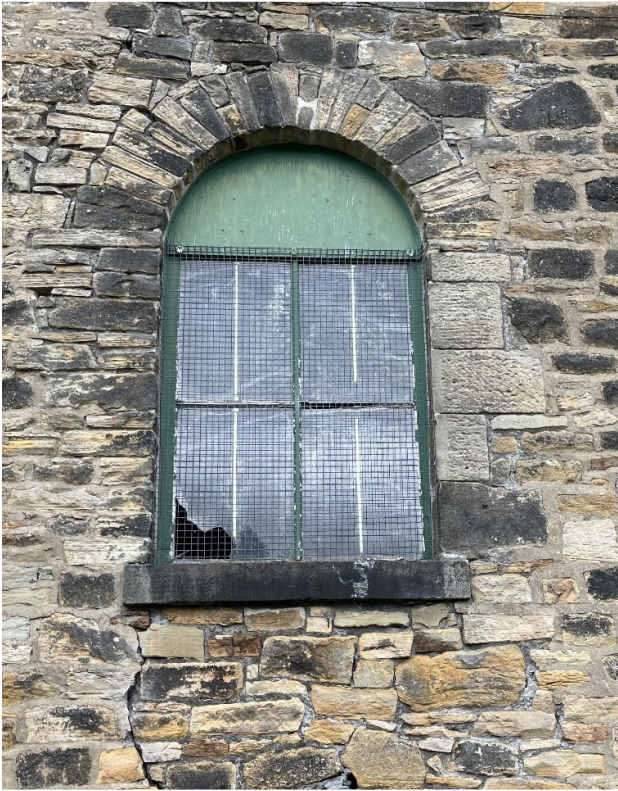
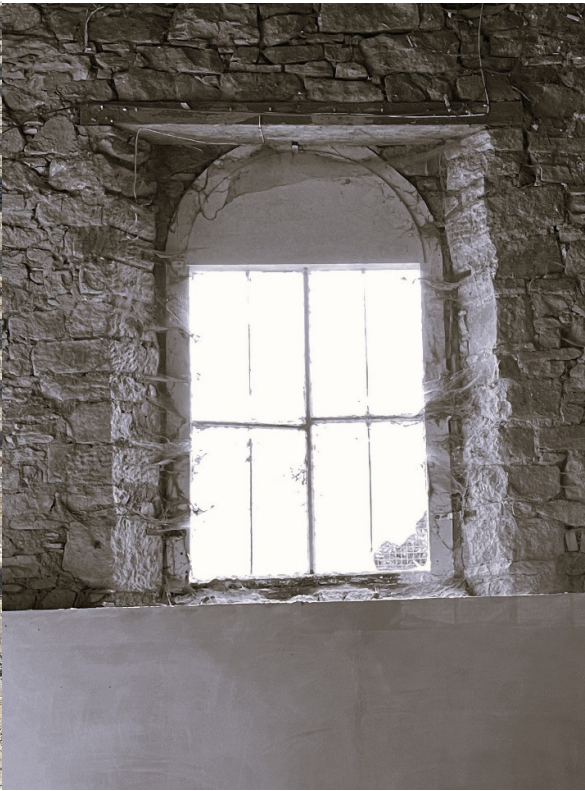
**Window W5 facing west :**

| Outer frame | Remove weldmesh and securing bolts.<br>Robust frame, requires sanding and painting. |
| Glazing bars | Beading missing.<br>Add/replace beading where required, sand and paint. |
| Glazing | Glazing satisfactory on lower 3 panes.<br>1 pane to be replaced.<br>Upper semi-circular light is boarded using plywood – sand and paint. |

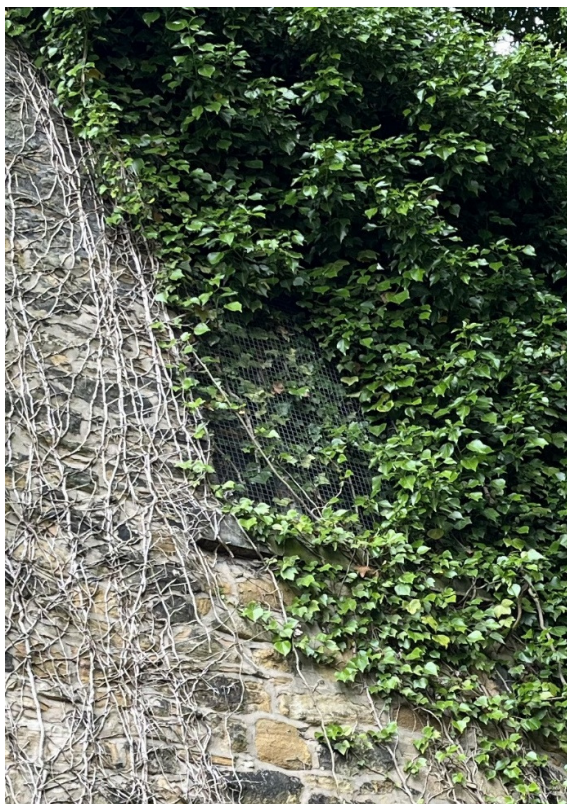
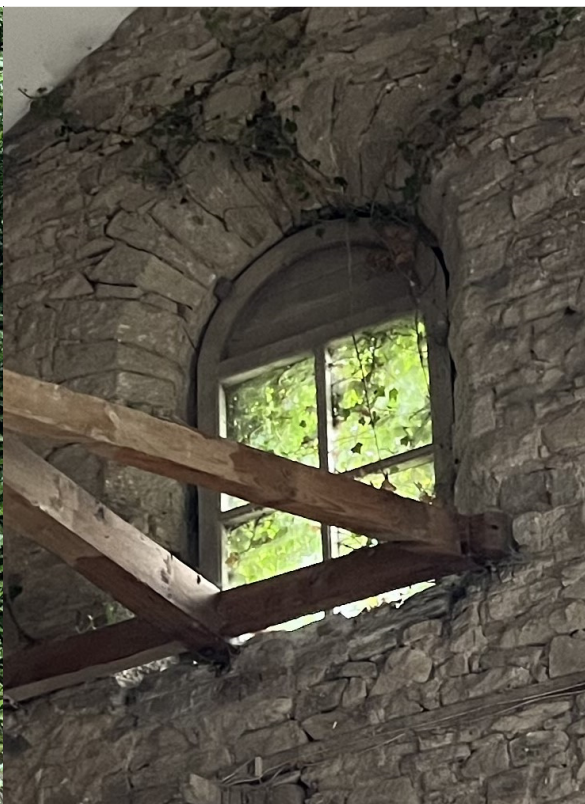
**Window W6 facing south :**

| Outer frame | Remove vegetation from around the window.<br>Remove weldmesh and securing bolts.<br>Robust frame, requires sanding and painting. |
| Glazing bars | Beading missing.<br>Add/replace beading where required, sand and paint. |
| Glazing | Glazing appears to be satisfactory.<br>Upper semi-circular light is boarded using plywood – sand and paint. |
