| <b>Project Title</b> | New Church Street, Radcliffe |
| <b>Document Title</b> | Validation Completion Report |

# **GAS MITIGATION VALIDATION COMPLETION REPORT**

| Date of Certificate: | 11 <sup>th</sup> December 2017 |

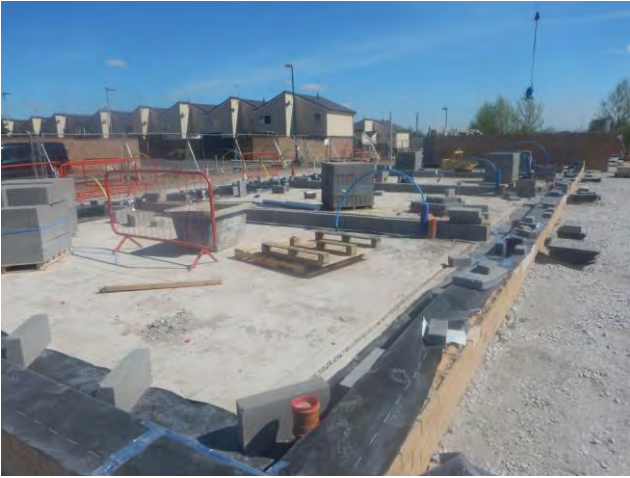
*Photograph 1: Showing the first stage of membrane construction on top of the cavity wall, with corners showing sufficient seal and overlap using detailing strip and the general condition of the membrane installation on Plots 7-10 during inspection on 4<sup>th</sup> May 2017.*

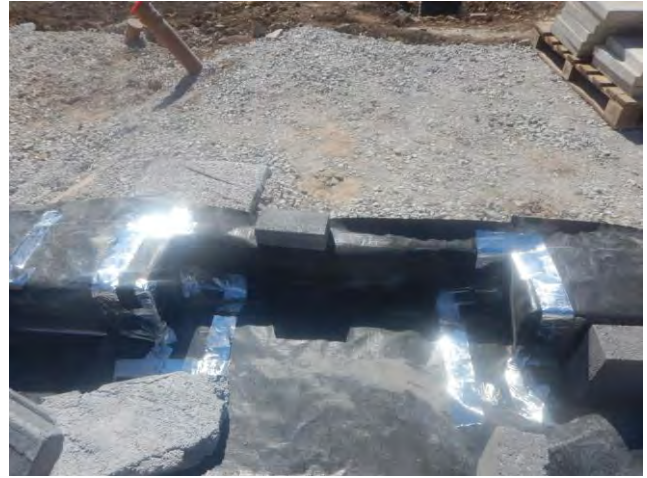
*Photograph 2: Showing the first stage of membrane construction on top of the cavity wall, with corners showing sufficient seal and overlap and the general condition of the membrane installation on Plots 7-10 during inspection on 4<sup>th</sup> May 2017.*

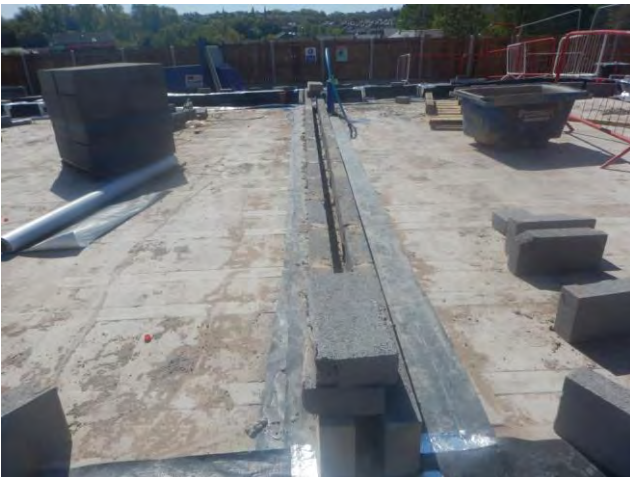
*Photograph 3: Showing the first stage of membrane construction across the party walls and the general condition of the membrane installation on Plots 7-10 during inspection on 4<sup>th</sup> May 2017.*

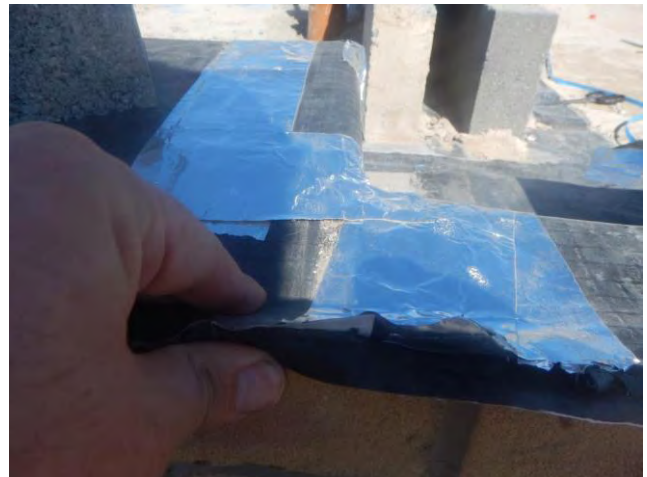
*Photograph 4: Showing the first stage of membrane construction on top of the cavity wall, with corners showing sufficient seal and overlap and the general condition of the membrane installation on Plots 7-10 during inspection on 4<sup>th</sup> May 2017.*

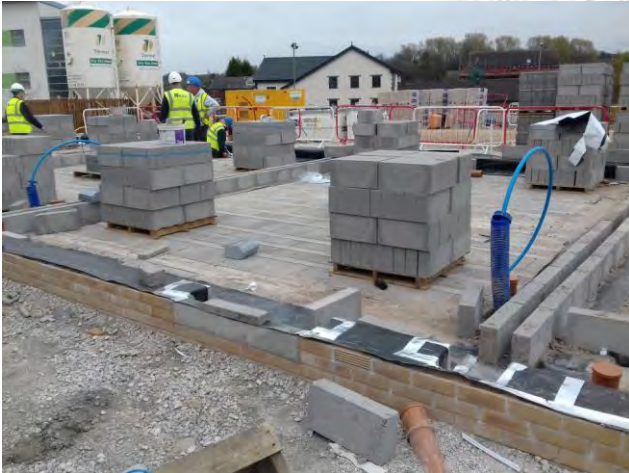
*Photograph 5: Showing the first stage of membrane construction on top of the cavity wall, with corners showing sufficient seal and overlap using detailing strip and the general condition of the membrane installation on Plots 28-31 during inspection on 7<sup>th</sup> April 2017.*

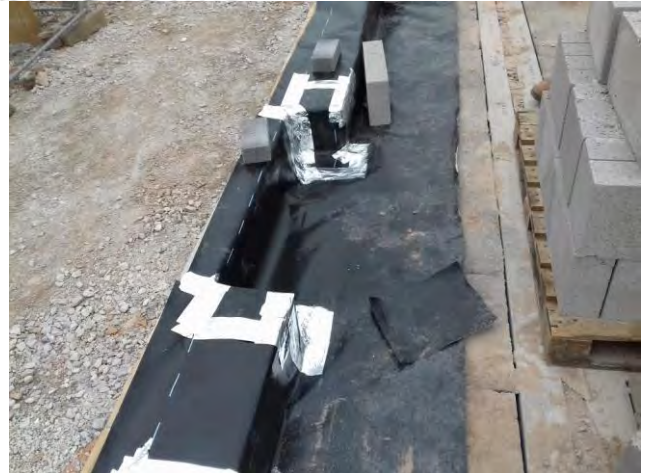
*Photograph 6: Showing the first stage of membrane construction on top of the cavity wall, with corners showing sufficient seal and overlap and the general condition of the membrane installation on Plots 28-31 during inspection on 7<sup>th</sup> April 2017.*

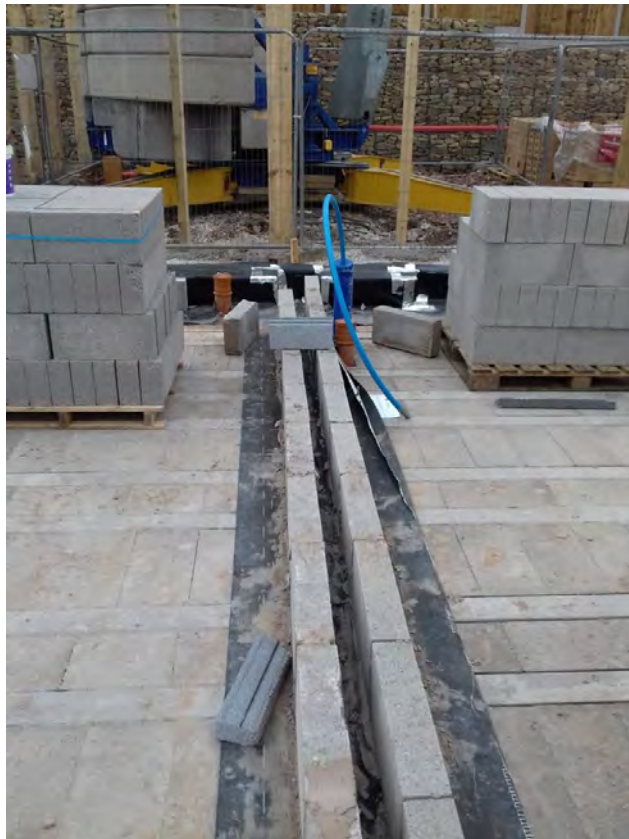
*Photograph 7: Showing the first stage of membrane construction across the party walls and the general condition of the membrane installation on Plots 28-31 during inspection on 7<sup>th</sup> April 2017.*

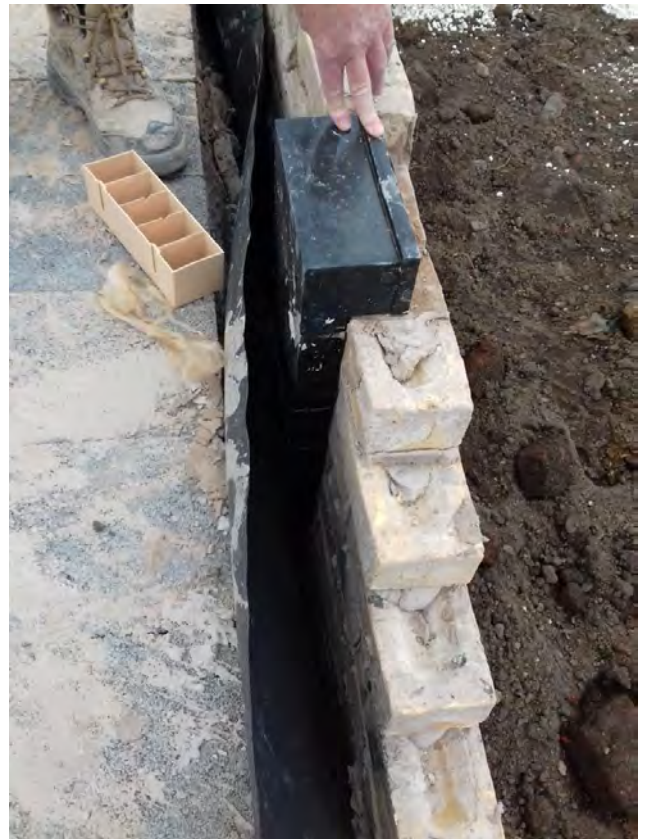
*Photograph 8: Showing a periscopic vent which was installed on Plots 28-31 during inspection on 7<sup>th</sup> April 2017.*

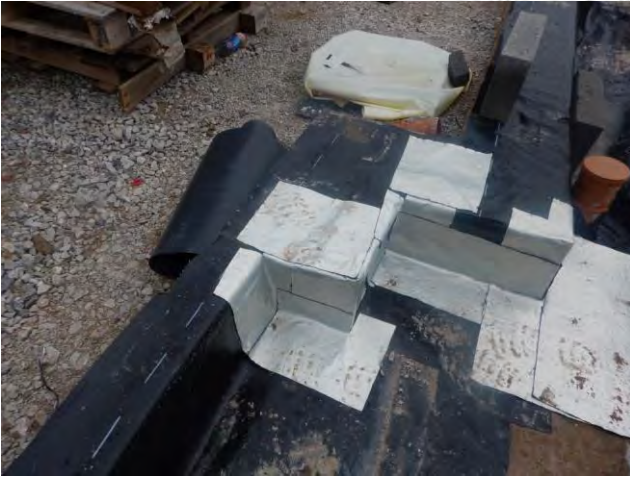
*Photograph 9: Showing the first stage of membrane construction on top of the cavity wall, with corners showing sufficient seal and overlap using detailing strip and the general condition of the membrane installation on Plots 36-37 during inspection on 8<sup>th</sup> August 2017.*

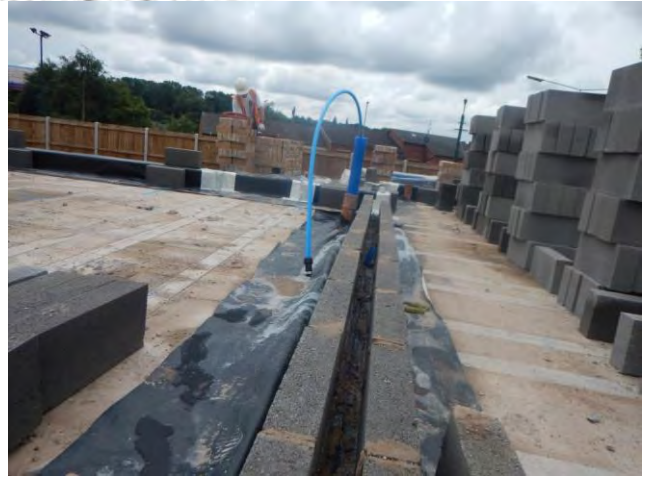
*Photograph 10: Showing the first stage of membrane construction across the party walls and the general condition of the membrane installation on Plots 36-37 during inspection on 7<sup>th</sup> April 2017.*

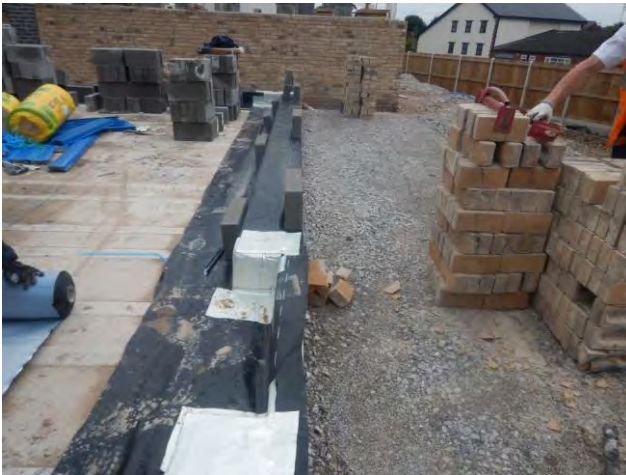
*Photograph 11: Showing the first stage of membrane construction on top of the cavity wall, with corners showing sufficient seal and overlap using detailing strip and the general condition of the membrane installation on Plots 36-37 during inspection on 8<sup>th</sup> August 2017.*

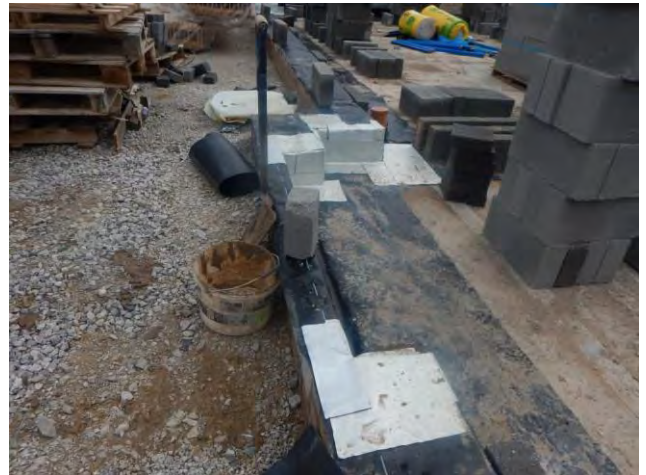
*Photograph 12: Showing the first stage of membrane construction on top of the cavity wall, with corners showing sufficient seal and overlap using detailing strip and the general condition of the membrane installation on Plots 36-37 during inspection on 8<sup>th</sup> August 2017.*

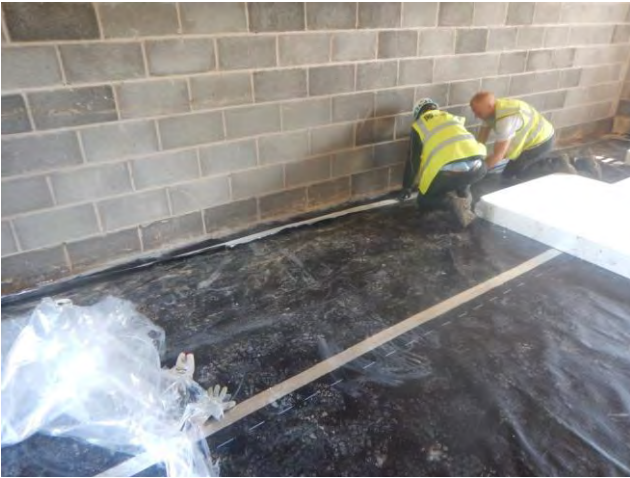
*Photograph 13: Showing the general condition of the membrane installation on Plot 4 during inspection on 14<sup>th</sup> August 2017.*

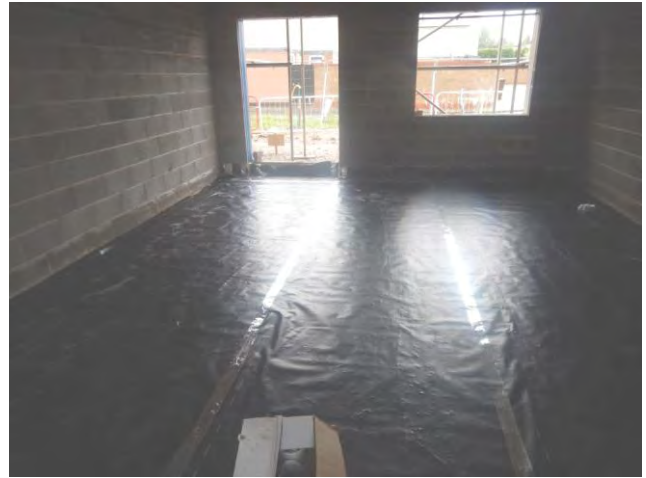
*Photograph 14: Showing the general condition of the membrane installation on Plot 9 during inspection on 27<sup>th</sup> July 2017.*

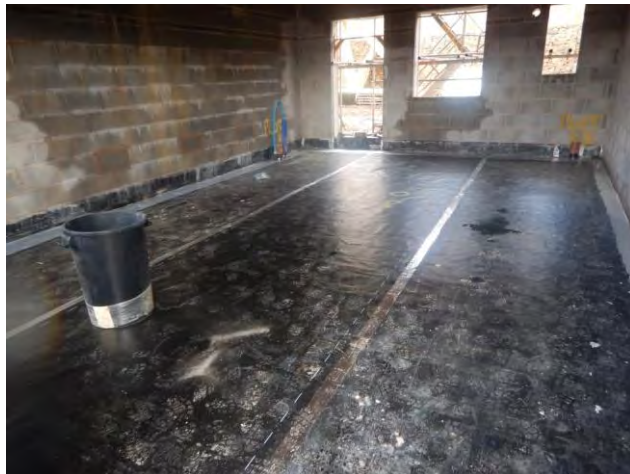
*Photograph 15: Showing the general condition of the membrane installation on Plot 28 with detailing strip used to seal and join onto the perimeter during inspection on 18<sup>th</sup> August 2017.*

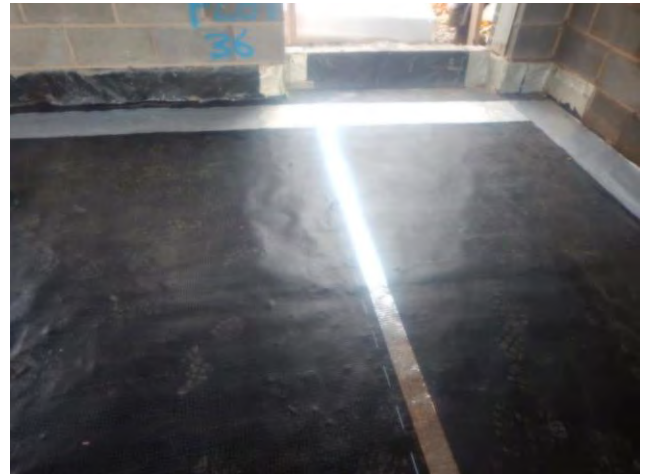
*Photograph 16: Showing the general condition of the membrane installation on Plot 36 with detailing strip used to seal and join onto the perimeter during inspection on 17<sup>th</sup> October 2017.*

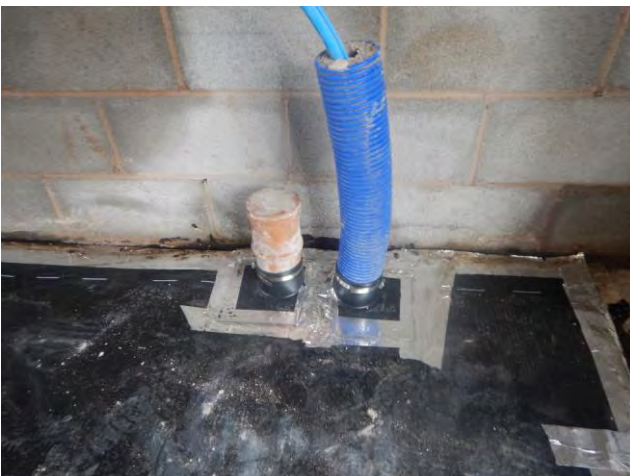
*Photograph 17: Showing the typical installation of a preformed tophat using a jubilee clip, butyl and silver joining tape on Plot 33 during inspection on 31<sup>st</sup> July 2017.*

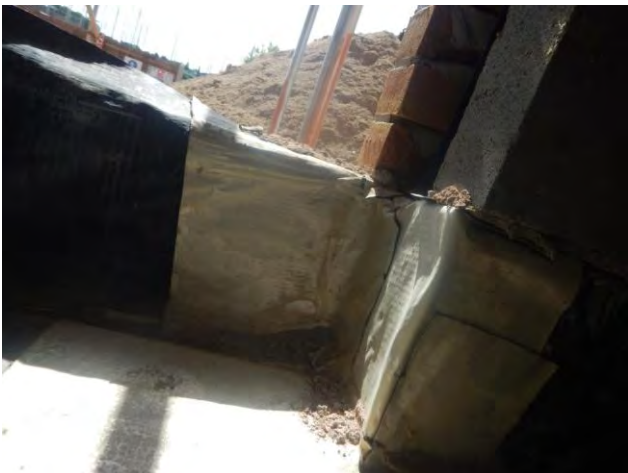
*Photograph 23: Showing the membrane jointed to the perimeter stage one membrane underneath the blockwork and formation around the corner and door threshold using detailing strip with >150mm overlap and the condition of the corners on Plot 4 during inspection on 14<sup>th</sup> August 2017.*

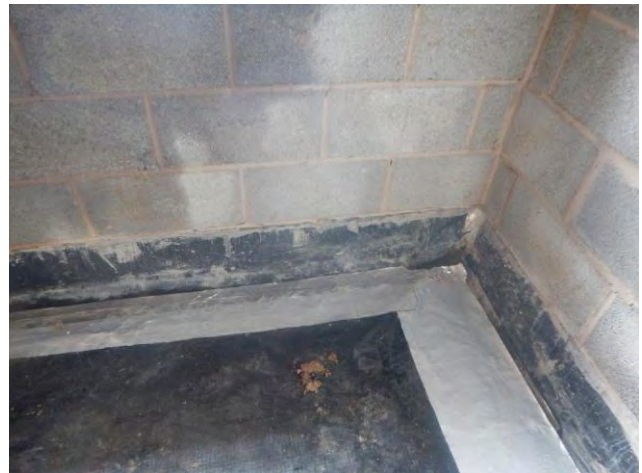
*Photograph 24: Showing the membrane jointed to the perimeter stage one membrane underneath the blockwork using detailing strip with >150mm overlap on Plot 28 during inspection on 18<sup>th</sup> August 2017.*
