## Gas Protection - Validation Record Sheet

**This Record sheet is only applicable to block and beam floor slabs for Characteristic Situation 2 gas protection systems**

Plot 29, Block 10

**For Residential Development at New Church Street, Radcliffe.**

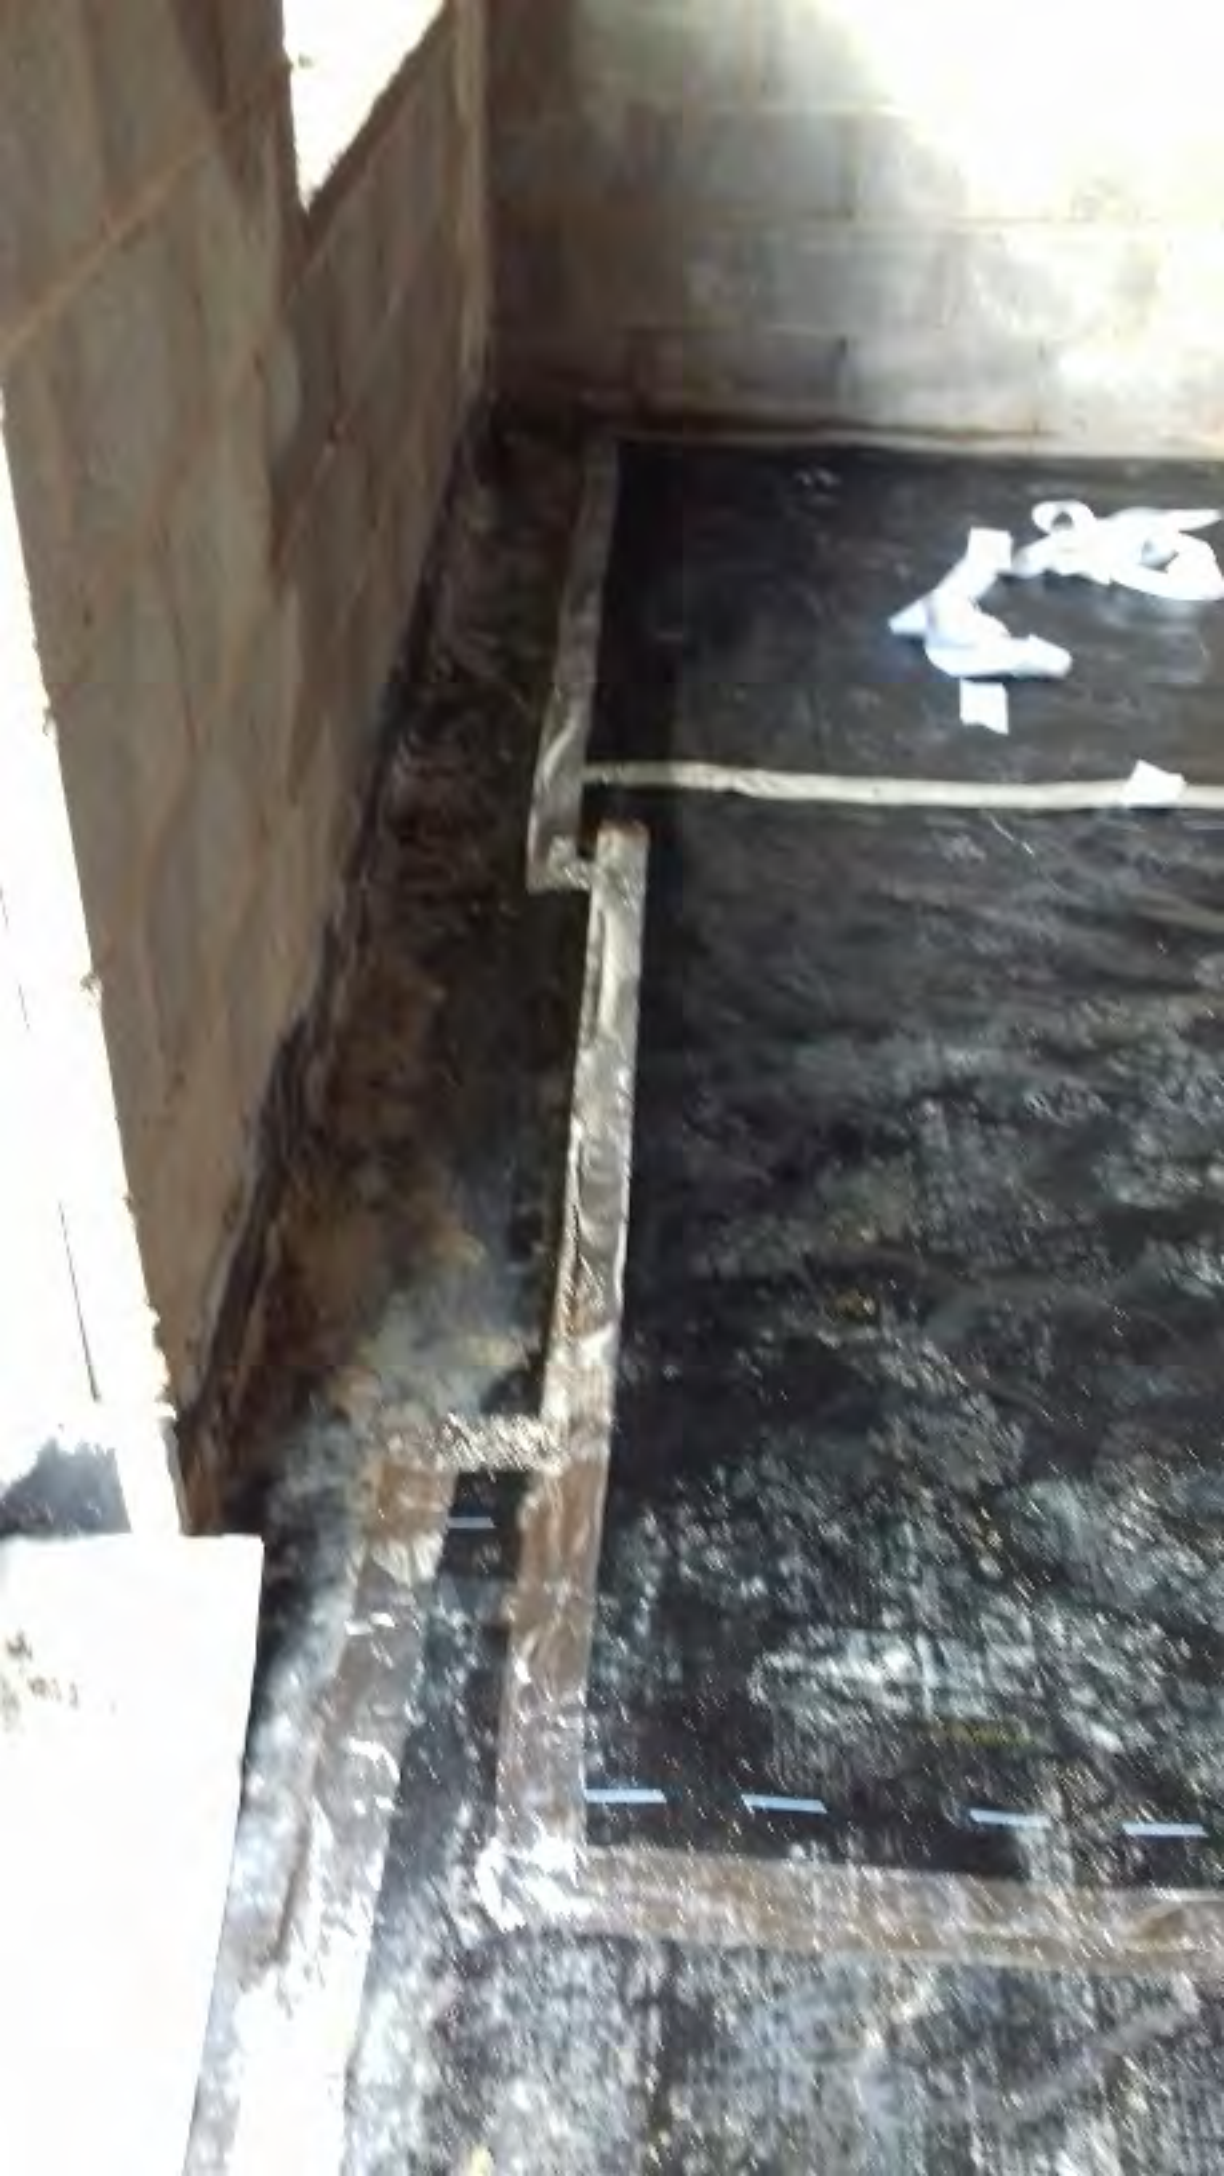
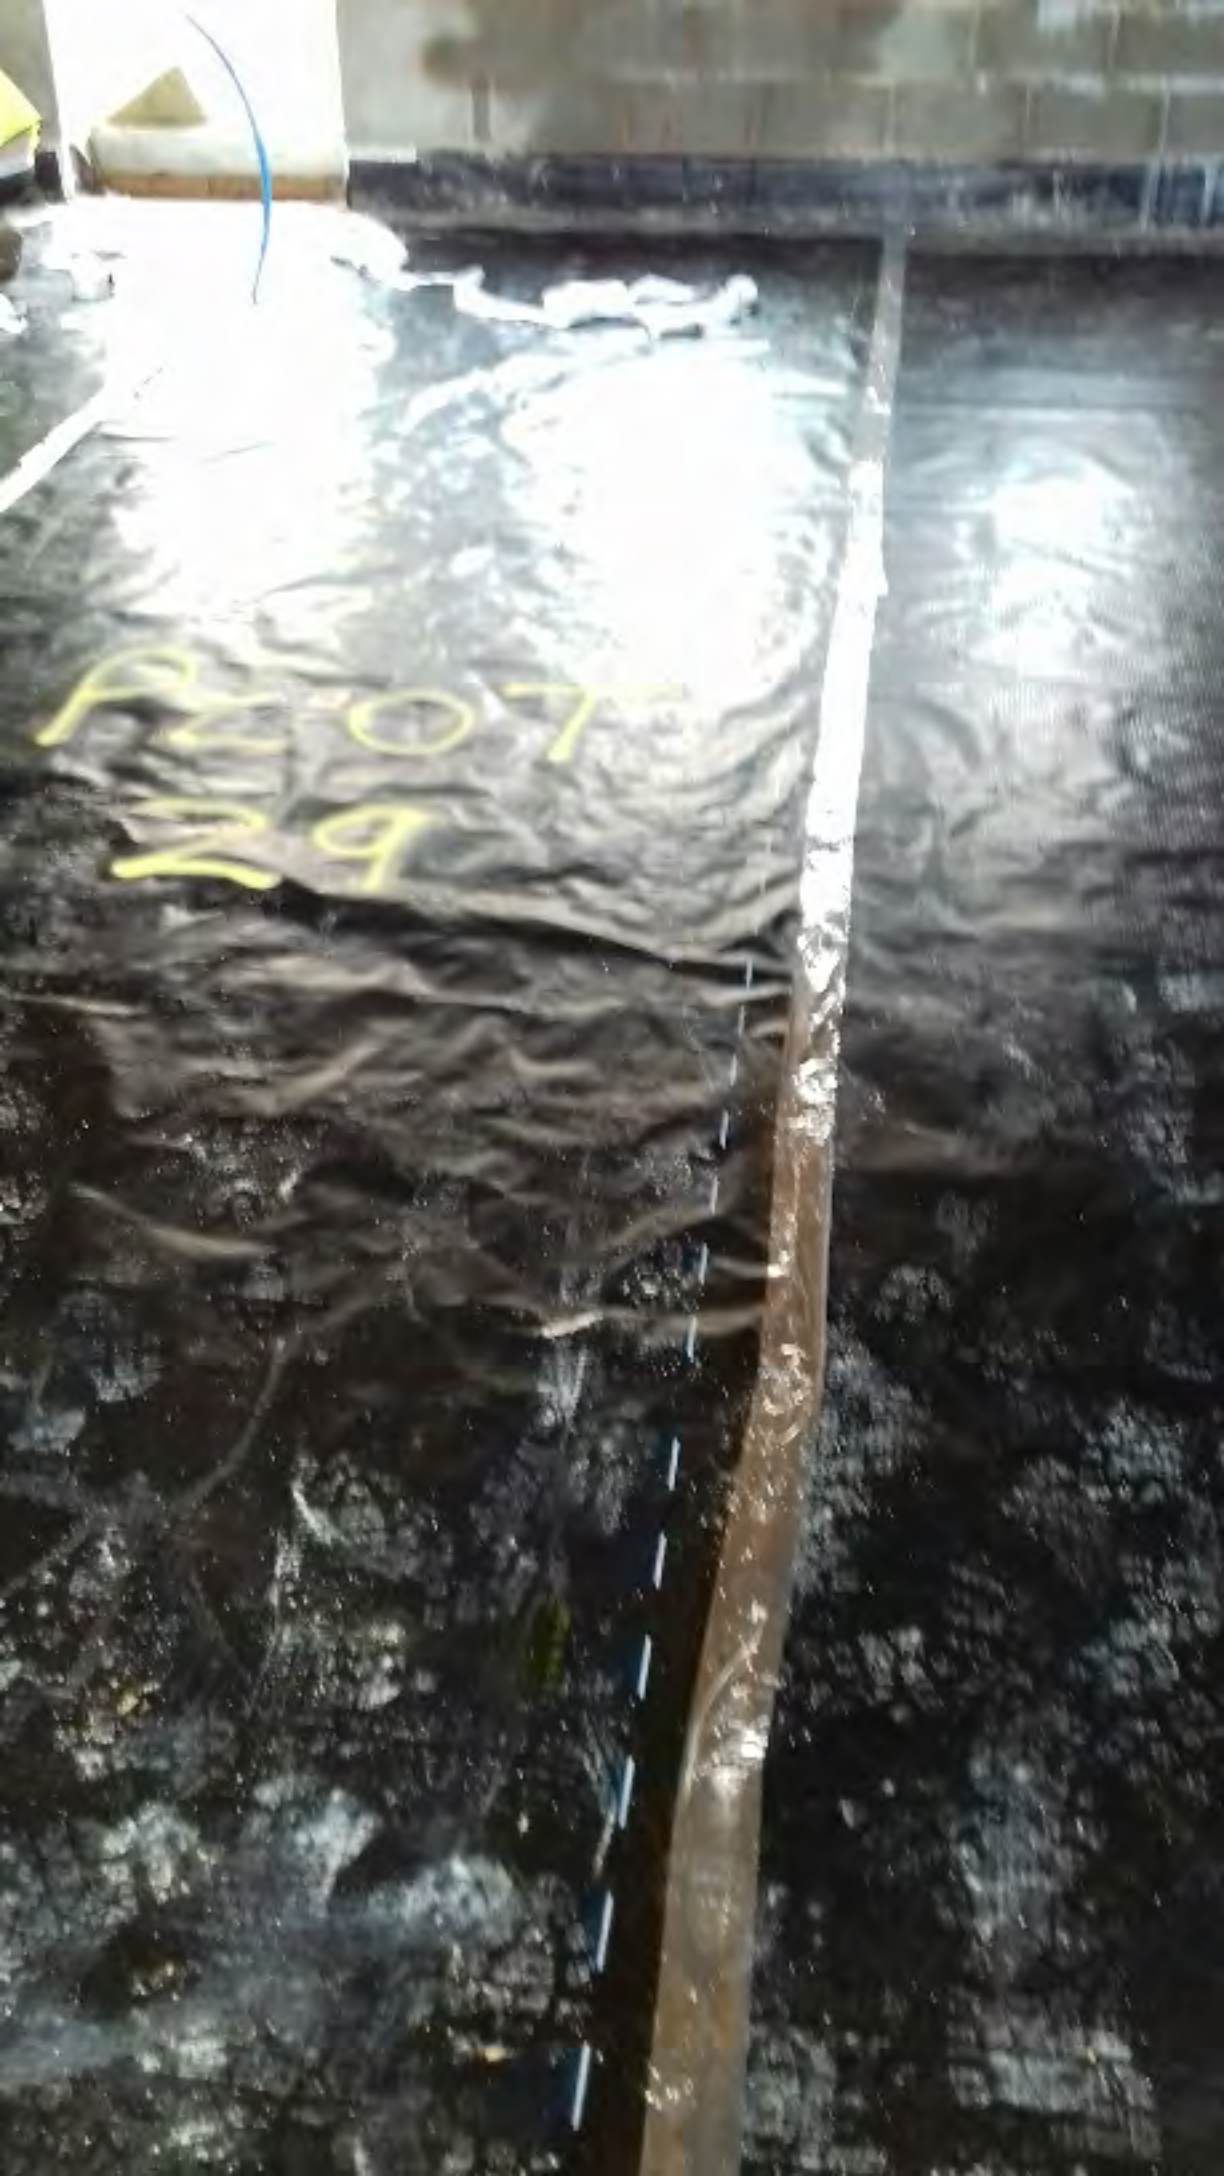
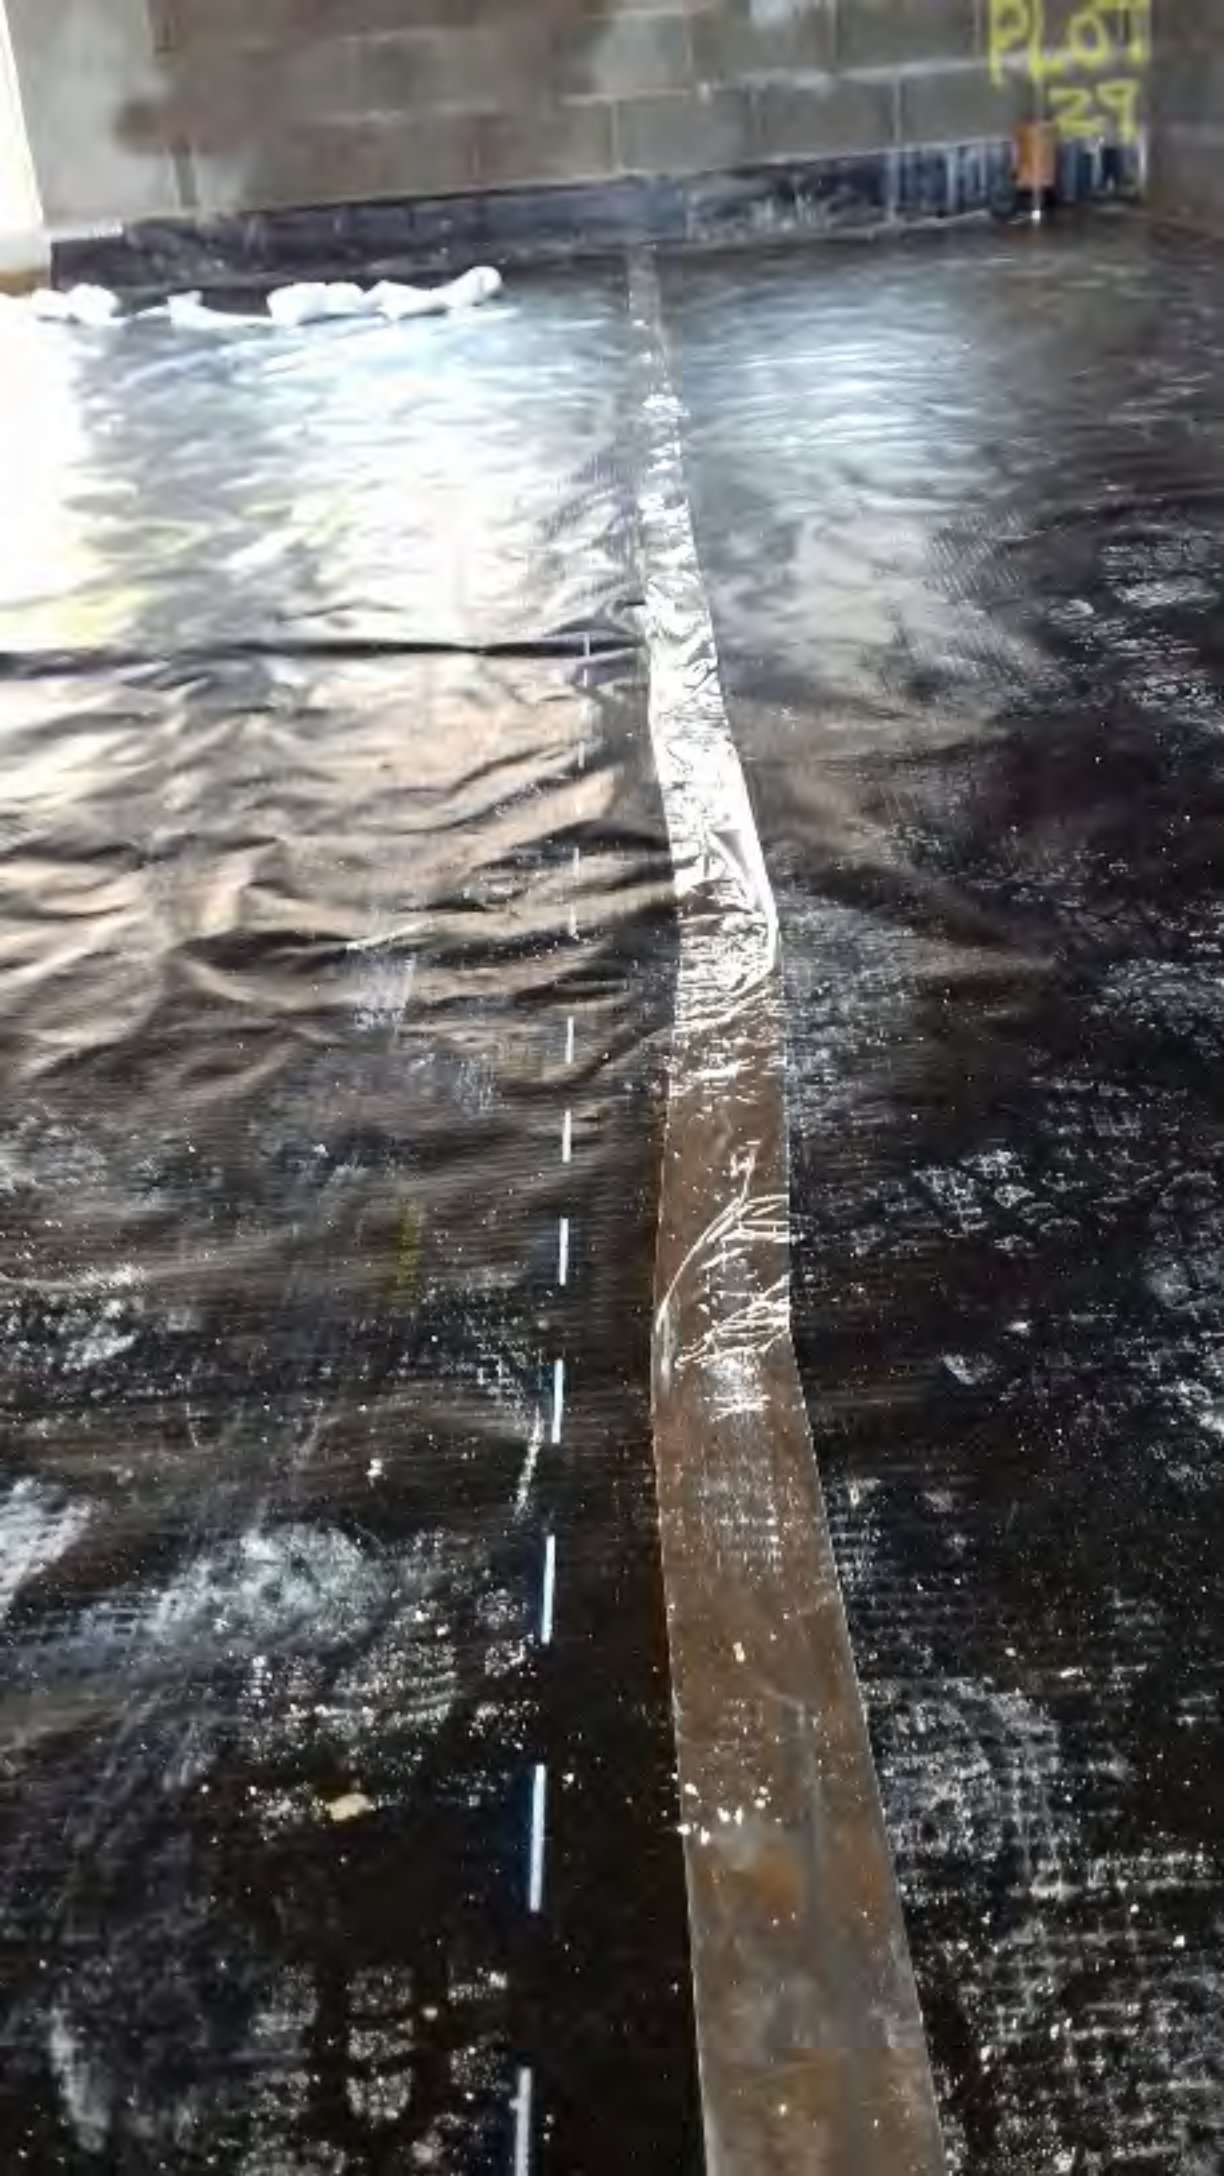
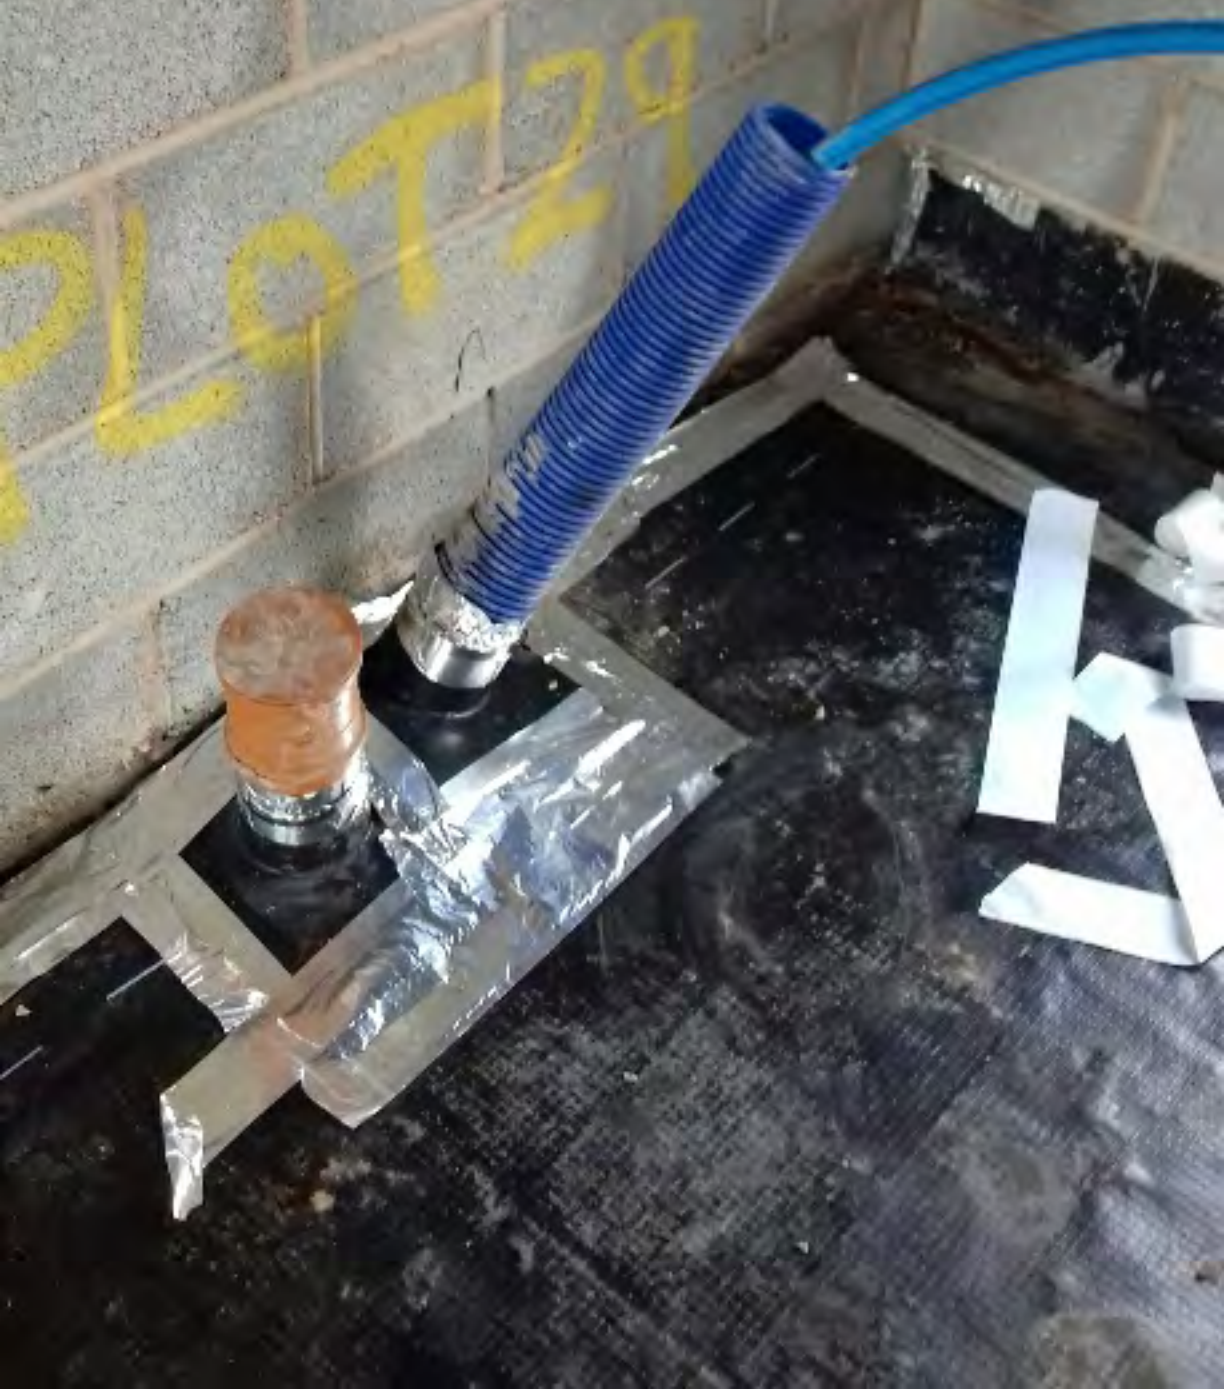
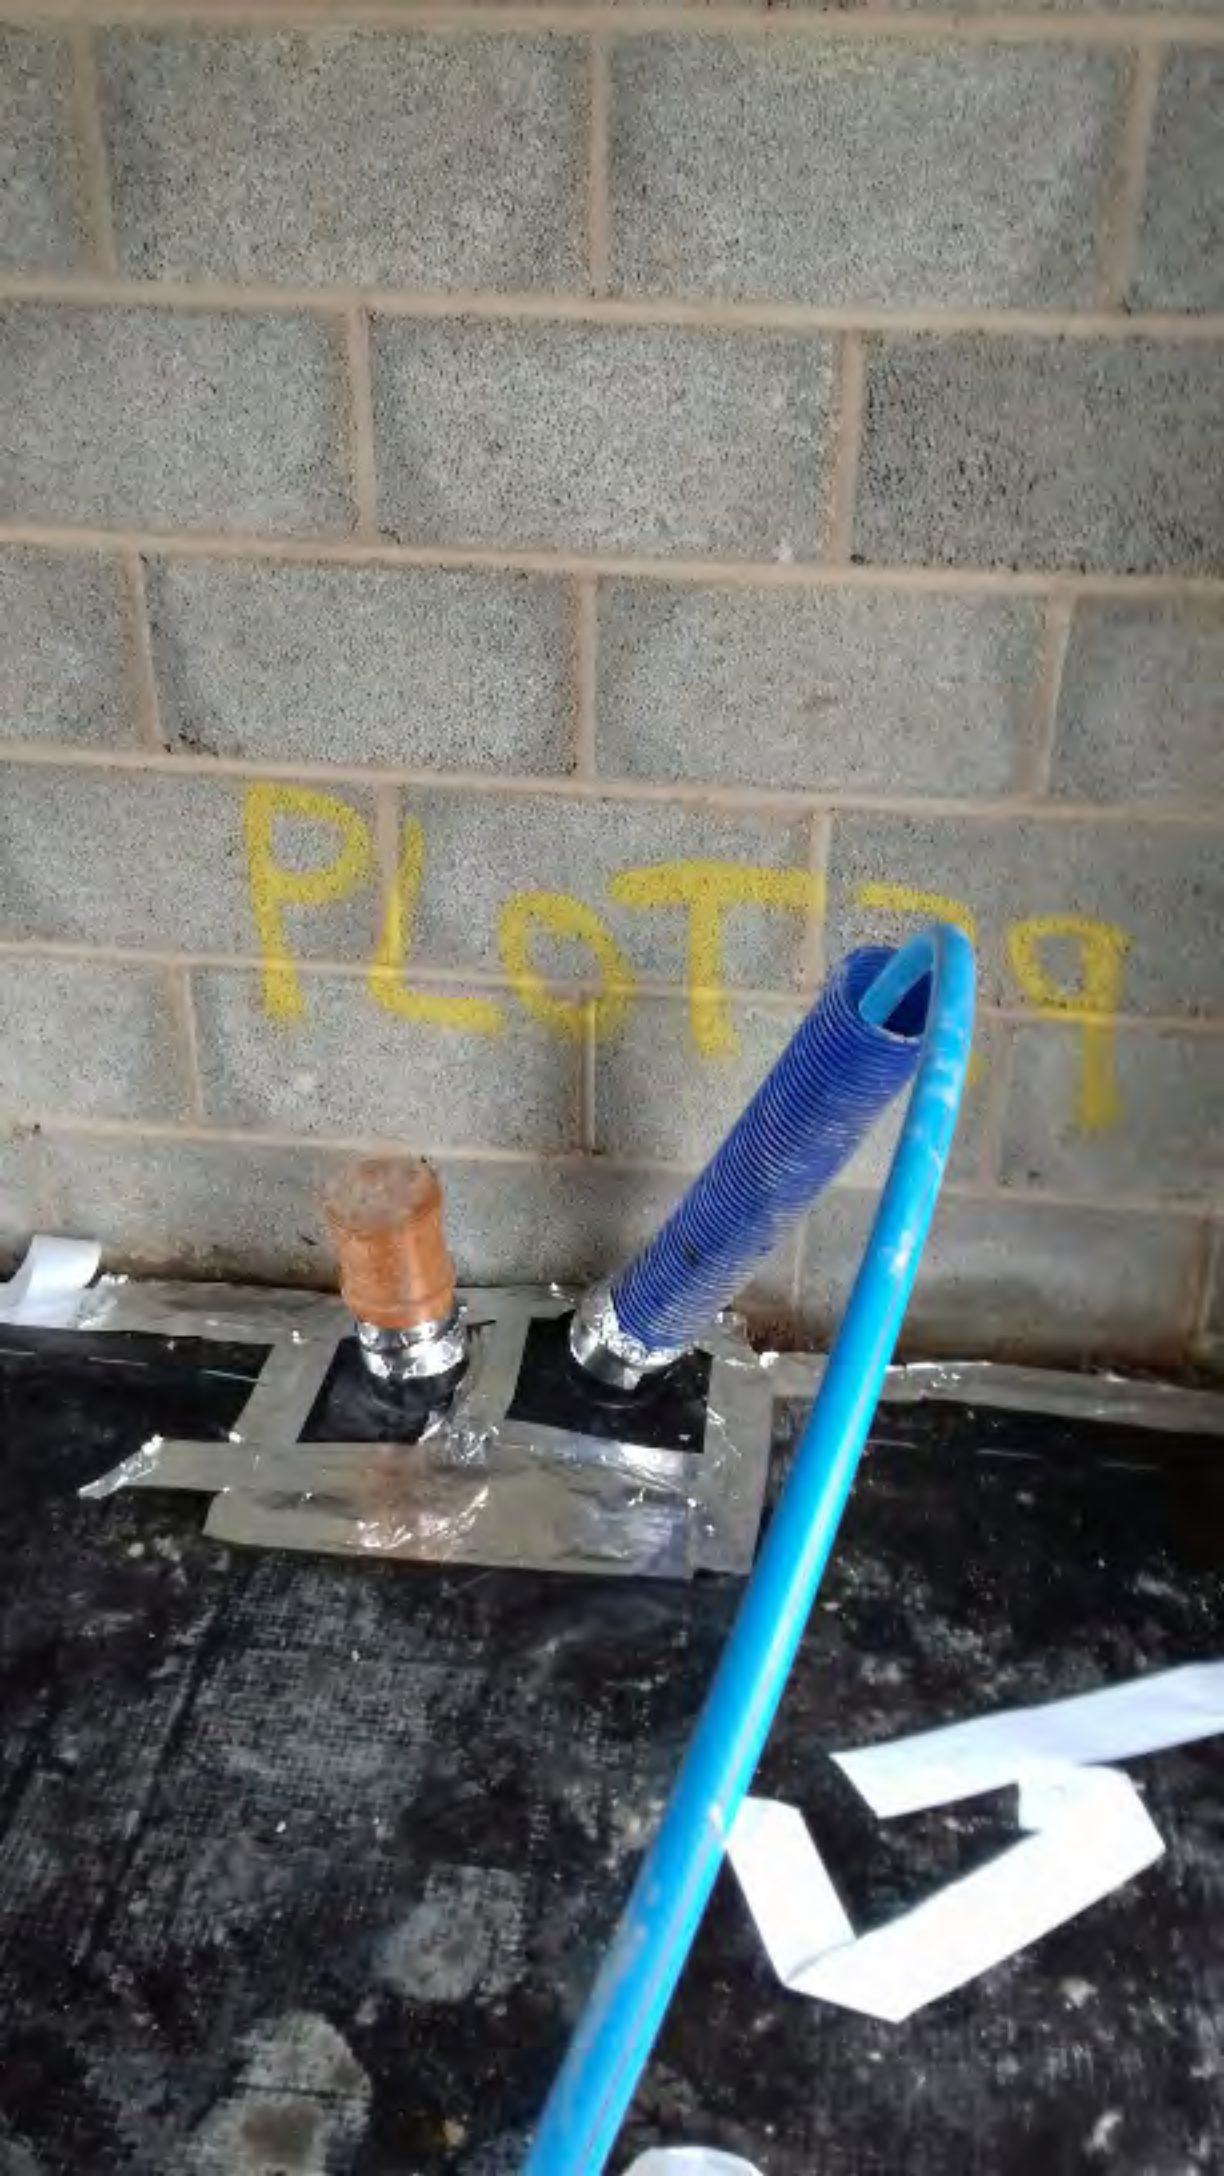
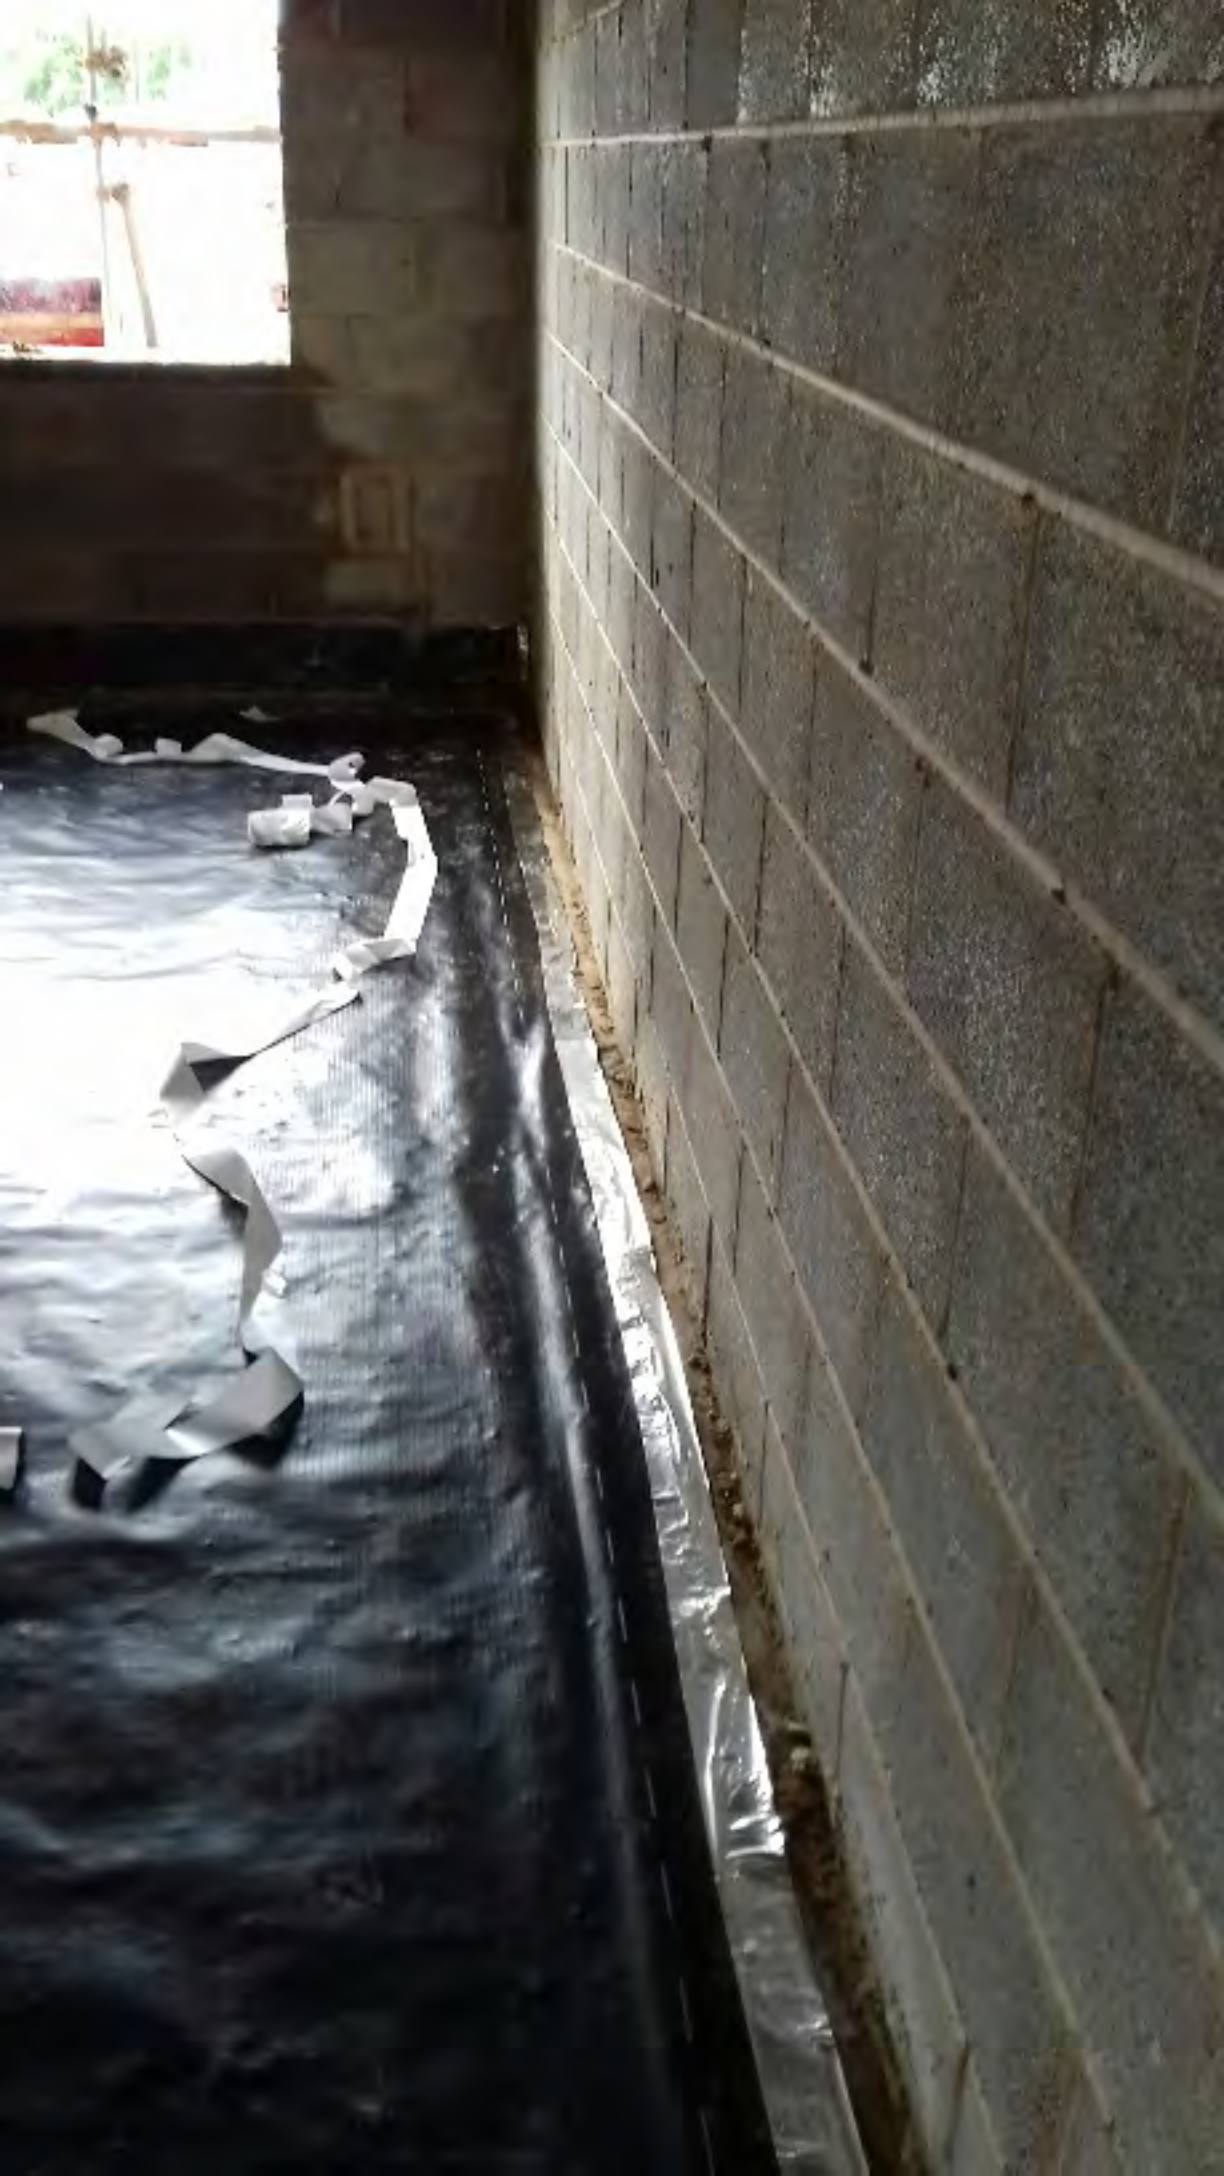
PLOT 29

| 2.2 | Condition of sub-grade & underside of gas membrane | FLOOR BRUSHED, ALL TAPES APPLIED WELL AND SEALED TO A GOOD QUALITY | | | | | |
| 2.4 | Gas membrane condition and coverage | GOOD, SEALED ON ALL FOUR SIDES | | | | | |
| 2.7 | Condition of joints/seals | VISIBLE OVERLAPS, ALL GOOD | | | | | |
| 2.8 | Number and condition of service entry seals | ALL OK, 3 N° TOPHATS WITH JUBILEE CLIPS - ALL TAPES CHECKED | | | | | |
