## Gas Protection - Validation Record Sheet

**This Record sheet is only applicable to block and beam floor slabs for Characteristic Situation 2 gas protection systems**

Plot 29, Block 10

**For Residential Development at New Church Street, Radcliffe.**

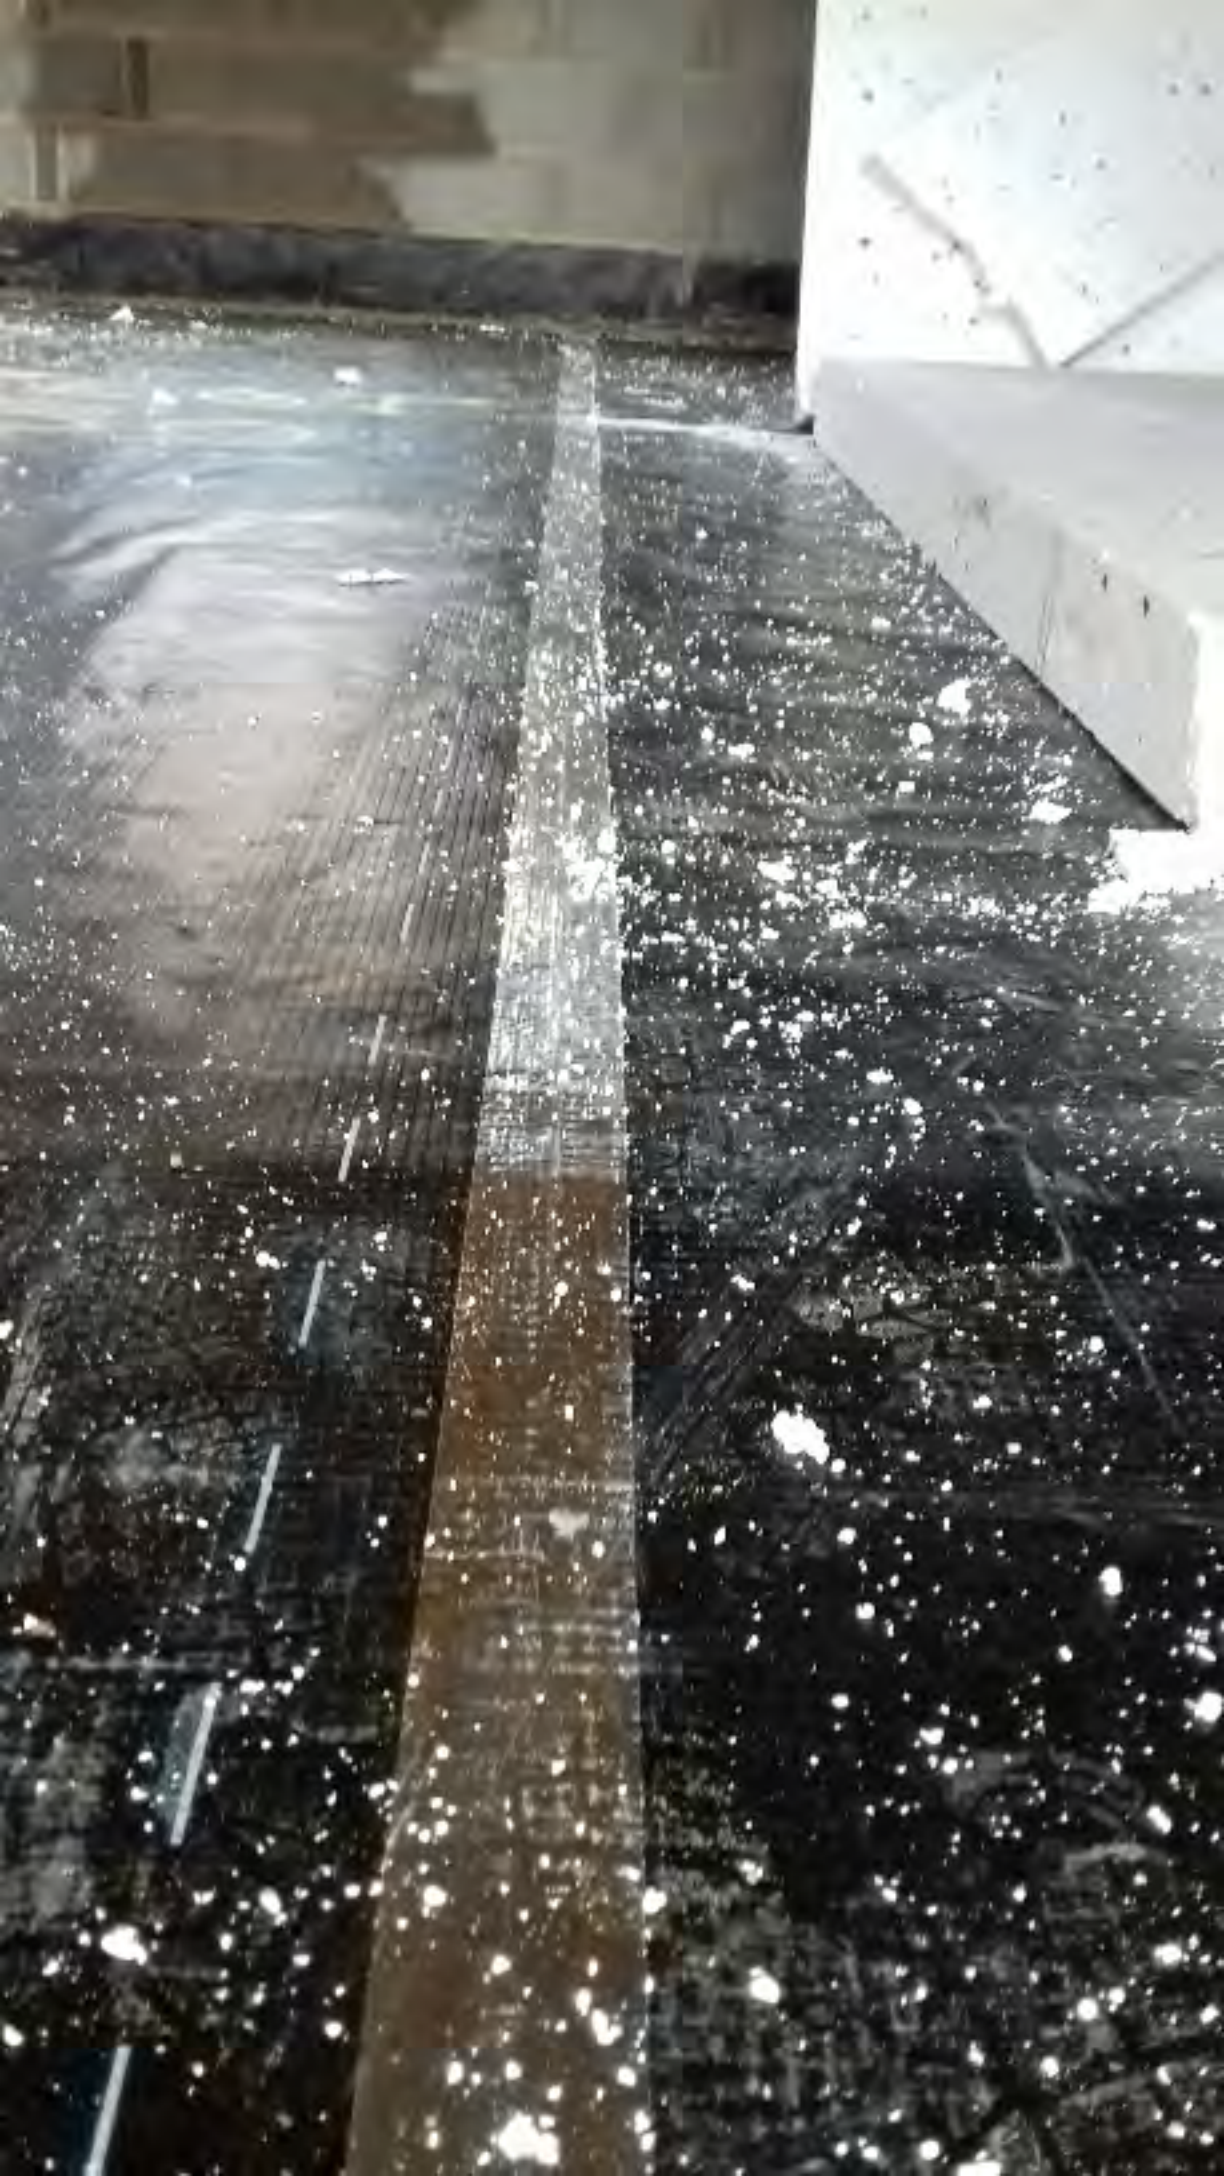
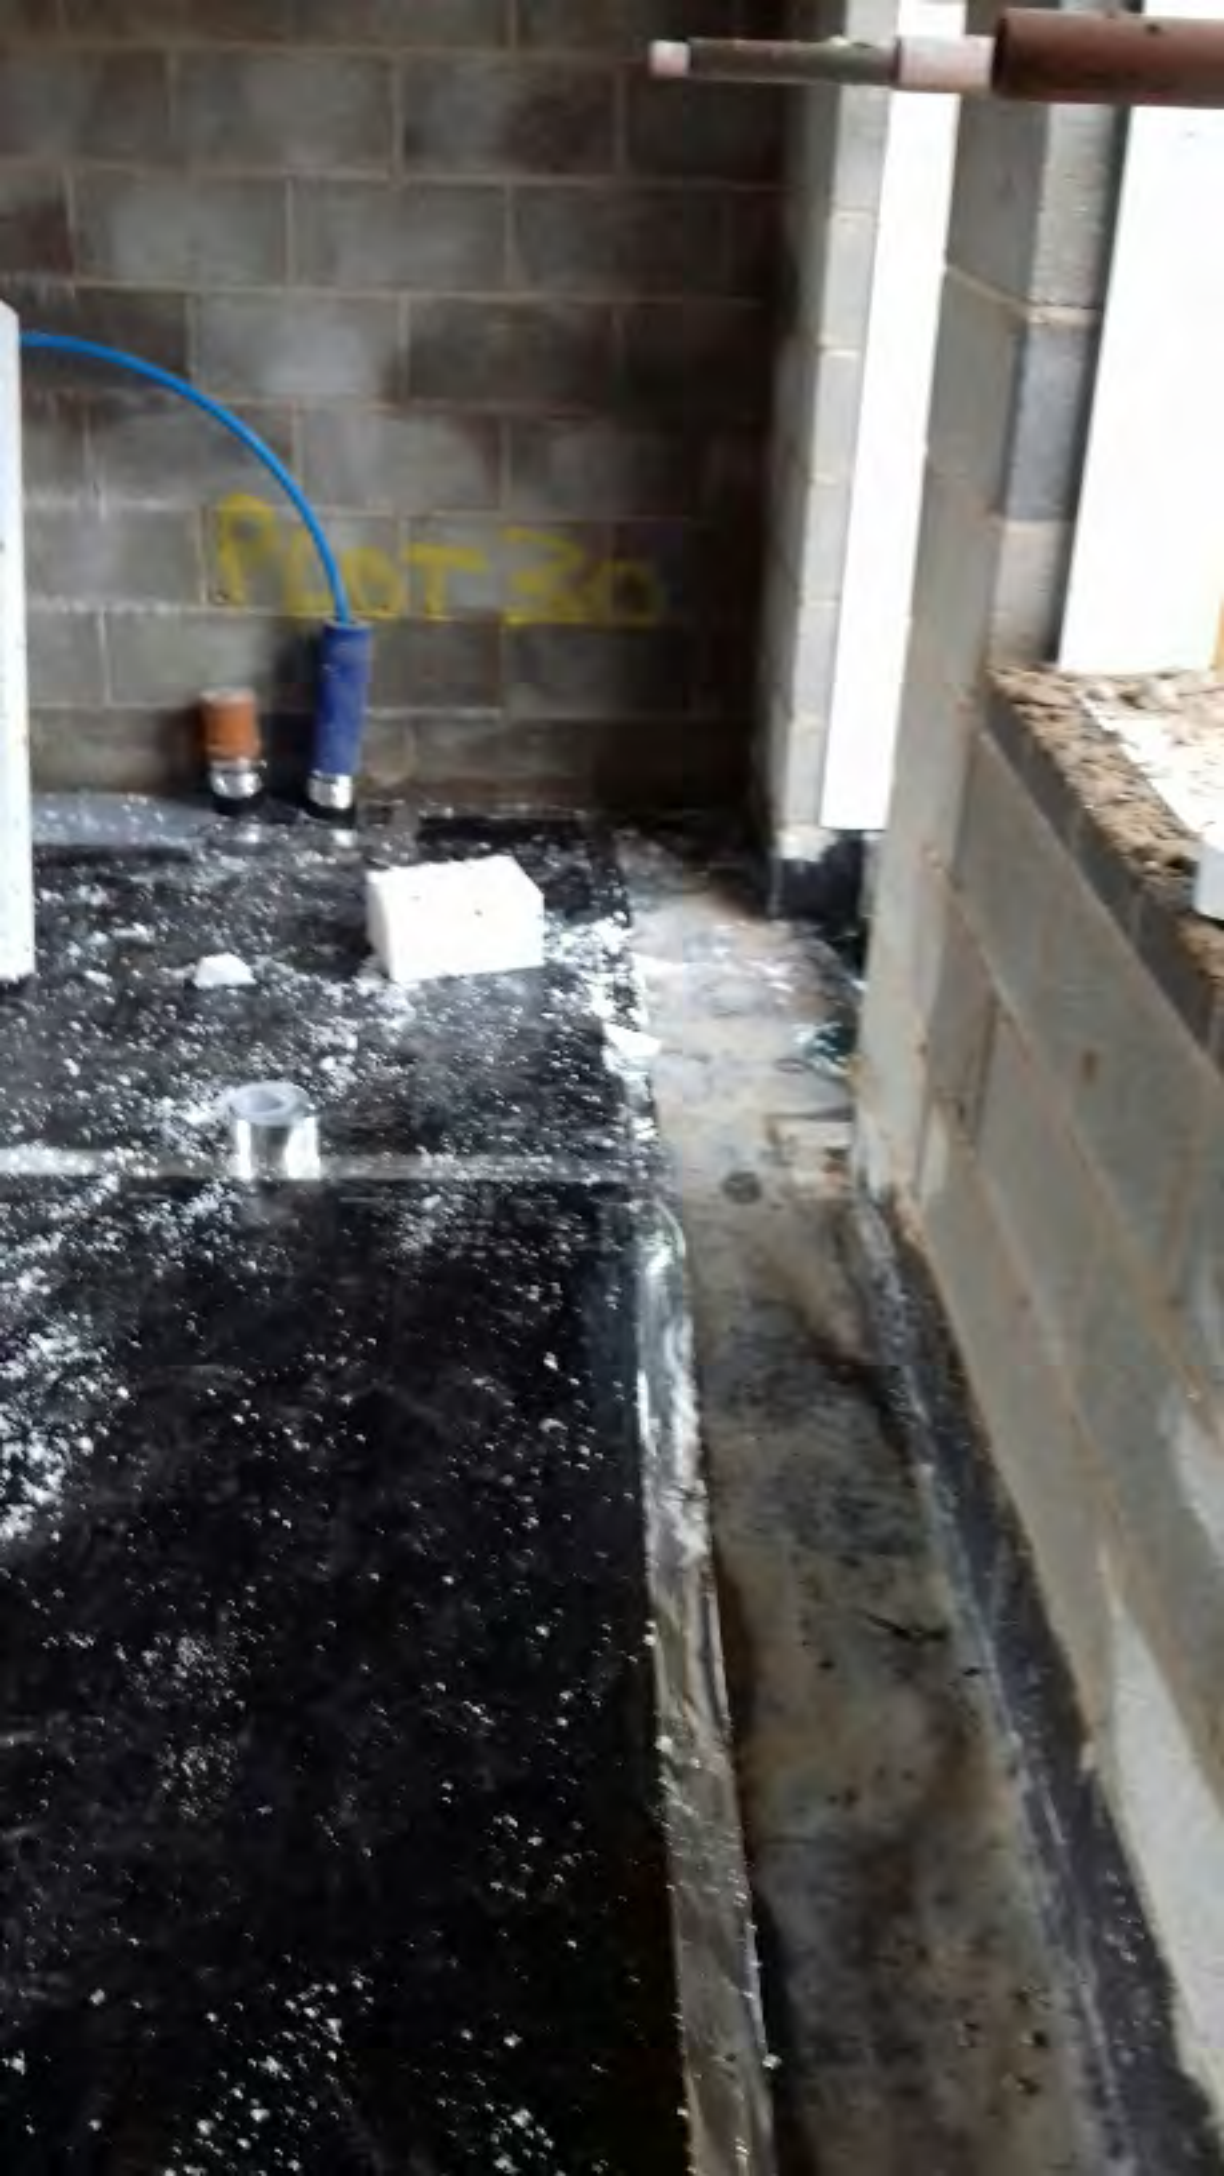
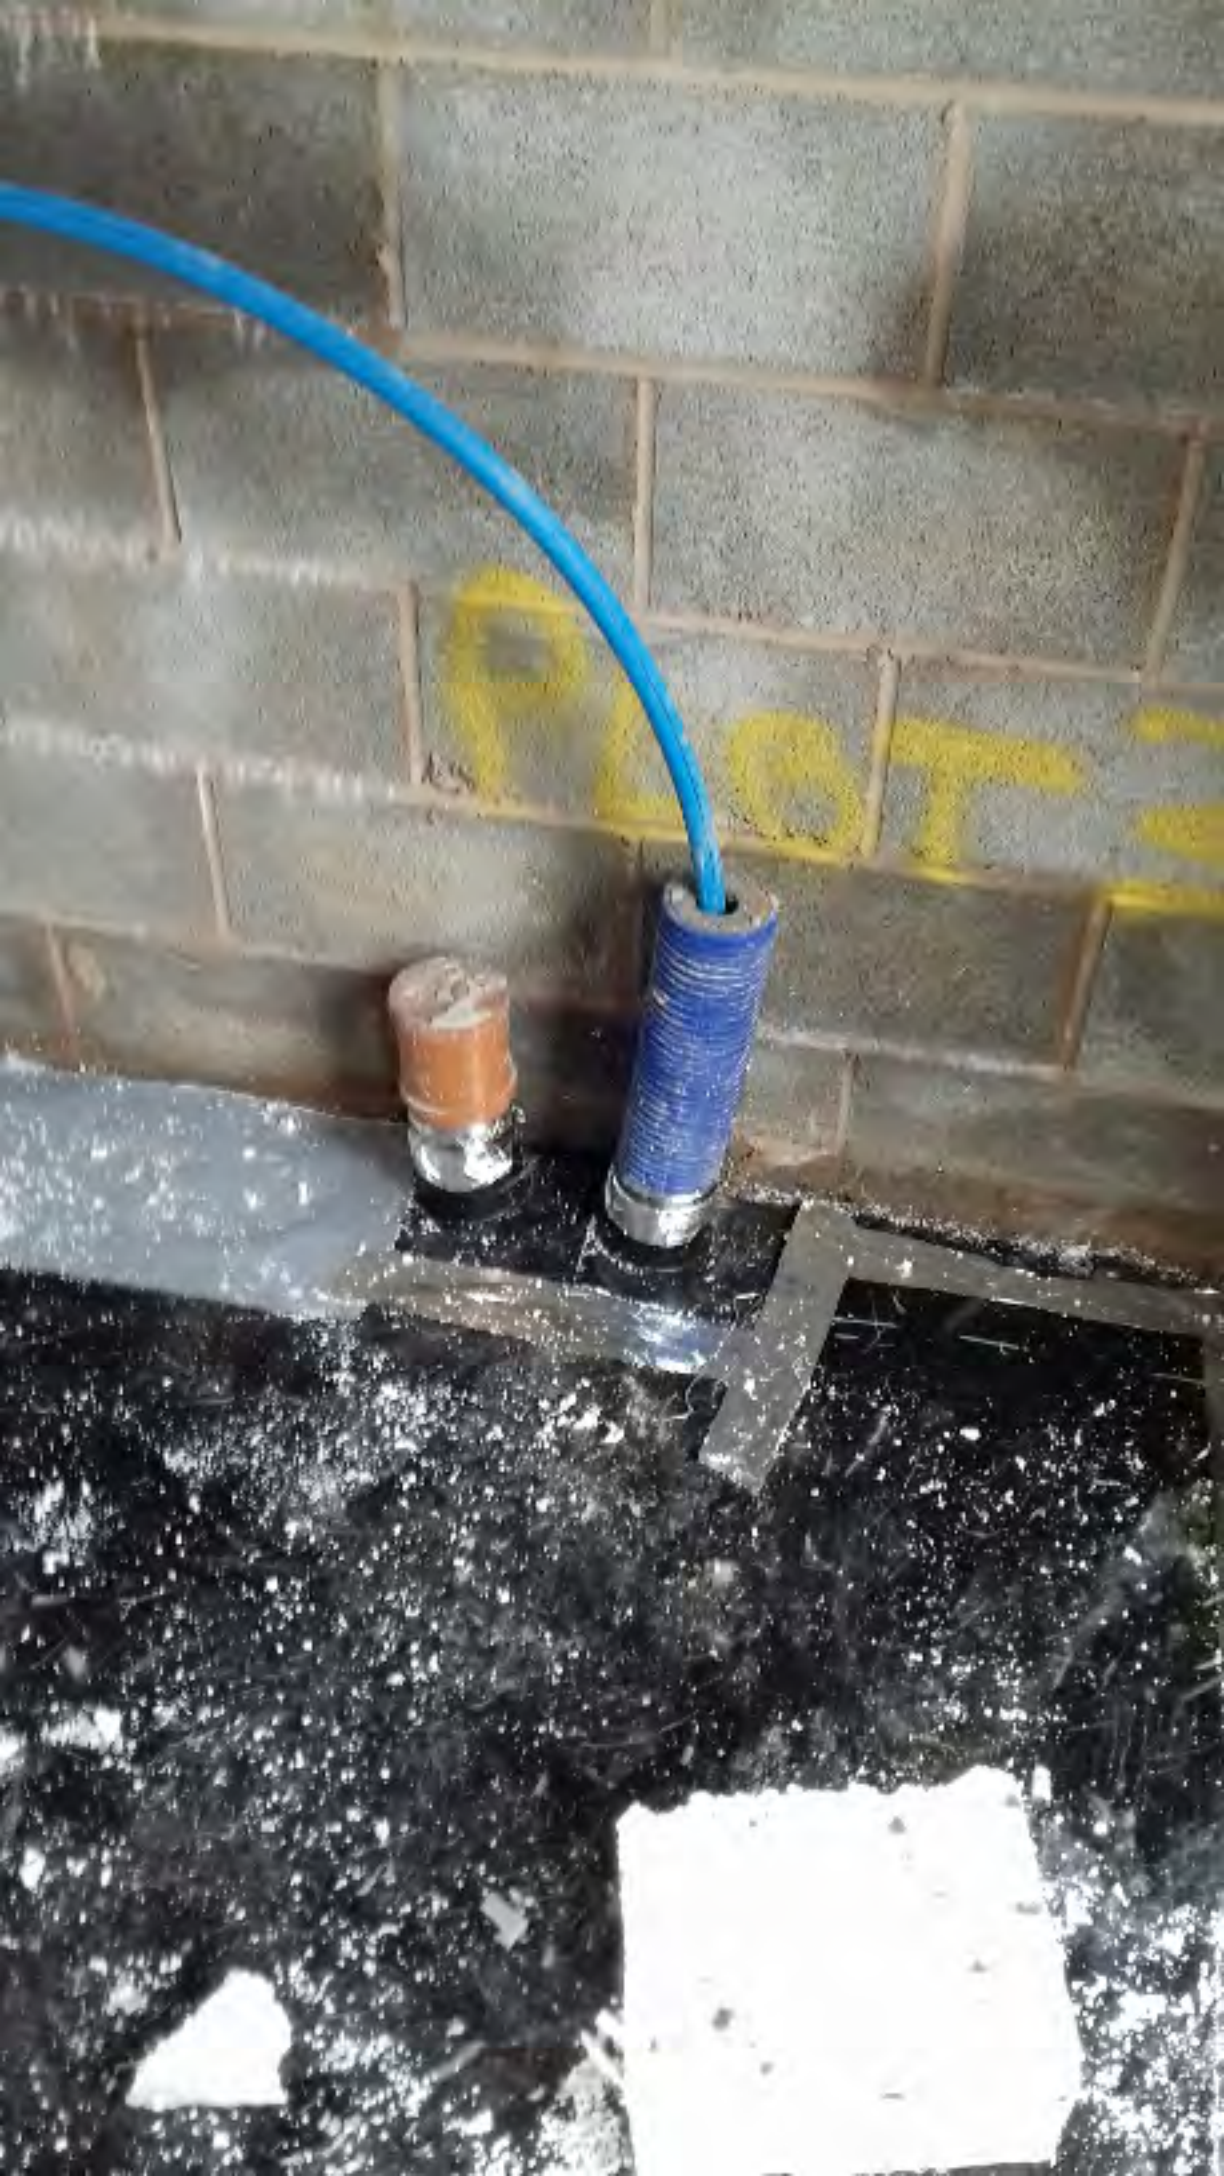
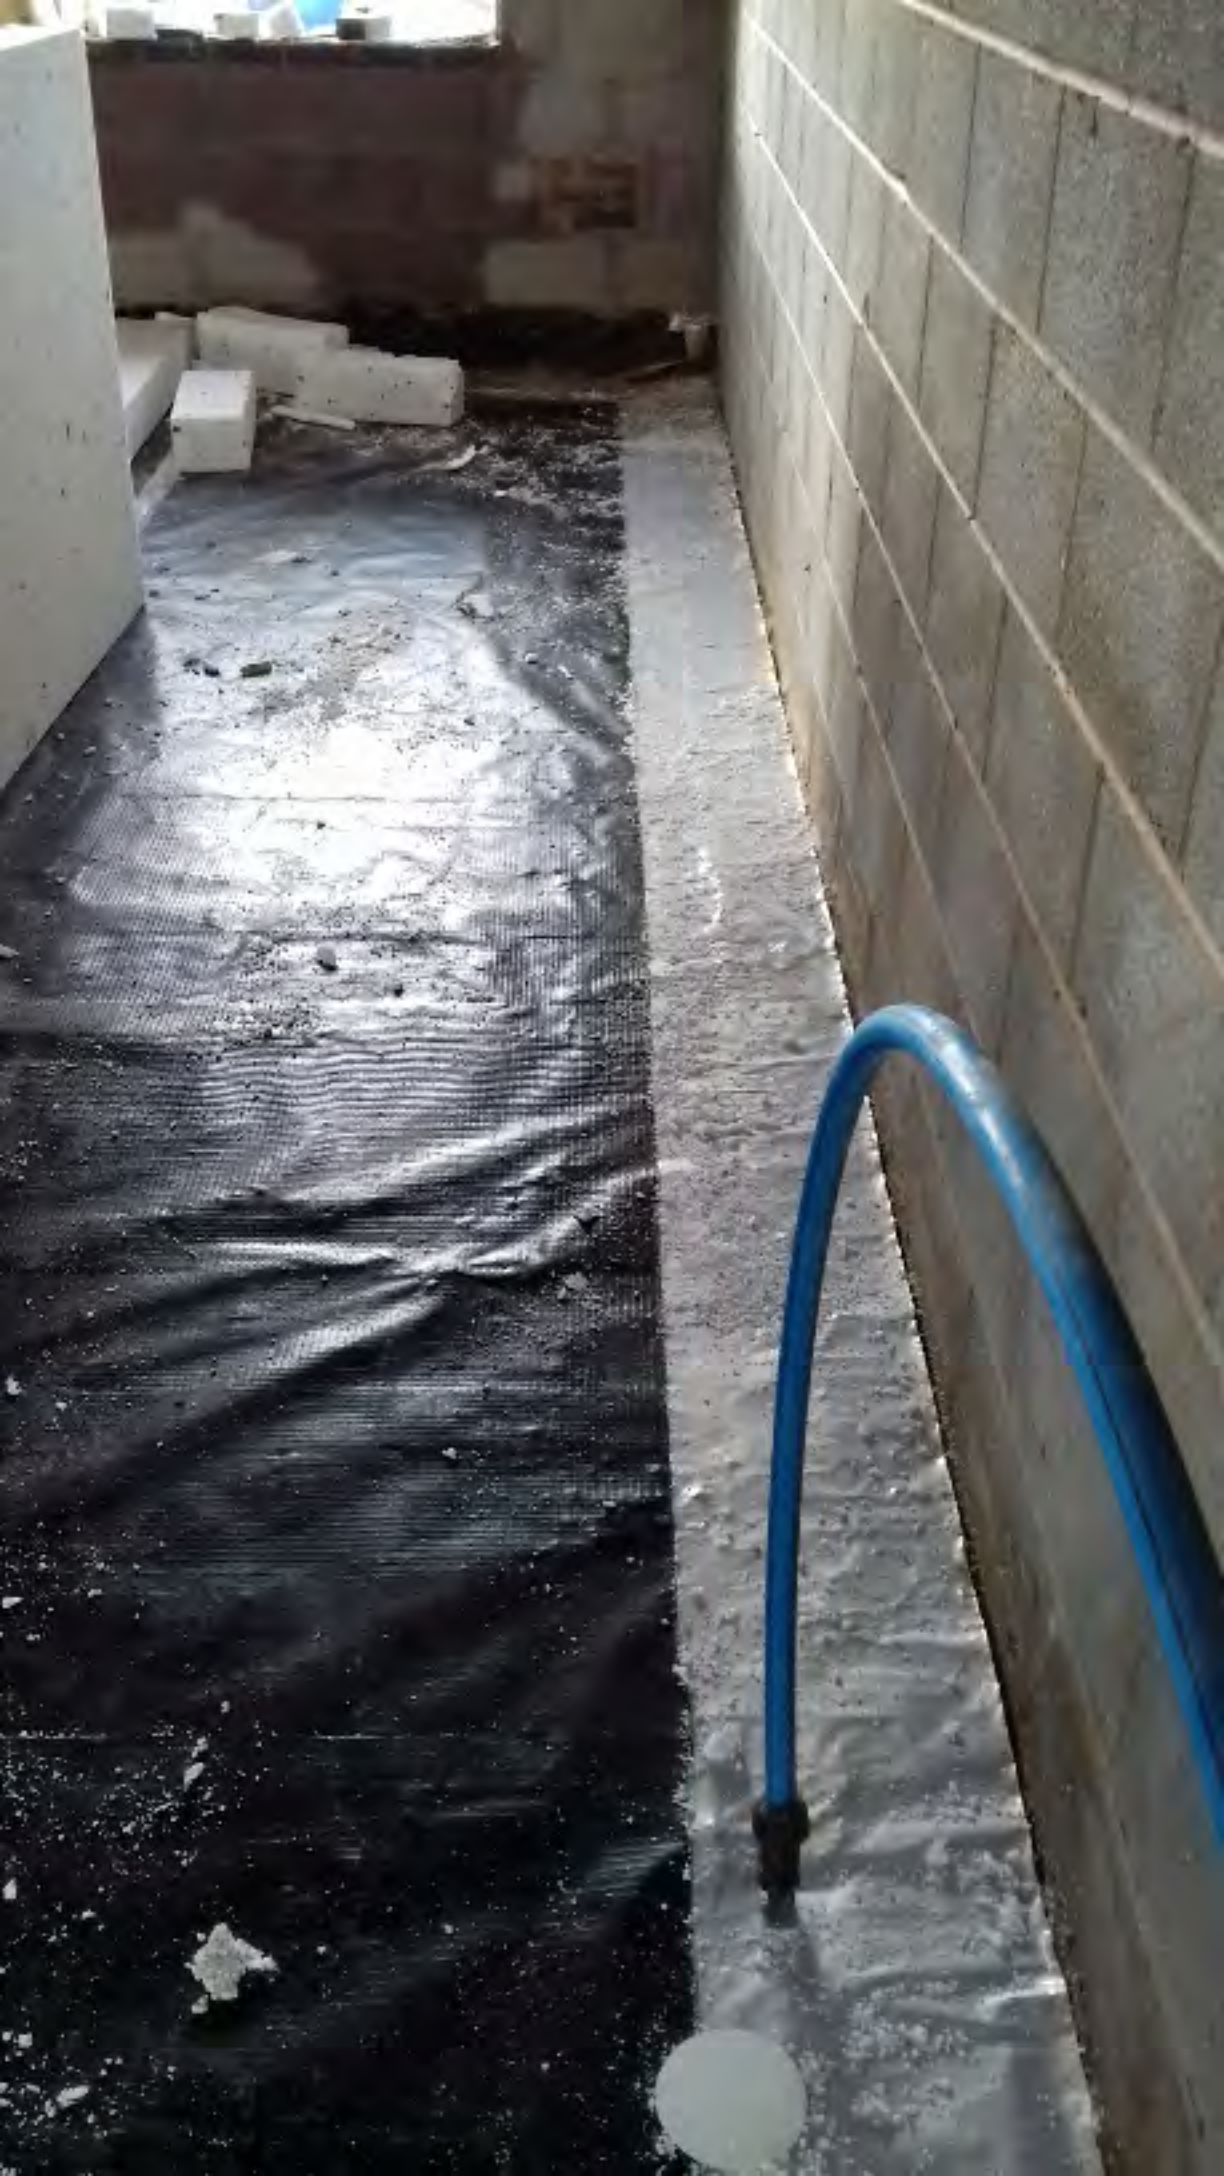
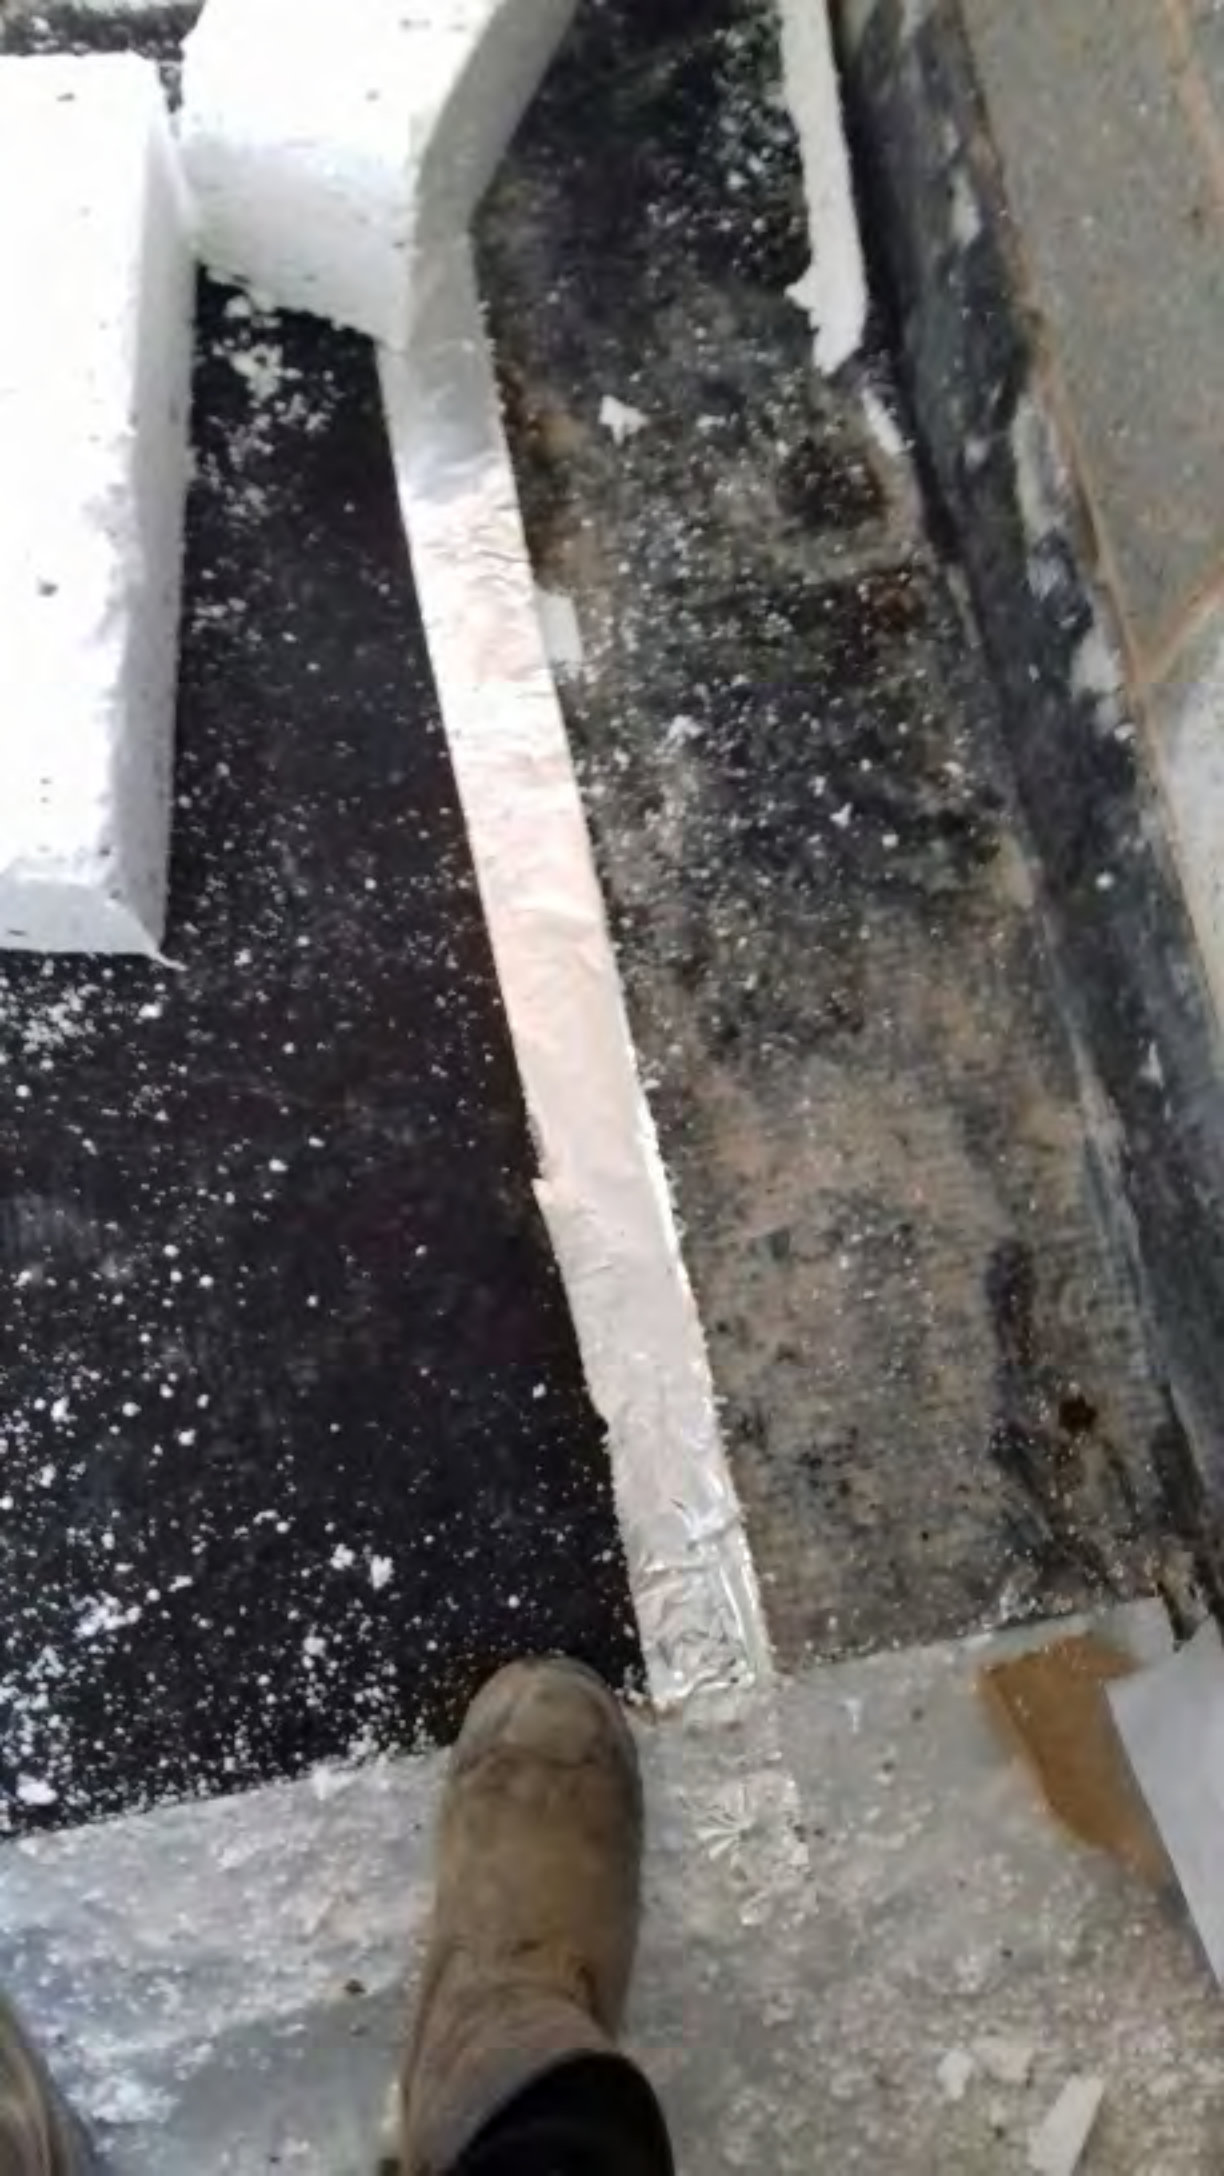
PLOT 30

| 2.2 | Condition of sub-grade & underside of gas membrane | FLOOR BRUSHED, ALL TAPES APPLIED WELL AND SEALED TO A GOOD QUALITY | | | | | |
| 2.4 | Gas membrane condition and coverage | GOOD, SEALED ON ALL FOUR SIDES | | | | | |
| 2.7 | Condition of joints/seals | ALL GOOD, VISIBLE OVERLAPS | | | | | |
| 2.8 | Number and condition of service entry seals | 3 NO TOPHATS WITH SUBILEE CLIPS - ALL TAPES CHECKED AND OK | | | | | |
