## Gas Protection - Validation Record Sheet

**This Record sheet is only applicable to block and beam floor slabs for Characteristic Situation 2 gas protection systems**

Plot 29, Block 10

**For Residential Development at New Church Street, Radcliffe.**

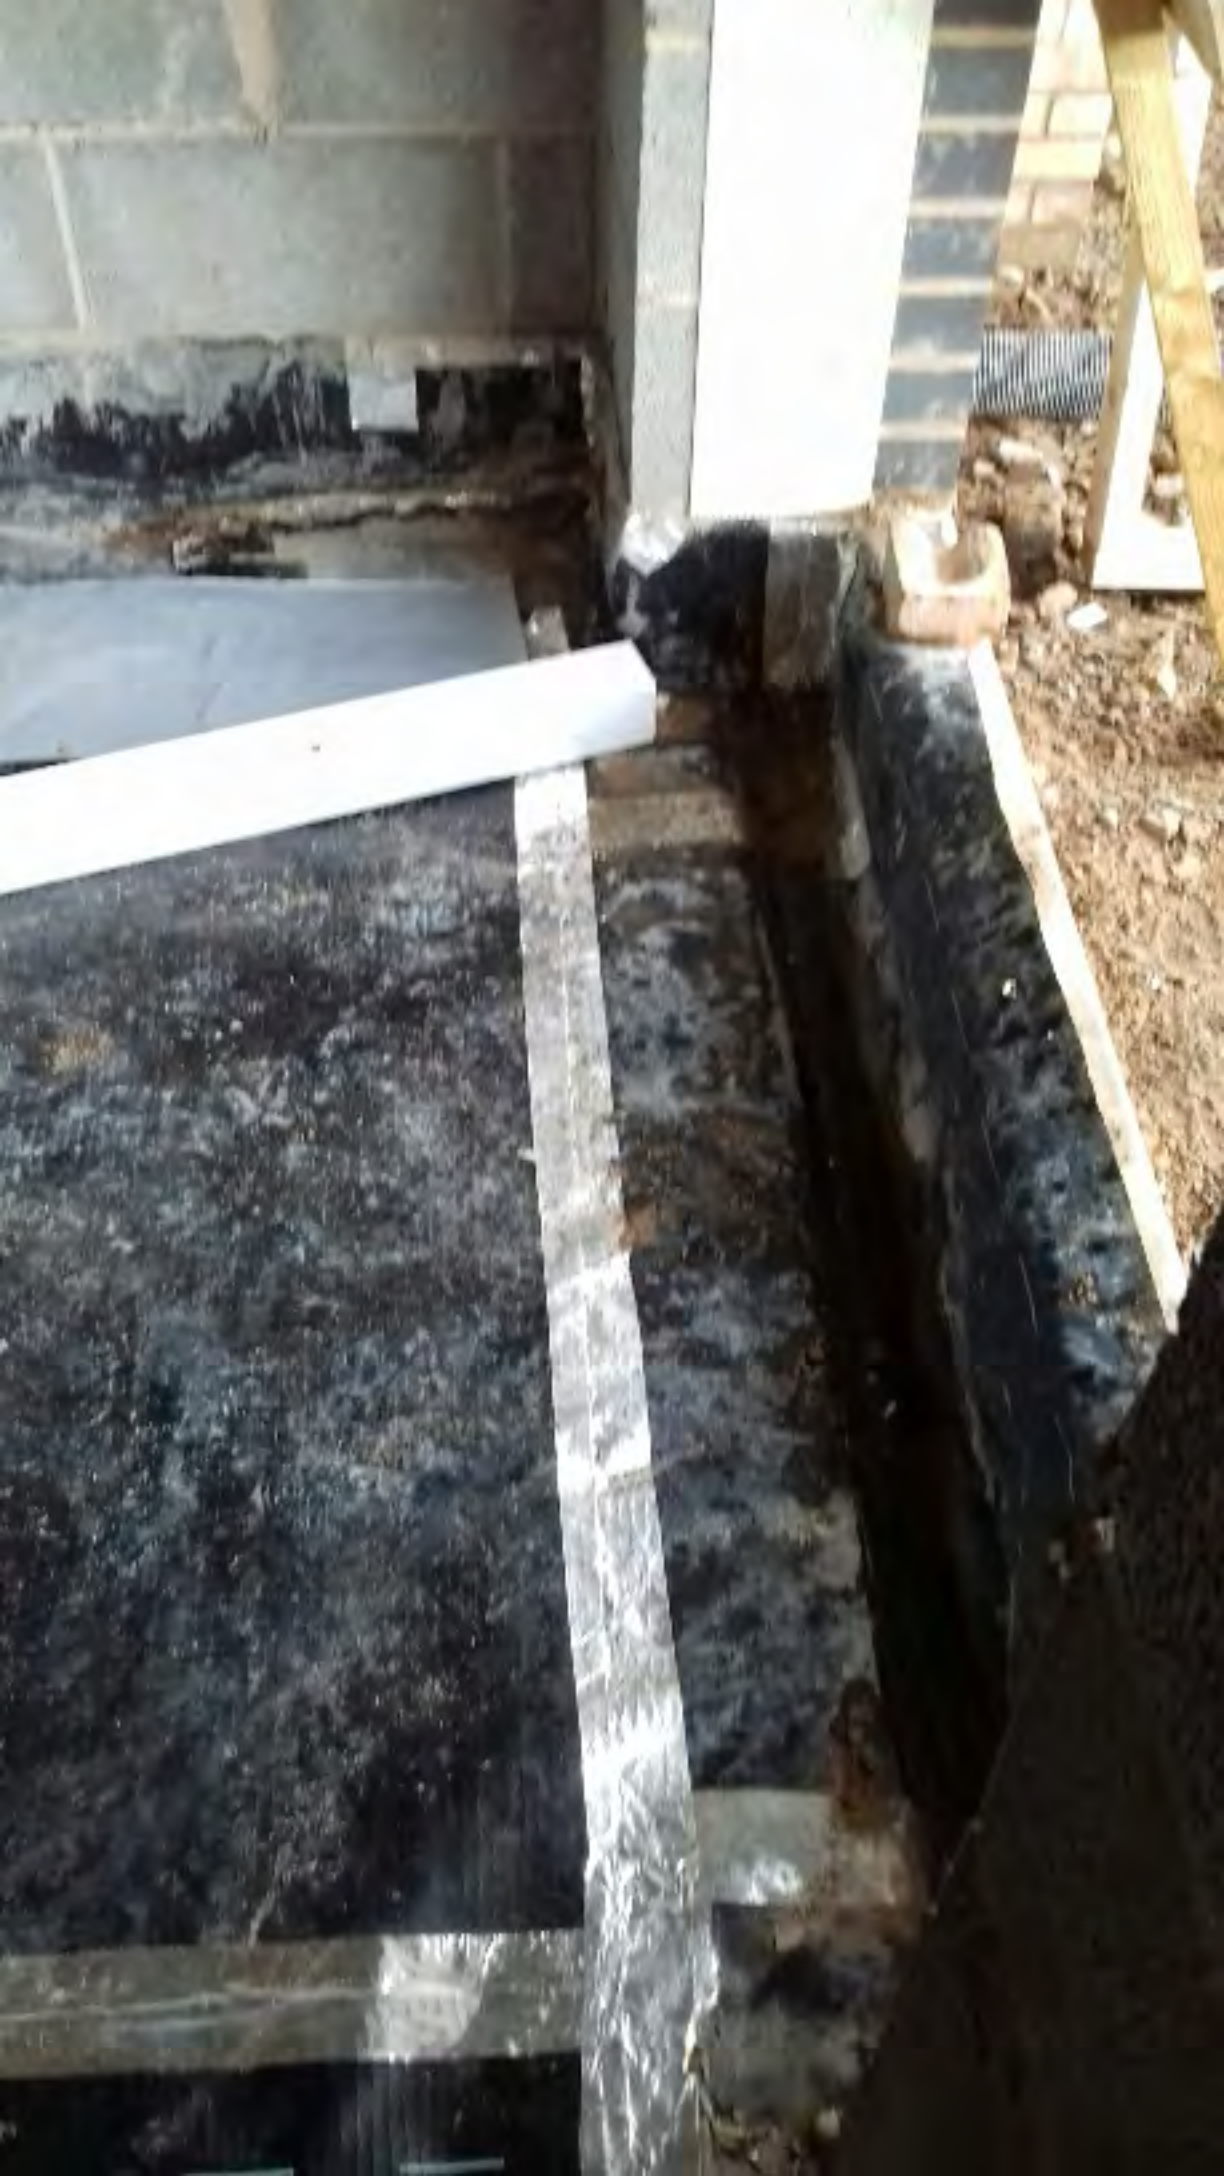
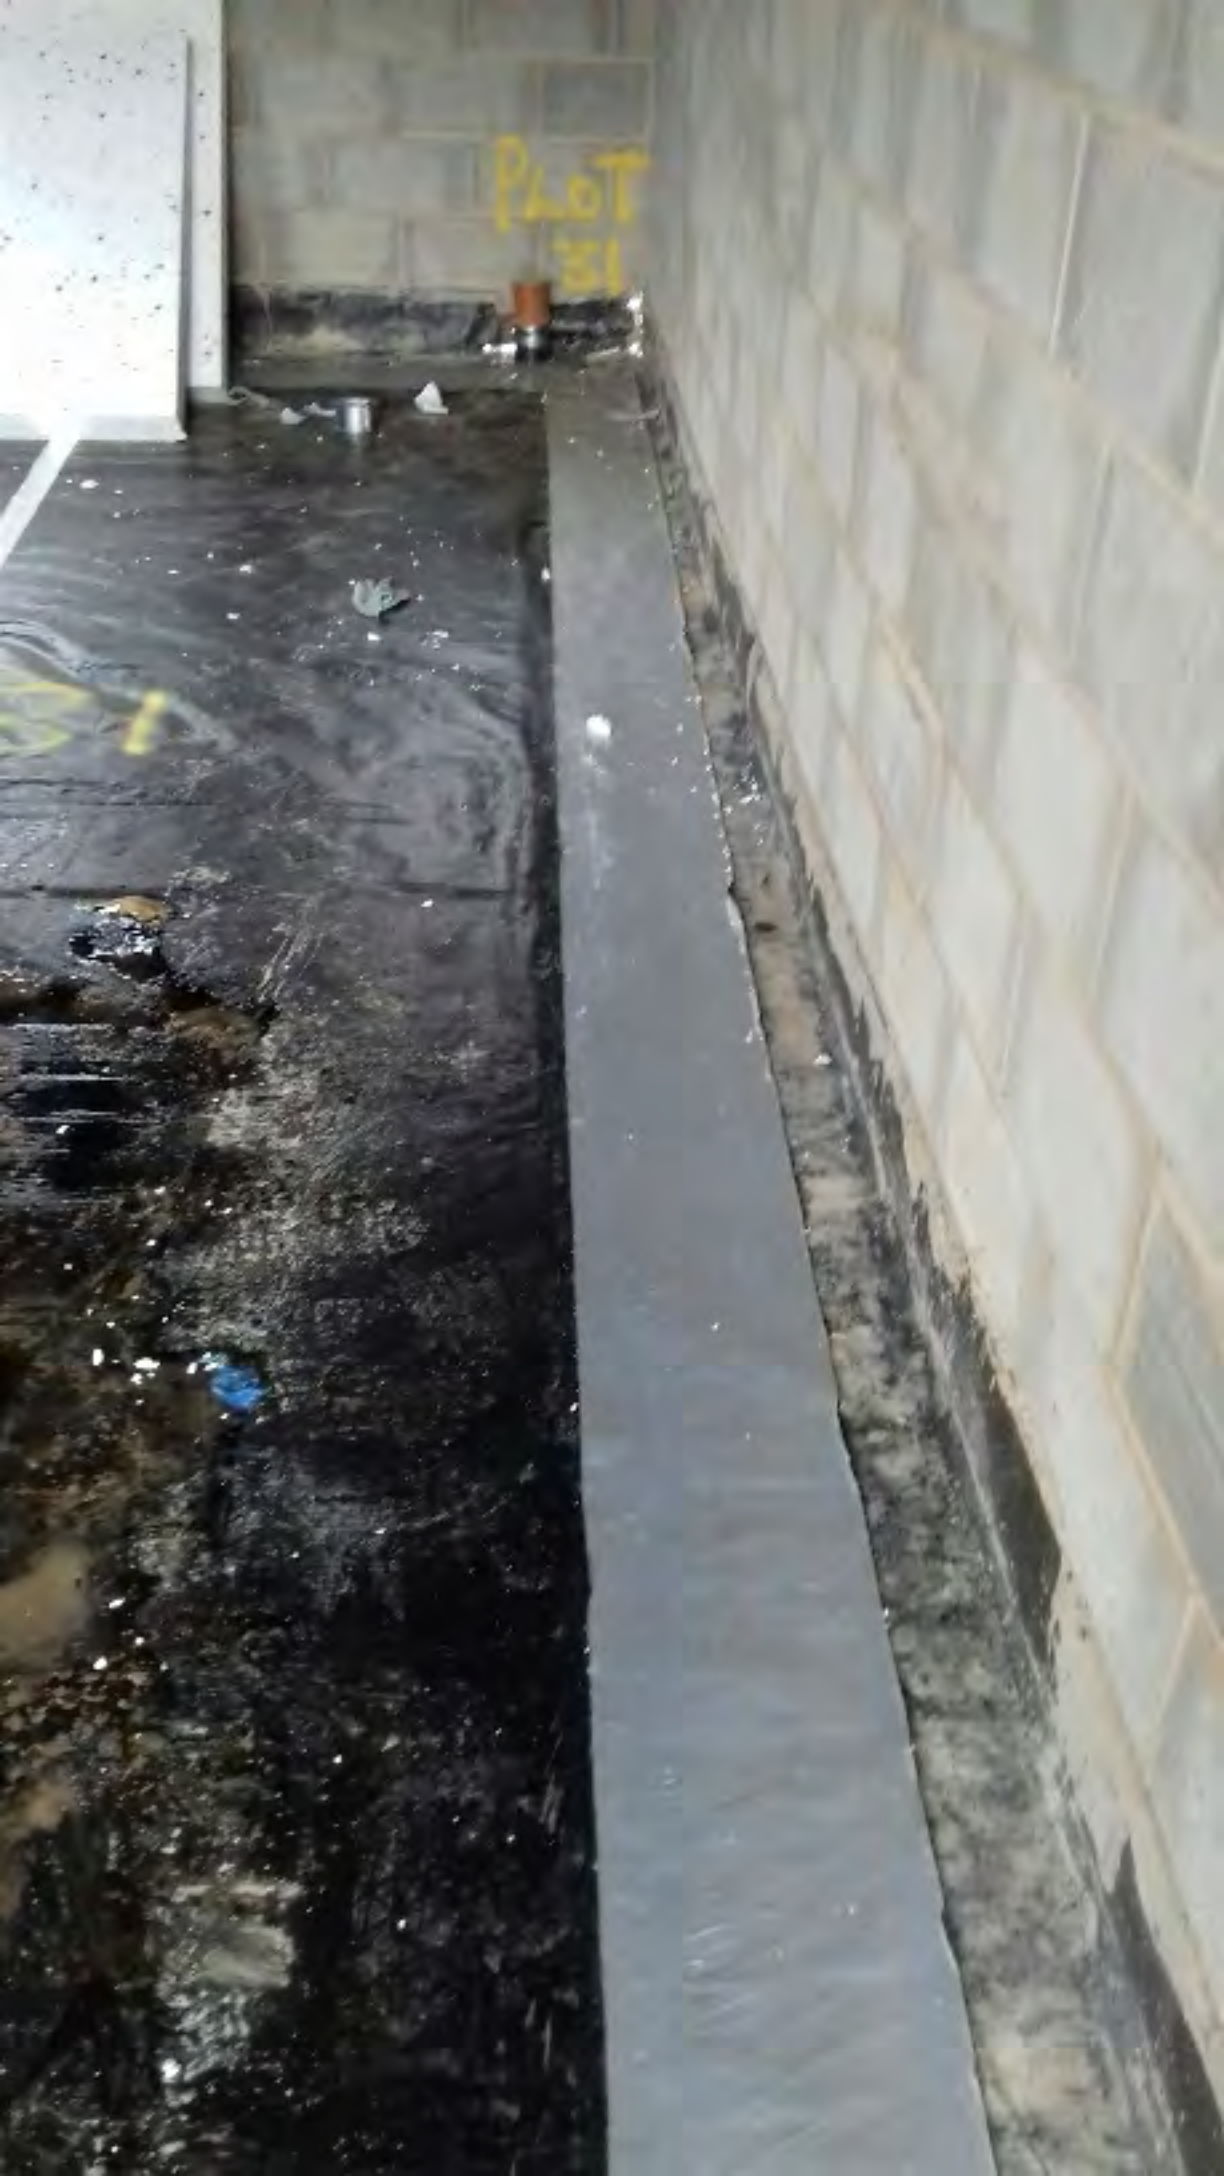
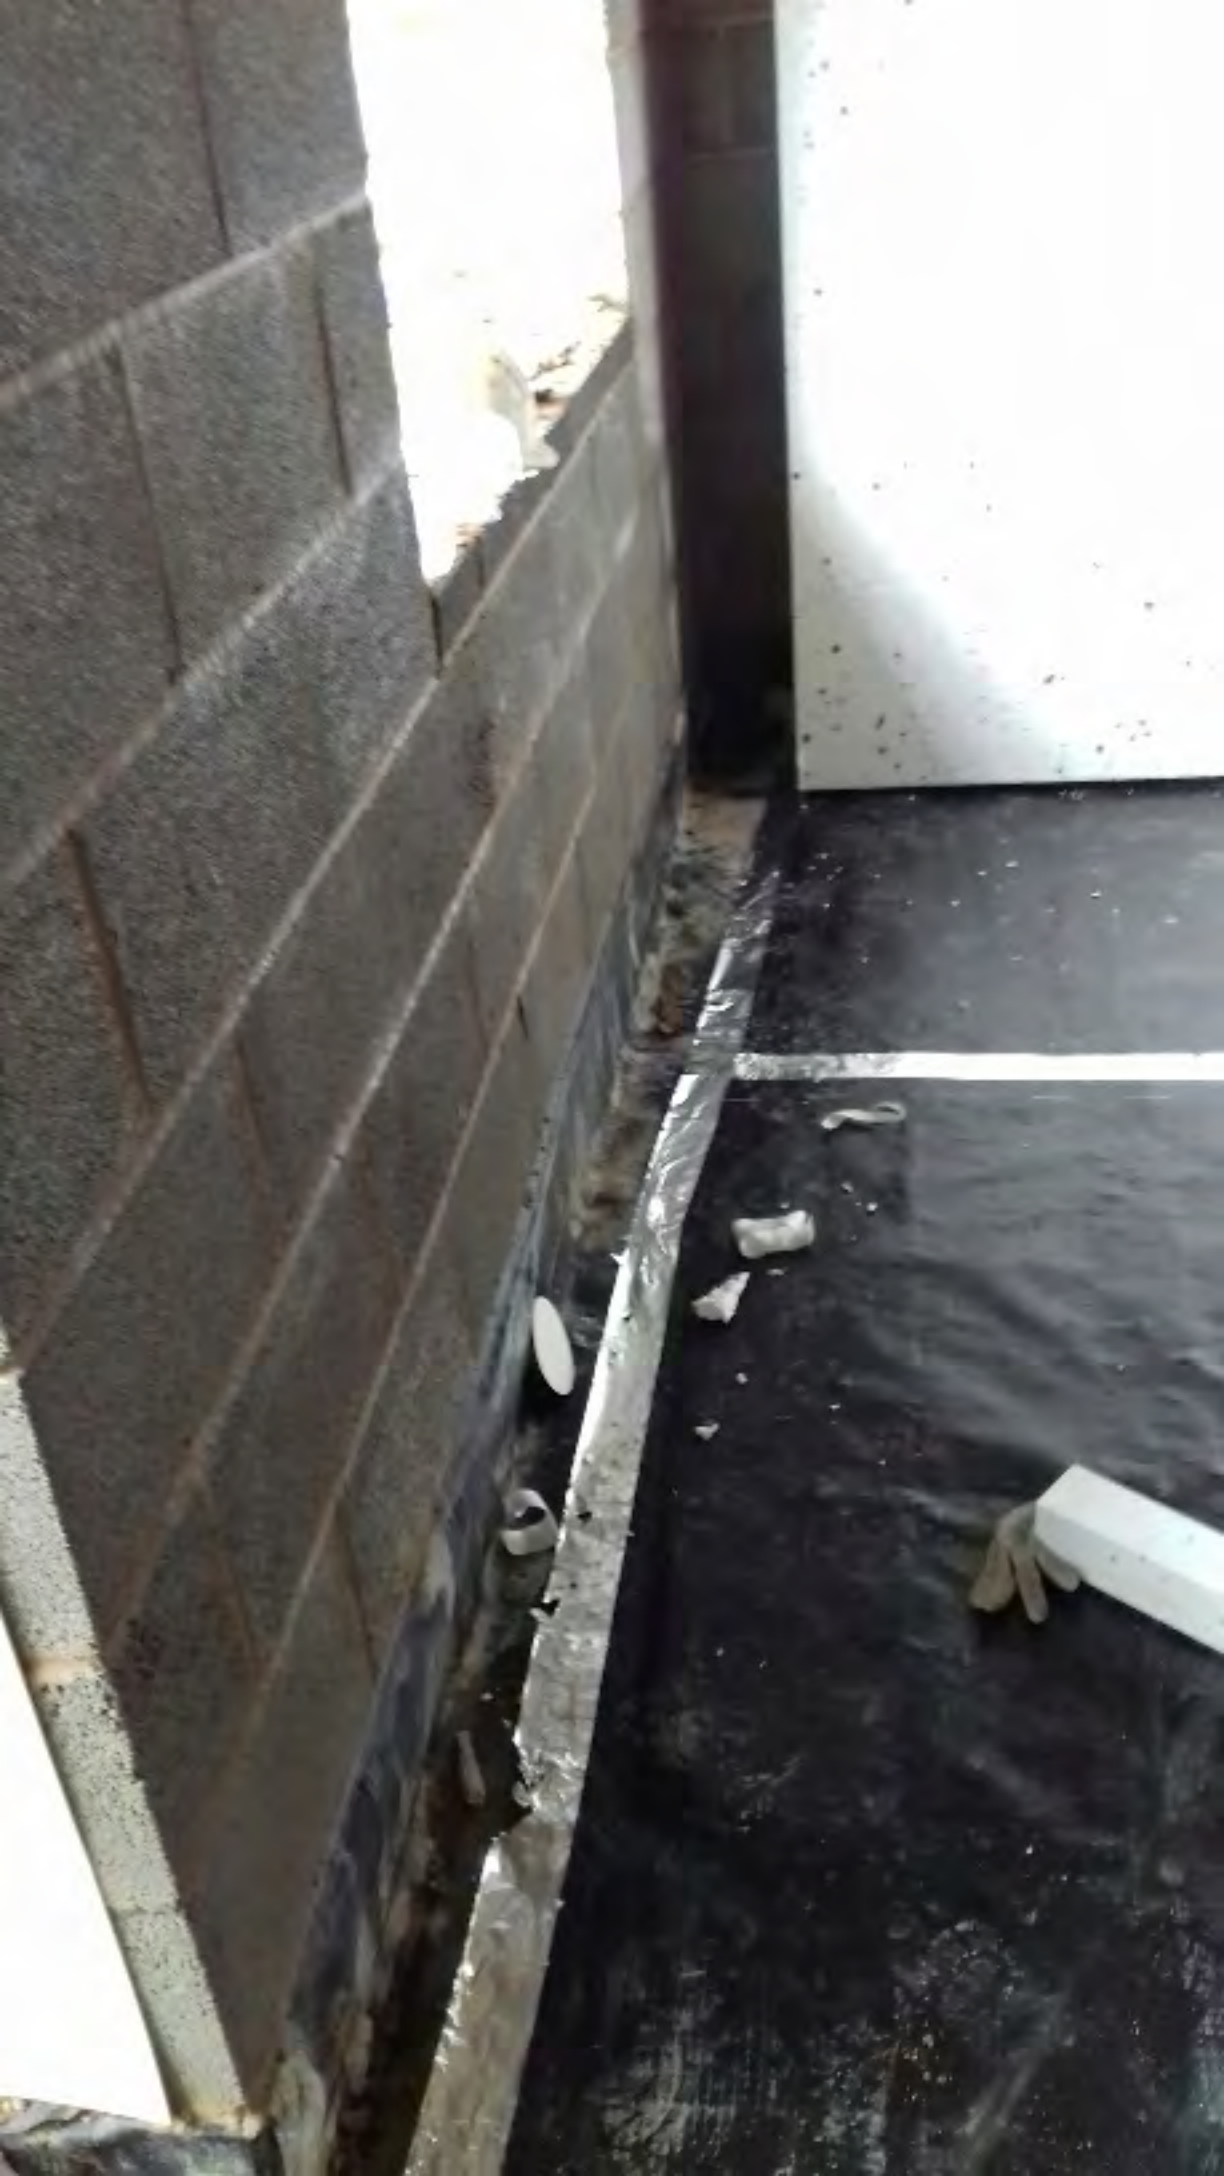
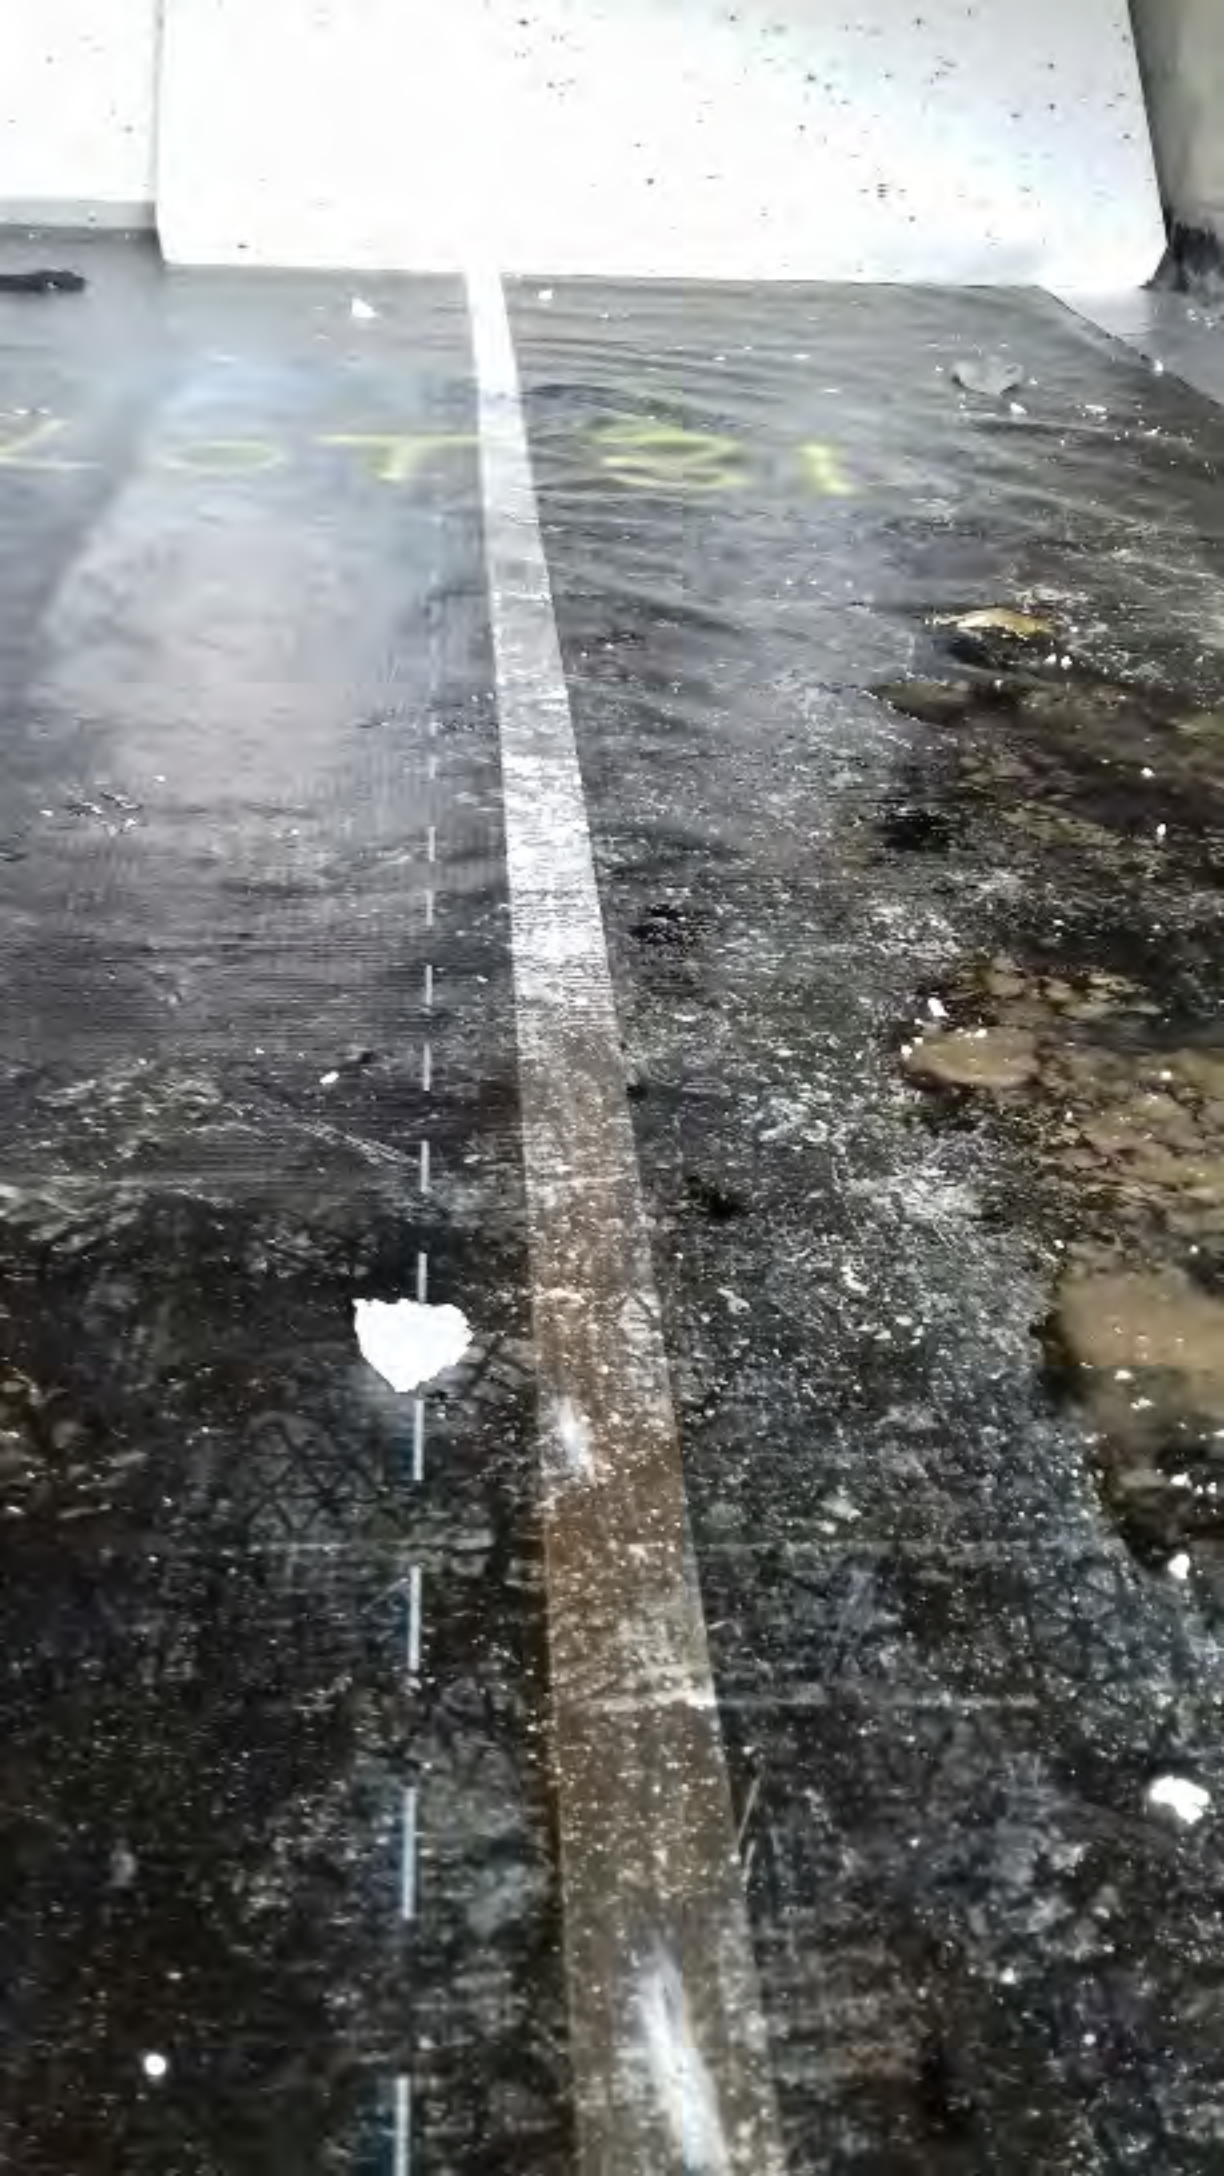
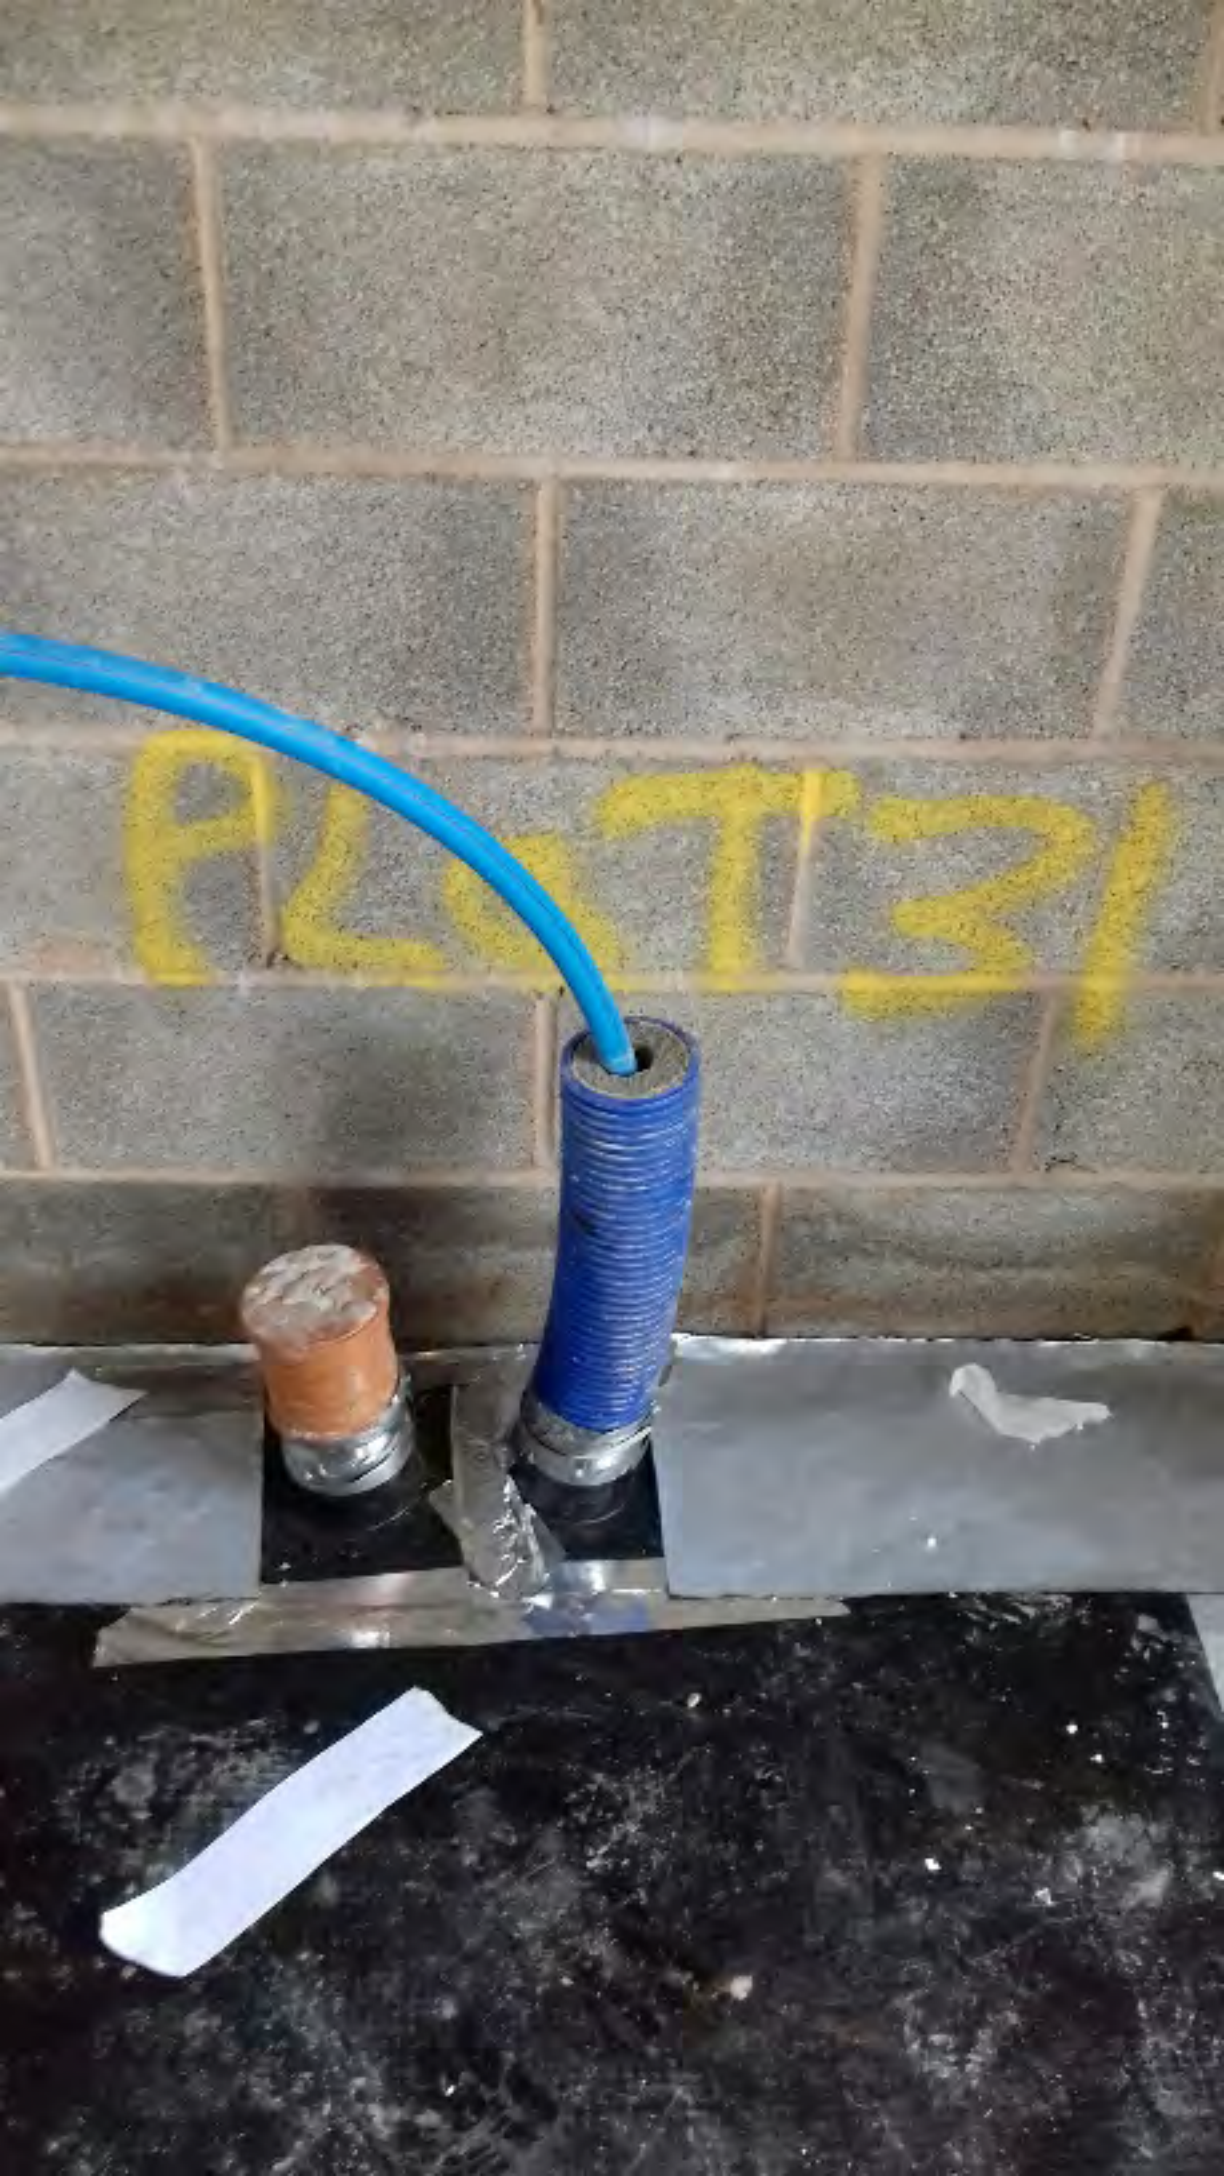
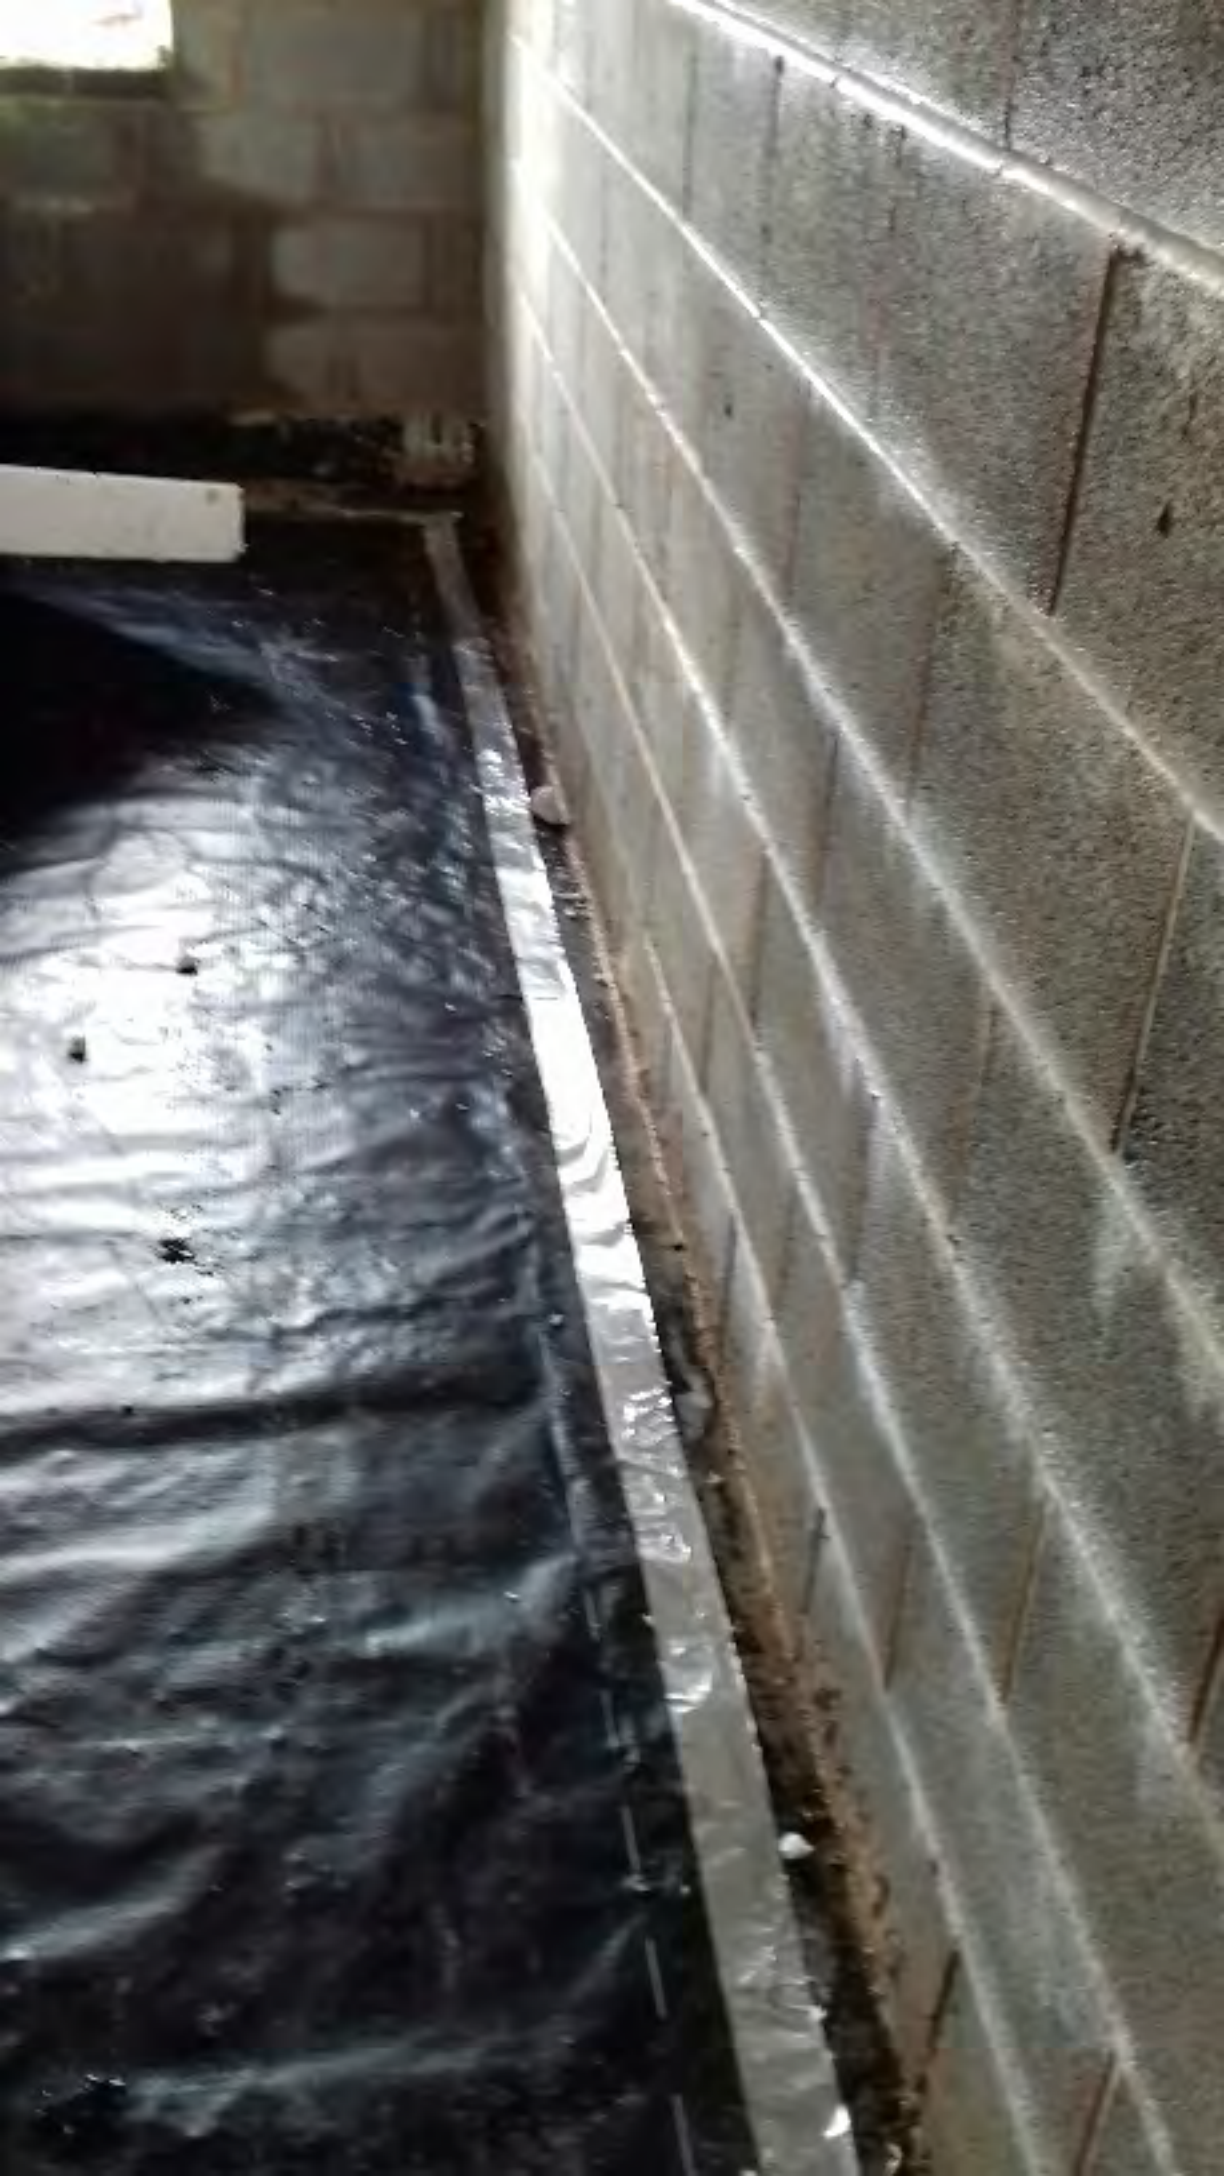
PLOT 31

| 2.2 | Condition of sub-grade & underside of gas membrane | ALL TAPES APPLIED WELL AND SEALED TO A GOOD QUALITY – FLOOR BRUSHED | | | | | |
| 2.4 | Gas membrane condition and coverage | GOOD, SEALED ON ALL FOUR SIDES | | | | | |
| 2.7 | Condition of joints/seals | VISIBLE OVERLAPS, ALL GOOD | | | | | |
| 2.8 | Number and condition of service entry seals | ALL OK, 3 NO TOPWATS WITH SUBILEE CLIPS – ALL TAPES CHECKED | | | | | |
